Field Testing of an Unvented Roof with Fibrous Insulation, Tiles, and Vapor Diffusion Venting

Building America Report - 1511

November 2015

Kohta Ueno and Joseph Lstiburek

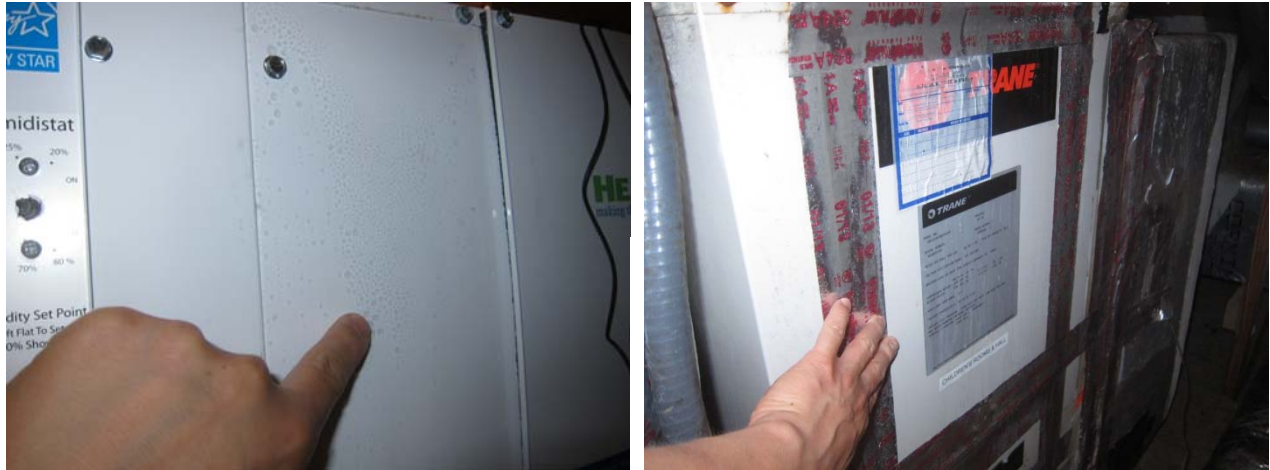
equipment surfaces compared with high-dew-point attic (essentially exterior) air (Figure 5). This condensation adversely affects durability of mechanical equipment over time.

Figure 5. Condensation on HVAC equipment located in vented attic (CZ 2A)

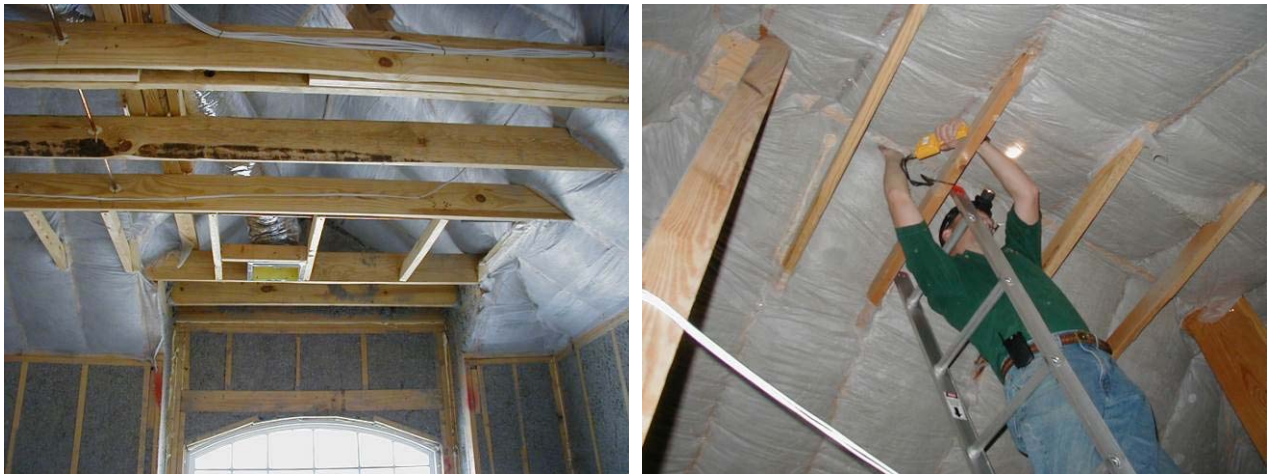
During the first fall of operation, the homeowner reported seeing reflections of moisture condensation and dripping from the ridge of the unvented attic from the interior. Site investigations (Figure 9, right) revealed elevated wood MCs at the ridge and evidence of previous condensation (such as rusted staples).

Figure 9. Netted and blown cellulose roof insulation in Houston (left); MC at the roof ridge (right)

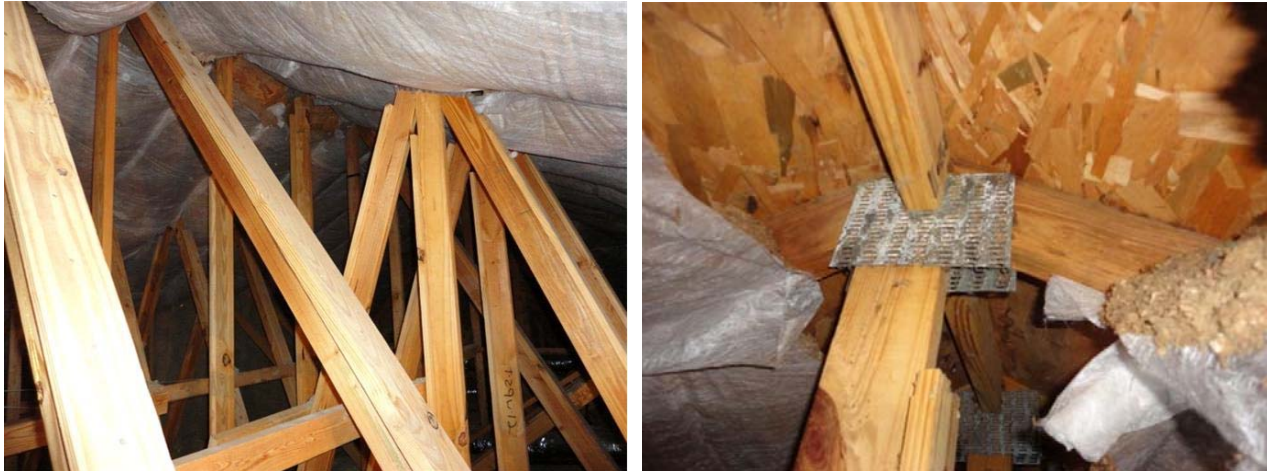
During a site visit, the cellulose and roof sheathing were wet to the touch, and the steel truss plate was corroded; however, the wood had not decayed. In response, the insulation was removed near the ridge (roughly 2 ft; Figure 10, right) to increase surface temperatures at the condensing roof sheathing surface. This roof has been rechecked over time (circa 2003 and as recently as March 2014); roof sheathing conditions remained dry with this assembly.

Figure 10. Cellulose roof insulation in Jacksonville (left); corrosion of ridge truss plate (right)

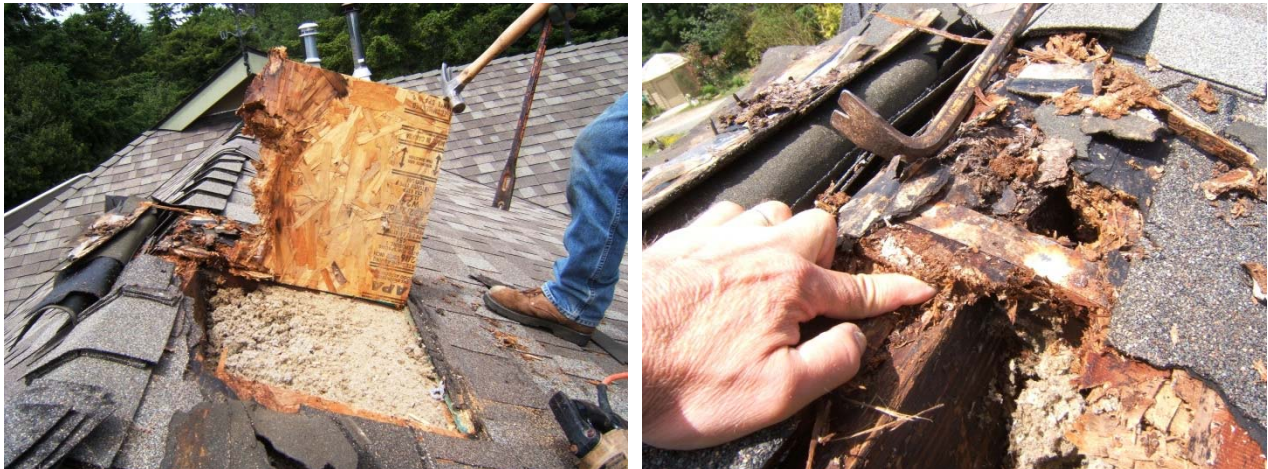
Moisture issues in unvented roof assemblies often manifest in the form of damage to the sheathing at the ridge of a sloped roof, colloquially known as *ridge rot*. An example is shown in Figure 11, which was a dense-pack cellulose roof in a northern California location (CZ 3C).

Figure 11. Ridge sheathing degradation with dense-pack cellulose in northern California

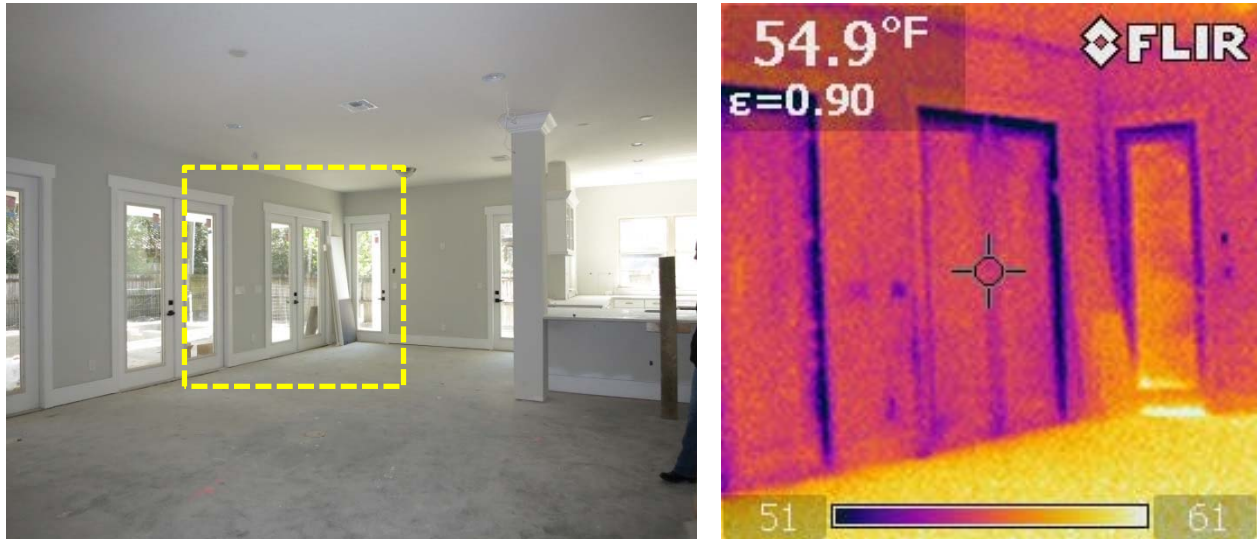
Figure 36. Visual (left) and infrared (right) image during depressurization testing, showing door leakage

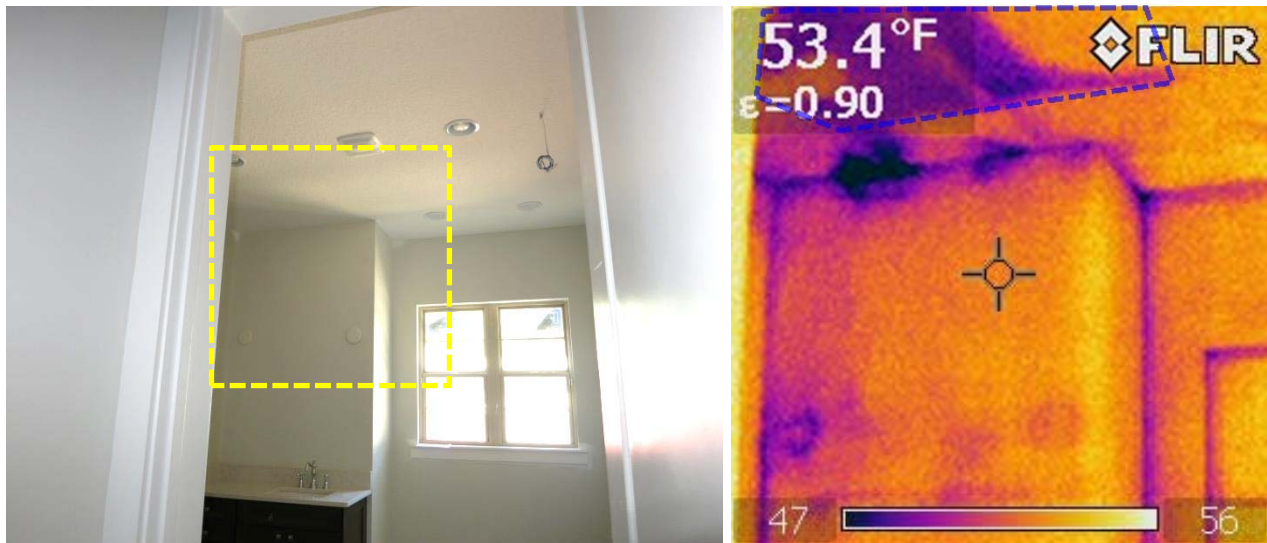
Figure 41. Bathroom ceiling air leakage at roof-wall interface; water leak in blue (Location A)

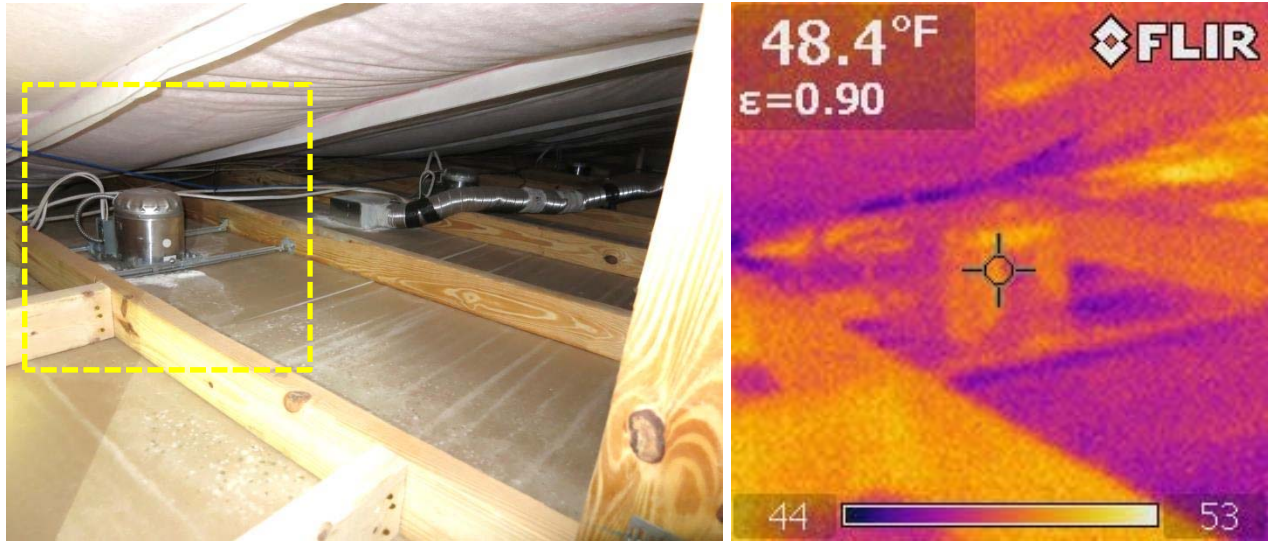
Figure 42. Roof-wall connection above bathroom; water damage at ceiling visible (Location A)

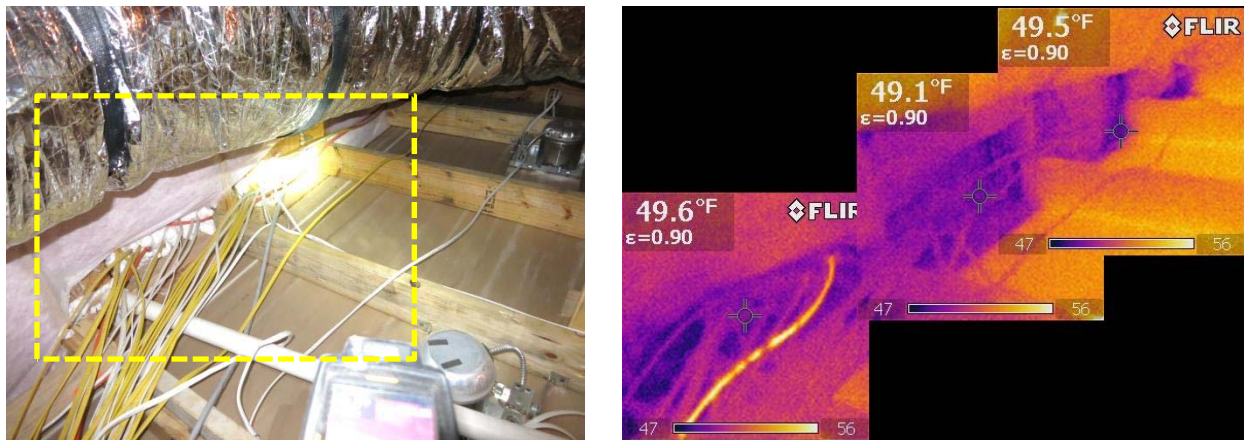
Figure 43. Air leakage at wiring penetrations at garage wall-top plate (Location B)

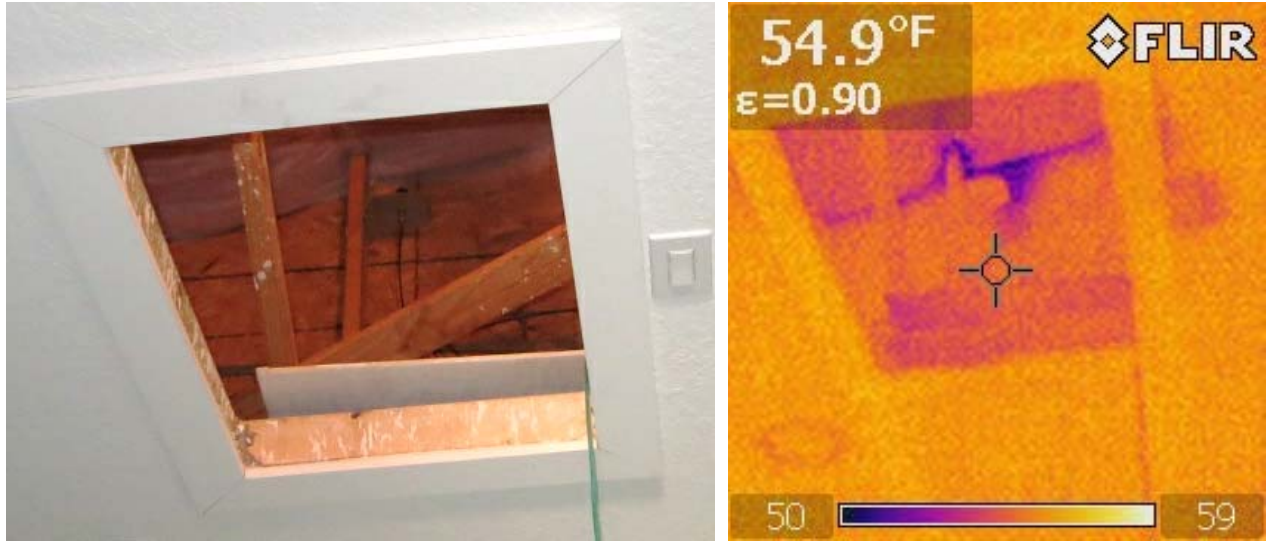
Figure 44. Air leakage at stud below roof-wall interface (Location C)

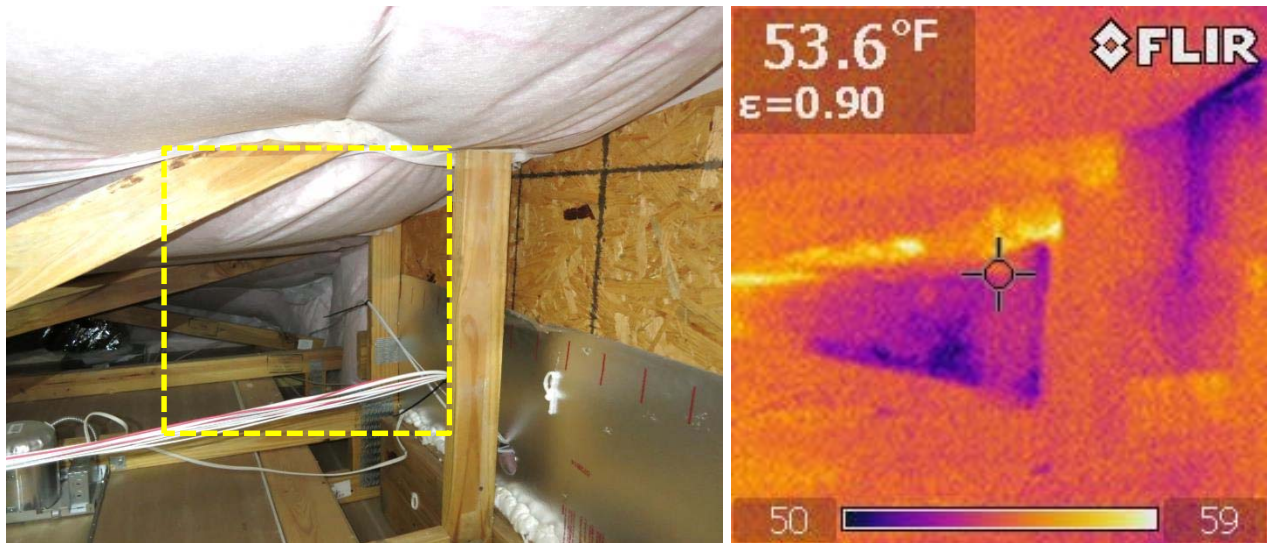
Figure 45. Air leakage at roof-wall interface, and at unconditioned porch attic (Location D)

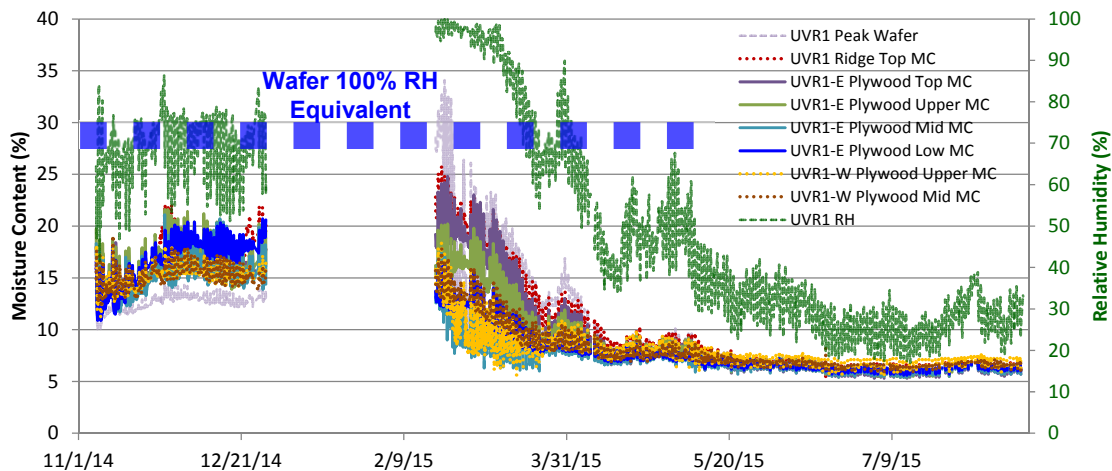
Figure 59. Unvented roof (UVR1) MC and RH measurements (second-floor attic)

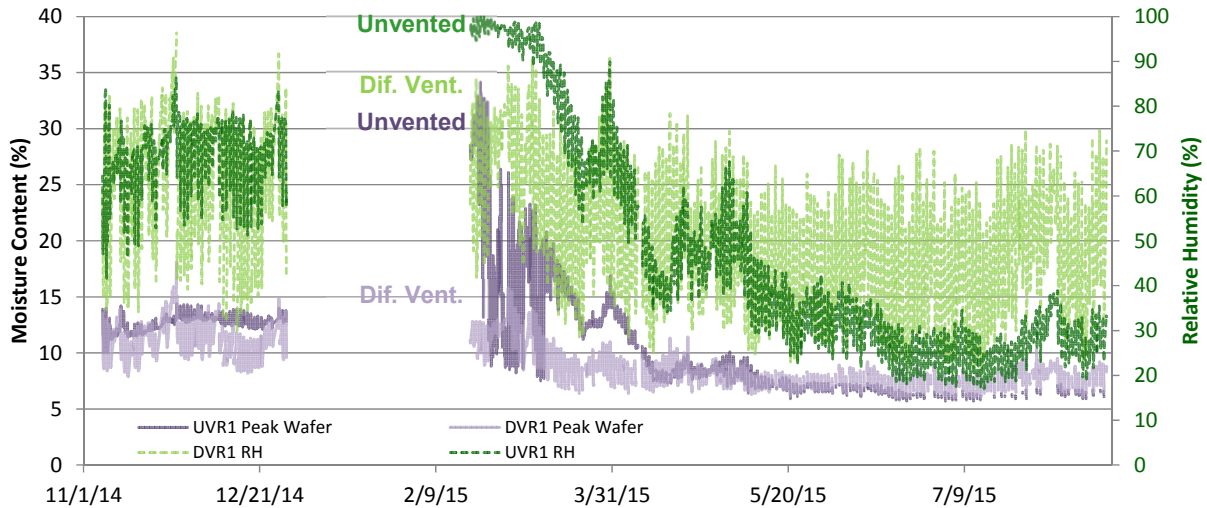
Figure 67. Comparison of unvented (UVR1) and diffusion vent (DVR1) ridge wafer MC and RH
