## Multi-Tenant Retail Building

New England  
2008

Investigation:  
Sewer Gas Odor

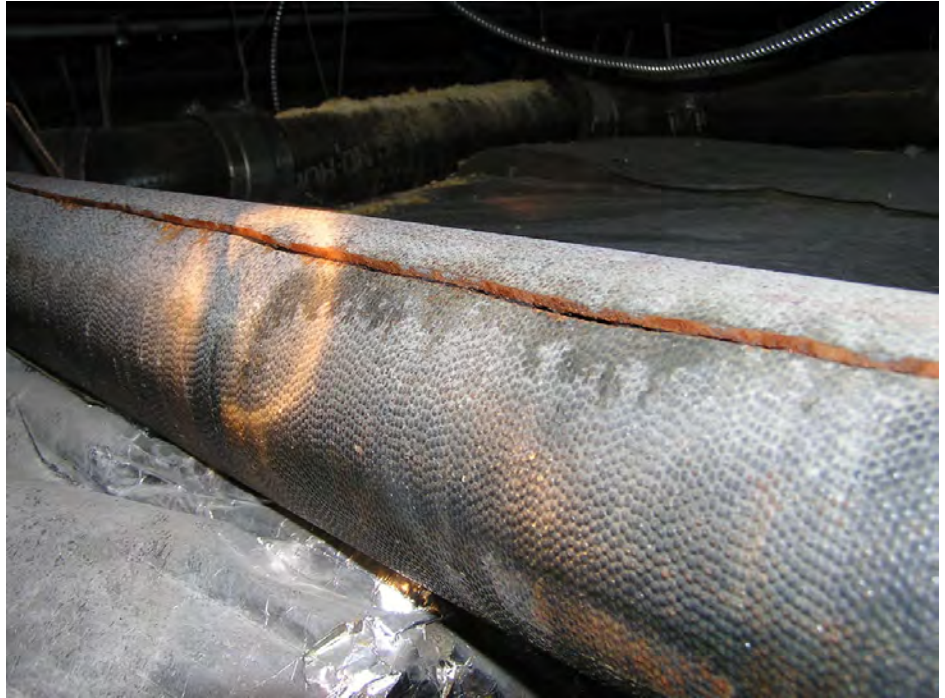
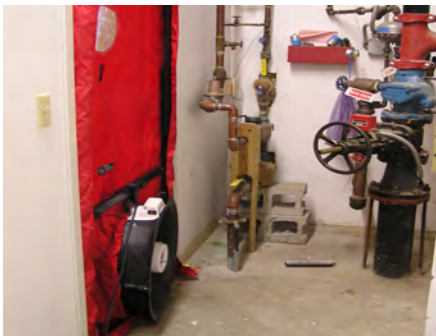
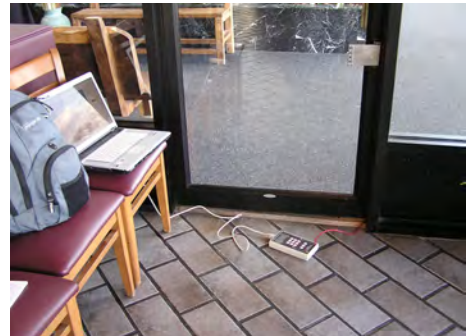
Complaints of intermittent sewer gas odors were reported in a two-story commercial building that included a restaurant and other tenant stores. BSC was retained by the building owner to help locate the cause of the odor. BSC testing to locate the odor included measuring pressure relationships between the building spaces under various conditions, reviewing a timeline of climate conditions during the time when the odor had been reported (wind speed, temperature, humidity, barometric pressure) and induced pressure differences to amplify the odor. During the investigation, a failed make-up air unit was discovered on one of the kitchen range hoods. But ultimately, the source of the odor was found in the suspended ceiling of a store adjacent to the kitchen; this location was investigated because of a measured pressure differential. The culprit was a horizontal cast iron soil pipe for second floor plumbing that had developed a crack along the length of its top side, releasing sewer gas odors when toilets were flushed, but not leaking drain water.
