Window Leakage

Midwest
2016

Investigation:
Forensic Investigations

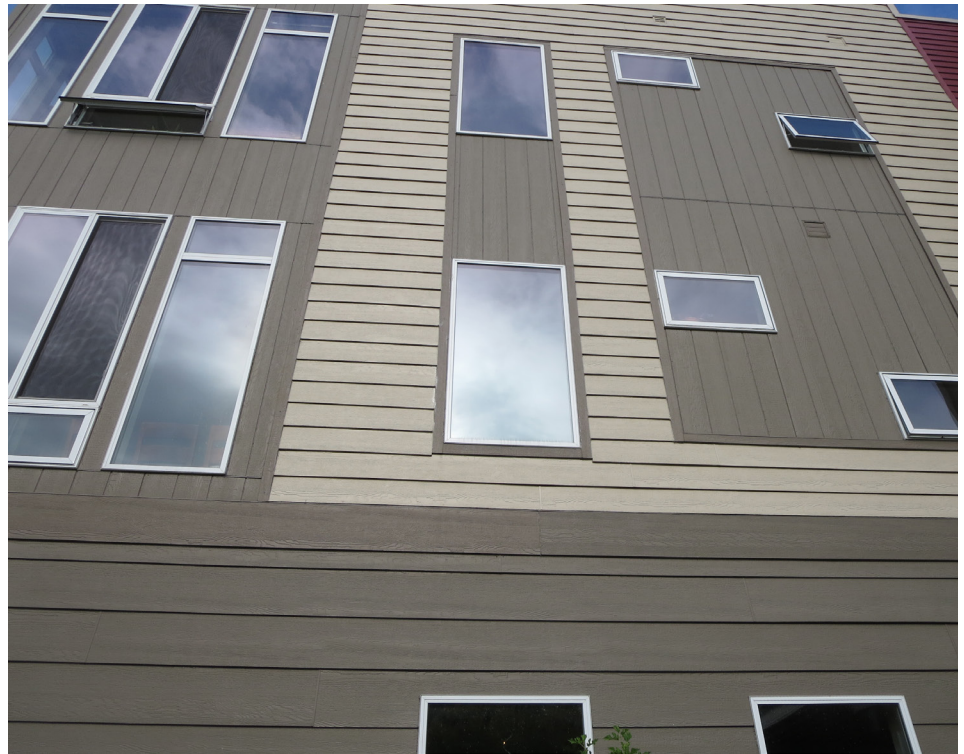
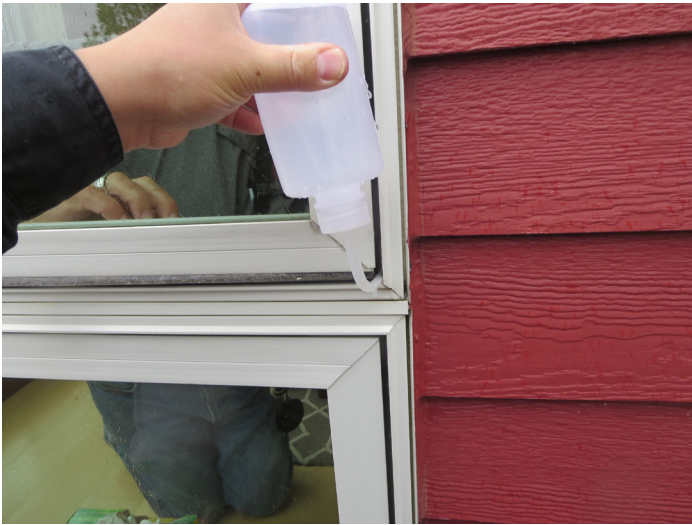
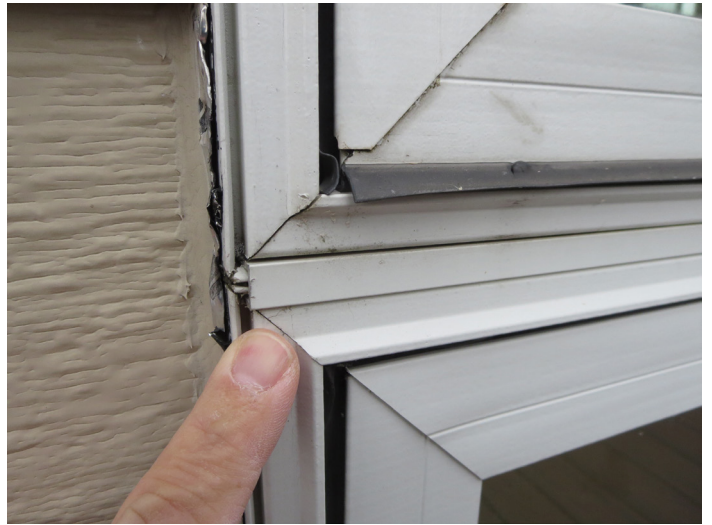
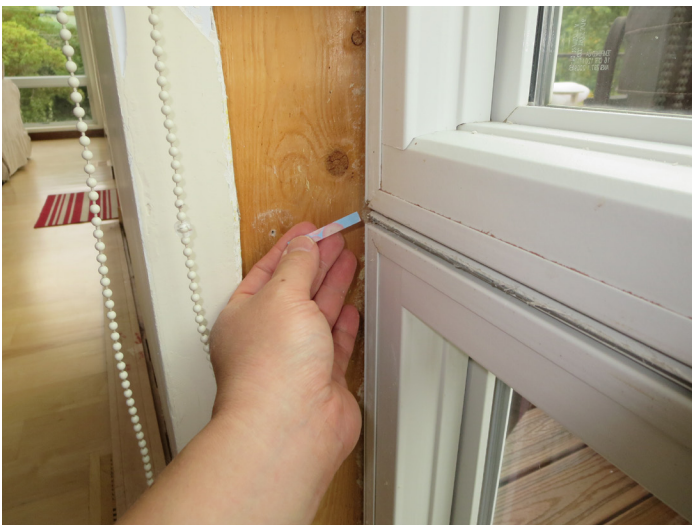
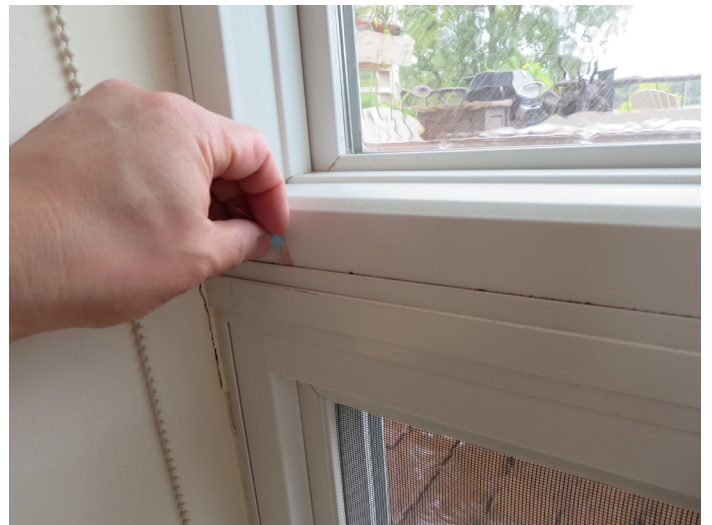
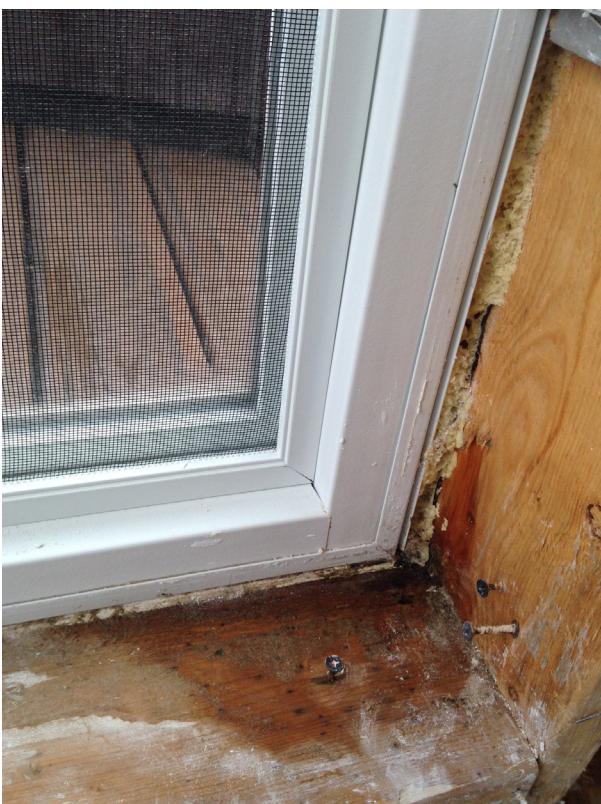
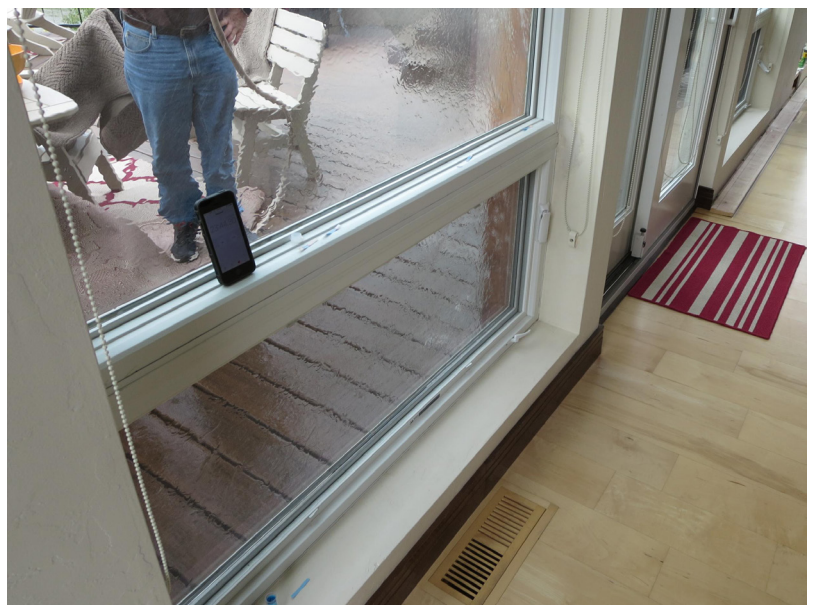
BSC was asked to examine bulk water intrusion issues occurring at windows (and window-wall interfaces) in recently built residential construction. The residences were a modern design, with low-slope roofs, no overhangs, and multiple cladding types and colors; the exterior wall sheathing was either OSB structural panel or structural rigid foam, with the exterior surface taped as the water control layer (drainage plane). The client reported that the window leaks typically began to occur over time, after the first year of operation. Closer examination revealed that most of the windows were factory-mulled units, with interior gypsum board/drywall returns, on all four sides. Existing damage was typically found at the bottom/sill corner of windows, and at the jamb mull joint. A sill flashing (adhered membrane tape in the window rough opening) extends roughly 6" up from the sill, but there is no sloped sill or backdam detail. The windows were tested via water spray and building depressurization to simulate the effect of wind-driven rain, similar to conditions causing the water leakage problems. This testing indicated that water accumulated at the factory mull and ran to the interior at the jambs, wetting interior finishes. In addition, the lack of a sill pan backdam or sloped sill meant that incidental water leakage was not drained out via the sill pan flashing. Additional testing using water injection past the fixed sash gasket demonstrated another water leakage path consistent with the interior leakage problems. BSC's recommendations included identification of the source of the water leakage, and recommendations on ameliorating the problems.
