# Exterior Portland Cement Plaster

15<sup>th</sup> ANNUAL WESTFORD SYMPOSIUM ON BUILDING SCIENCE

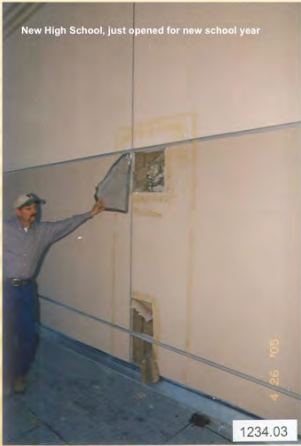
New High School, just opened for new school year

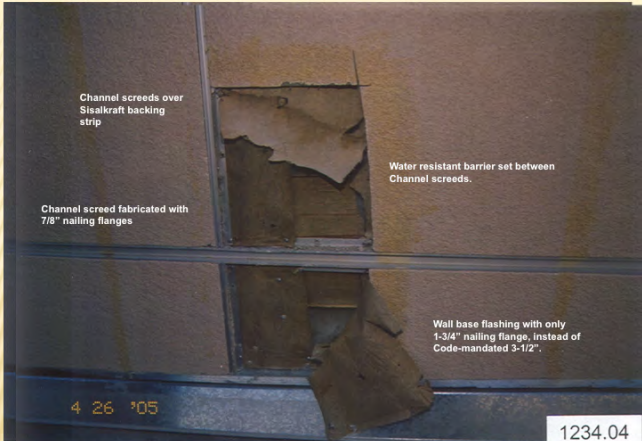
1234.04

Channel screeds over Sisalkraft backing strip

Water resistant barrier set between Channel screeds.

Channel screed fabricated with 7/8" nailing flanges

Wall base flashing with only 1-3/4" nailing flange, instead of Code-mandated 3-1/2".

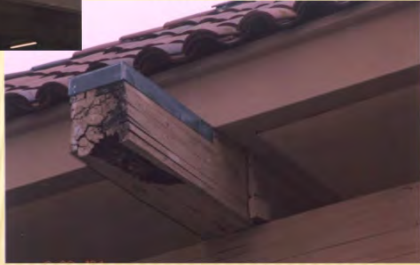
Galvanized sheet metal caps added month after original site observations.
