How to Look at a House like a Building Scientist (Part 4: Water)

By Kohta Ueno, Senior Associate, Building Science Corporation

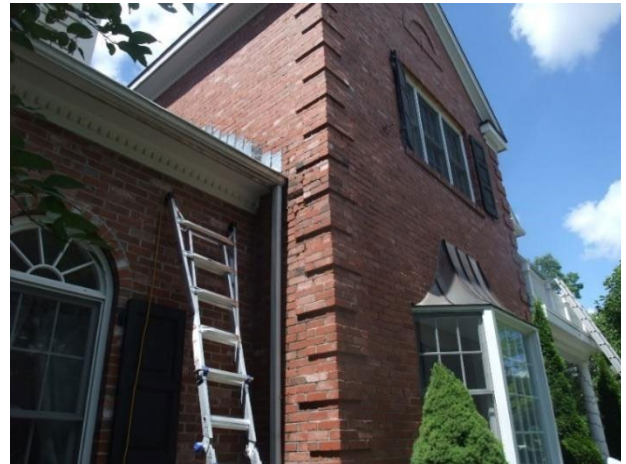
An example of a water deflection problem is a kickout flashing. Figure 2 shows a case where a downward-sloping roof terminates in the middle of a wall. Looking closer (Figure 3), you can see moss growing

Figure 2: Roof-to-wall interface at brick building

The answer, of course, is that this geometry requires a kickout flashing (Figure 6), to deflect the concentrated roof runoff away from the vulnerable wall surface. Figure 7 shows some of the critical dimensions for fabricating a sheet metal kickout flashing, or you can buy commercially made kickout flashings [LINK: <https://www.dryflekt.com/>]

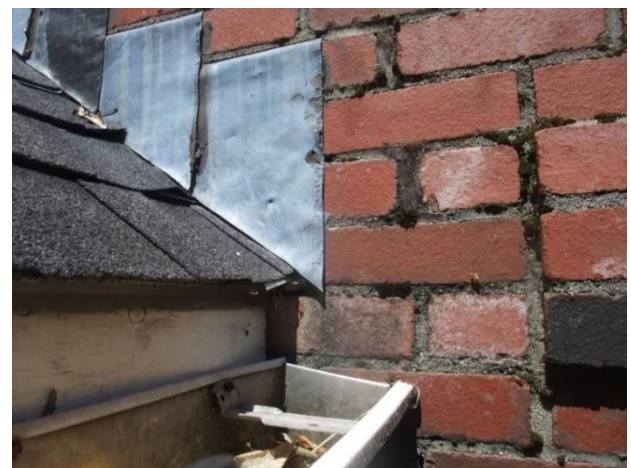
Figure 3: Moss growing on brick mortar joints

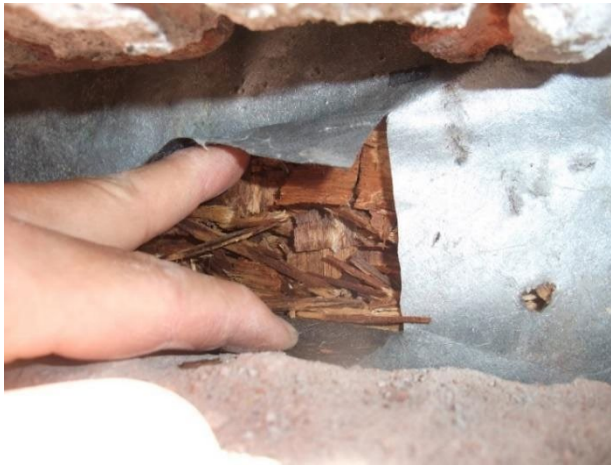
We opened up a brick, slit the housewrap (Figure 4), and the OSB sheathing showed signs of distress from long-term moisture exposure—you could pull strands off the surface by hand (Figure 5). The housewrap itself wasn't leaking—it was just more water than this assembly could take without degradation.

Figure 4: OSB behind housewrap

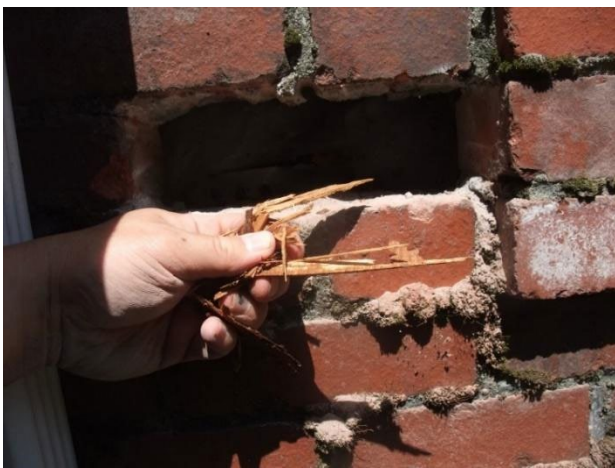
Figure 5: OSB strands hand-removable

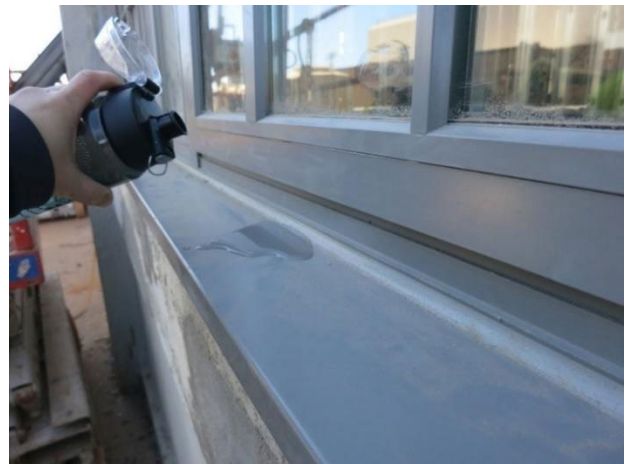
Figure 11: Water testing a sill with minimal slope

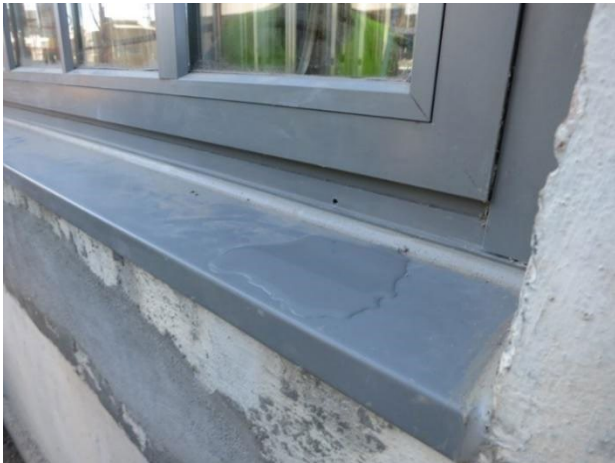
Figure 12: Water testing a sill with minimal slope

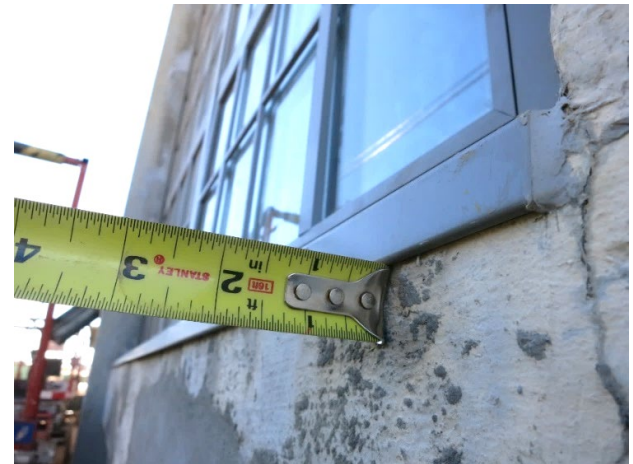
Also, this type of basic testing demonstrates the effectiveness of window drip edges. If the drip edge is pushed tight to the wall below (Figure 15), water’s surface tension will “wrap” it around the edge, and it will all end up on the wall below, instead of being ‘dripped’ away (Figure 16).

Figure 15: Sill drip edge pushed against wall

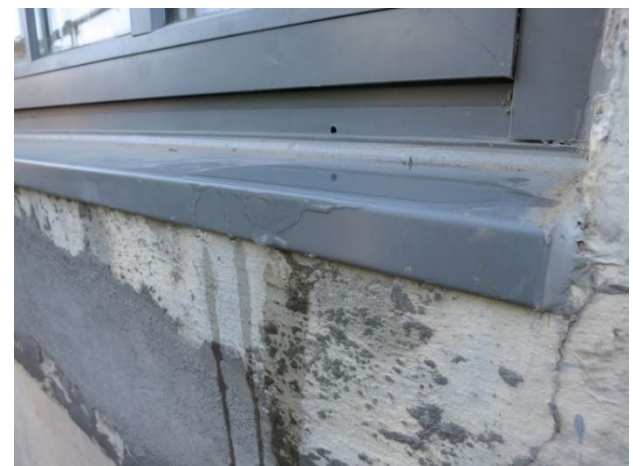
Figure 16: Window runoff spills onto wall below

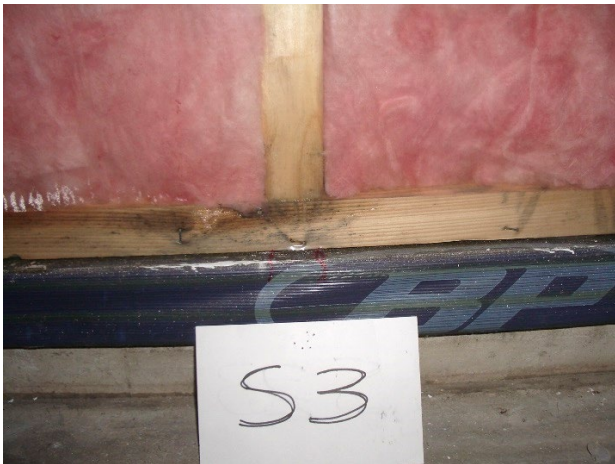
Often, you barely need a moisture meter to tell there's a problem—the wood feels wet to the touch, and you see other signs of distress. For instance, Figure 20 shows a test hut where we demonstrated inward moisture vapor drives from brick veneer: the brick was wetted by rain, the sun came out, “pushed” the moisture into the wall framing cavity, which condensed on the interior polyethylene, and ran down to the sill plate, soaking the inboard face. The MC measurement (Figure 21) was over 30%—we joke that MC is judged by how hard the needle hits the peg at the top of the scale.

Figure 20: Test hut sill plate soaked with water

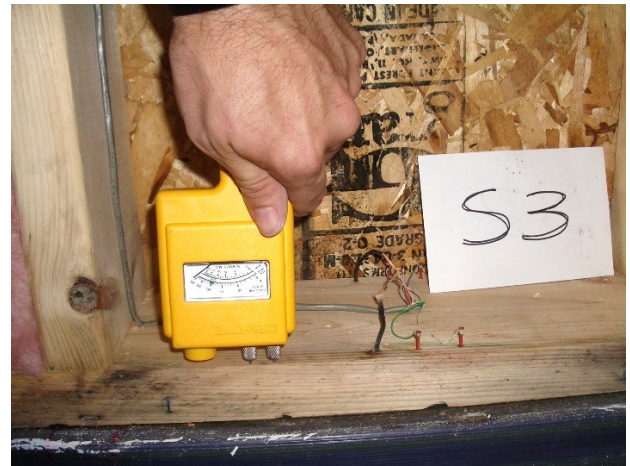
Figure 21: Delmhorst meter at interior of sill plate

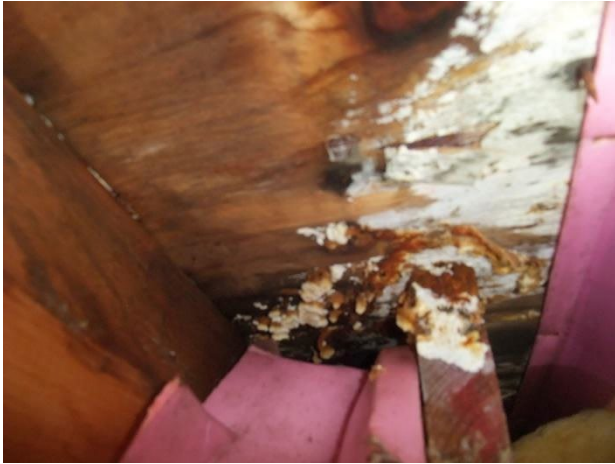
Similarly, if you have white and brown slimy mold growing on your roof sheathing, you know that you have a big problem (Figure 22); again, the moisture meter was pegged (Figure 23). Although the moisture problem seems obvious, taking these measurements can let you know—for instance—that the roof is dry in

Figure 22: Poorly vented cathedral roof fungus

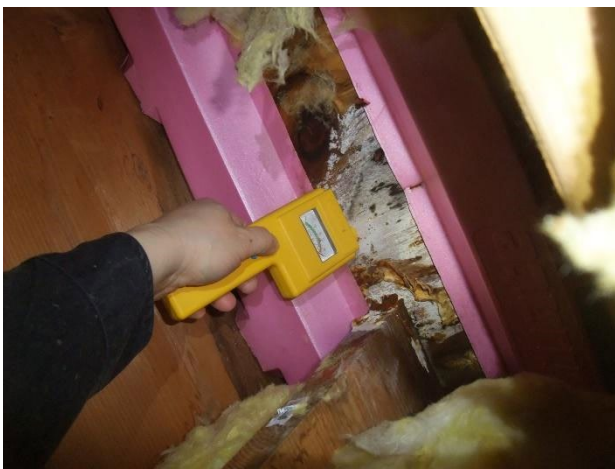
Figure 23: Delmhorst meter at roof sheathing

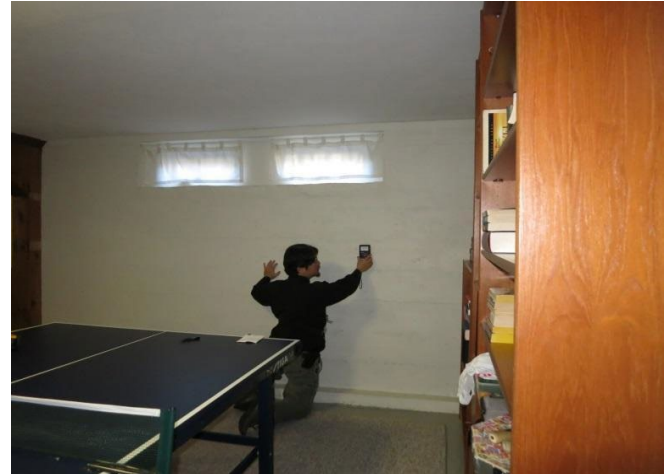
For example, in Figure 24, the homeowner complained about foundation moisture issues, as demonstrated by the interior paint/coating bubbling in spots. A map of the wall’s moisture (Figure 25) showed some pretty clear patterns: only the below-grade part of the wall was affected, and the worst

Figure 24: Tramex moisture meter measurement of CMU basement wall

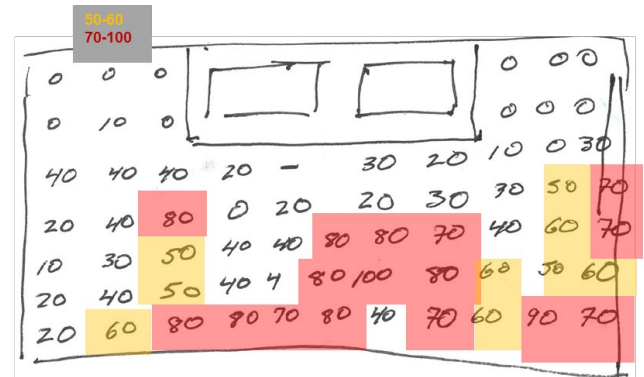
problems were near the bottom of the wall and the corner. That’s all consistent with groundwater penetrating the below-grade wall, and possibly running down to the bottom via the hollow CMU block cores.

Figure 25: Moisture map of CMU basement wall

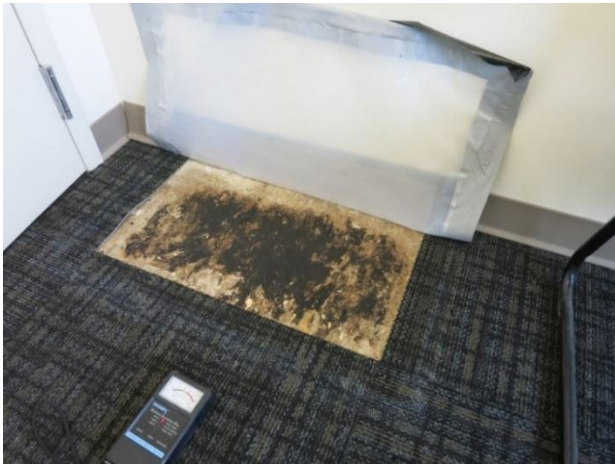
subfloor rot at areas over a slab on grade. The finish floor was rubber-backed carpet tile, adhered to the Advantech OSB subfloor; removing the carpet tile revealed black staining at problem areas (Figure 26). The same subfloor and carpet tile were used over the basement, which had no moisture problems or black staining (Figure 27).

Figure 26: Subfloor discoloration under carpet tile at slab-on grade condition

The problem was caused by moisture of construction in the concrete slab and the design of the sleeper and subfloor system. The rubber-backed carpet tiles are vapor impermeable (i.e., a “vapor barrier”), trapping moisture within the assembly. This moisture accumulated in the subfloor and sleepers, resulting in the rot damage. The “grid” pattern was caused by the small amount of drying available at the rubber carpet tile joints. The assembly was built contrary to the subfloor manufacturer’s directions, which call for a polyethylene vapor barrier on top of the slab, below the sleepers.

Our recommended remediation was to remove the sleeper and subfloor assembly, and rebuild with a layer that controls moisture emission from the slab.

Epoxy paint on the slab was recommended to control moisture, while being unaffected by the wet slab.

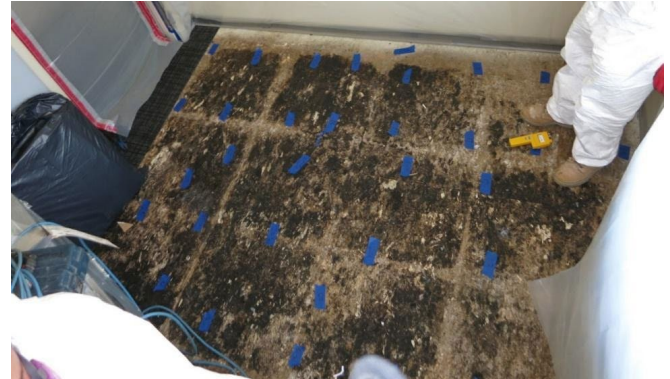
When the floor of an office was demolished, we found the black patterns exactly matched the carpet tile

layout—you could make out every joint (Figure 28 and Figure 29).

Figure 28: Discoloration matches carpet tile patterns

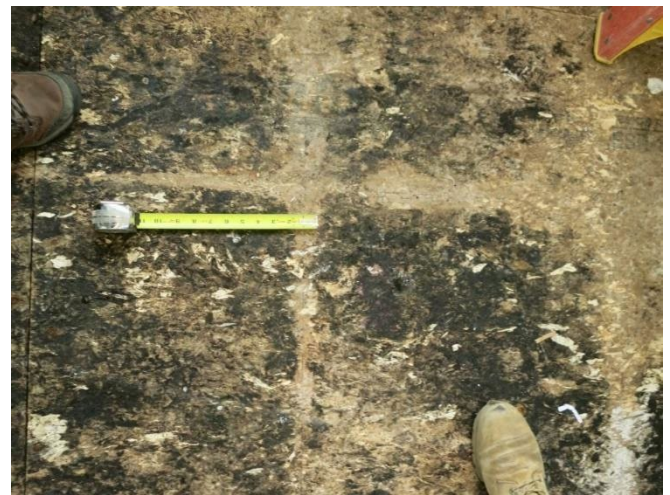
Figure 29: Less discoloration at seams

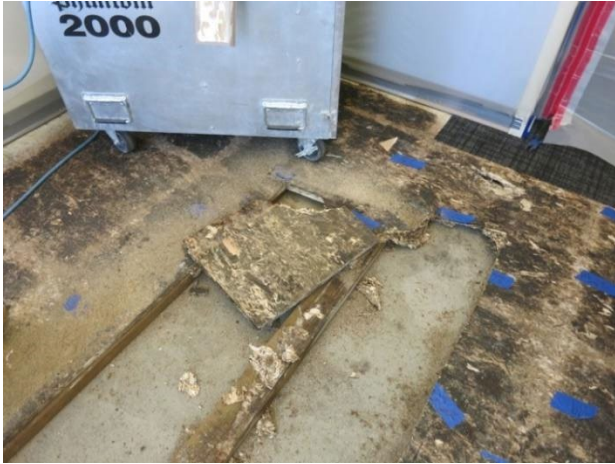
When they demolished the floor (Figure 30), we found extensive damage and high wood moisture contents in the subfloor and horizontal lumber sleepers on the slab (Figure 31). Typical subfloor MCs were in the 18-

Figure 30: Disassembly of floor over slab

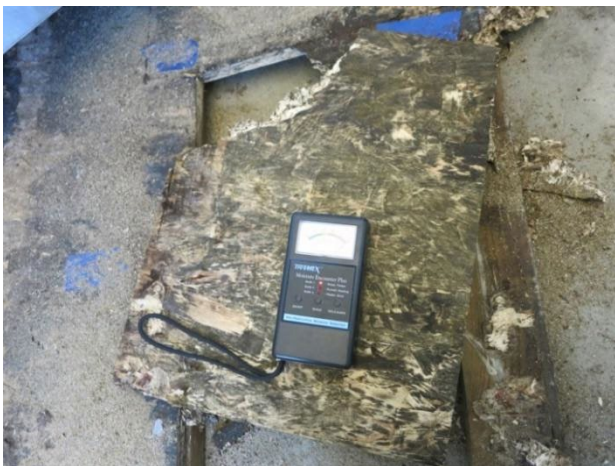
25% range; damage was visible on both top and bottom sides, but the bottom was wetter.

Figure 31: Tramex measurement of subfloor

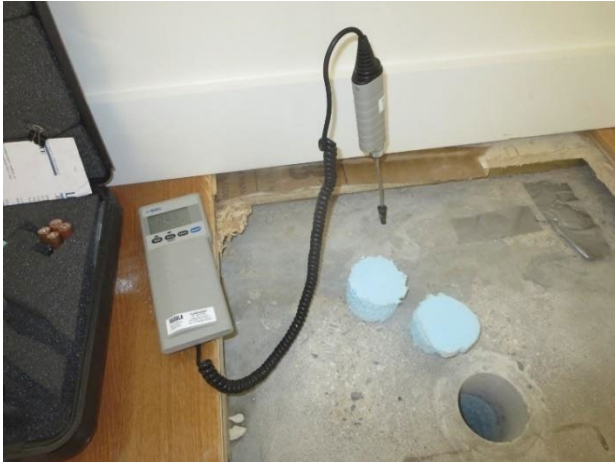
Much of the industry has switched to a measurement of the slab’s internal relative humidity, using a hole drilled into the slab (ASTM F2170). We did a quick field expedient version of this test at this project (Figure 32)—the full test involves leaving the probe in place for 72 hours. When we drilled down towards the bottom of the slab (Figure 33), we found there was

Figure 32: Slab internal T/RH measurement

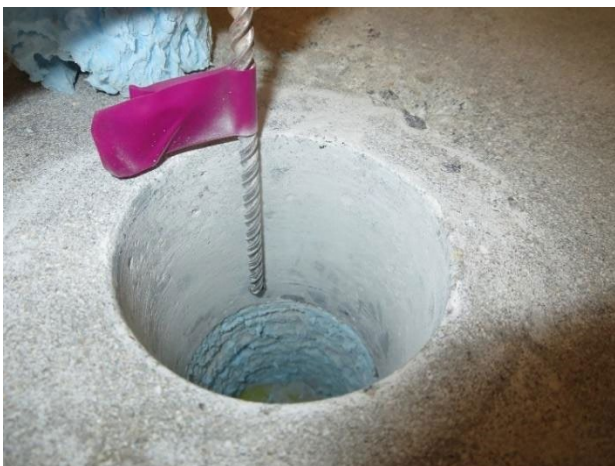
still a major reservoir of moisture there—95% RH and still creeping upward after 15 minutes.

Figure 33: Drilled hole to lower part of slab

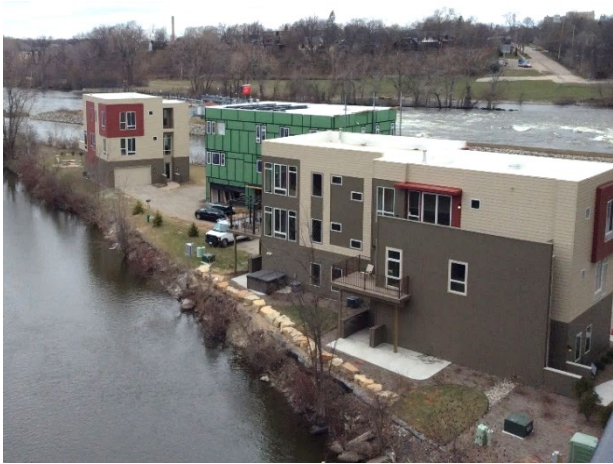
For example, we were asked to diagnose windows that leaked, but only when there was wind-driven rain coming from a certain direction at the site (Figure 39). The windows had been leaking since they were installed, with problems commonly showing up as

Figure 39: Residences with window leak issues

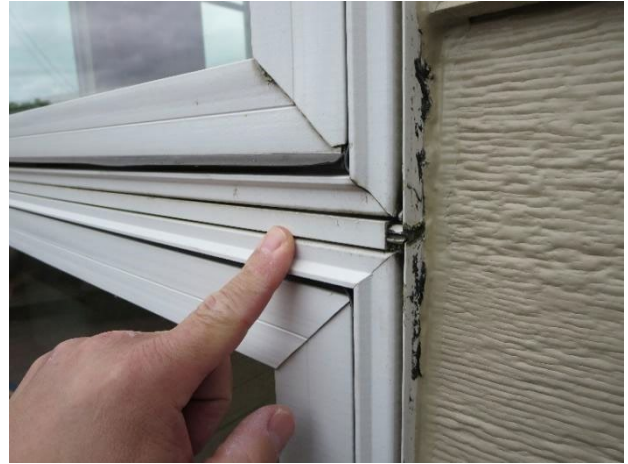
Figure 41: Windows muddled together (upper/lower)

But drywall problems were also seen at the window jambs, at the mull joint between the upper and lower window units (Figure 41 and Figure 42). Muddled

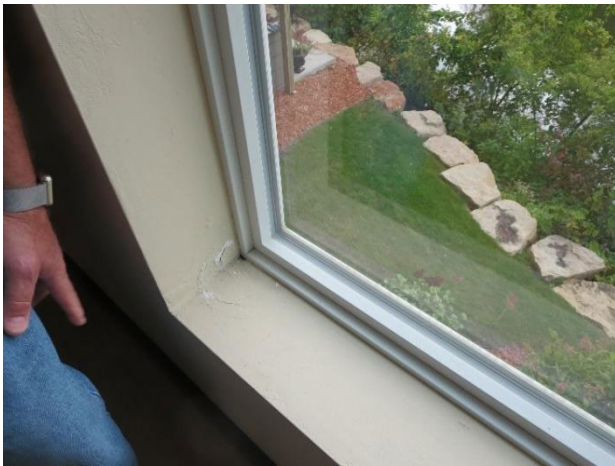
drywall bubbling at the bottom corners of windows (Figure 40), where leakage would tend to run down.

Figure 40: Damage at bottom window corners

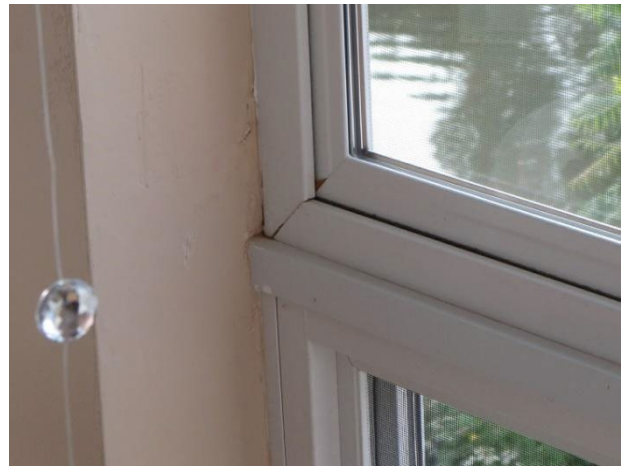
Figure 42: Damage at jamb at mull joint

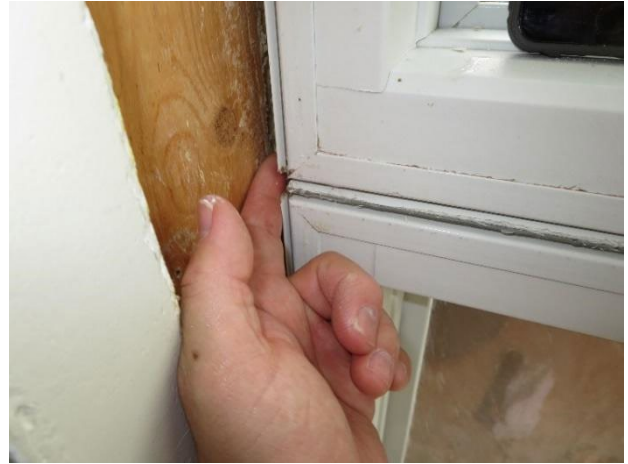
Figure 45: Water leakage coming in at mull joint

Within five minutes, we saw water coming in at the horizontal mull joint (Figure 45). We also demonstrated the leak with cobalt chloride water indicator paper strips (Figure 46): the color change is

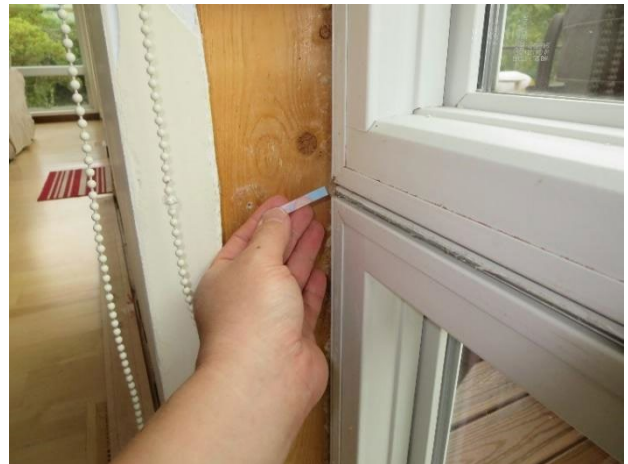
Figure 46: Cobalt chloride water indicator paper

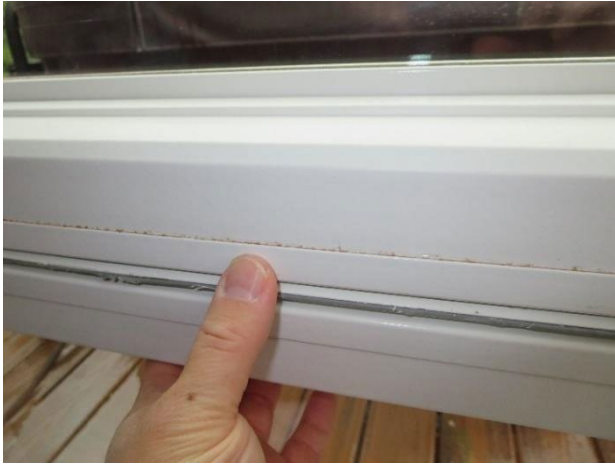
Also, pushing on the vinyl extrusion at the bottom of the upper window made water seep out of the joint (Figure 47); this was also confirmed with water indicator paper inserted into the joint (Figure 48). After taking a closer look at the window design, this water was on the “dry side” of the window (inboard of

the gaskets)—water getting back here is an indication that things had failed.

Figure 47: Water pushing on vinyl joint

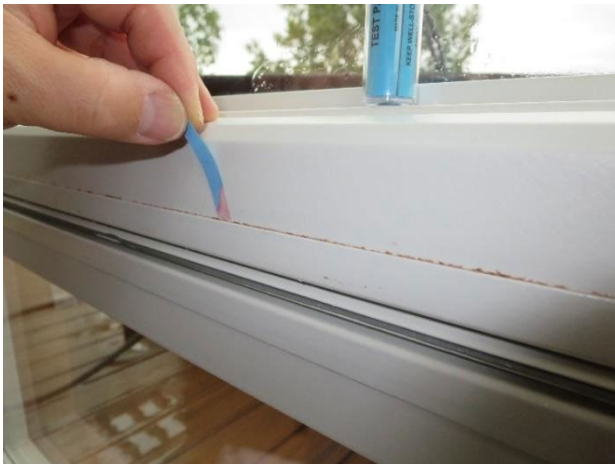
Figure 48: Water indicator paper to probe joint

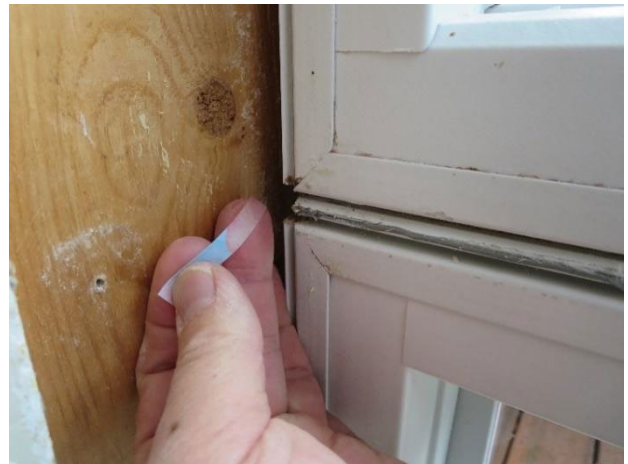
outboard ‘fin’ gasket, it would leak right in—again, confirmed with water indicator paper (Figure 50).

Figure 50: Water leakage due to injection

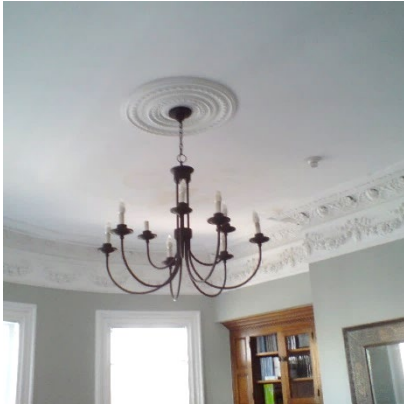
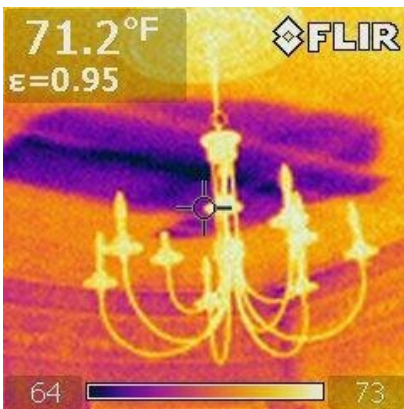
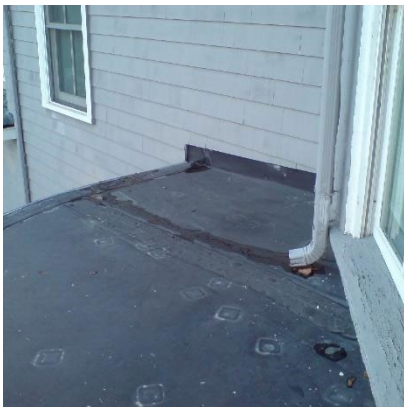
We can also use infrared thermography (i.e., an infrared camera) to look for water leaks; we touched on this topic briefly in Part 2 [LINK <https://buildingscience.com/documents/published-articles/pa-1902-how-look-house-building-scientist-part-2-heat>]. Water leaks often show up as cooler areas, both from cold water temperatures (e.g., rainwater), the cooling effect of evaporating water, and/or water’s thermal mass. An infrared camera made the roof/ceiling leak in Figure 51 obvious; the cause was a poor flashing connection between the

window sill pan flashing and the EPDM roof membrane.

Figure 51: Water leakage at roof/ceiling insulated with open cell spray foam; EPDM roof-to-wall joint

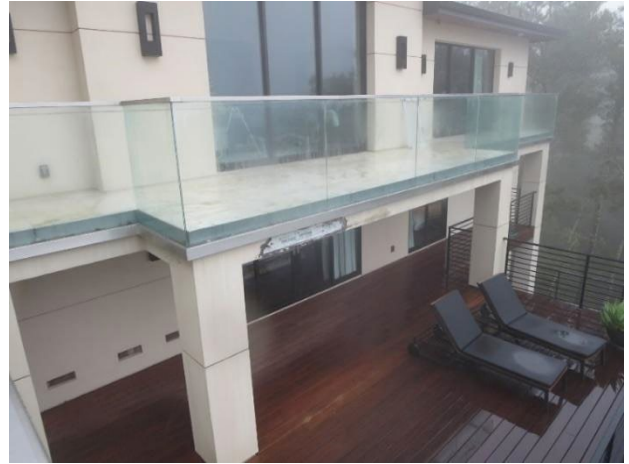
resulted in dripping, staining, and cracks in the stucco wall below (Figure 52 and Figure 53).

Figure 52: Balcony with glass railing

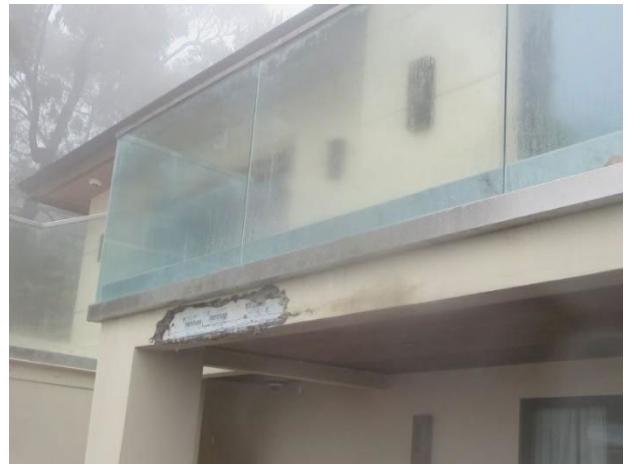
Figure 53: Leakage into stucco soffit below

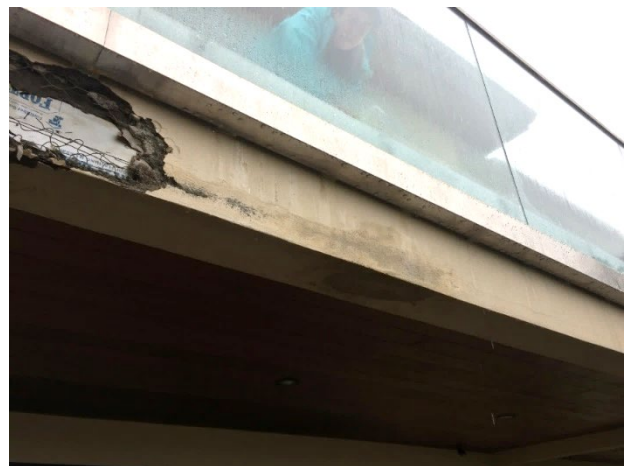
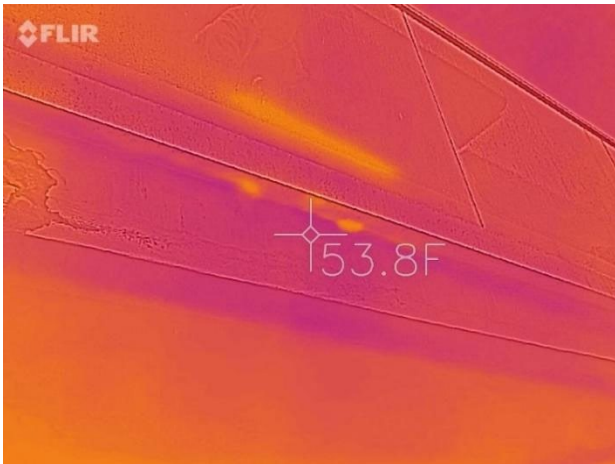
properly: it was damming up and getting into the stucco, rather than dripping freely to the deck below.

was all dammed up by the glass railing detail, causing the stucco damage (Figure 57).

Figure 57: Visual and infrared image of incorrectly-draining glass railing detail (no drainage gap)
