## Concrete Warehouse-Loft Conversion

Philadelphia, PA  
2013

Investigation: Endemic water leakage to interior

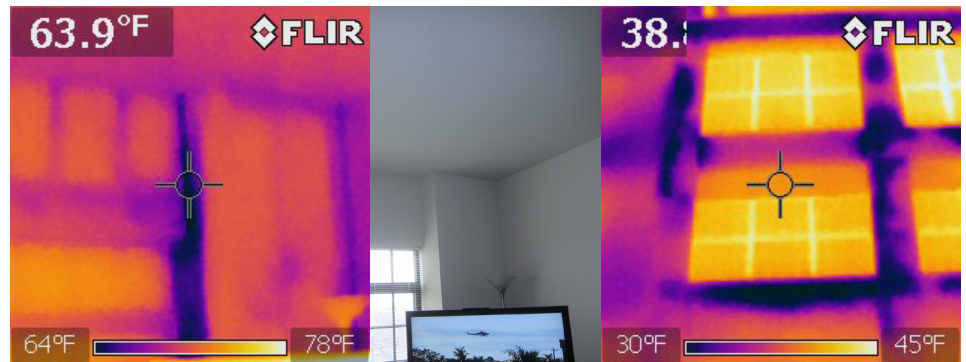
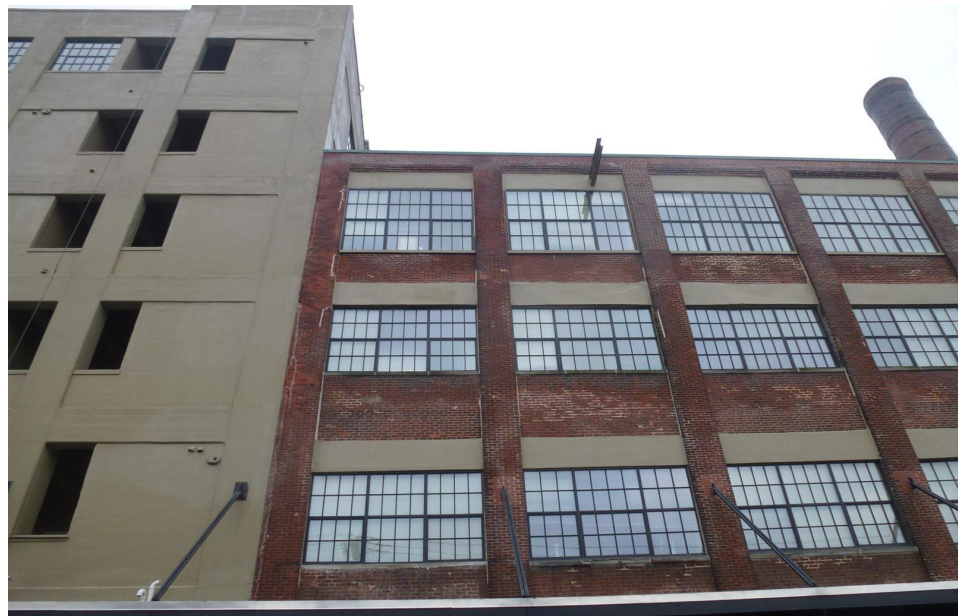
BSC investigated a circa 1940 concrete cast in place warehouse that was converted to residential lofts in 2005. There have been persistent water intrusion issues at the exterior walls; BSC was asked to determine the cause of some still-unsolved leaks. One issue was determined to be not water leakage, but interstitial (within the cavity) condensation. This problem manifested as water leakage at the window head return; opening the cavity showed pooling water, coming from the floor above. The floor above was finished with an insulated steel stud wall offset from the concrete wall by 8 inches, creating a cavity between the framing and masonry. Interior air leaked into the cavity, condensed, and ran out of the window head below. Other persistent leaks occurred at the top of the exterior wall on the uppermost floor. Disassembly revealed the pattern of water staining coming through at the roof-wall connection. The plans showed that the roof structure is sloped; the suspected issue was that rain leakage through roof deficiencies drain to the lowest part of the slab-insulation interface, and then leak to the interior. Water spray testing was used to eliminate rain penetration issues as a leakage source at some details. BSC provided remediation recommendations, including wall retrofit options, parapet, and window details.
