Corrosion of Galvanized Fasteners used in Cold-Formed Steel Framing

Ian N. Robertson Ph.D., P.E.

Steel Framing Alliance
and
University of Hawaii

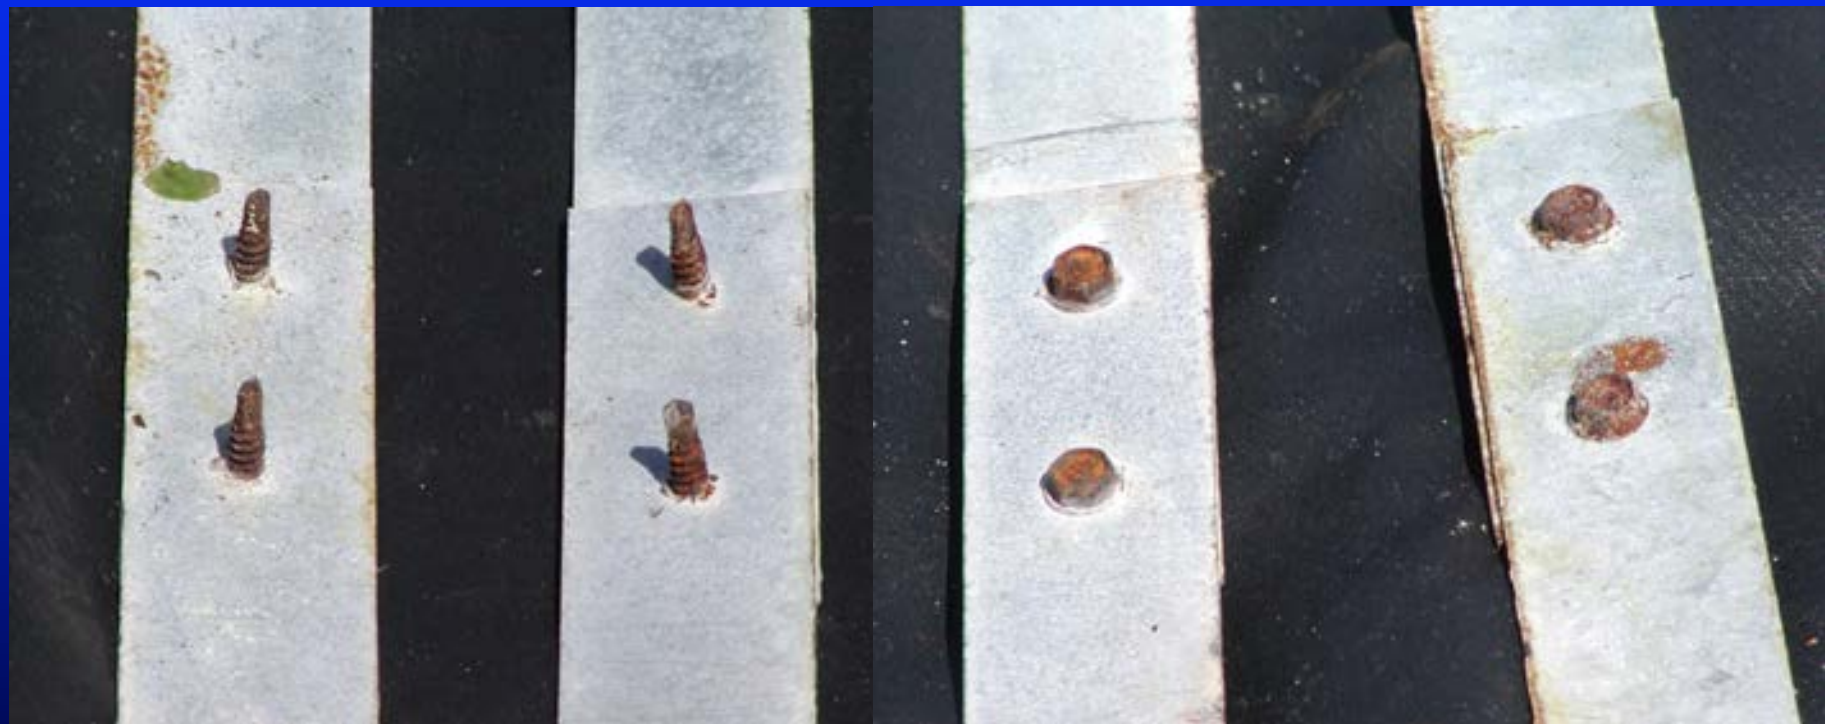
MCBH Coastal – Exterior Connections 7 Months Exposure

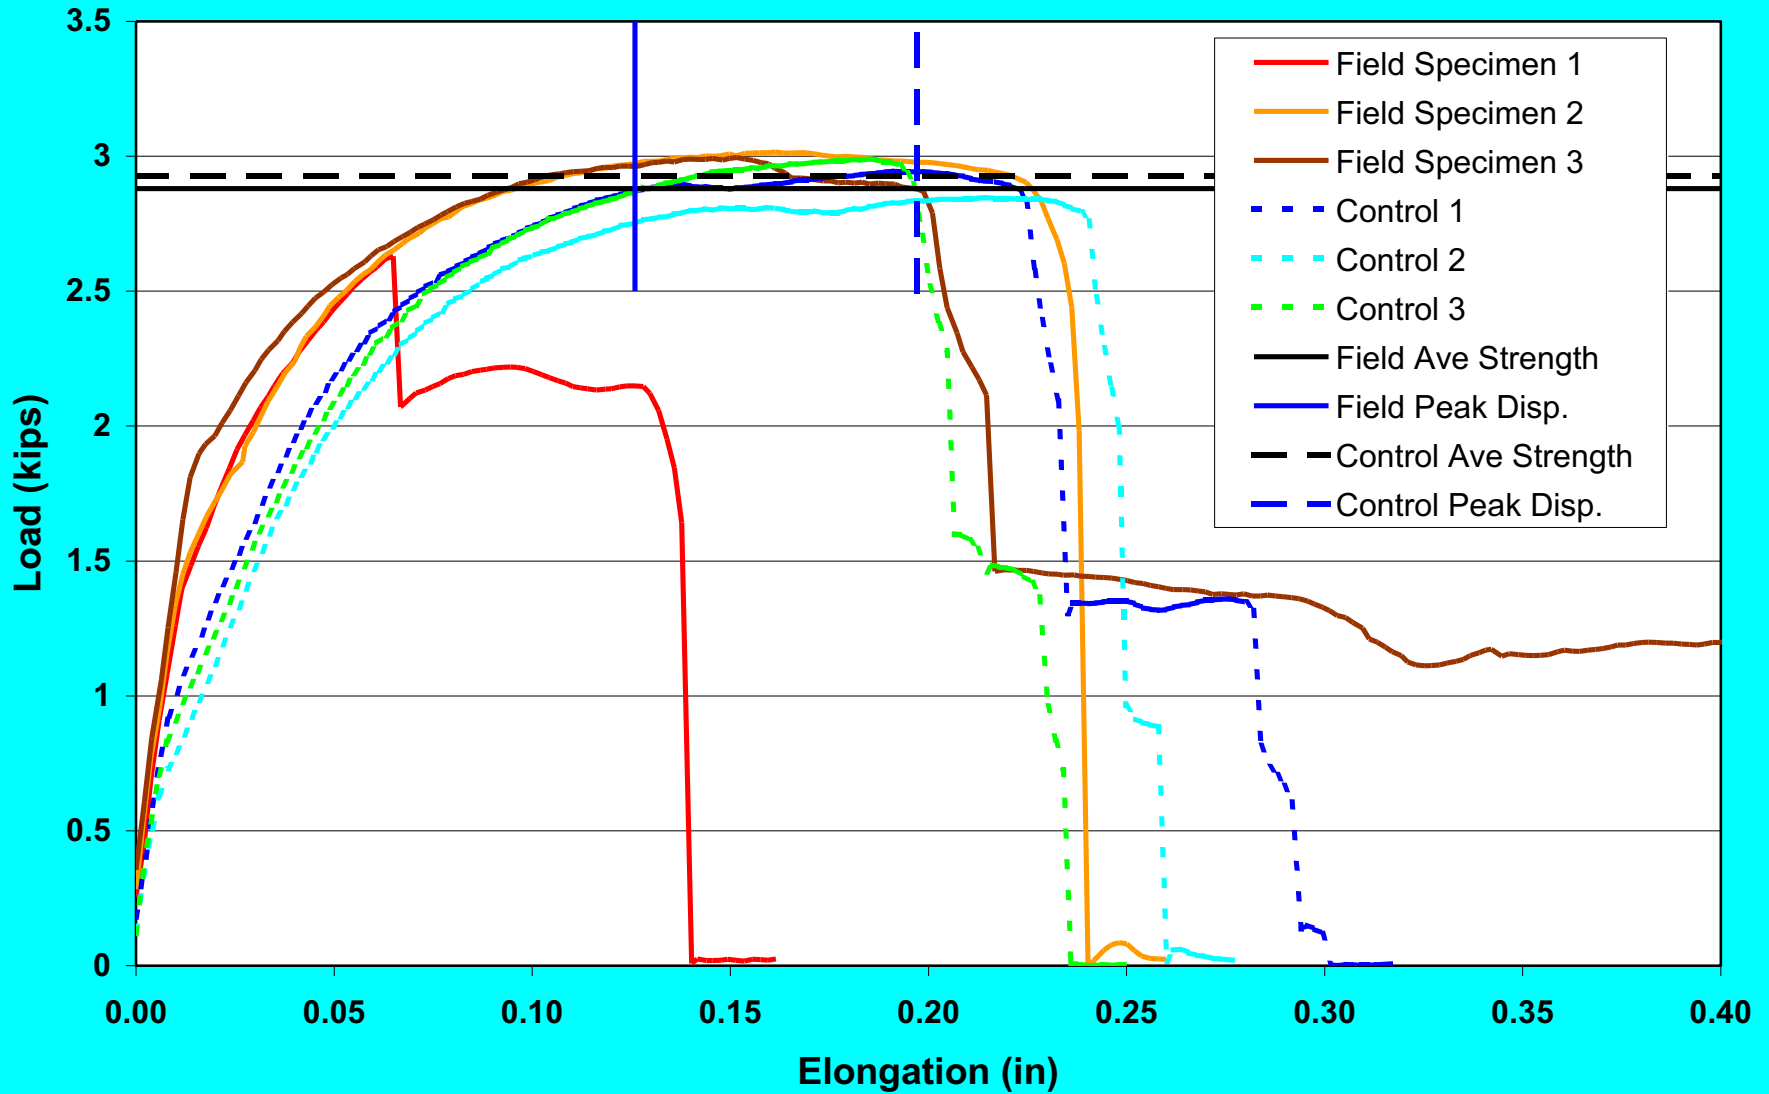
MCBH Coastal - Exterior exposure (L7) - 7 Months

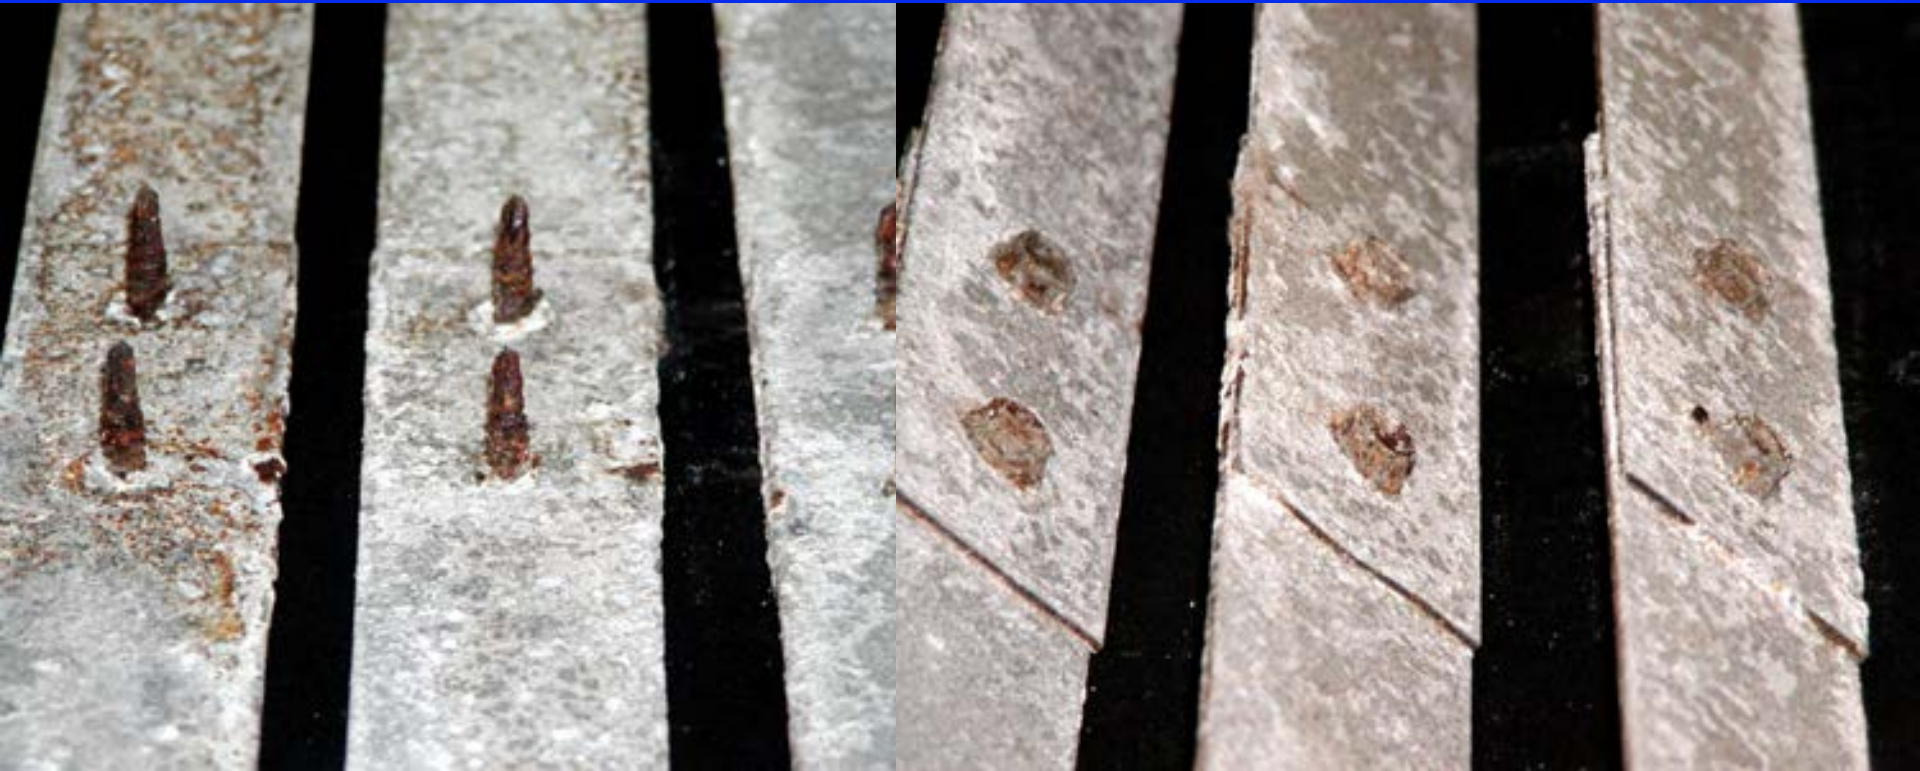
MCBH Coastal – Open Crawl Connections 7 Months Exposure

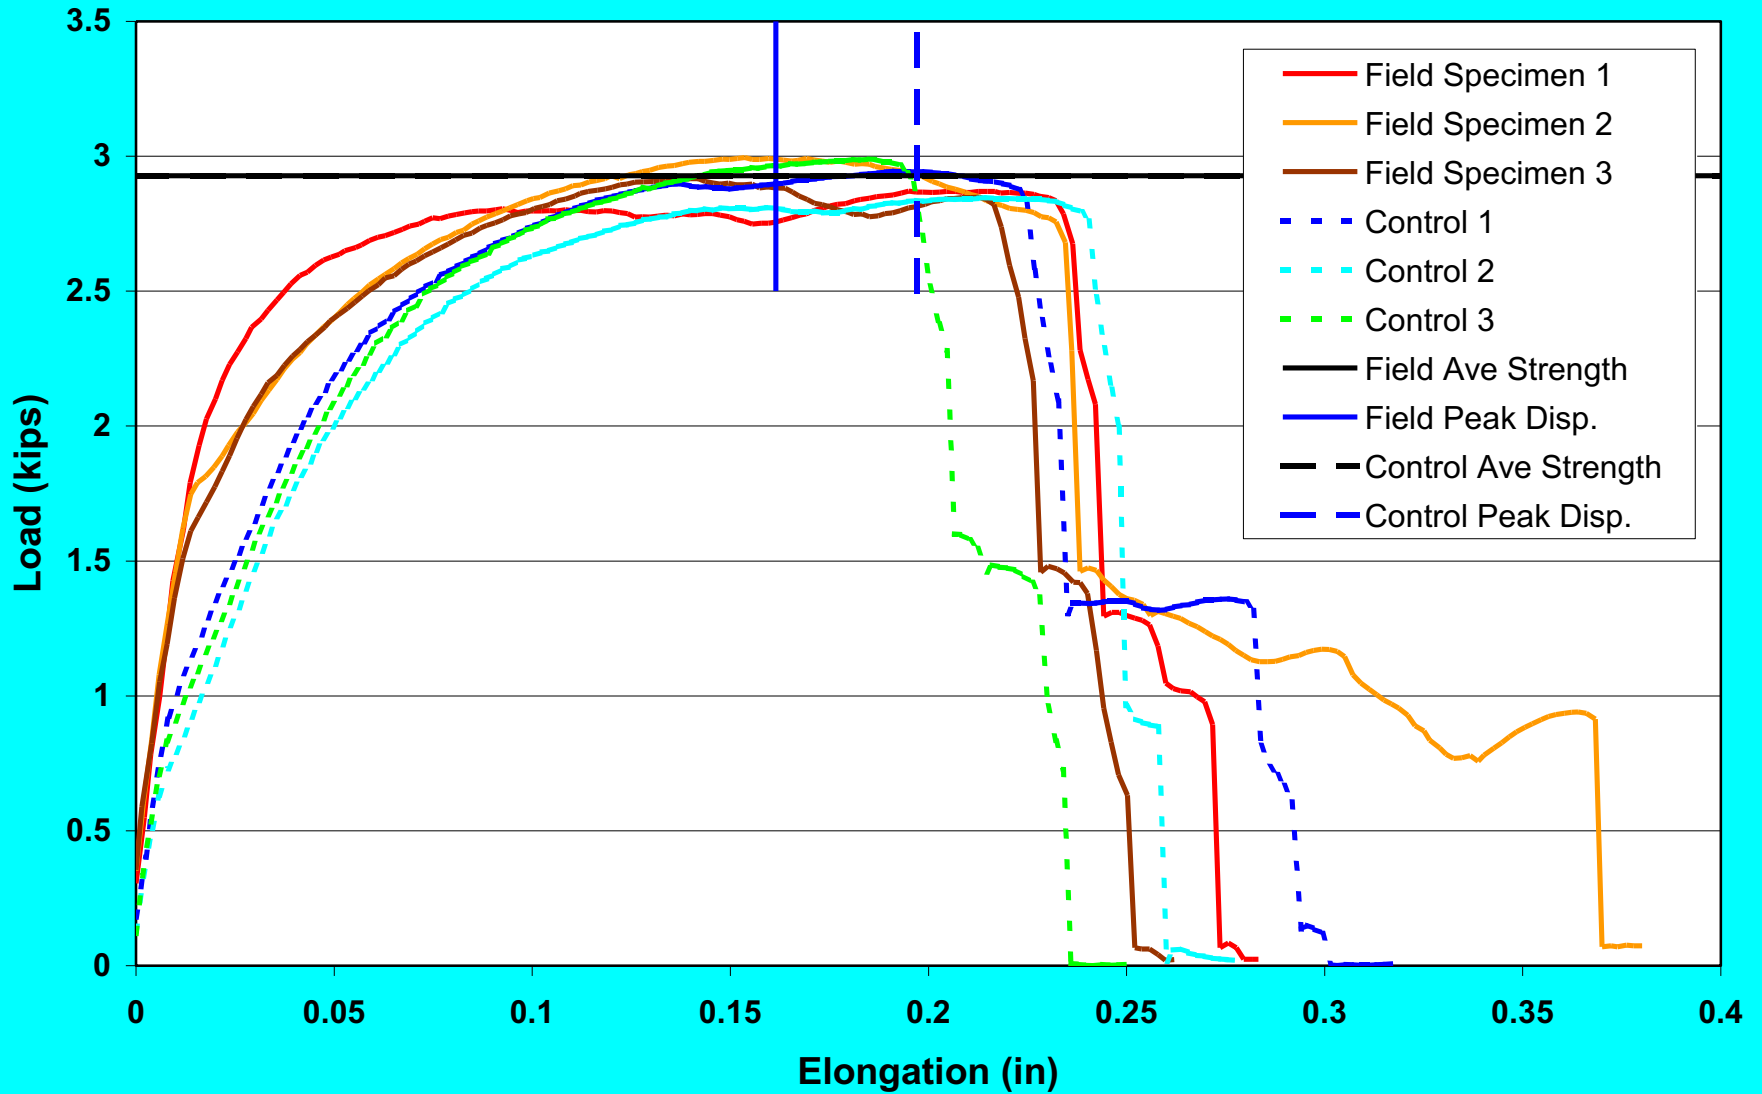
MCBH Coastal - Open Crawl exposure (L5) - 7 Months

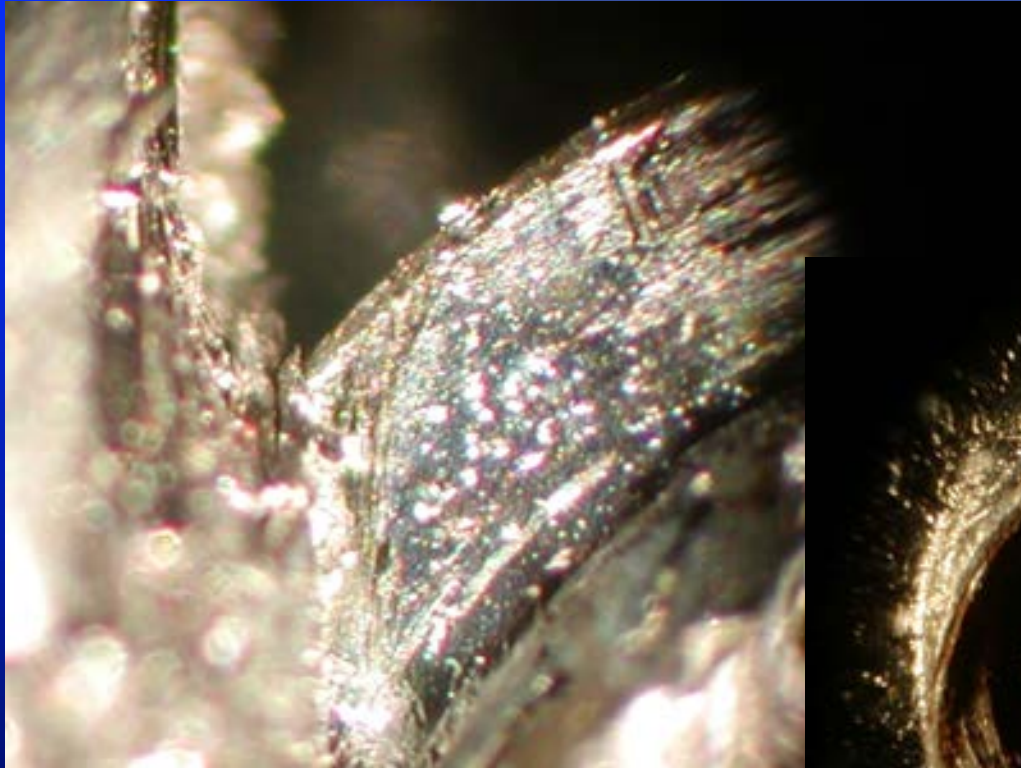
Failed
Connection -
Original

Failed
Connection –
1537 Cycles

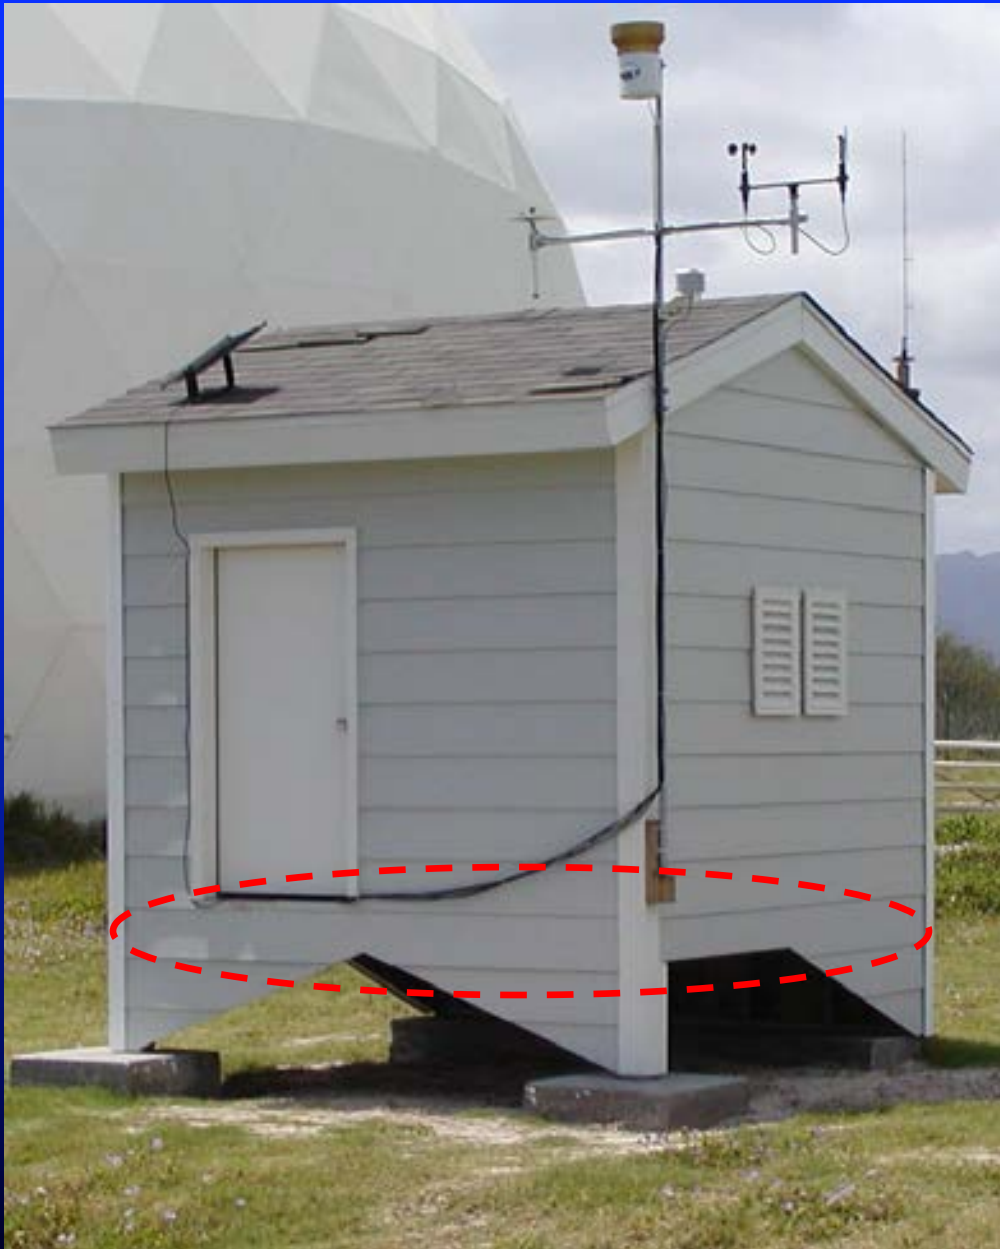
Exposed and Covered Floor Framing

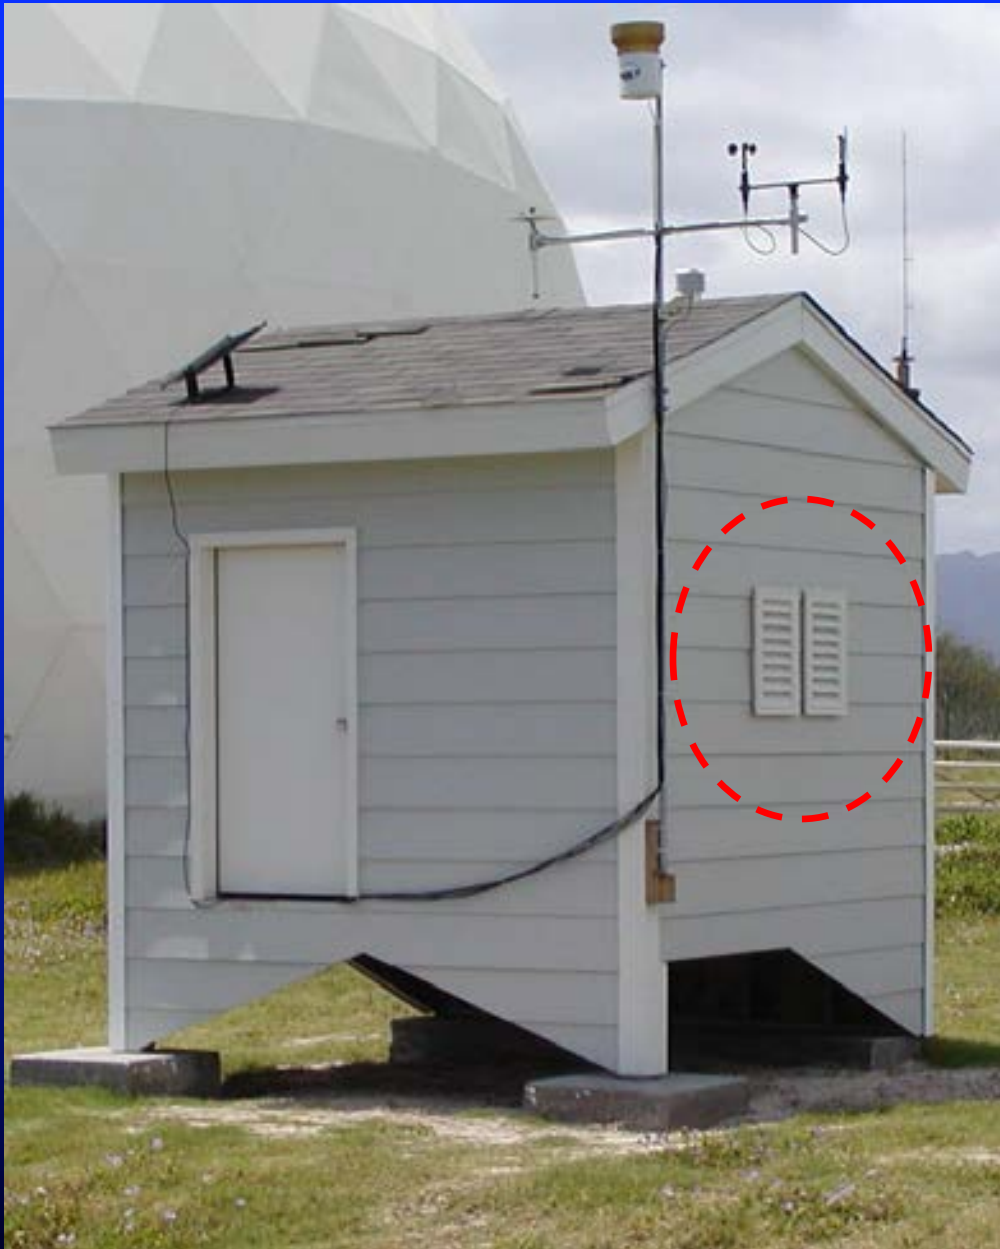
Hardy Board lap-
siding without vapor
barrier

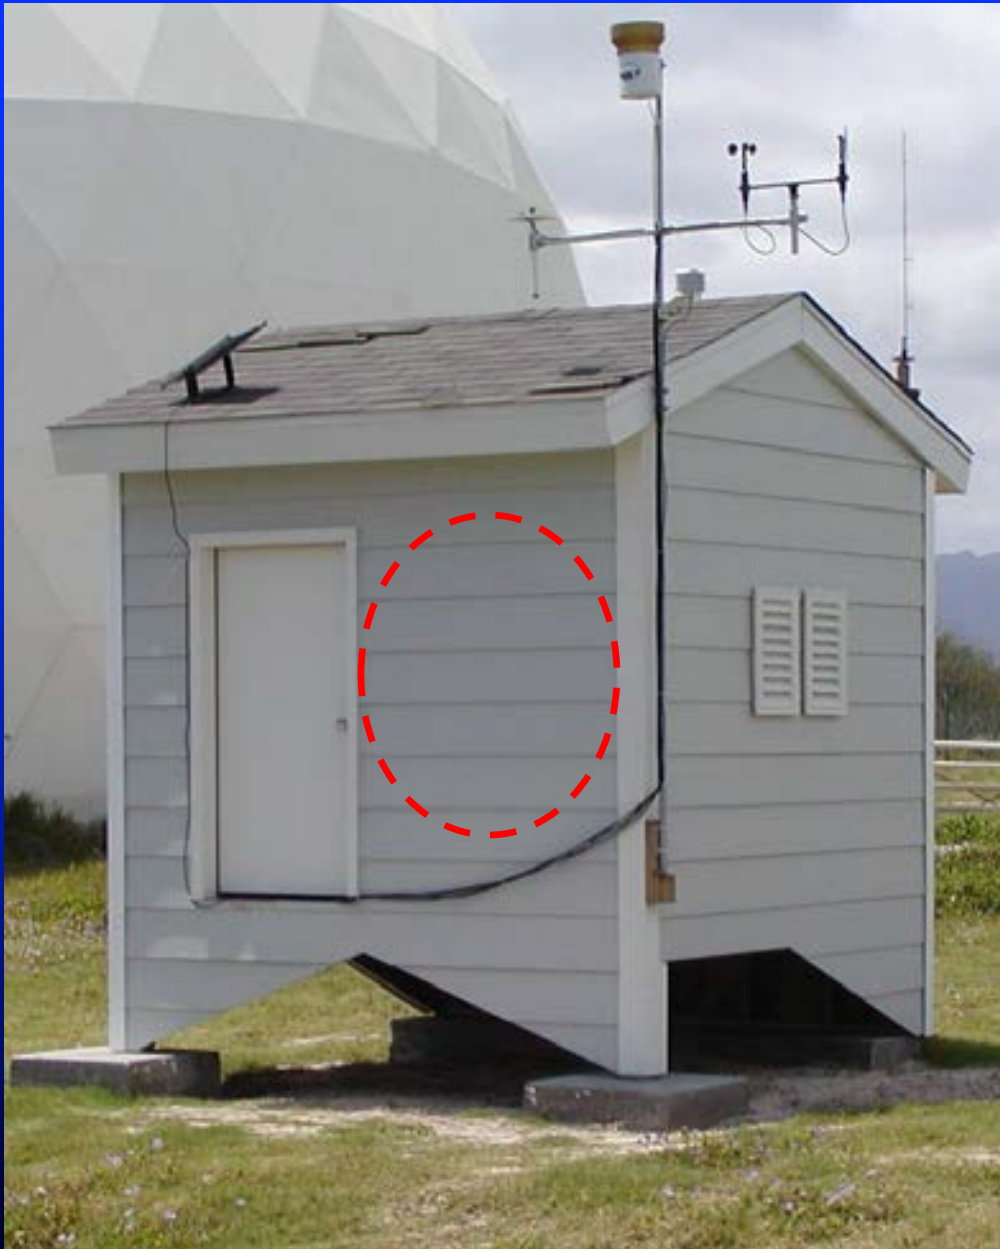
Hardy Board lap-
siding with vapor
barrier

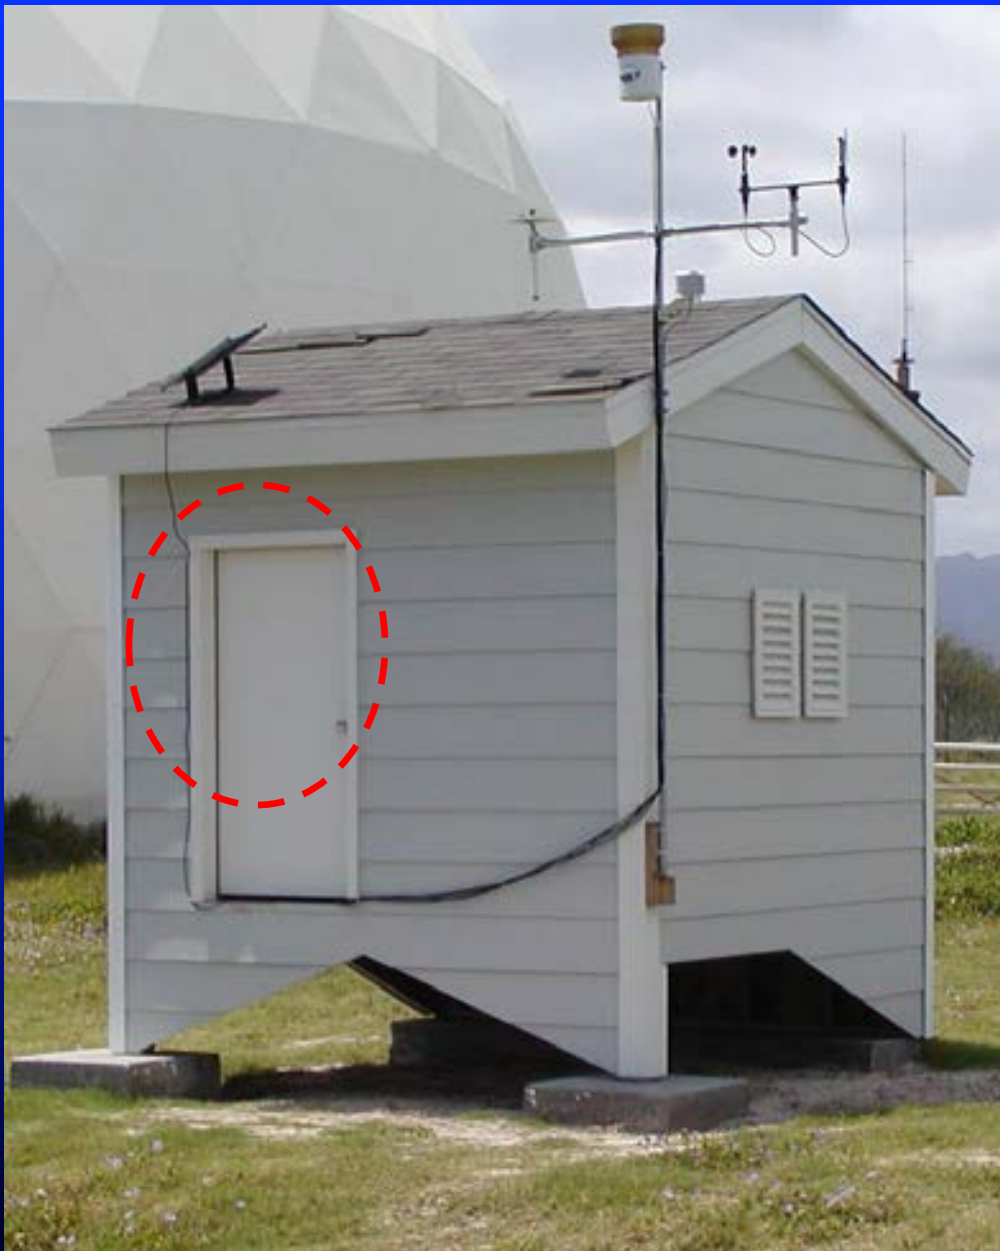
Plywood sheathing and vinyl siding

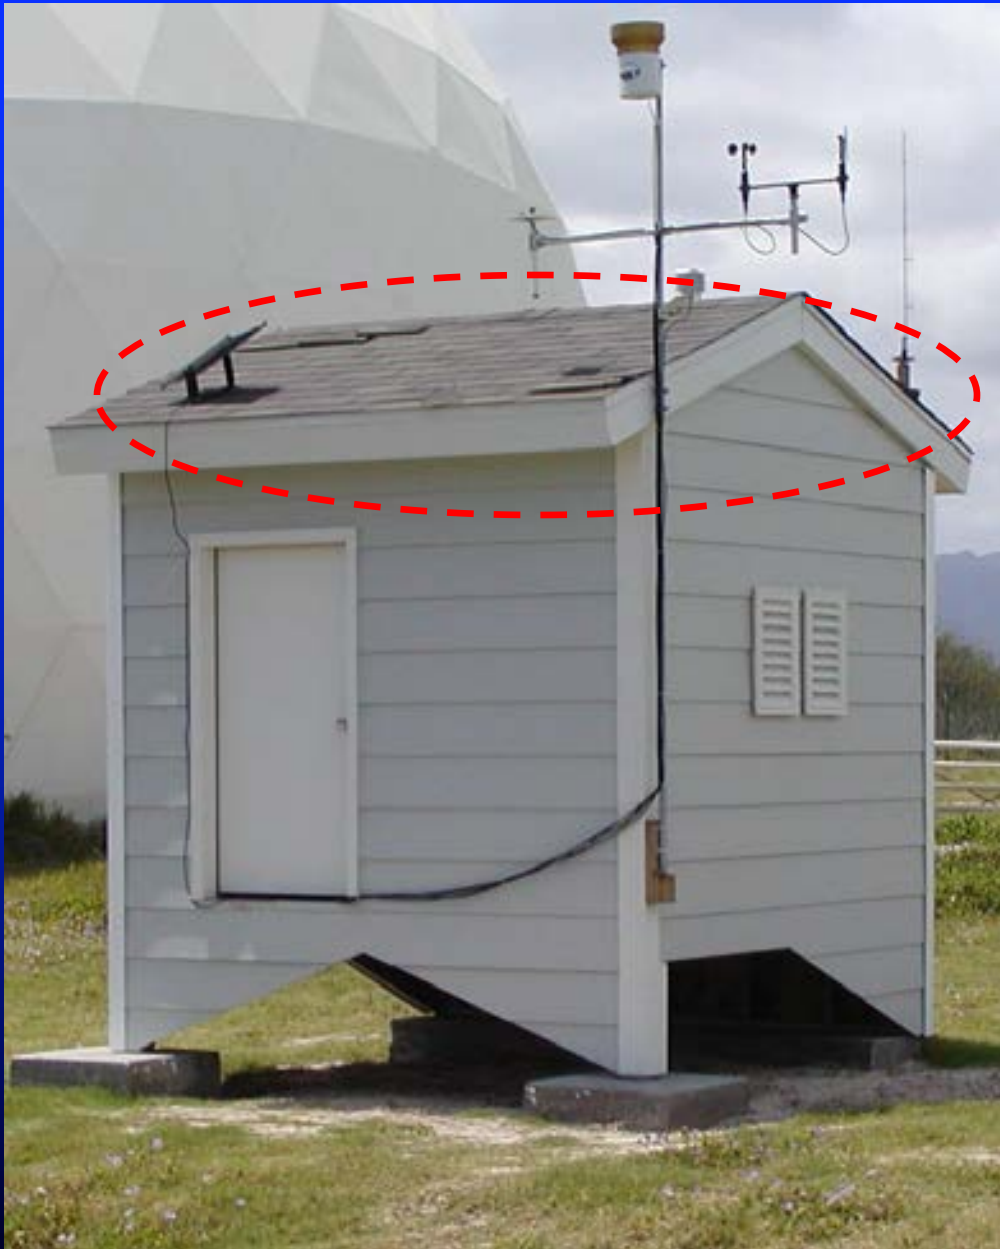
Vented Attic

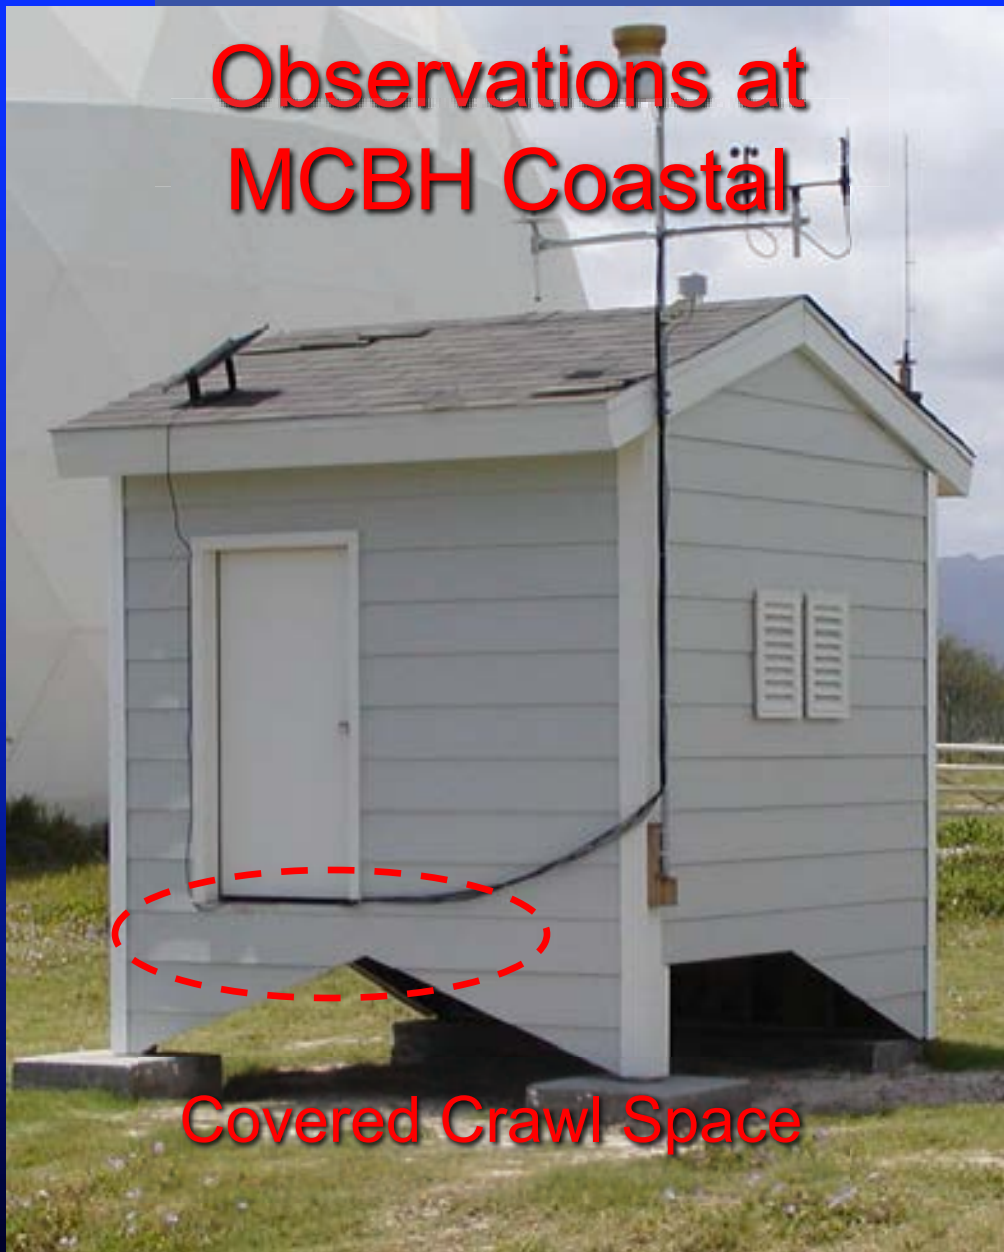
Covered Crawl Space

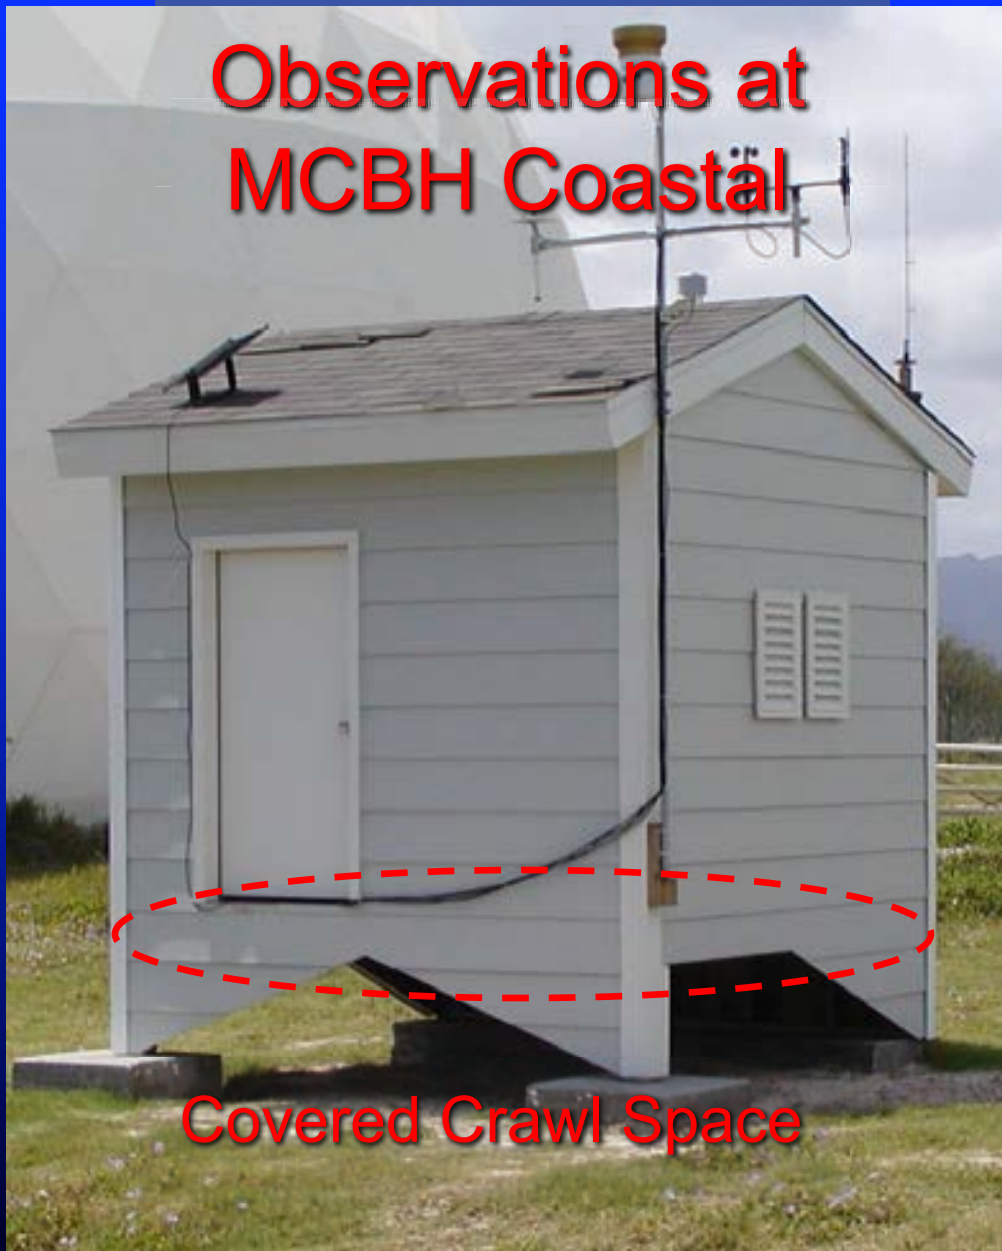
Covered Crawl Space

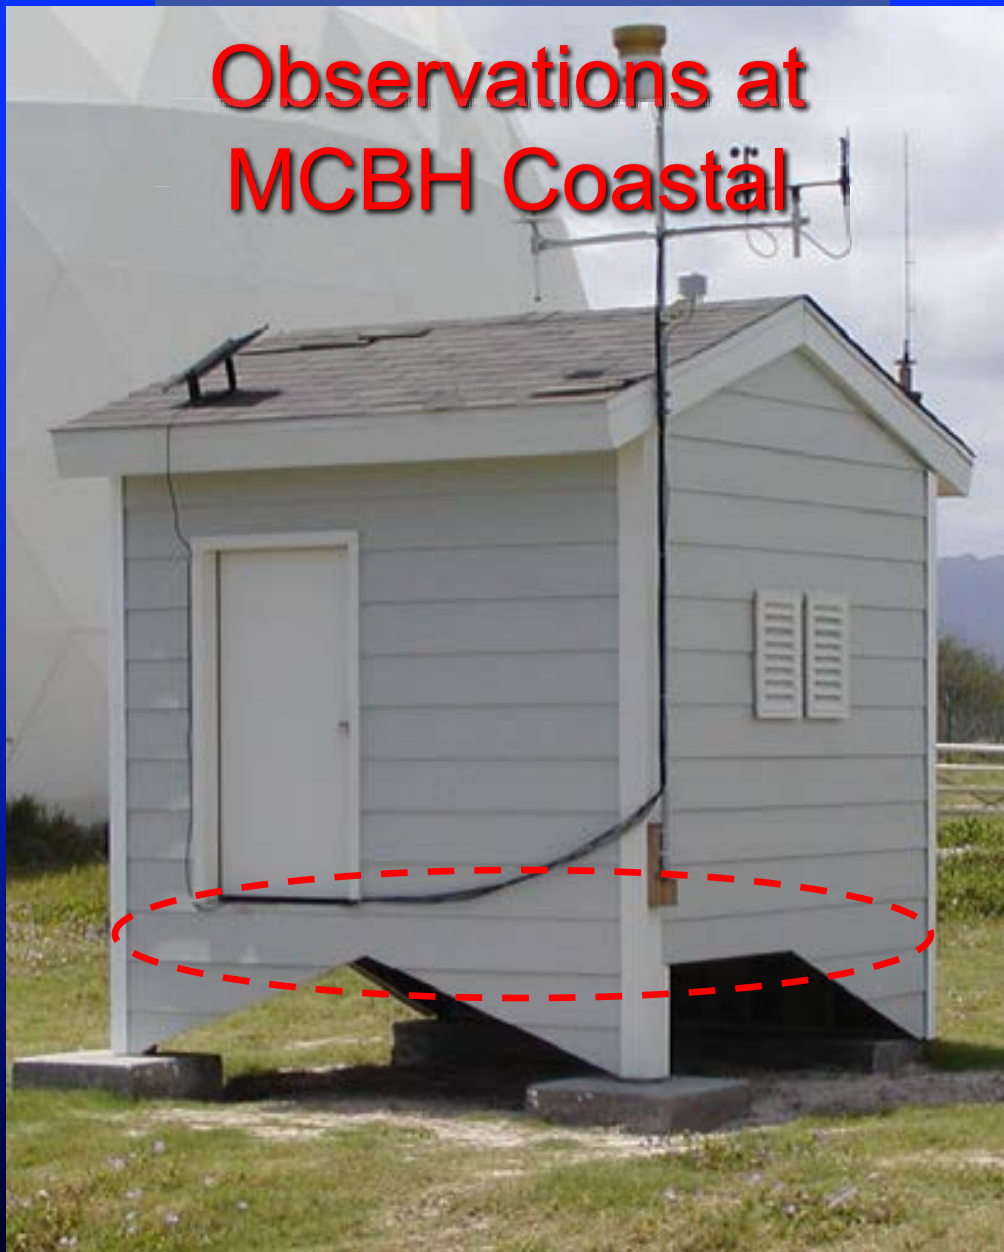
42 Months Open Crawl
Space

42 Months Covered Crawl
Space

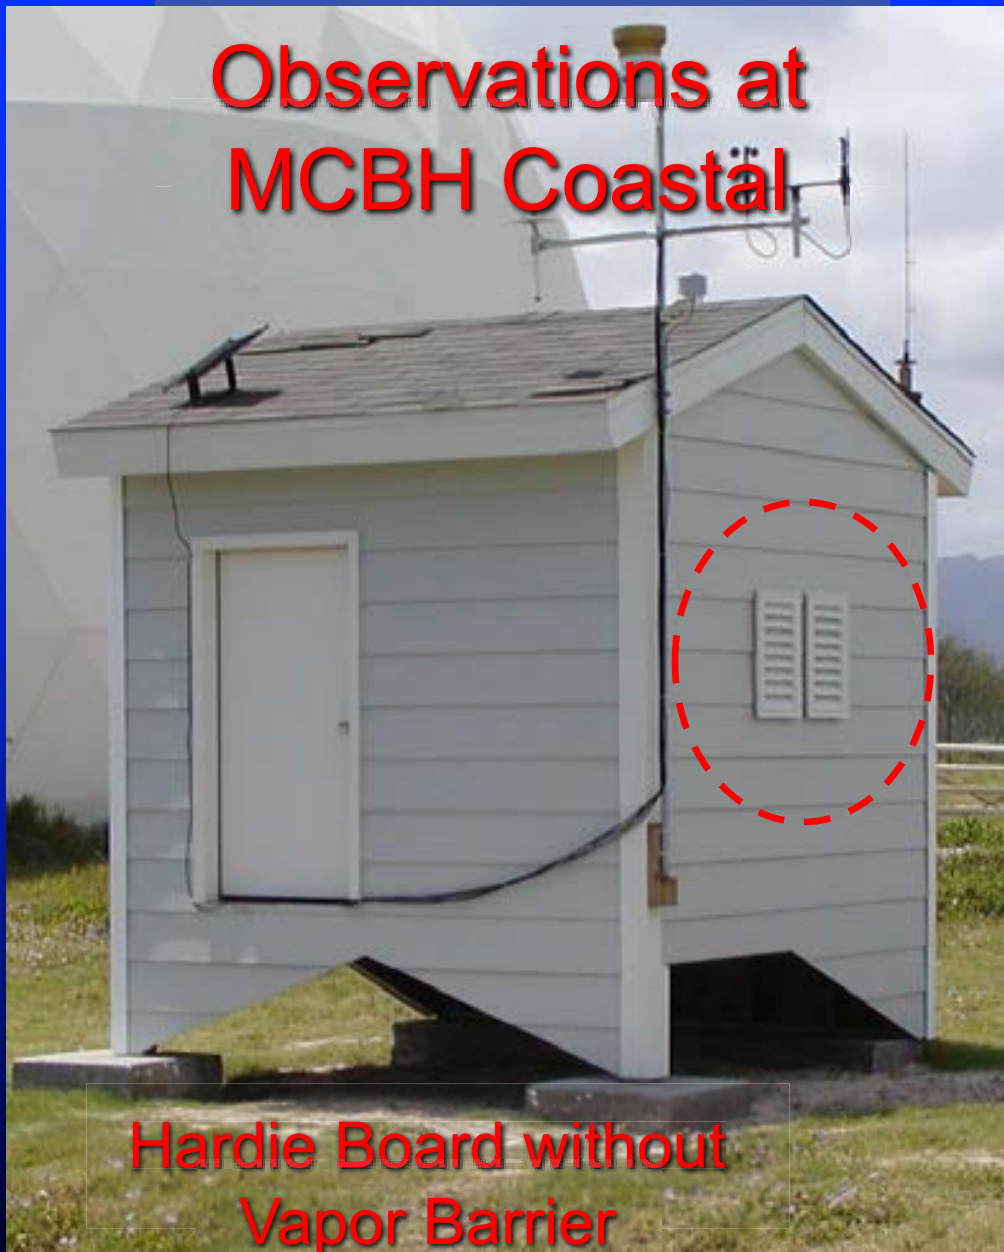
Hardie Board without
Vapor Barrier

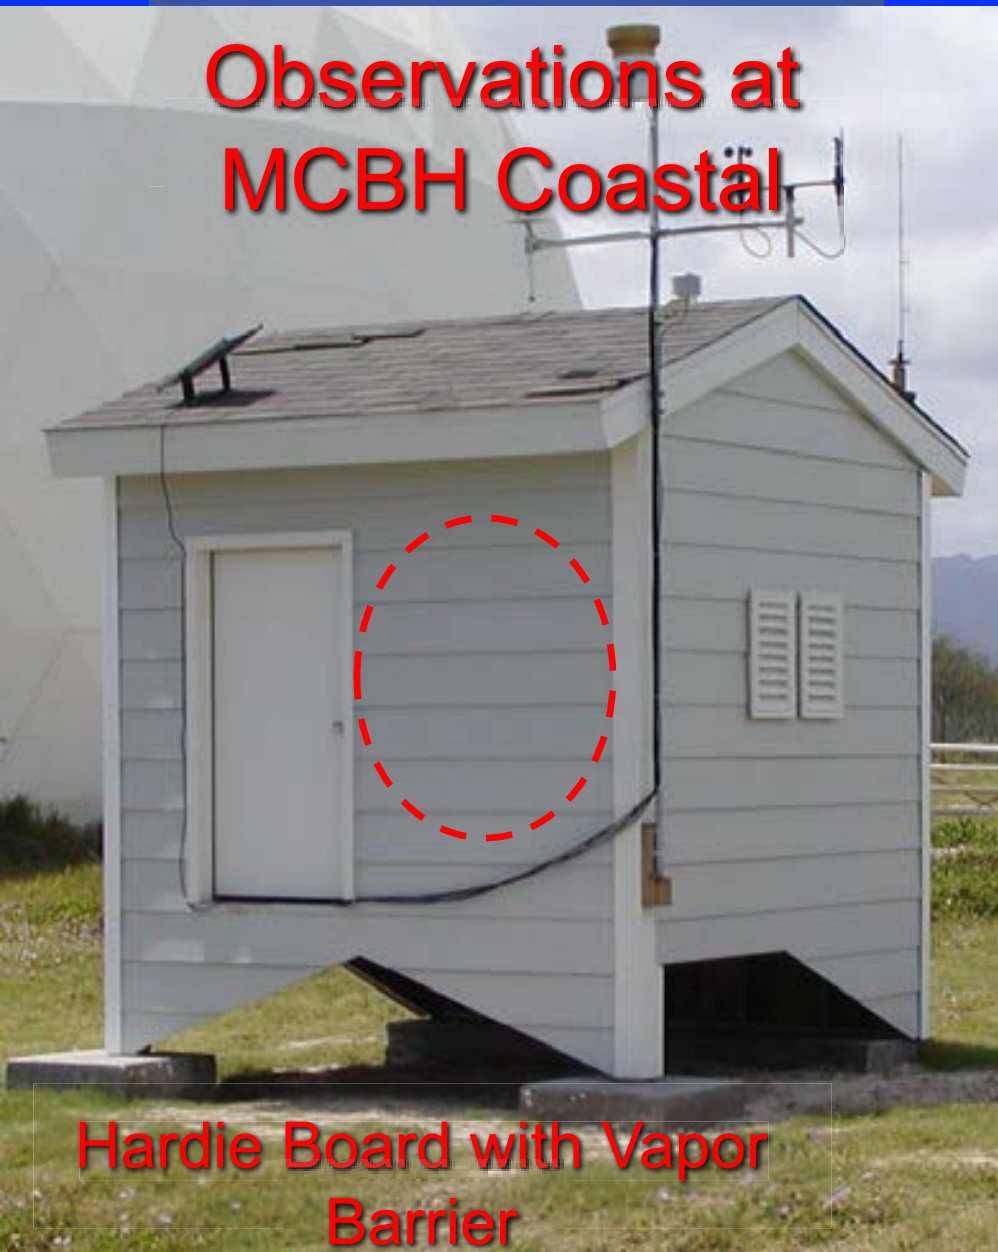
Hardie Board with Vapor
Barrier

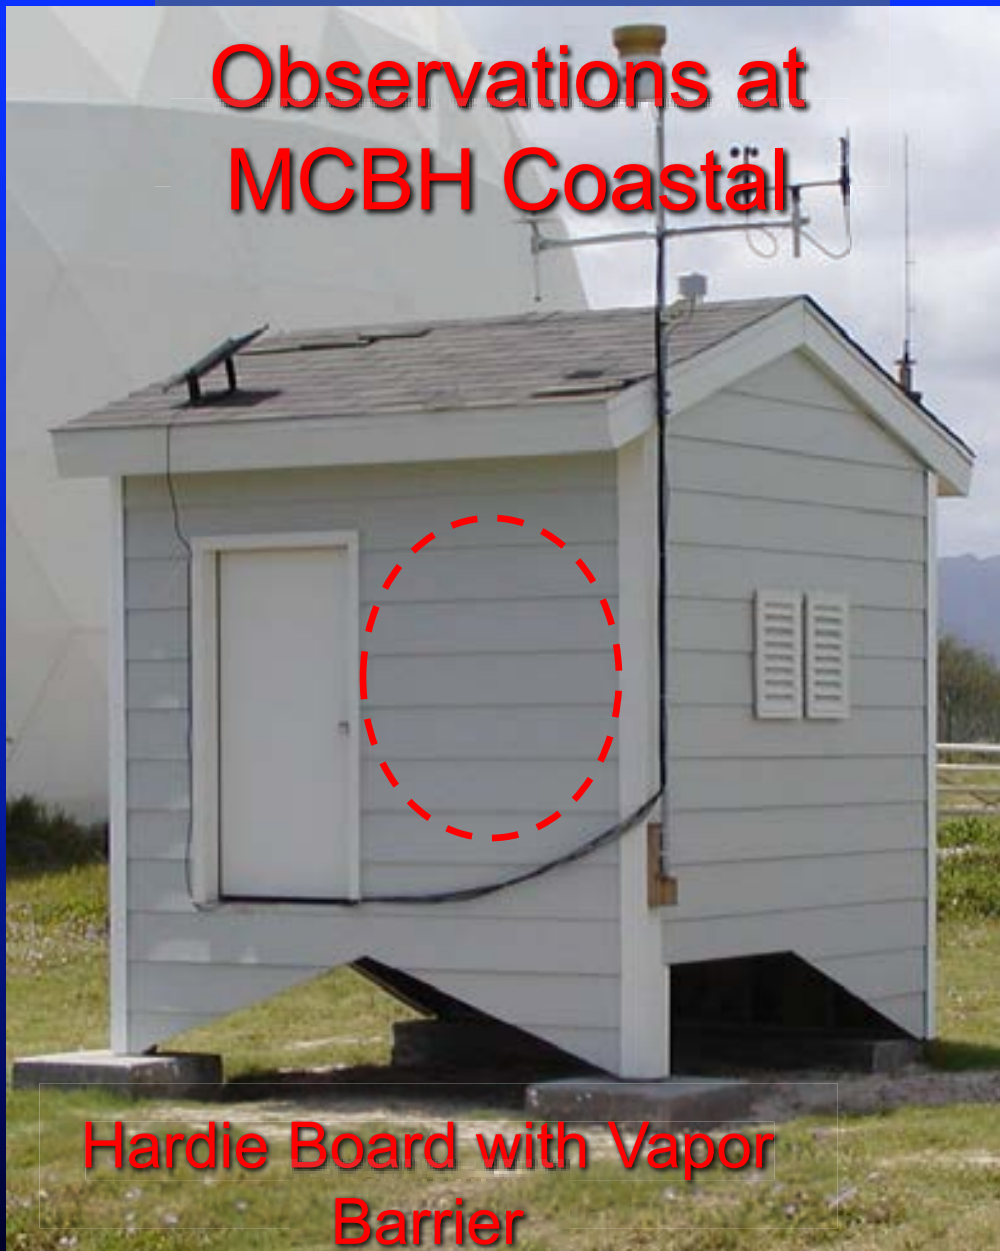
Hardie Board with Vapor
Barrier

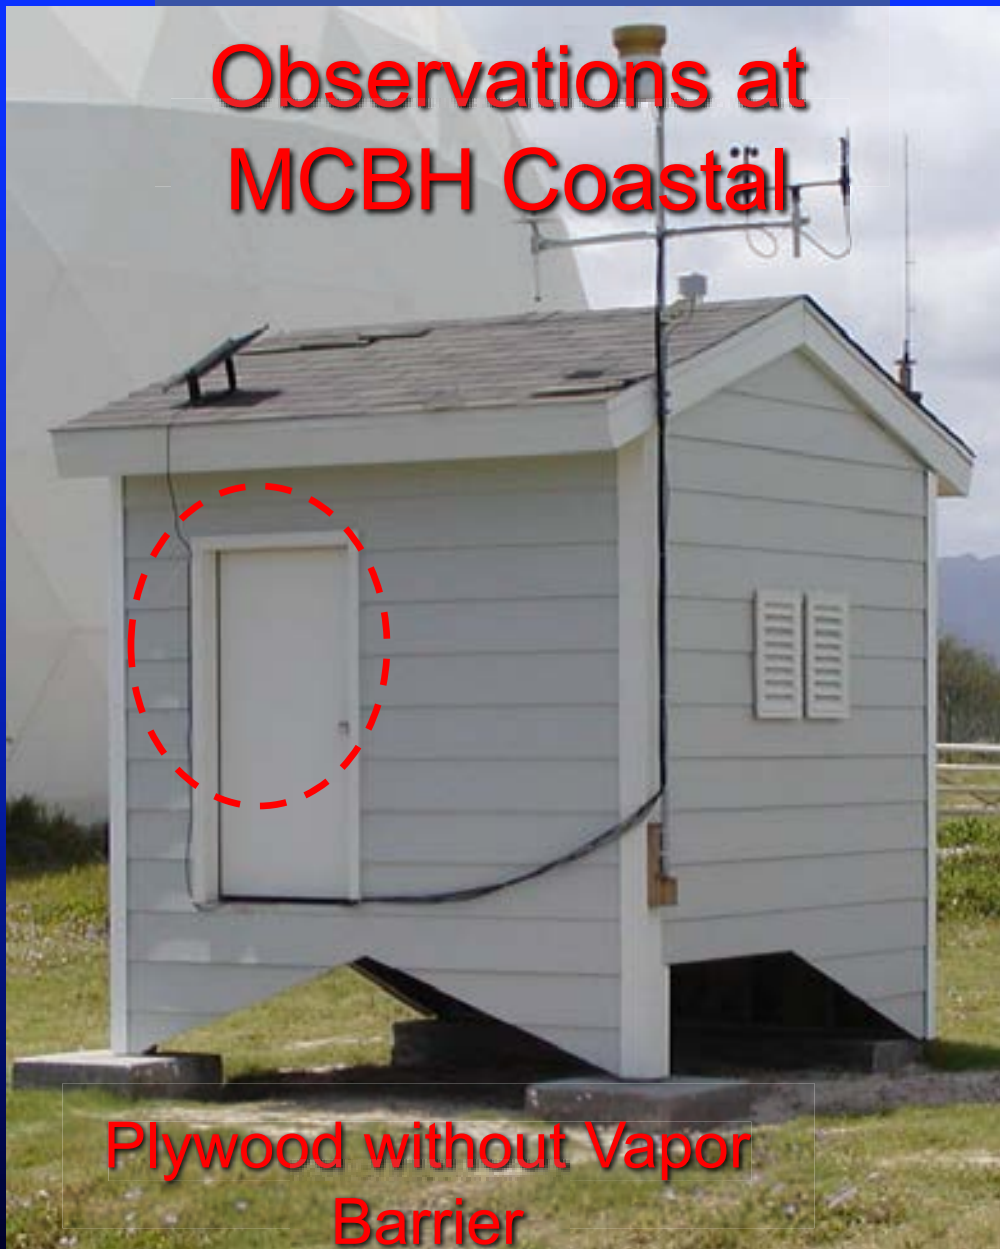
Plywood without Vapor
Barrier
