Building Science Digest 139

Deep Energy Retrofit of a Sears Roebuck House: A Home for the Next 100 Years

2009-03-30 by Betsy Pettit, FAIA

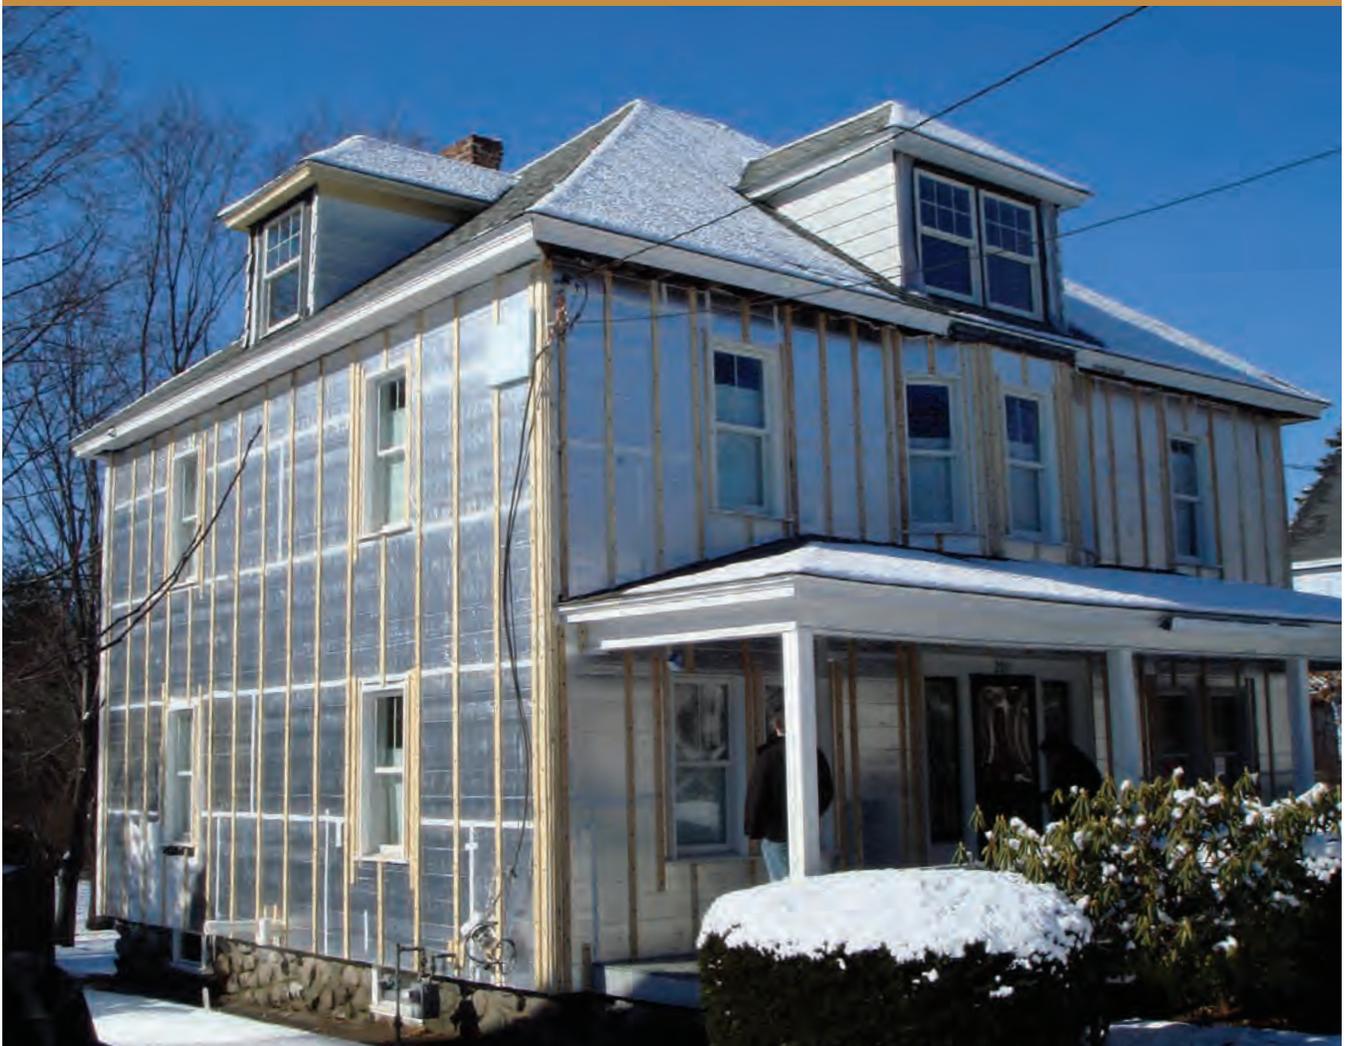
Wood furring strips hold exterior foil faced rigid insulation in place. The windows are recessed inboard of the rigid insulation so that interior window trim geometry was not altered. The interior look remained true to the original design.

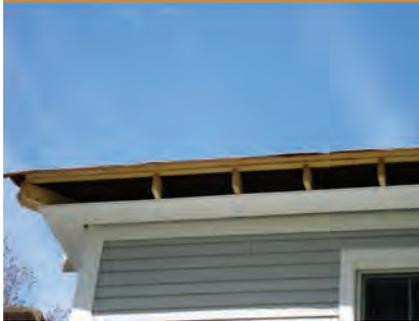
Two layers of rigid insulation were installed over the top of the roof deck. Rafter tails were extended to provide a sufficient overhang.

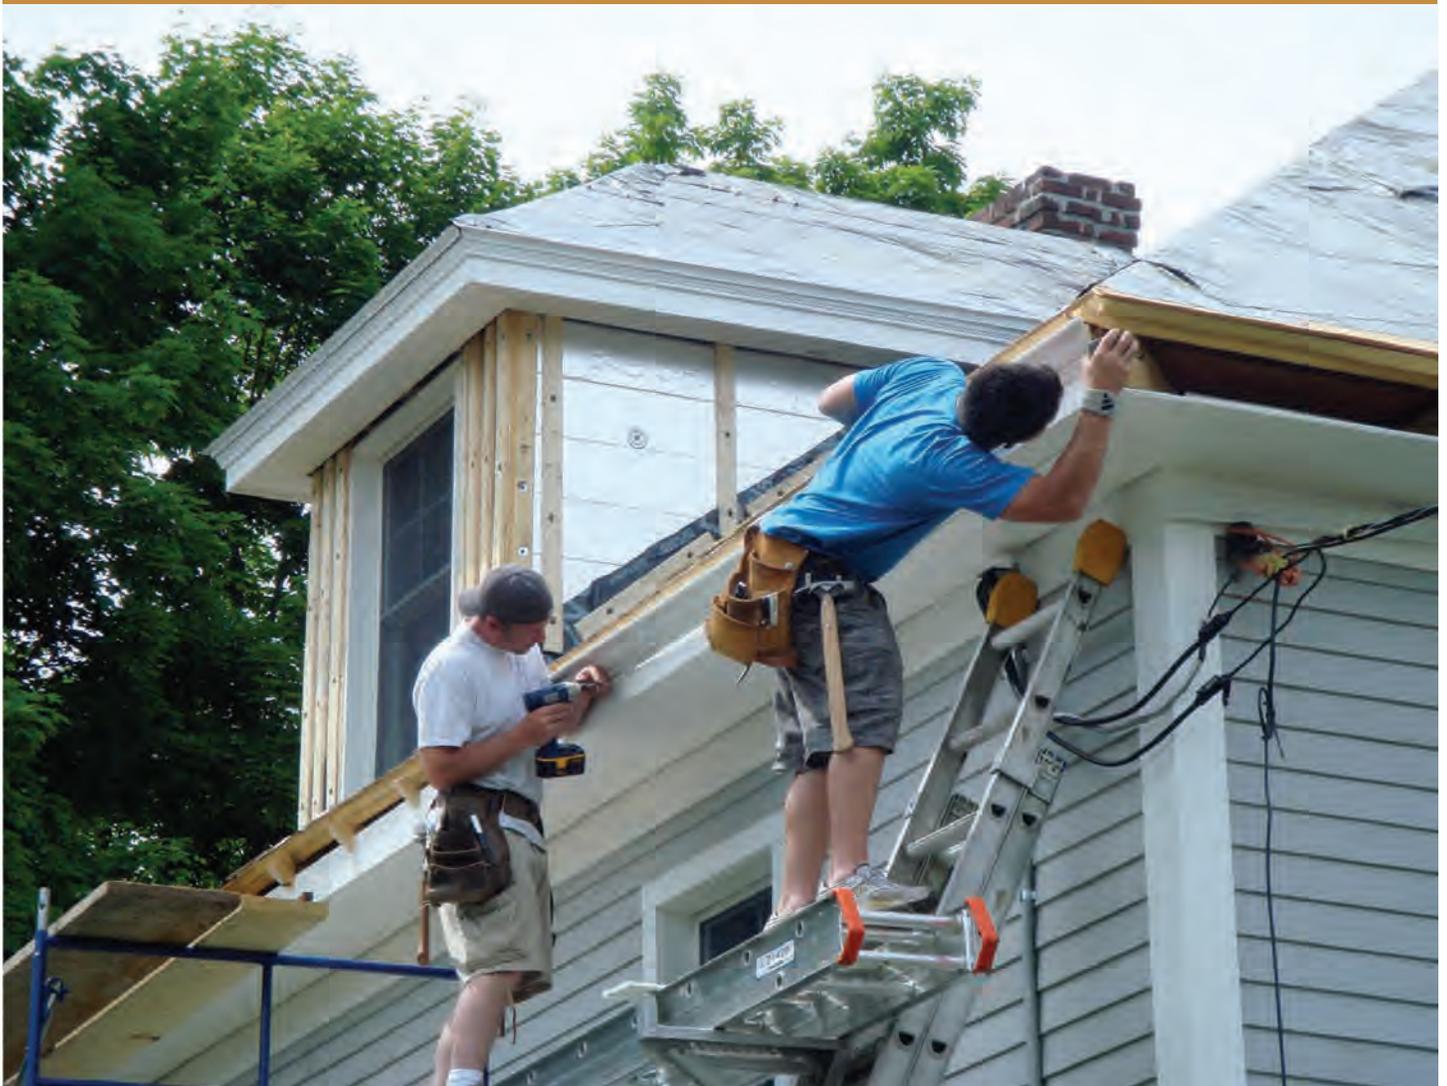
Crown molding was installed to hide the thickness of the two layers of rigid insulation installed on the top of the existing roof deck.

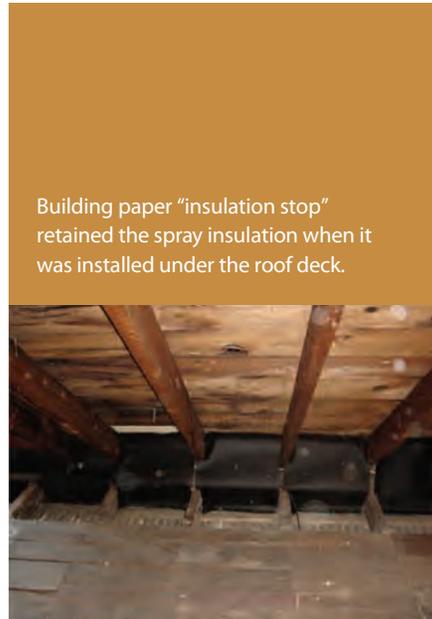
Building paper "insulation stop" retained the spray insulation when it was installed under the roof deck.

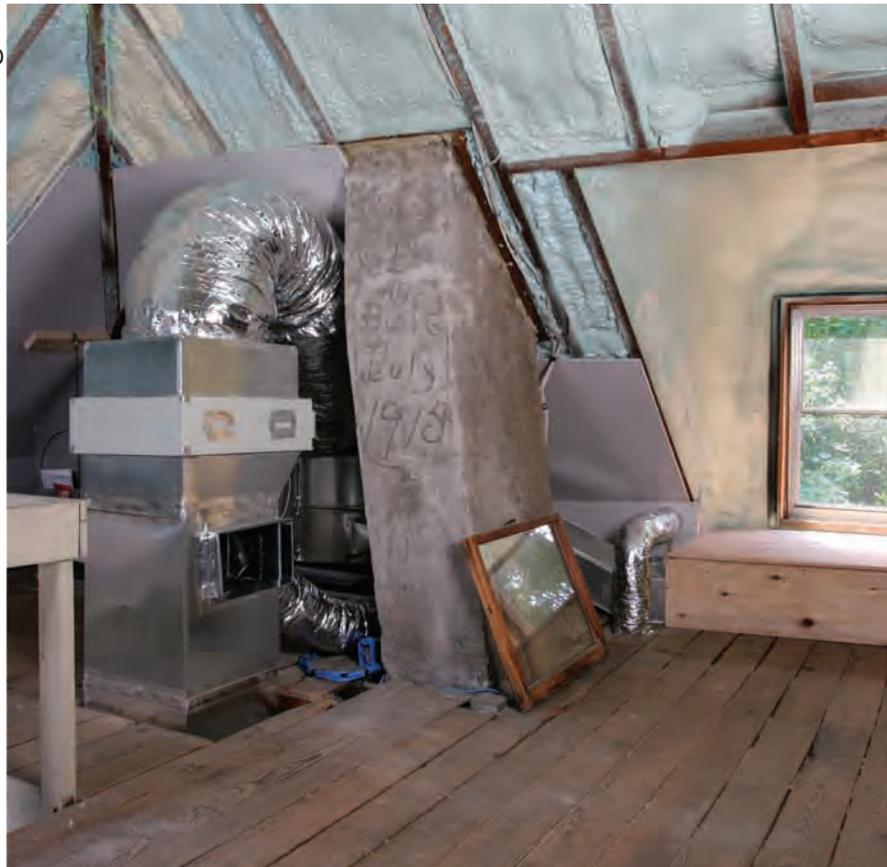
An air handler in the attic supplies the attic and second floor. A pleated media filter was installed at the return. The original builders left their mark embedded in the parge coat over the chimney, "Built July 1915."

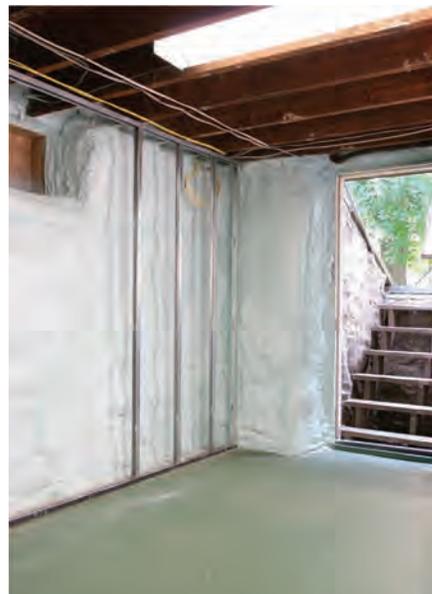
Exposed spray foam insulation on the basement walls was covered with gypsum board over metal studs.

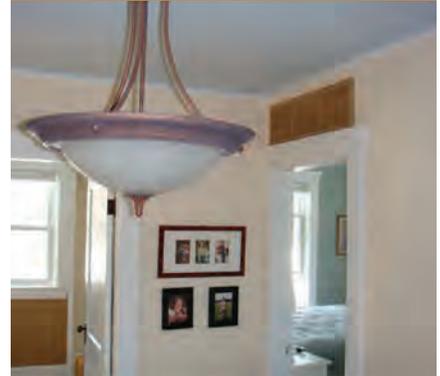
The transfer grilles above the hallway doors provide a return path to the air handler.

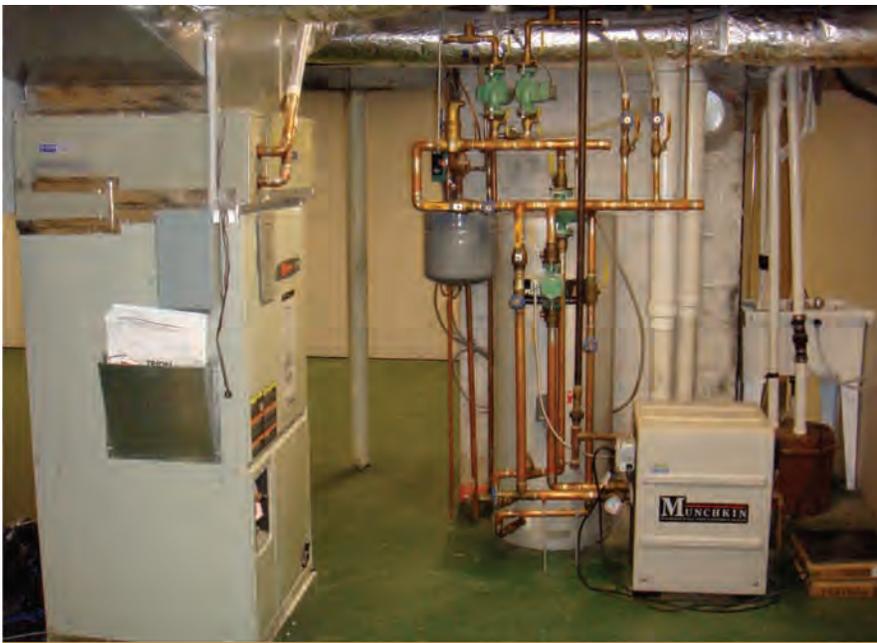
Mechanical systems upgrades in the basement include an air handler, high efficiency boiler and a super insulated water tank.

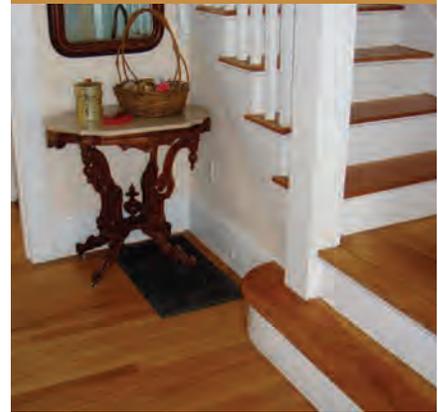
A return grille for the basement air handler is located at base of main stairwell.

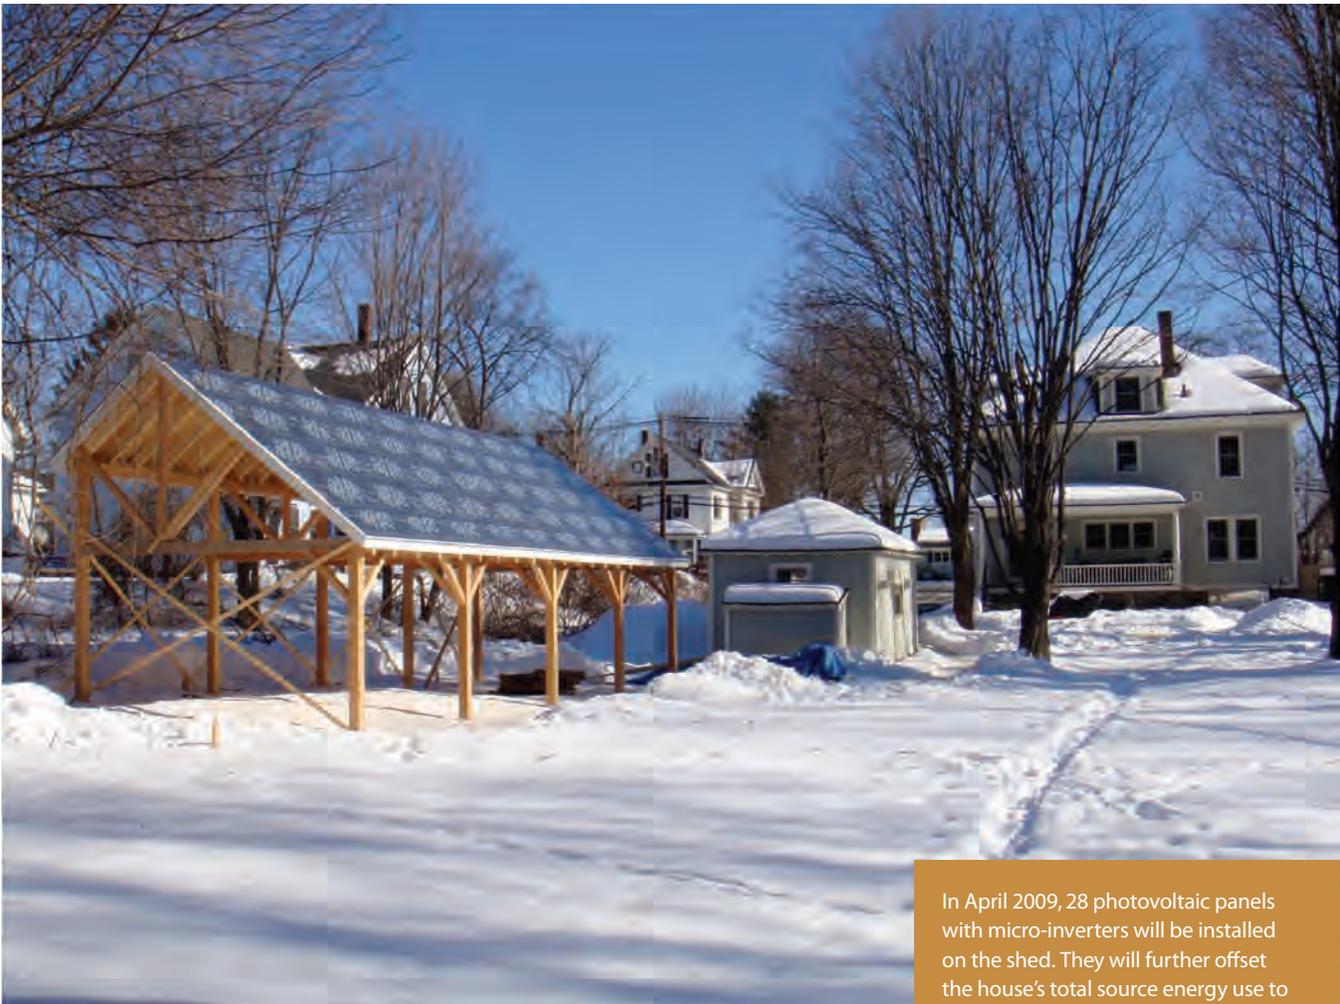
In April 2009, 28 photovoltaic panels with micro-inverters will be installed on the shed. They will further offset the house's total source energy use to approximately 40 million Btu.
