# Insight Leiningen Versus The Ants<sup>1</sup> Redux

By Joseph W. Lstiburek, Ph.D., P.Eng., Fellow ASHRAE

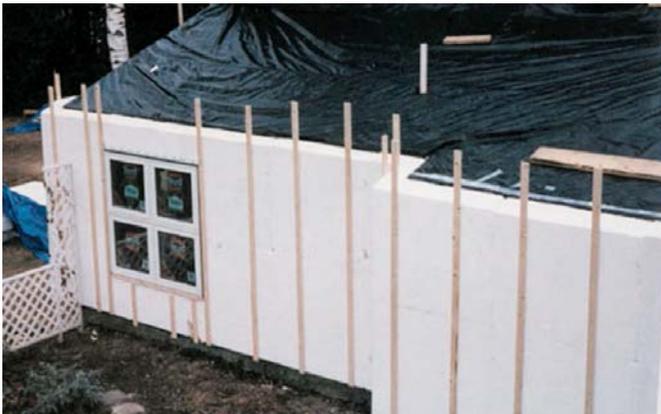
**Photograph 1 (left): Perfect Wall**—Water control layer, air control layer and vapor control layer outside of structure. EPS rigid insulation thermal control layer held in place with 1x4 wood furring strips over the top of everything else. The world's largest Canadian Beer Cooler built in Boston 15 years ago. Back-ventilated siding yet to be installed on wood furring strips. **Photograph 2 (right): Rigid Roof Insulation**—Note the billowing polyethylene air barrier/vapor barrier. I should have known then.

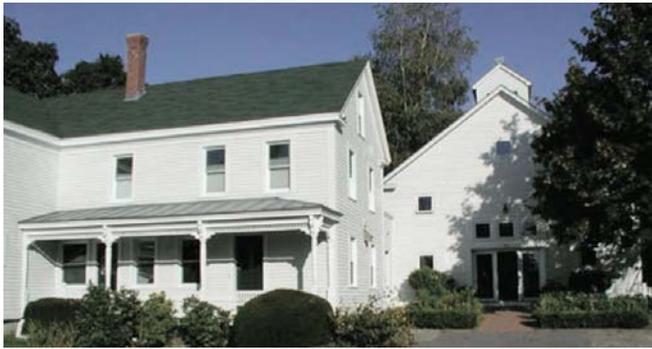
**Photograph 3 (top left): Good Looking Barn**—In this case the beauty is only skin deep

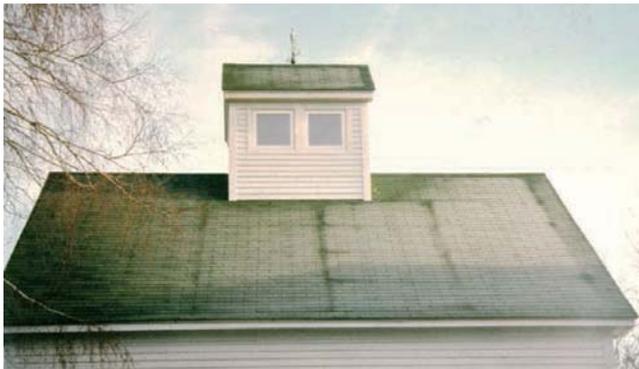
**Photograph 4 (above): The Embarrassment Starts**—Can anyone say 3-D airflow network?

It was so obvious it was embarrassing. I had already had enough embarrassment with the barn renovation. I learned about three-dimensional airflow networks the first year after the renovation—the first winter in fact (**Photograph 4**). I should have never installed the roof

foam in one layer. It should have been done in several layers with the joints off-set horizontally and vertically.<sup>4</sup> This was nothing that some old roof guy couldn't have figured out or prevented. Ouch. But I already knew about this. Dumb, yes. But dumb that I knew about already. I needed to find new dumb. It didn't take long.

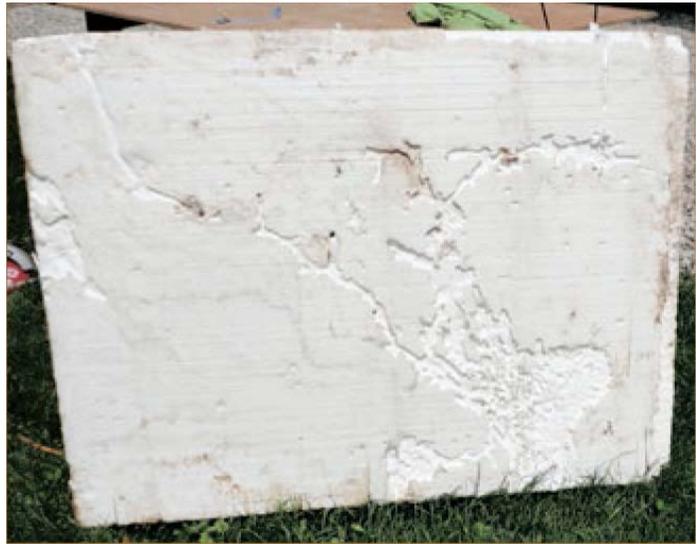
**Photograph 5 (right): Ant Gallery**—The ants don't eat the foam, they live in it. But they like and need water. Good thing I made sure they had some. This is a 4 ft x 6 ft (1.2 m x 1.8 m) ant gallery. There was one other like it. That was it for the entire structure: two of these bad boys. But the gallery went through the 10 in. (245 mm) thickness. Lots of space for lots of ants and lots of aggravation.

I found the ants. Tracked them layer by layer. Yes, they loved my foam. They made themselves a fabulous ant condominium—a fabulous ant “gallery” (**Photograph 5**)—in two spots. But I was ecstatic. Huh? The crew thought I was nuts. I was jumping around all happy about ants in my foam. Why so happy? The ants were only in two spots in the whole damn building. They were in the only two “wet spots” in the whole damn building. The ants only loved my “wet foam.” Where there was dry foam there were no ants. Duh. And it gets even better.

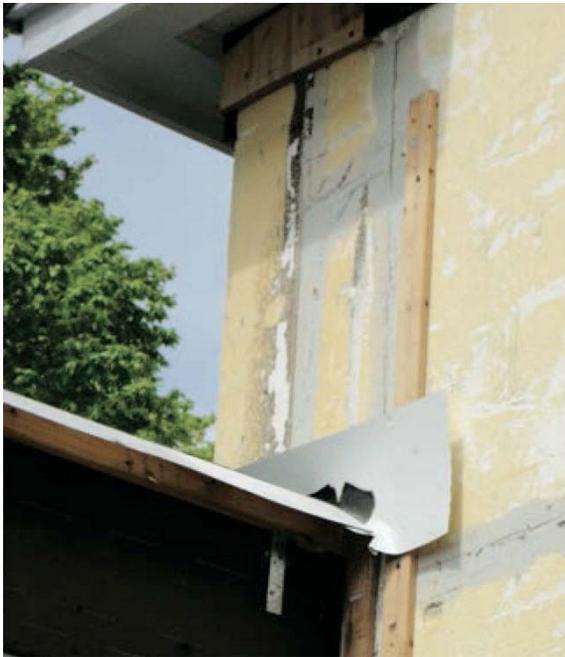
The wet spots were due to something really obvious—something unbelievably embarrassing—reverse flashing. Reverse flashing in two critical areas lead to a whole bunch of water getting into my roof insulation and wetting it. But not enough water leaked in to get past my water control layer. So my roof leaked because of two dumb mistakes—but my roof didn't leak “inside” for me to see it. A bush league mistake—reverse flashing of all things (**Photograph 6**). And in two spots. In the entire building two flashing mistakes, two wet spots and two ant galleries. How long have I been talking about flashing issues? The shoemaker's children are, in fact, barefoot.

**Photograph 6: Reverse Flashing**—This image makes me ill just looking at it. The sheet metal should have been tucked under the furring strips and sealed—and even better there should have been a membrane that extended under the 8 in. (203 mm) of foam on the wall and tied into the wall water control layer behind the EPS foam. This happened twice. Guess where the ants were? You absolutely know that when this puppy was rebuilt, this did not happen again. Check out **Figure 2** if you want to see the way it should have been built originally, and the way we rebuilt it.

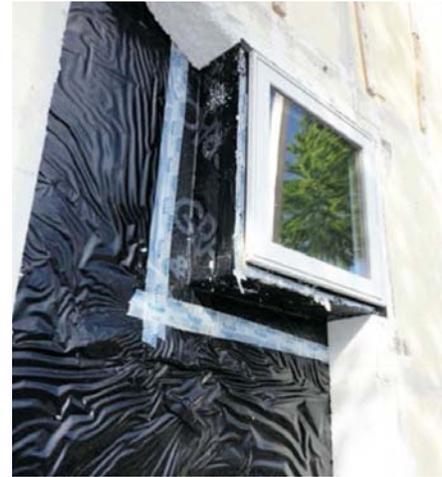
**Photograph 7: Poly Air/Vapor Barrier**—The sheathing tape worked well. The polyethylene had trouble withstanding the construction process. The membrane wrap around the window boxes held up well, except where it was reverse lapped and fishmouthed. Easy to prevent now that we know about the problem. Yes, I know, face-sealed window. I know better now. They didn't leak, but I should have known better.

Having said that, the tape used to seal the polyethylene was fabulous (**Photograph 7**). In fact the same tape was used to seal sheets of XPS together on the main house and performed fabulously there as well. I opened up a bunch of spots on the main house to check adhesion and

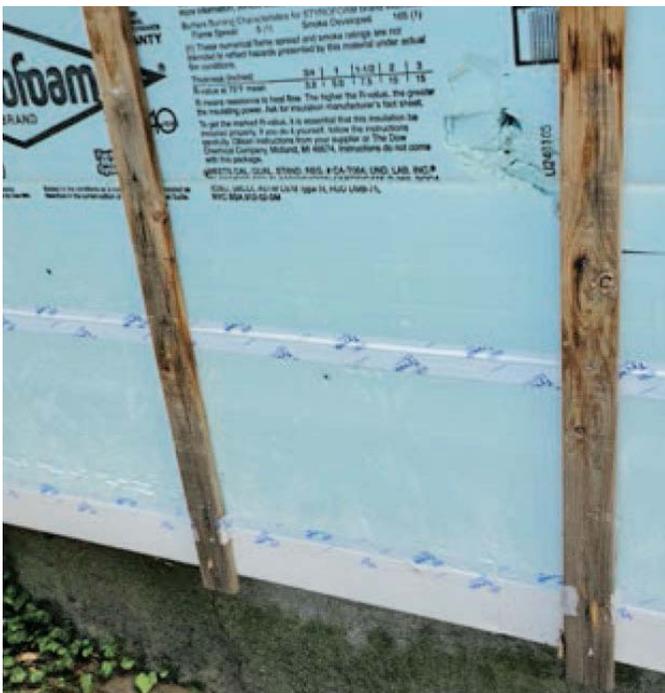
**Photograph 8 (left): Sheathing Tape Works**—Look at how good this looks after 15 years. That is not new tape; that is 15-year old tape. Awesome. Note the aluminum C-section at the bottom of the blue XPS capping the bottom protecting it from critters. Note how good the untreated wood furring looks.

after 15 years the sheathing tape was like new (**Photograph 8**). There was nothing wrong with the main house; I just needed to know. I really, really needed to know. I have been finding this to be the case pretty consistently in other projects that I have opened up, as have others. Sheathing tapes are proving to work over the long term in terms of sealing XPS joints, foil-faced isocyanurate board joints and joints in housewraps/buildingwraps.

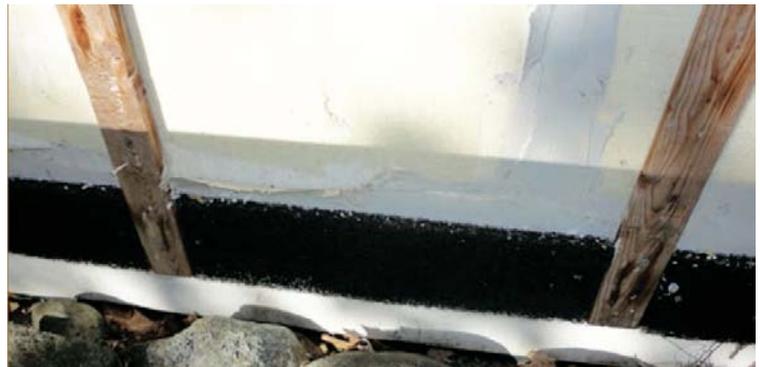
**Photograph 9 (bottom): Insect Mesh**—Polypropylene mesh acting as an insect barrier is installed between the furring strips at the bottom of the wall. This particular mesh typically is used in attic ridge vents to keep bugs out of roofs.

not been finding that to be the case. Here is the caveat: don’t leave the air gap completely open at the bottom or at the top. Check out **Photograph 9**. I used a polypropylene mesh at the bottom of the assembly to allow airflow and drainage but to block insects. I also used an aluminum “C-Section” to seal the bottom cantilevered portion of my exterior foam insulation to keep squirrels and chipmunks and other animals from getting into the foam. No insect damage (except for the ants discussed earlier), and no critter damage have occurred after 15 years.

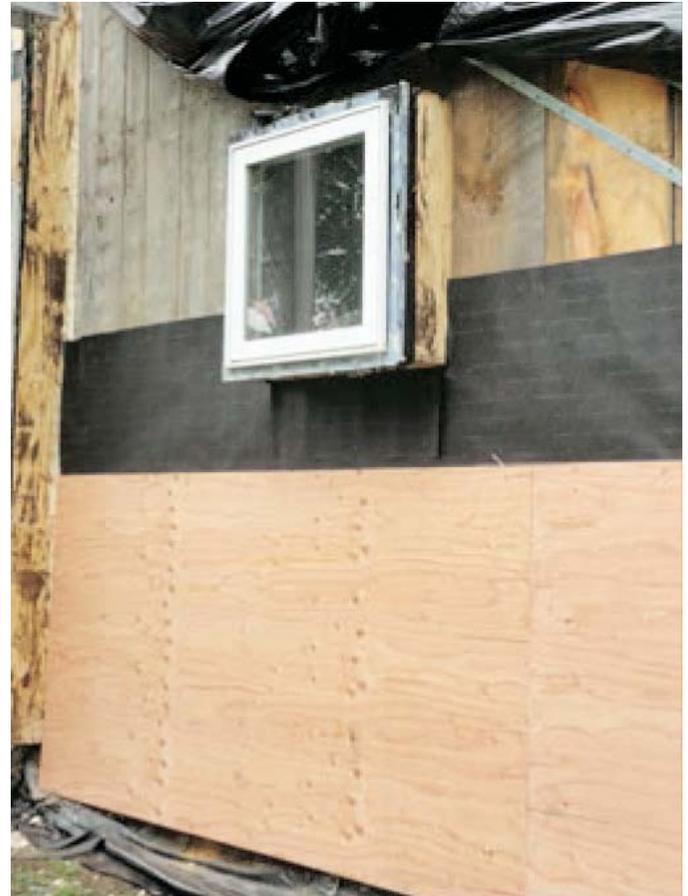
**Photograph 10: New Wall**—Note the “new” tar paper on the old barn boards under the new plywood structural sheathing.

something to fill the gaps. Then the entire building was sheathed with plywood for shear reasons (**Photograph 10** and **Photograph 11**).

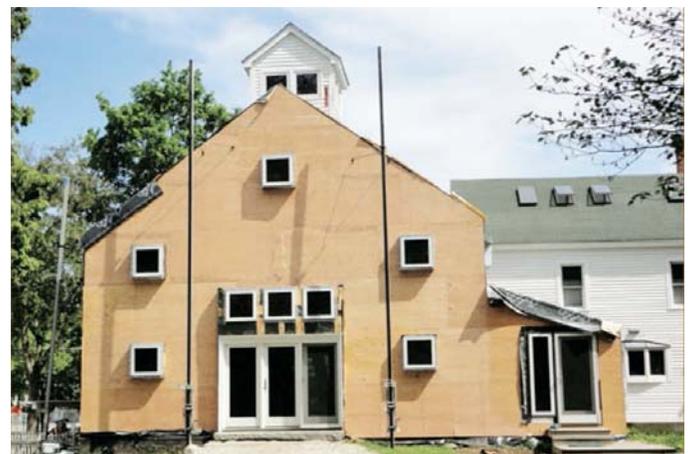
**Photograph 11: Shear Control**—A beautiful sight: plywood structural sheathing wrapping the walls and roof of a hundred-year board-sheathed timber frame. Bring on the nor'easters.

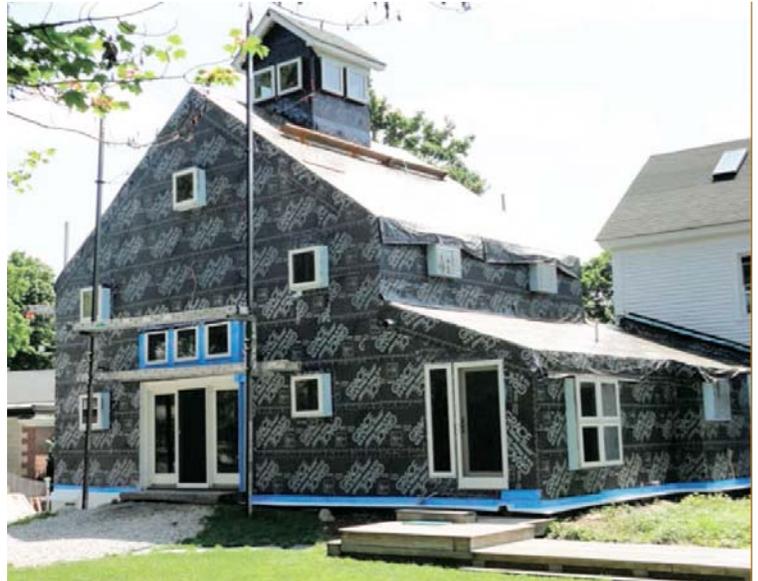
**Photograph 12: Control Layers**—An even more beautiful sight: a fully adhered membrane acting as a water control layer, air control layer and a vapor control layer. Reverse laps are taped with sheathing tape. No more poly for me.

The plywood sheathing was then wrapped with a fully adhered peel and stick membrane (**Photograph 12**). This layer acts as a water control layer, an air control layer and a vapor control layer. Note the control layer continuity between the roof assembly and the wall assembly. Reverse laps in the membrane were taped with sheathing tape. Reverse laps in the membrane were taped with sheathing tape.

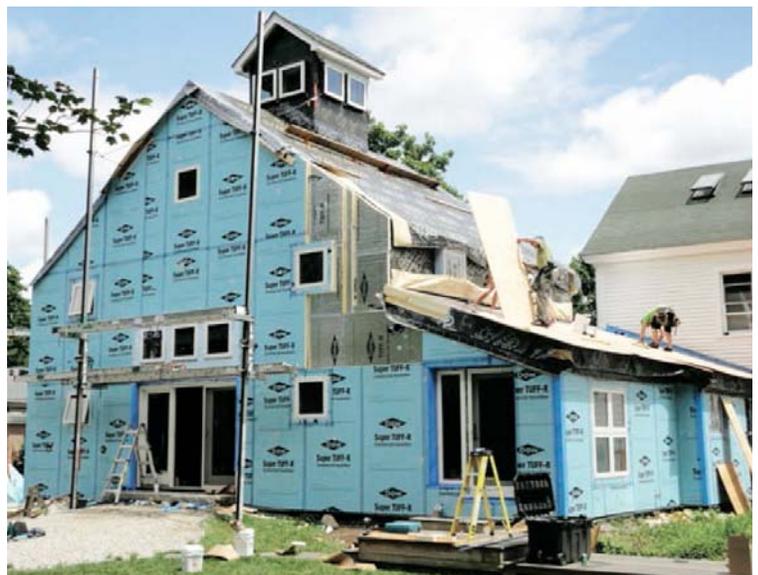
**Photograph 13: Thermal Control Layer**—Note the four layers of rigid insulation on the walls and the five layers of rigid insulation on the roof. You had better believe that each layer was offset horizontally and vertically and that each layer was sealed. I watched every sheet go in this time. None of this “faith-based” stuff anymore.

The thermal control layer for the walls and roof went on next: 8 in. (203 mm) of isocyanurate for the walls (four layers: each layer 2 in. (51 mm) thick with joints offset and each layer taped); 10 in. (254 mm) of isocyanurate for the roof (five layers: each layer 2 in. (51 mm) thick with joints offset and each layer taped). Check out **Photograph 13**.

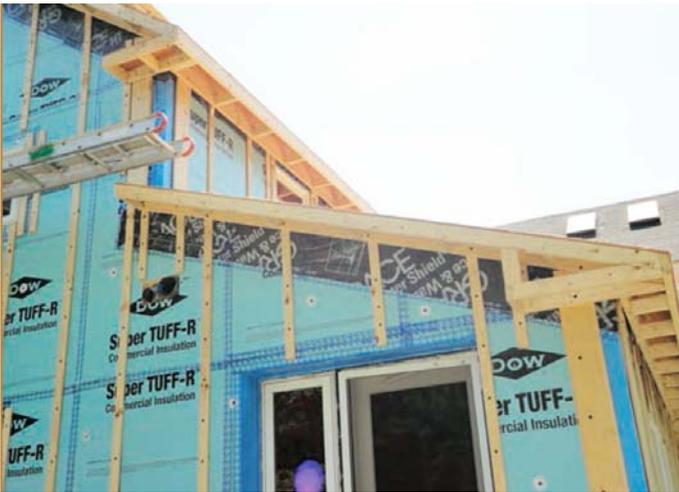
**Photograph 14 (top left): Floating Roof**—This takes a little bit of thinking to see what is going on. Check out **Figure 1** and **Figure 2** and then come back to this photograph. The overhangs are structurally sound, they just don't look that way until you understand how box beams work and that the rigid foam is not going to slide down the slope.

Wood furring (untreated) was then installed with long epoxy-coated steel screws through the rigid insulation into the structural sheathing and original board sheathing. Roof overhangs float on the top of the rigid insulation and tie into the wood furring on the walls (**Photograph 14**, **Figure 1** and **Figure 2**).

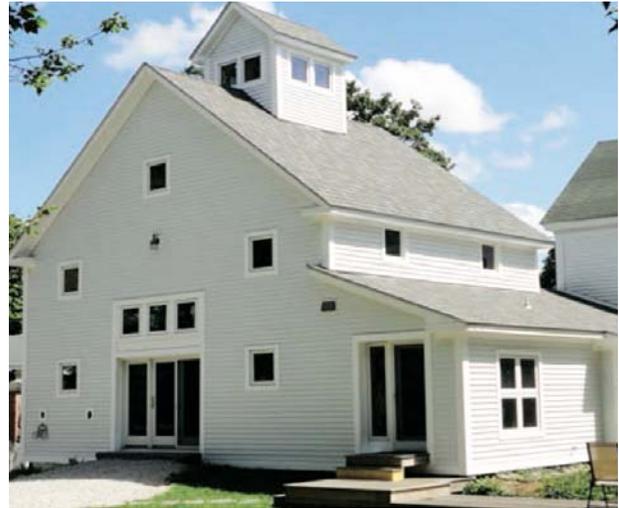
How did it turn out when all was said and done? Check out **Photograph 15**. New shingles. Lots of new insulation. Lots of shear.<sup>7</sup> No three-dimensional airflow networks. Not quite the plantation house of Charlton Heston and Eleanor Parker—but it will do—the Marabunta be damned.

**Photograph 15 (top right): Done**—Looks almost normal. R-65 roof and an R-52 wall more or less. And tight. How tight? Pick an outrageous phrase. The actual numbers are for another column. Check out the two round holes where the heat recovery ventilator (HRV) intake and exhaust goes. The extreme tightness leads to some interesting problems with exhaust fans and extreme pressures that require some nifty solutions. Later babe.

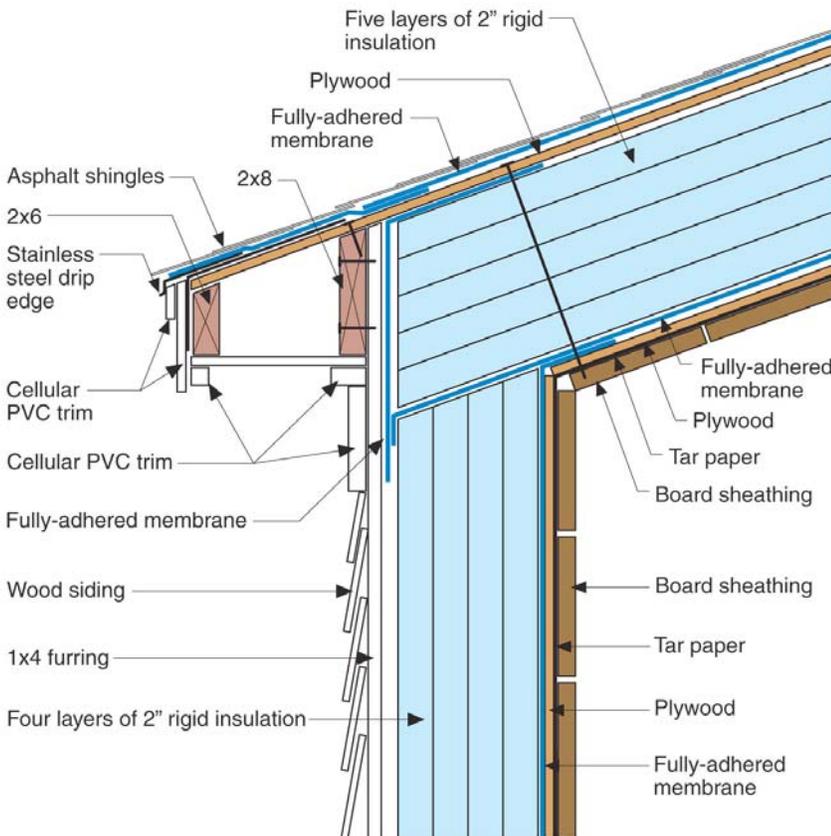
**Figure 1: Control Layer Continuity**—Note how the “under” roof is drained over the top of the wall. Also note how the overhang is framed. The roof plywood is screwed to the 2x8, locking the 2x8 into its vertical position. The roof plywood isn't going anywhere due to the long screws attaching it into the structural sheathing.

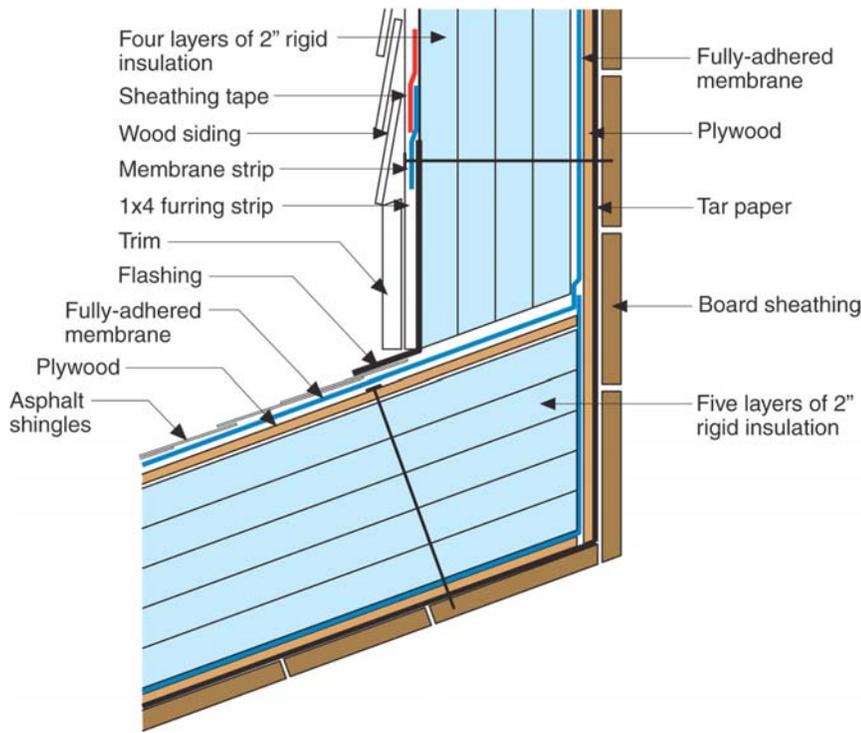
**Figure 2: Ant Control**—Note how the “under” roof and “over” roof membranes are tied into the wall’s water and air control layer behind the wall insulation.

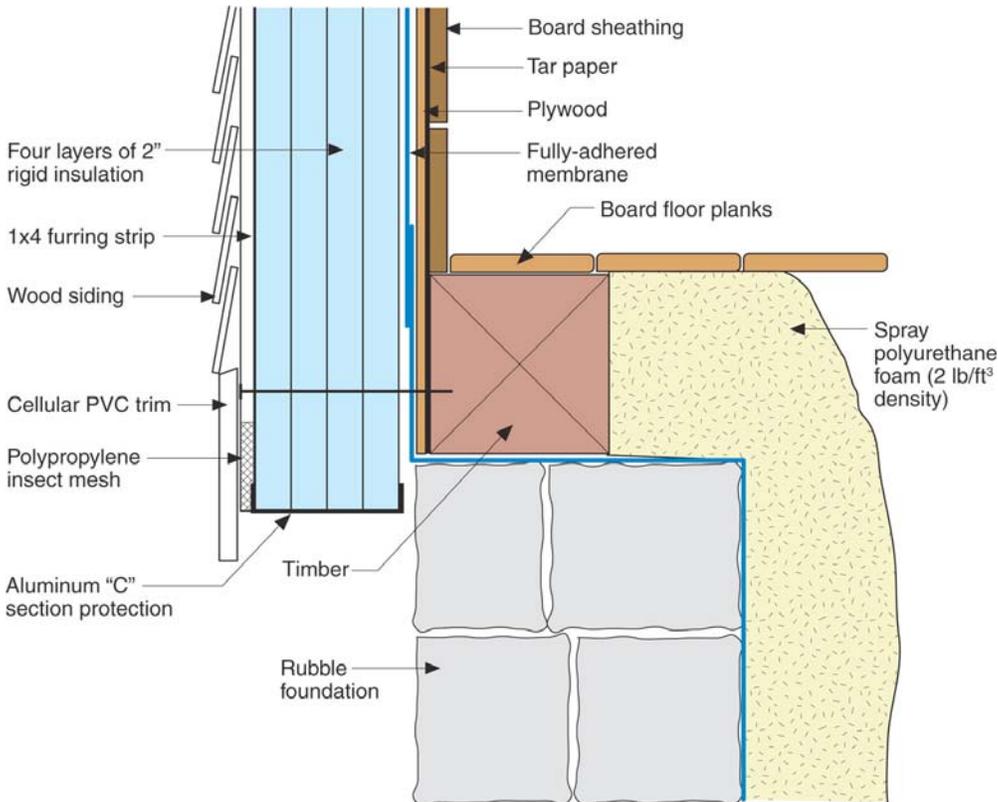
**Figure 3: Bug and Critter Control**—The aluminum sheet protects the underside of the wall rigid insulation layers. The polypropylene mesh keeps bugs out of the furring strip cavity. Photo 15 (top): Done. Looks almost normal. R-65 roof and an R-52 wall more or less. And tight. How tight? Pick an outrageous phrase. The actual numbers are for another column. Check out the two round holes where the heat recovery ventilator (HRV) intake and exhaust goes. The extreme tightness leads to some interesting problems with exhaust fans and extreme pressures that require some nifty solutions. Later babe.

Wood siding was installed over the wood furring strips. The wood siding was treated identically to the original wood siding and was installed identically to the original. However, the trim used was cellular PVC. Why? Ah, I couldn't get anyone to do wood trim the way we did it originally, and I felt the PVC stuff would be easier to install and work better and look better. The detail at the bottom of the wall did not change (**Figure 3**). Why mess with success?
