# Residential Exterior Wall Superinsulation Retrofit Details and Analysis

Conference Paper - 1012

15 December 2010 (rev. May 2011)

Kohta Ueno

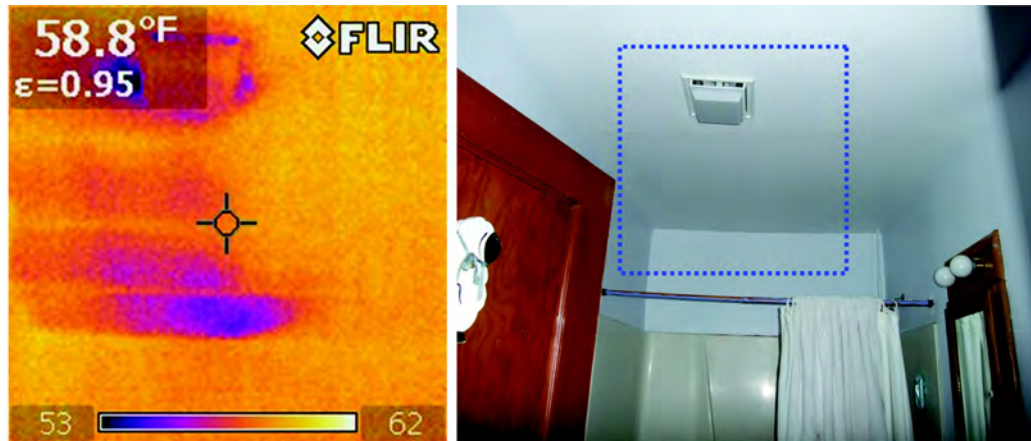
- **Mechanical:** Several mechanical exhaust fans proved to be significant leakage locations, including the kitchen range hood at the Concord Four Square and the bathroom exhausts at the Arlington Duplex, as shown in Figure 6. In addition, leakage bypassing the backdraft damper is visible. It is not clear whether the leakage occurs at the exterior penetration, or via leakage of the exhaust duct within the joist cavity.

**Figure 6** Air infiltration visible at bathroom exhaust fan; exterior wall beyond shower. Infrared image shows strapping/furring at ceiling, perpendicular to joists, supporting lath and plaster.

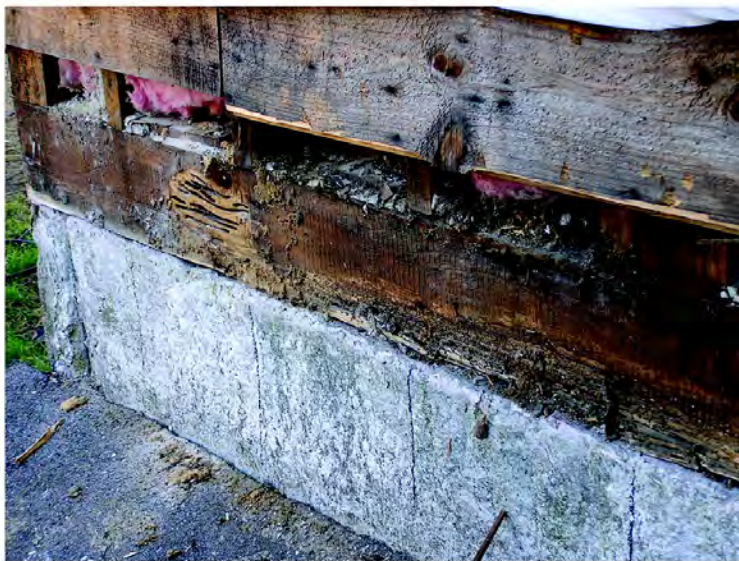
**Figure 7** Sill detail, including air barrier transition wrapped to front of foam, and capillary break over foundation (left); existing sill beam, showing long-term moisture damage (right).

location. The roof gable ends were part of the conditioned space enclosure (unvented roof); however, noticeable leakage was found coming in at the gaps between the board sheathing, indicating an air barrier failure exterior to that layer. It was retrofitted with spray foam from the interior. In addition, the connection detail between the foundation wall and the above-grade wall was difficult to achieve; a detail was drawn that provides air barrier continuity without introducing bulk water to the interior (Figure 7). However, this detail did not provide acceptable air barrier performance when executed in the field. In addition, it should be noted that the sill beam showed significant rot on several sides of the house, perhaps due to splash-back, capillarity, or bulk drainage issues, thus requiring sill replacement. A thorough inspection of the existing structure, although intrusive, is strongly recommended to avoid investing an energy retrofit on an unsound frame.

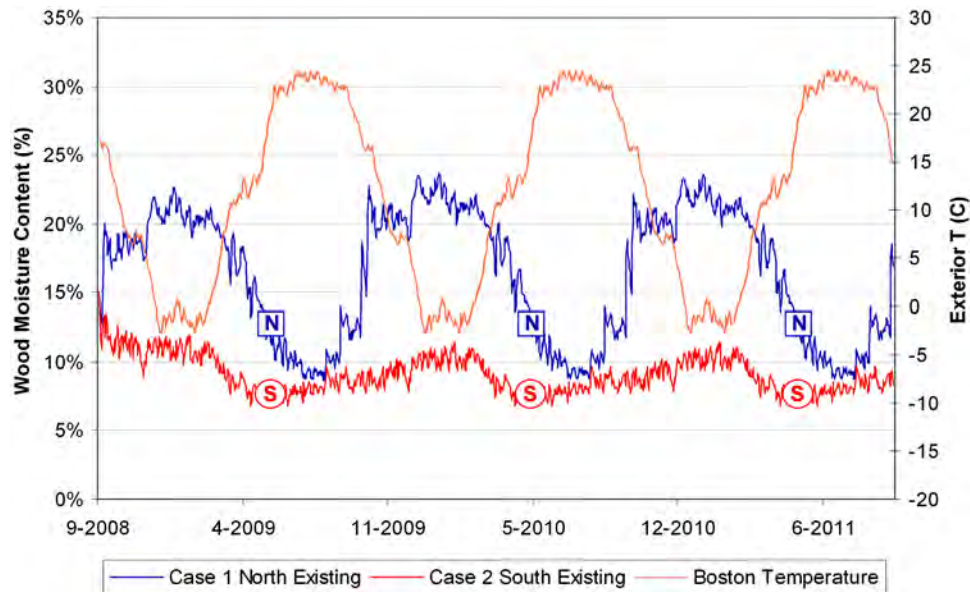
**Figure 8** Existing wall with 0.5% of incident rain penetration, north and south exposures, with exterior temperature for reference (seasonal patterns).

When the rain penetration was reduced to 0.5% of rainfall, the results are shown in Figure 8 (with the exterior temperature to show seasonal patterns): moisture contents peak in wintertime to 23%, and dry to below 10% in summertime, with a seasonally stable pattern.

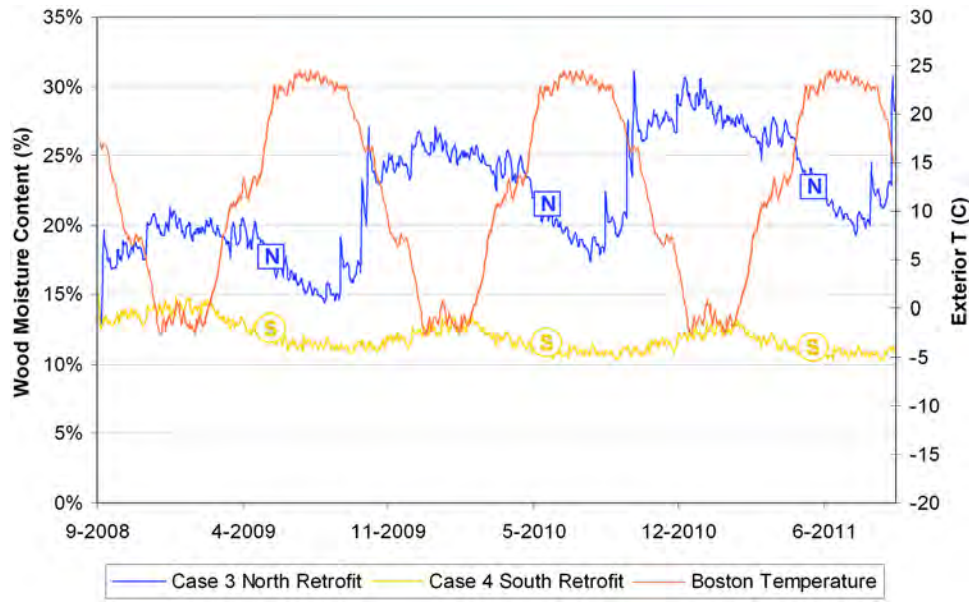
However, when these same rain penetration levels are applied to the retrofitted wall (Figure 9), the north side shows a seasonally increasing moisture content, exceeding 30% by the third winter. This indicates a greater sensitivity to rain penetration. If the rain penetration is reduced by half (to 0.25%), the moisture content of the north-side sheathing stays at safe levels, with lower peak moisture contents relative to the original wall (peaks at roughly 17%).

**Figure 9** Retrofitted wall with 0.5% of incident rain penetration, north and south exposures, with exterior temperature for reference (seasonal patterns).

These results demonstrate that if an exterior foam retrofit is done, it is vital to ensure that windows and other penetrations are flashed properly. In fact, this potential damage is a strong reason to consider window replacement, in order to provide subsill window pan flashings at all window openings. This information was used to persuade the homeowner of the Arlington project to take this course of action. Alternately, pan flashing might be retrofitted to existing window installations, although it would likely require removal and reinstallation of the windows.
