BSC Information Sheet 709

What's Wrong With This Project?

Extra Window Framing

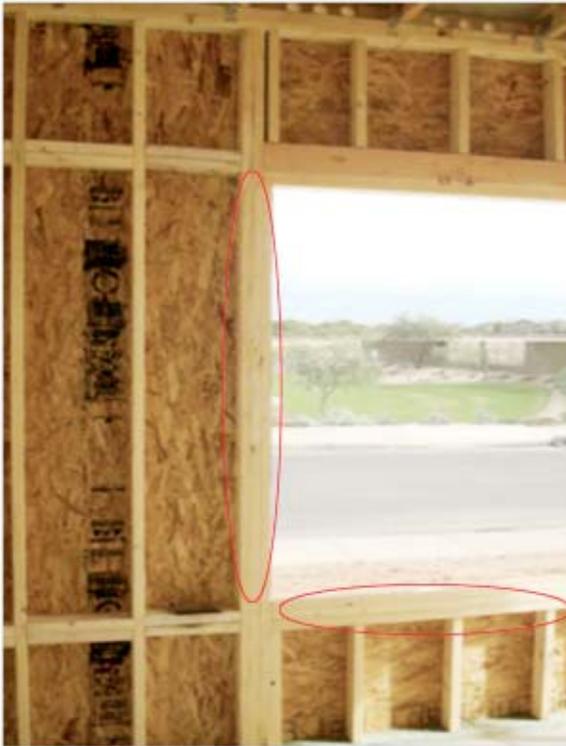
- Extra framing used unnecessarily around window opening

Extra framing used unnecessarily around window openings.

Extra horizontal framing members at the window sill and extra vertical framing members beside the window openings.

Incorporating Advanced Framing techniques around the windows would greatly reduce the wood required below the top plate of the upper story, and it's estimated that between \$500 and \$750 in material costs could be saved in this example alone had a single beam been used directly under the roof trusses.

Only one horizontal framing member is required at the bottom of the window; remove extra vertical framing members.

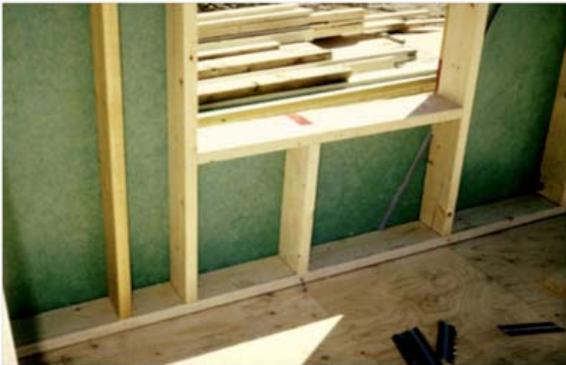
- Correct window framing using Advanced Framing with single horizontal and vertical framing members
