Analysis of Joist Masonry Moisture Content Monitoring

Building America Report - 1508

October 2015

Kohta Ueno

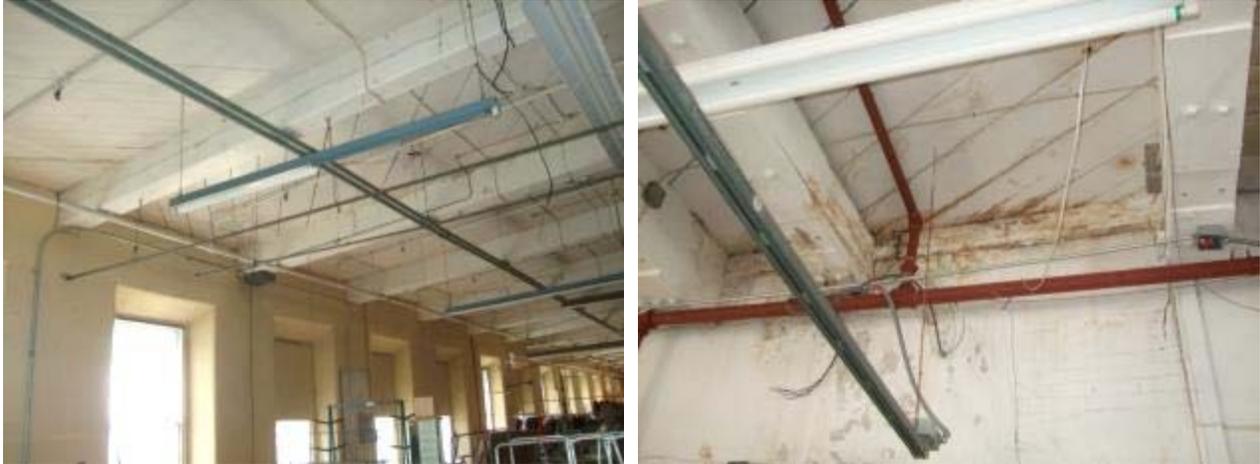
One common geometry, especially in mill or industrial buildings, is large timber beams (8–10 in. minimum thickness) at a wide spacing (Figure 5, left). The beams are fire cut (slant cut at the end to prevent wall collapse during a building fire; see Figure 30) and embedded in the masonry wall. Signs of water damage at the beam end (Figure 5, right) were relatively rare and were typically associated with roofing failures (on the top floor), water issues near grade, and poorly detailed roof-wall connections (which deposit excess water on the wall).

Figure 5. Typical large beam geometry (left); water damage at beam end (right)

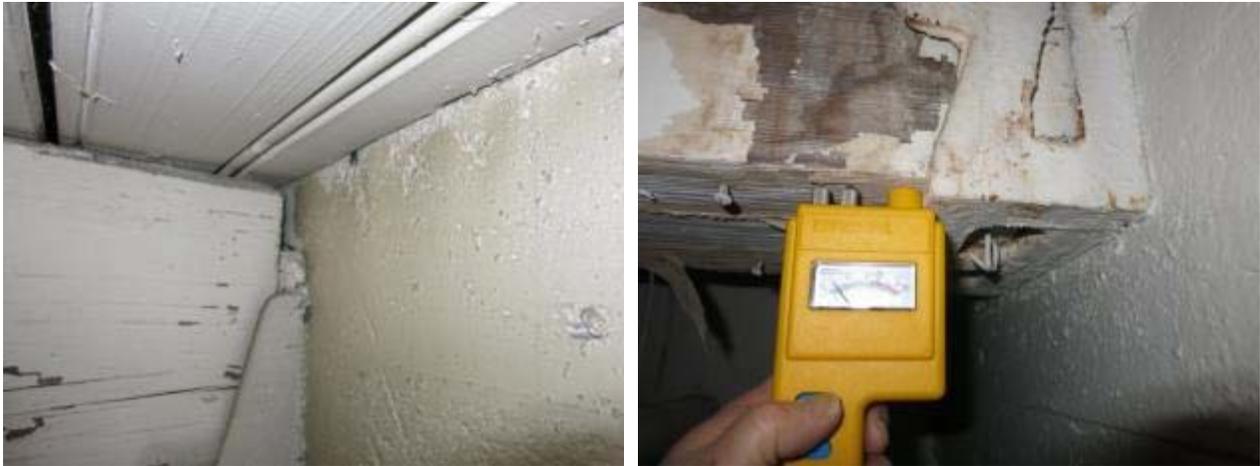
This wetting might have been caused by interior-sourced flooding, based on the water stain patterns (e.g., visible staining between subfloor gaps). Whatever the wetting source, however, this detail allows for greater drying than an embedded beam.

Figure 9. Wood clear of masonry (left); low MC despite wetting stains (right)

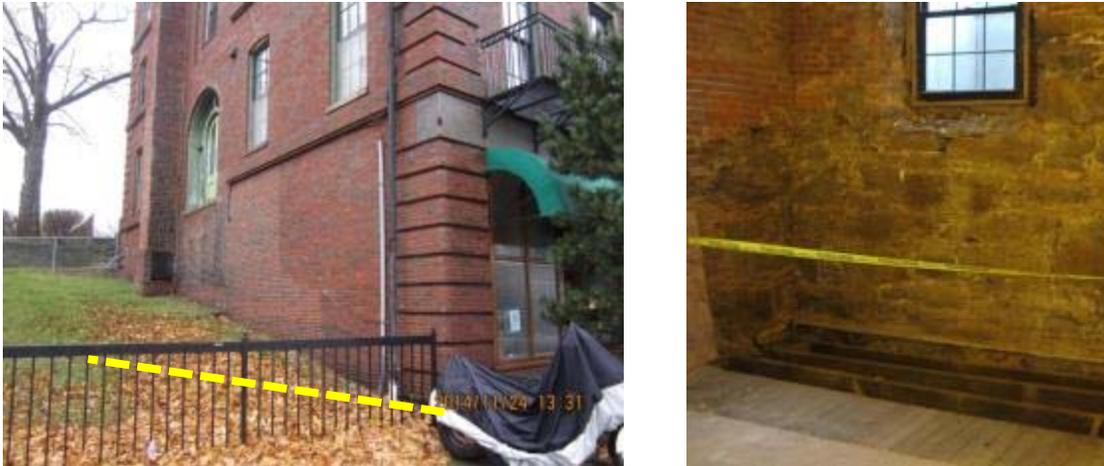
These risks are demonstrated in demolition at a circa 1850 brick building in the Boston area. The exterior grade rises at the sides of the building, which puts the floor framing below grade (Figure 11).

Figure 11. Building exterior grade condition (left); beam interface to below-grade wall (right)

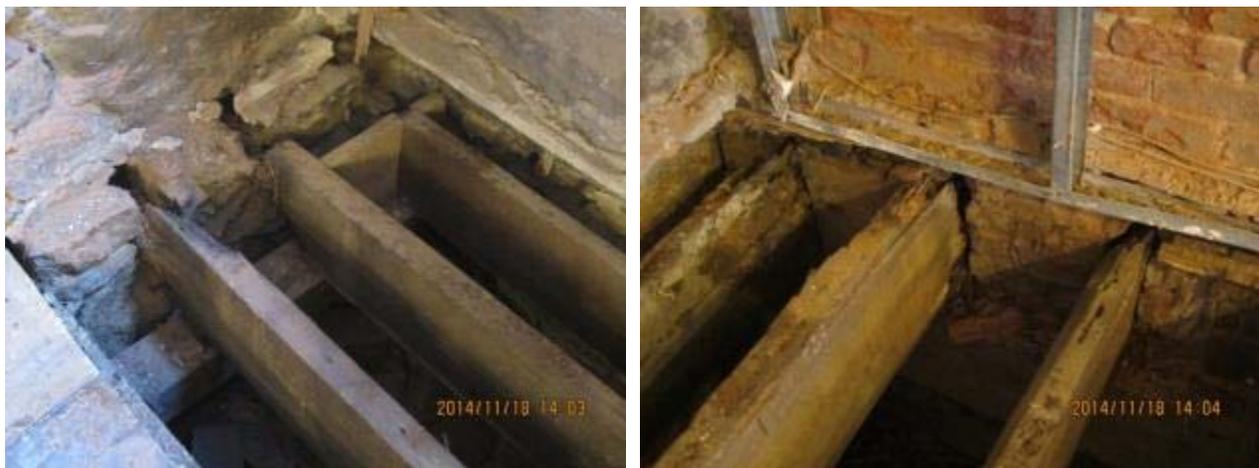
The floor framing had severely deteriorated at the beam pockets (Figure 12). This floor system had no insulation. This damage had likely been continuing for some time, but it postdates the circa 1980s–1990s renovation (which was being demolished here).

Figure 12. Damage to embedded beams at walls

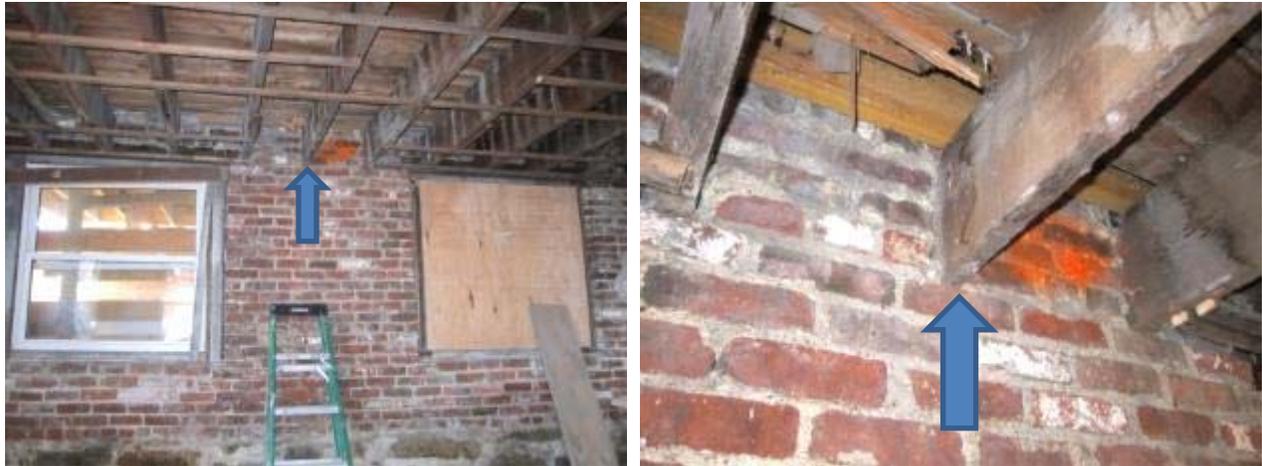
Figure 25. BSMT-E2 joist, showing existing water staining

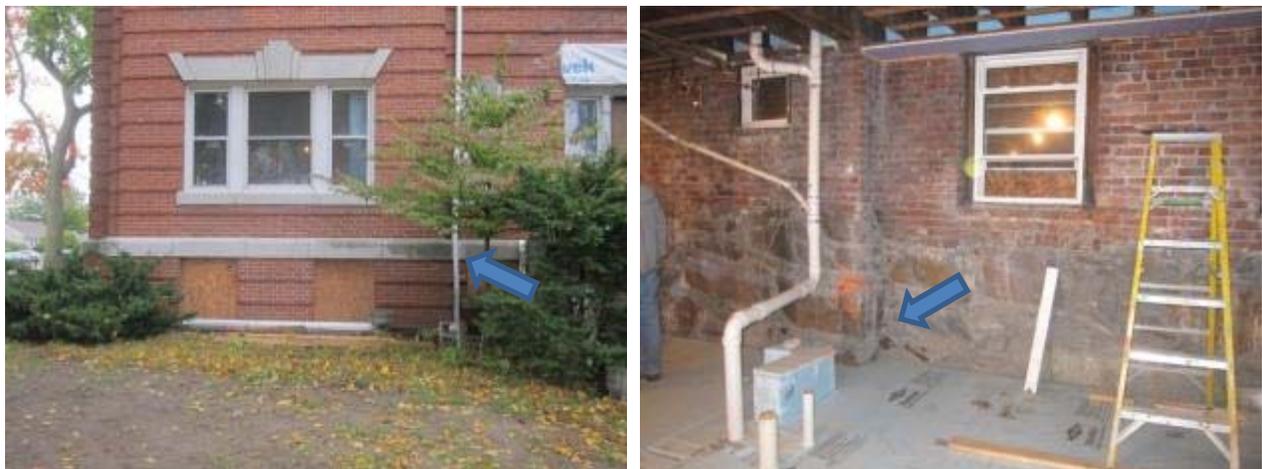
BSMT-W1 and BSMT-W2 are of interest because the site inspection revealed that rainwater was being deposited on the wall at the jog (see Figure 21). BSMT-W1 was set up to capture the mostly dry field of the wall; BSMT-W2 was located close to the jog to determine whether this bulk water was sufficient to cause issues with the embedded joist end moisture behavior. This cardinal orientation has low driving rain exposure (see Figure 15).

Figure 26. BSMT-W1 and BSMT-W2 joists showing water deposition at wall jog

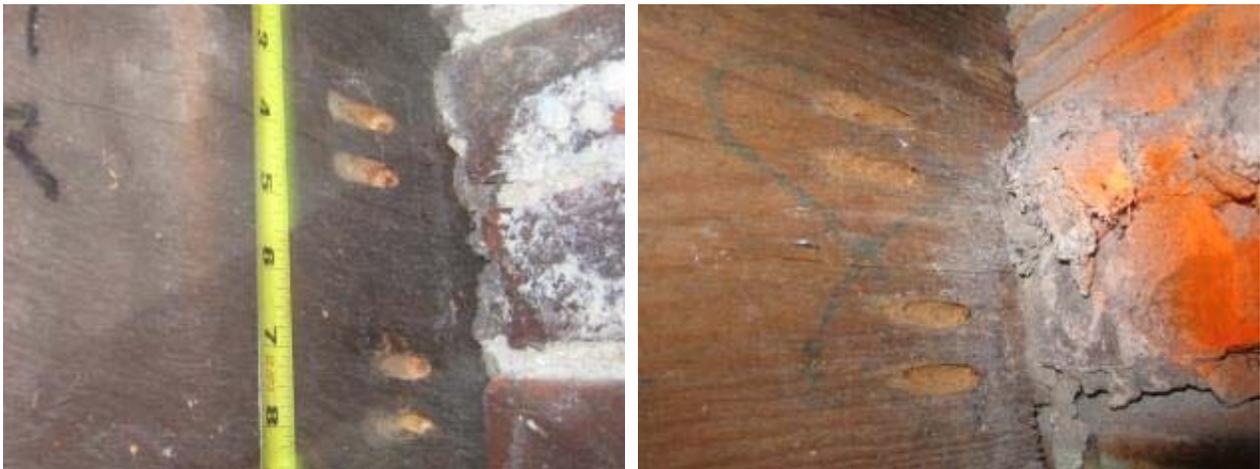
Figure 28. Wood color comparison at BSMT-E1 joist (left); FIRST-E joist (right)

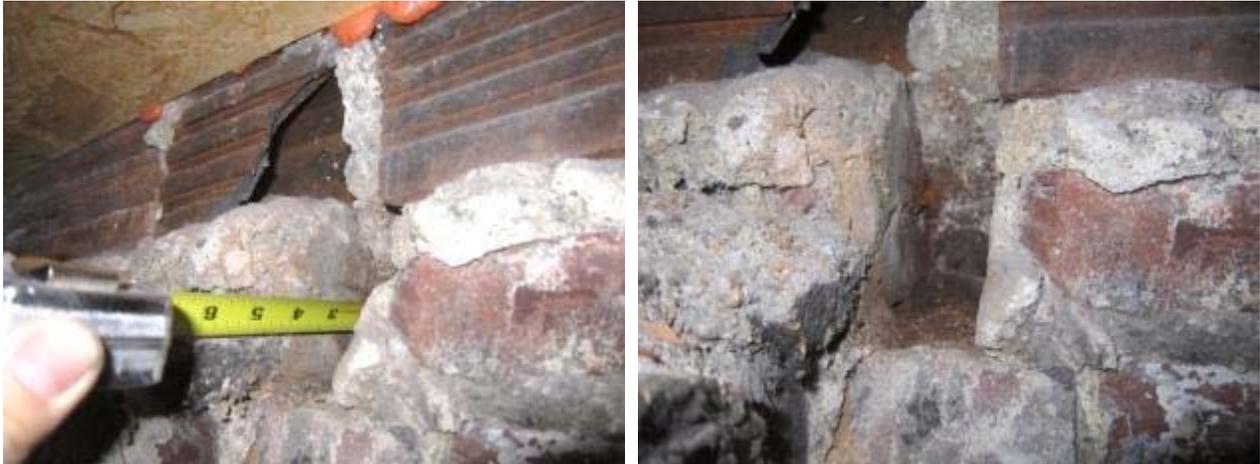
Figure 35. Conditions in joist pocket at north-facing building at addition

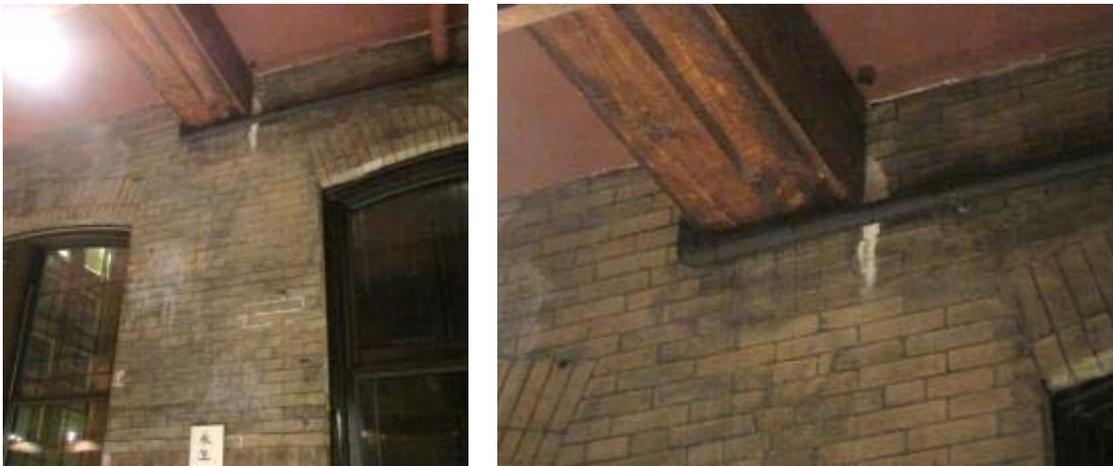
Figure 67. Evidence of water penetration at embedded beam end in masonry
