Monitoring of Double-Stud Wall Moisture Conditions in the Northeast

Building America Report - 1501

January 2015

Building Science Corporation

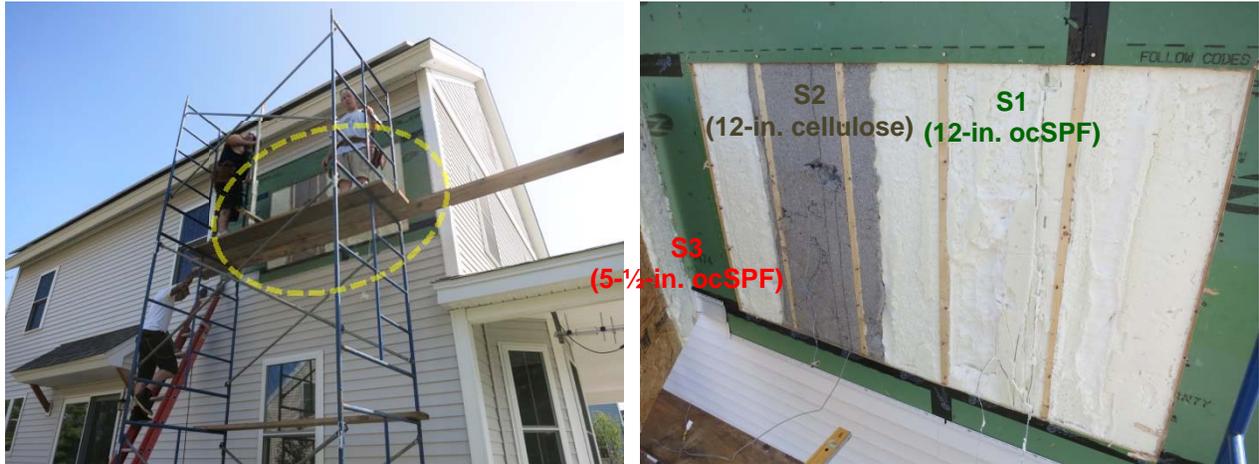
Figure 39. South-facing wall disassembly, showing test bay cavities

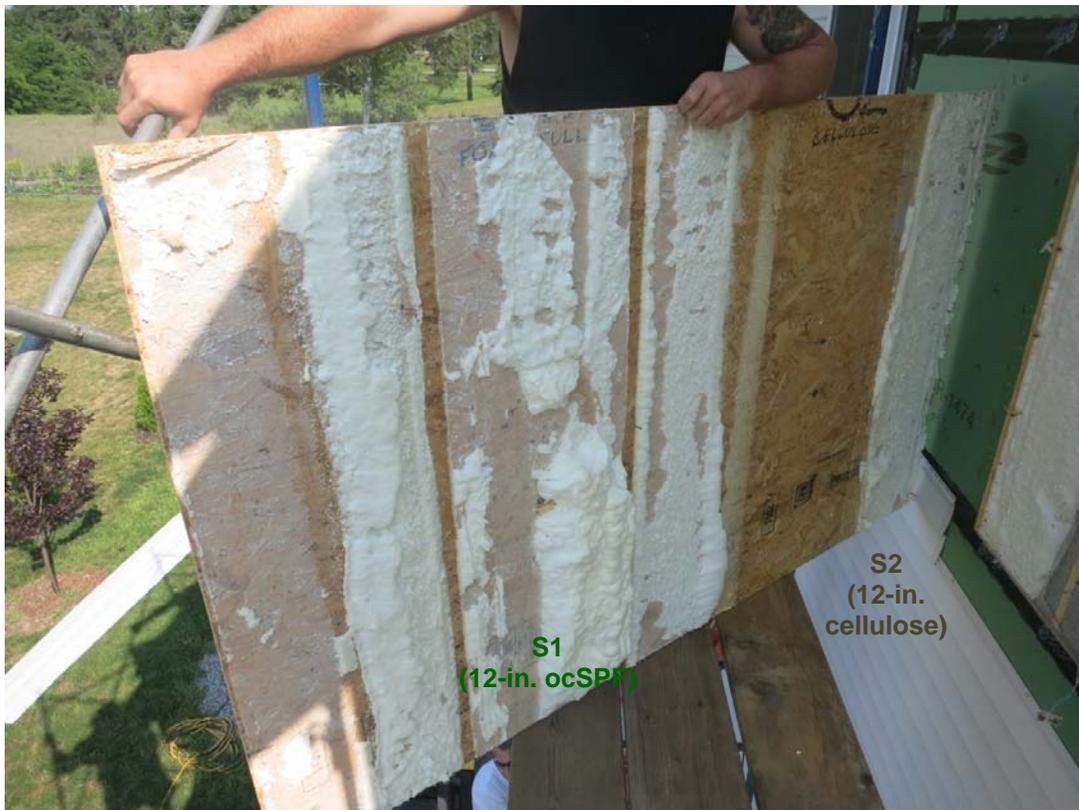
Figure 40. South-facing wall sheathing conditions

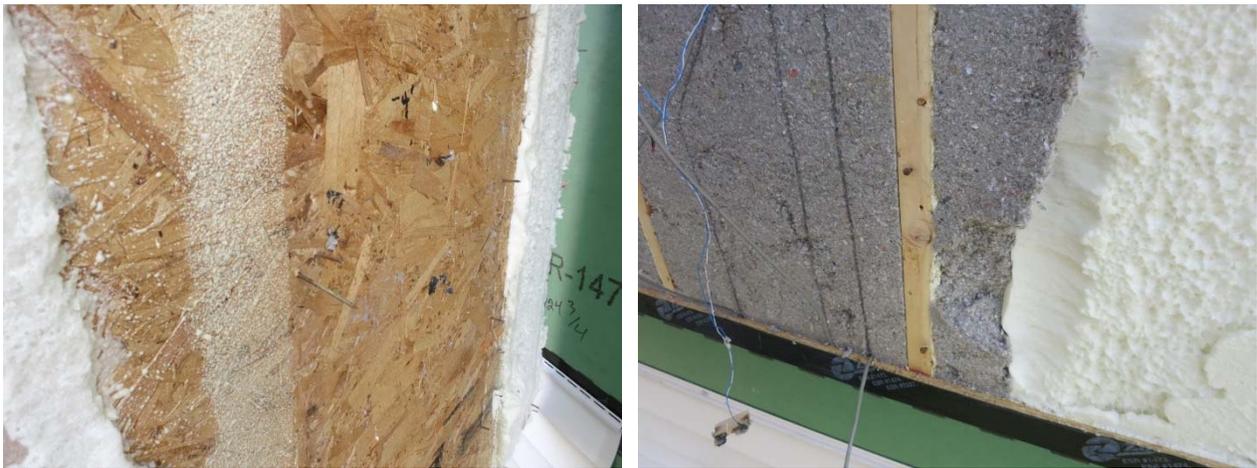
Figure 41. Sheathing and framing conditions at south-facing walls

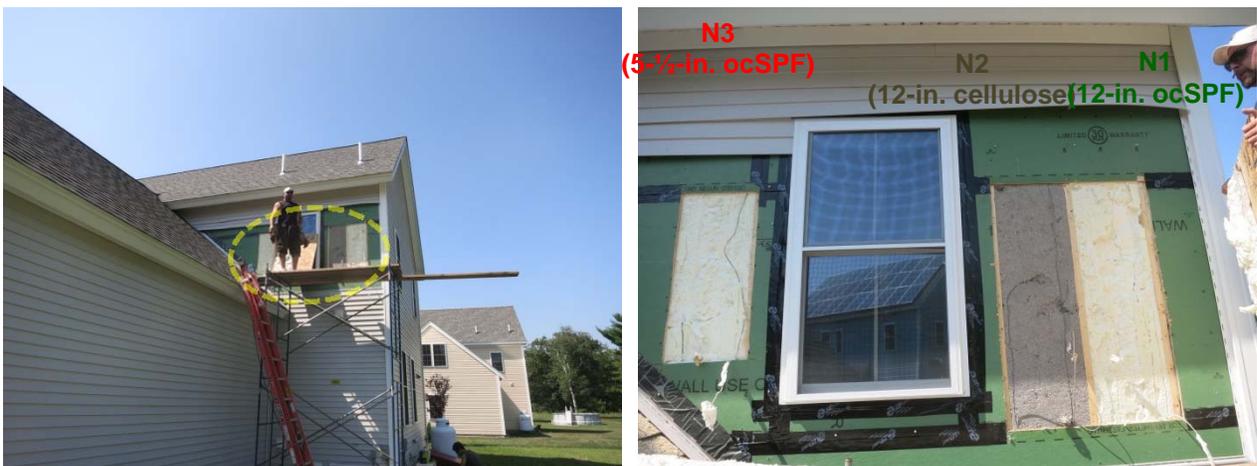
Figure 42. North-facing wall disassembly, showing test bay cavities

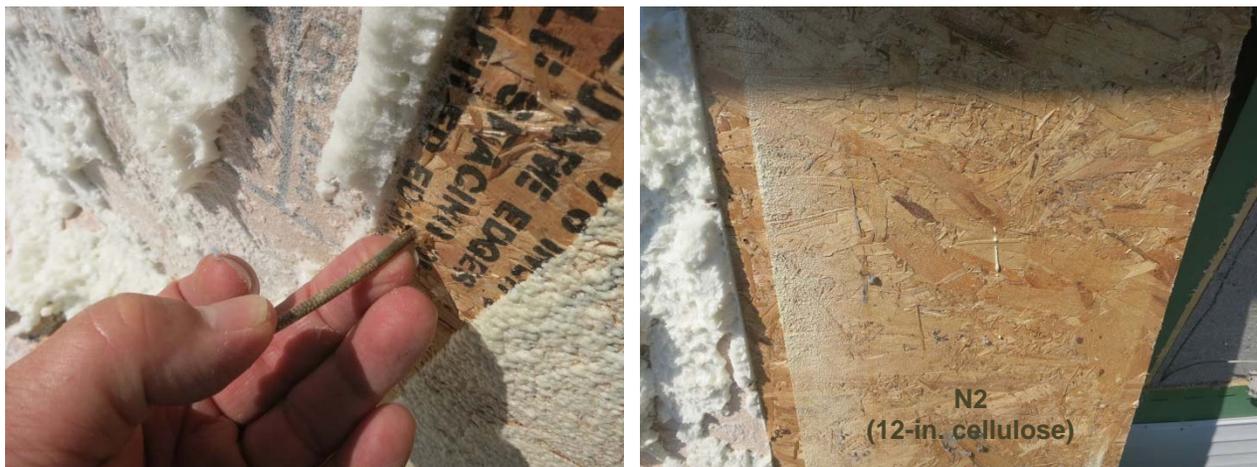
Figure 44. North-facing wall conditions at fastener and sheathing at cellulose bay (N2)

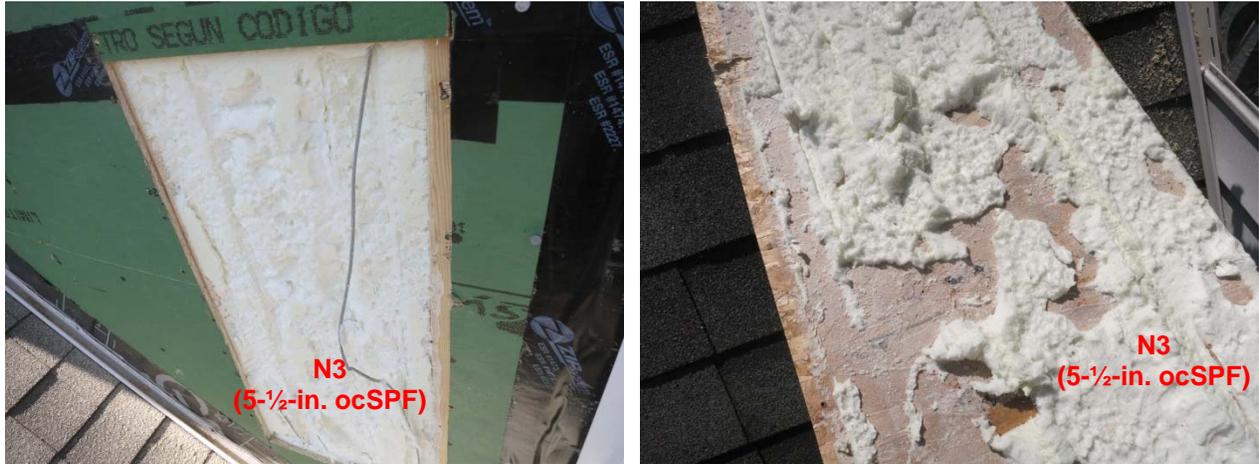
No evidence was seen of voids or “pockets” in the ocSPF stud bay insulation, which is has been observed at other installations.

Figure 45. Stud bay cavity and sheathing conditions at 5-1/2-in. ocSPF north-facing wall (N3)

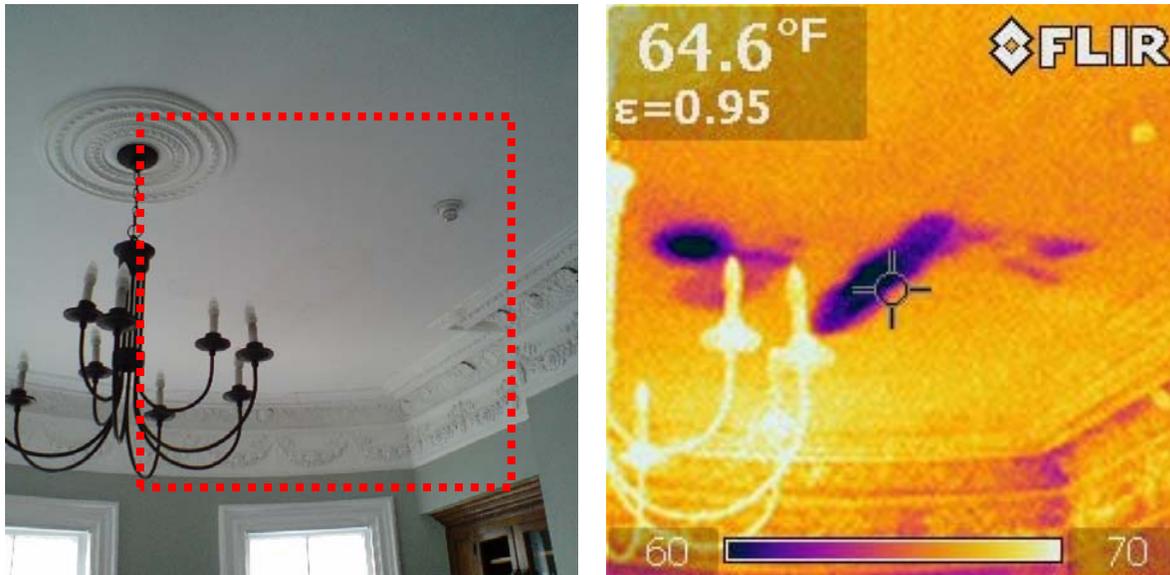
Figure 56. Bulk water leakage through ocSPF, visible at interior
