# Public Housing Breaks the Mold

**Multifamily public and low-income housing have particular problems when it comes to moisture and air pollutants. In this first of a two-part series, we look at one particular type of multifamily construction: midrise housing.**

# Part I: Midrise Housing

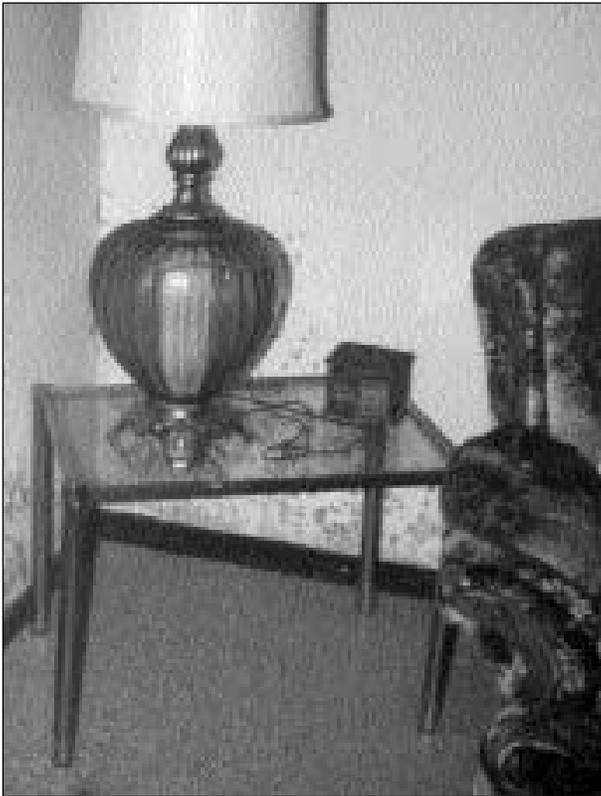
This “cold climate mold” often occurs where you have lots of framing members but no insulation, such as in corners of rooms.

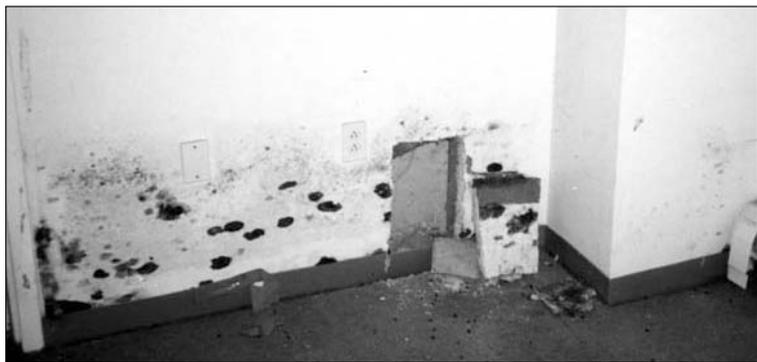
After the rain leakage test is performed on the building exterior, field engineers removed sections of the interior wall to see if water had leaked into the walls. Because it had not, we knew that condensation was the cause of the mold growth.

Investigators concluded that the mold growth occurred at Roxbury Corners because warm, humid air drawn into the building during the summer was condensing on cold surfaces, especially at metal studs. Basement level apartments are susceptible to this problem because they experience substantial heat loss to the ground at the below-grade portions of the perimeter walls and the bottom plates of the interior

*Increase the surface temperature of cold surfaces.* This measure required significant remediation and mitigation efforts in the lower-floor apartments. Investigators recommended reconstructing the lower apartments by adding rigid thermal insulation to the exterior walls in order to eliminate the thermal bridging. This required management to strip the damaged gypsum board and place rigid insulation between the metal framing and the concrete foundations at the perimeter.

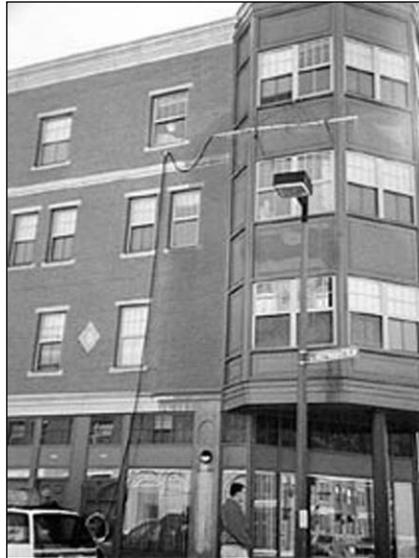
At Roxbury Corners, we performed a rain leakage test to determine if rainwater was leaking into the walls.

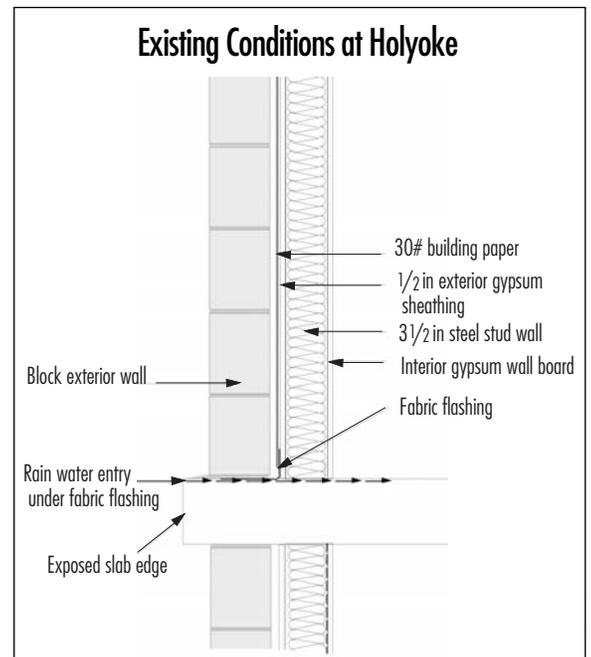
Figure 1. Rainwater entered the building, driven by wind, under the fabric flashing at the exterior balcony.

Water leakage test results showed that rainwater was entering at the slab edge of each floor under the fabric flashing. At the same time, thermal bridging at the ceiling/exterior wall intersection was increasing the surface relative humidity in these locations high enough to support mold growth.

*Reduce building envelope water infiltration.* Upgrade the building envelope. Figure 1 shows how water entered through the wall. Figure 2 shows a detail of the water dam and drainage path design recommended for locations where water entered the building. Figure 3 shows details of the solution to eliminate the thermal bridge effect of the exposed concrete frame. After these recommendations were implemented, water stopped entering the apartments.

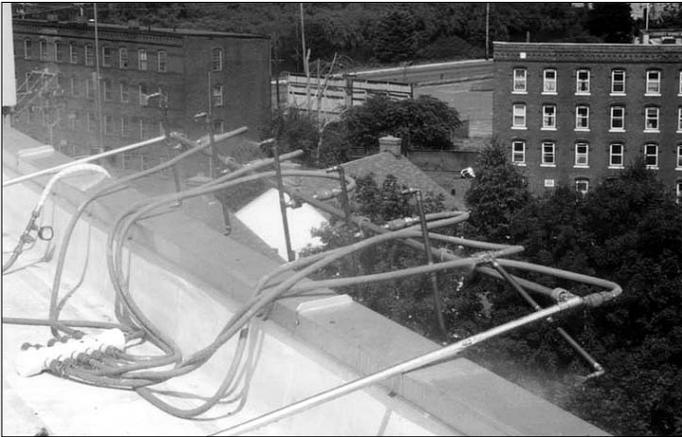
At Holyoke, the rain leakage test determined that rain water was indeed the moisture source.

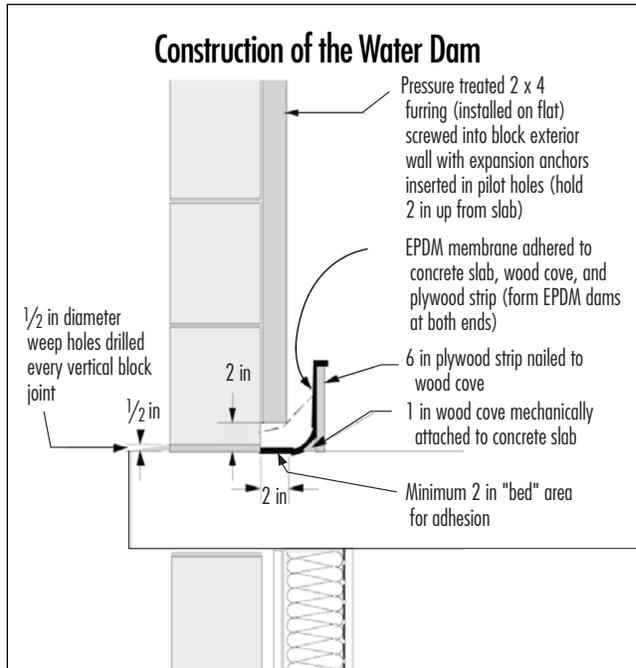
Figure 2. The existing stud wall and insulation were removed from the inside, and weep holes were drilled to allow the water to drain out.

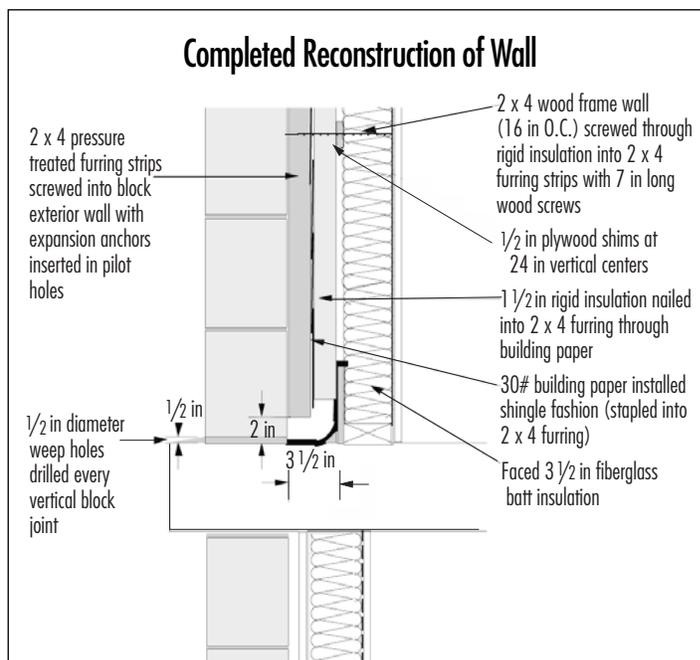
Figure 3. Once the water dam was installed, the interior wall was reconstructed. With the moisture source removed, the mold disappeared.

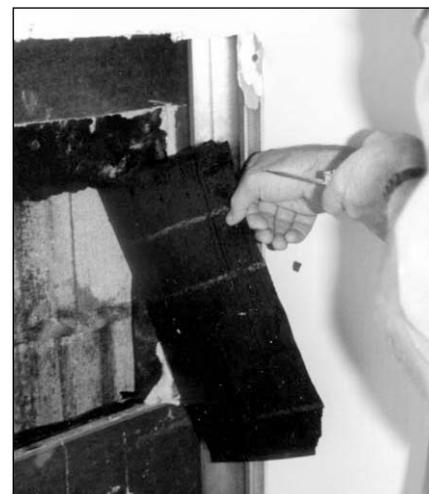
When the wall section at Holyoke was removed, water (and mold) were found within.
