Kohta Ueno and Joseph Lstiburek, Ph.D., P.Eng.

**Unvented Roof Research:**  
**The "Ridge Rot" Accelerator**

March 3, 2015

**BUILDING ENERGY 15**  
MARCH 3-5, 2015 AT THE SEAPORT WORLD TRADE CENTER

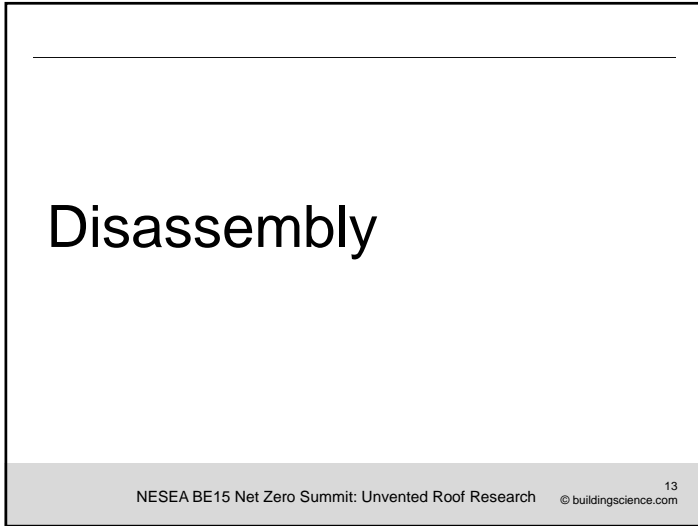
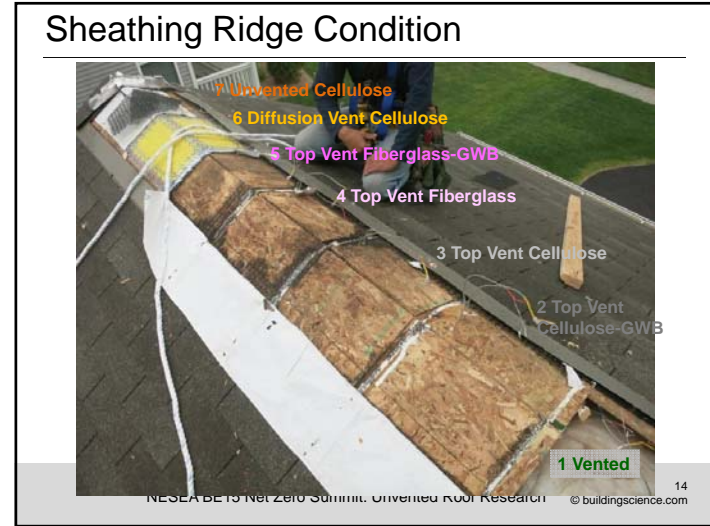
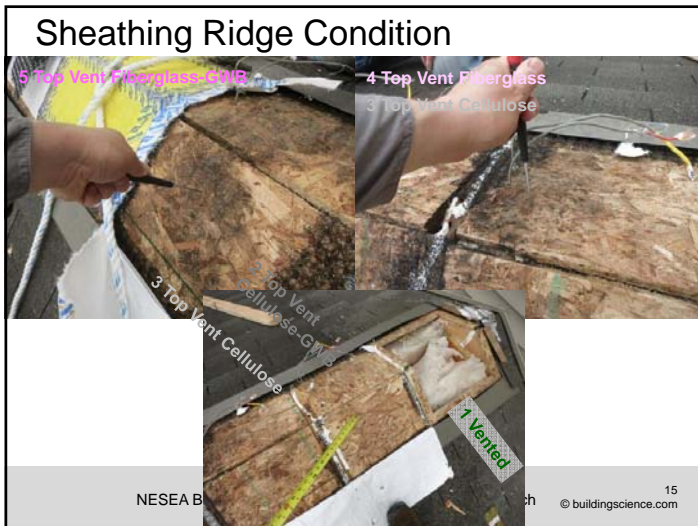
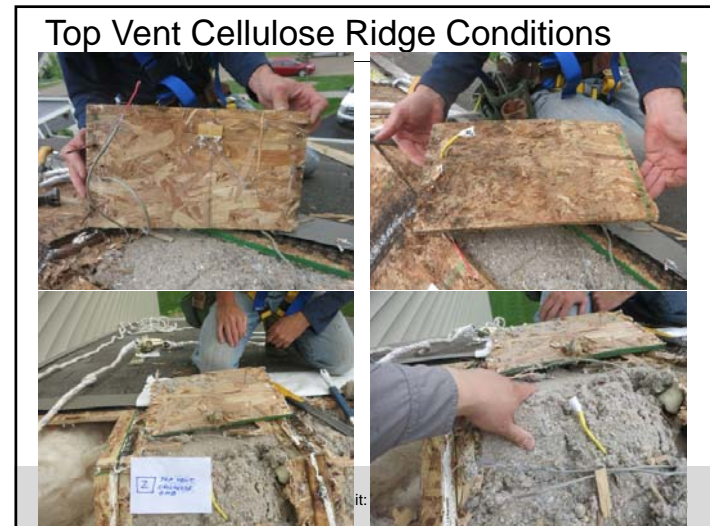
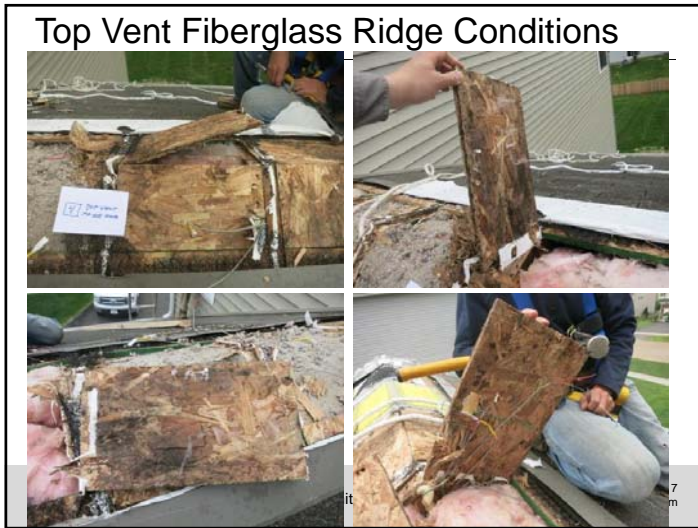
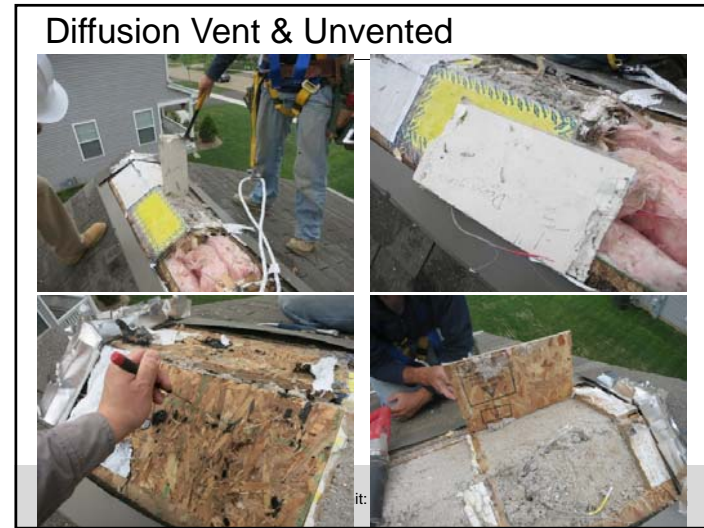
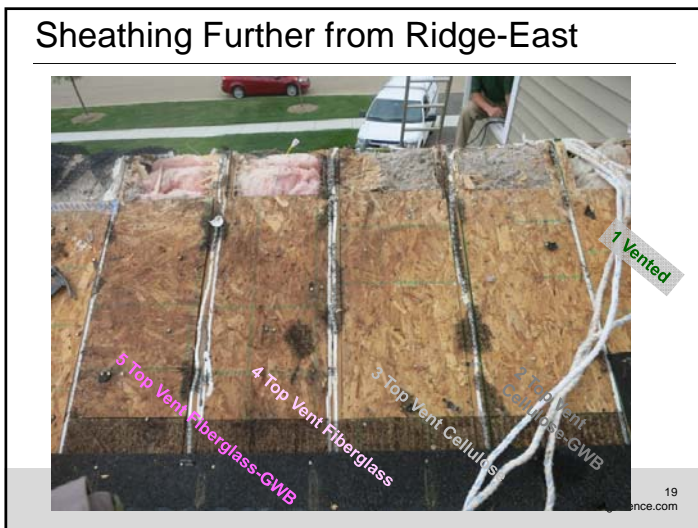
- ### Disassembly Takeaways
- Results consistent with monitoring data
  - Sheathing stained but not punky/structural damage
  - Damage concentrated/severe at ridge
  - Fiberglass sheathing & framing: extensive damage & staining, possible mold growth
  - Cellulose sheathing: some delamination, adhesions, and rusty fasteners—not as bad
  - Cellulose did not settle over one winter
  - Fiberglass batts leave lots of air leakage paths
