# Measuring the Impact of Interior Insulation on Solid Masonry Walls in a Cold Climate

By J. Wilkinson, D. De Rose, B. Sullivan and J.F. Straube

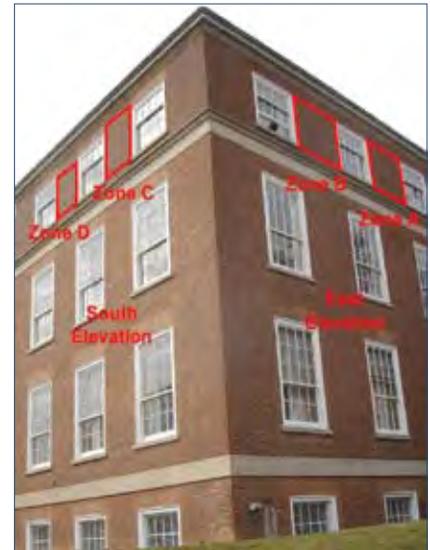
Picture 1. Exterior south-east corner. All wall mock-up zones shown, zones A/B (east elevation), zones C/D (south Elevation).

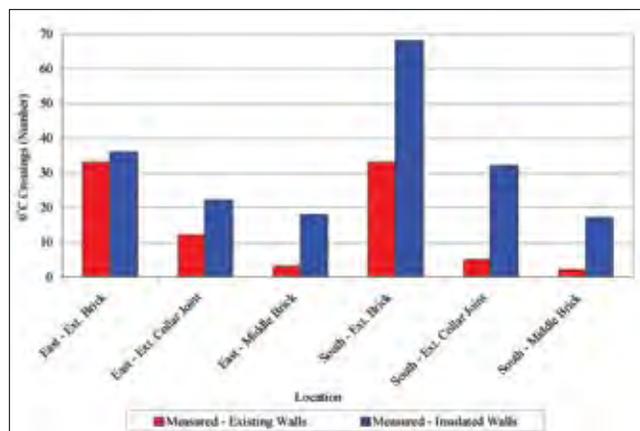
Figure 4. This figure illustrates climate conditions relevant to freeze-thaw cycles. All insulated walls have an increase in the number of zero crossings, particularly the south elevation due to impacts from solar radiation. There were no hours when freeze thaw cycles were observed (when a zero crossing occurred and moisture contents were also above 85 percent of free water saturation).

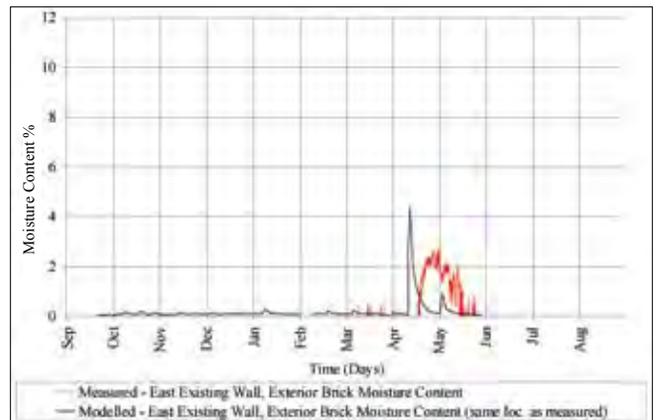
comparable between the calculated/ modeled and measured results (see **FIGURE 8**). However, there are spikes in the modeled exterior brick moisture content soon after rain events, which do not appear as significantly in the measured walls. This discrepancy is discussed in more detail later in this article. The model was used to evaluate these peak moisture content values, as they are important to freeze-thaw performance.

Figure 8. Moisture contents are generally similar, apart from severe spikes in modeled moisture content soon after rain events that are not observed in measured values. This discrepancy should be resolved with artificial wetting of the field sensors to test reaction time to wetting events.

as pronounced in the measured values due to slow sensor response, given sensor size and encasement in bentonite clay (which may impact capillary connectivity). After a rain event, the moisture may dry or be redistributed before the sensor can fully react.

The moisture content sensors in the monitored walls should be checked to confirm their reaction time to rain events. This evaluation could be performed by applying water to the area in question, which would allow for a constant wetting condition with

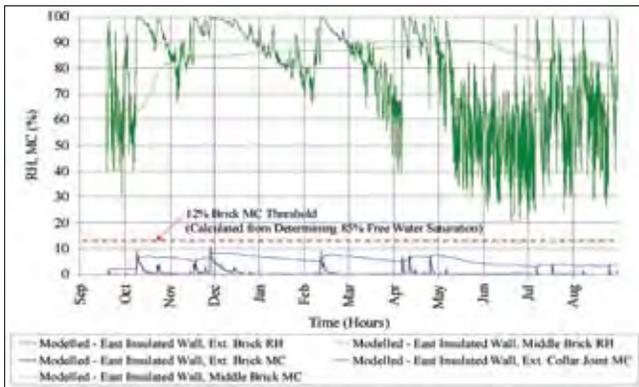
In the modeled walls subjected to more severe weather conditions than those experienced in the field (using rain deposition factor of 0.5), there were no instances where freeze-thaw damage was likely to occur (see **FIGURE 9**). The maximum moisture content was 10.6 percent (peaking in the brick soon after rain events). The moisture content in the brick between rain events is typically near 0 percent. The mortar moisture content is fairly constant between 2 to 8 percent. These moisture contents are below the estimated threshold levels of 12 percent and 13 percent (brick and mortar respectively) where freeze-thaw damage is expected to occur.

Figure 9. Brick moisture content in most severe modeled case is 10.6 percent, which is below the 12 percent MC freeze-thaw threshold.

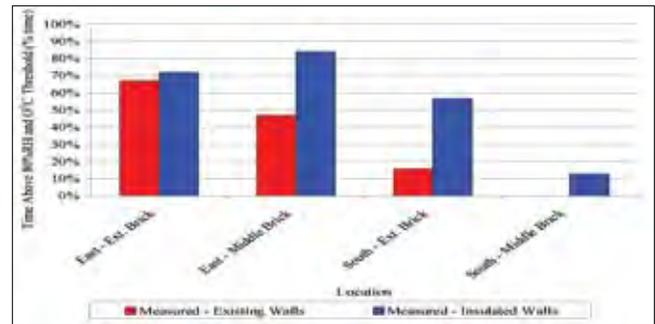
**FIGURE 10** shows the time above corrosion thresholds. Corrosion threshold is Time of Wetness (i.e. hours above 0°C and 80 percent relative humidity) as defined in ISO (1992).

The modelled walls show no increase in corrosion risk between un-insulated and insulated walls. However, the measured walls show an increased risk. We believe this discrepancy is, in part, due to the nature of the sensor installation, with a wood resistance sensor embedded in the parent material using bentonite clay. In addition, moisture transport in the model may occur by liquid transport, while moisture transfer to the sensors is predominantly by vapor diffusion (i.e. slower process). This may result in

Figure 10. Insulated walls have significantly more time above corrosion thresholds than existing walls, increasing risks for embedded steel corrosion in insulated walls.

Inspection openings in the walls should be used to determine the function, extent and condition of the embedded metal components prior to insulating walls given the high number

of hours above corrosion thresholds even for the existing walls. The depth of carbonation in the mortar (passive protection of metal by mortar) should also be checked. Metal components could be replaced with stainless steel components where embedded metal corrosion risk is expected to increase (e.g. stainless steel helical ties could be used to replace or supplement metal ties).

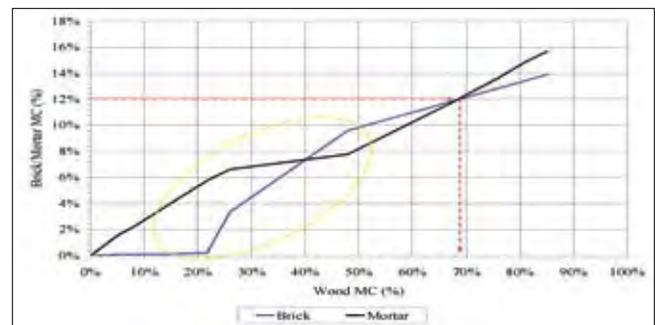
The wood moisture content sensors used to evaluate the brick moisture content operate accurately in the 20 percent to 50 percent wood MC range (corresponding to 0 percent to 8 percent MC in this brick), as shown in **FIGURE 11 AND FIGURE 12**. The wood moisture content did not exceed 30 percent (4 percent in this brick) over the monitoring period due to a lack of wetting, so the upper range of the sensors was not an issue in this case (SEE **FIGURE 10**). However, given that critical limits for freeze-thaw damage correspond to approximately 70 percent in wood (12 percent in this brick), these wood sensors would not adequately evaluate moisture content near the threshold in this brick.

Figure 12. Corresponding brick MC for given wood MC reading. Wood sensors operate accurately in the range circled in yellow. Critical moisture content range for brick freeze-thaw analysis (and corresponding wood moisture content), shown with dotted red arrows.
