Insight Rubble Foundations

By Joseph W. Lstiburek, Ph.D., P.Eng., Fellow ASHRAE

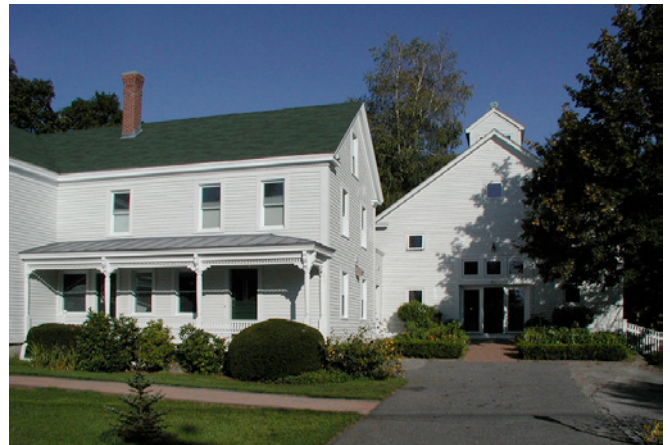
Photograph 1: Looks Good Now—You should have seen this place when the timber frame was rotting and the basement was smelly and the rubble foundation was leaking and the floors were freezing.

Check out the house in **Photograph 1**. Built in 1880 on top of a rubble foundation. It was a dump. Every time it rained the basement flooded. And it wasn't really a basement. It was sort of a tall crawlspace with a short crawlspace attached to one side. The house smelled. It smelled bad. Moldy, musty, and dirt-like. The floors were freezing in the winter. During cold weather it was not possible to keep the basement door closed because of the draft rushing up from purgatory. In other words it was the perfect house for us so we bought it—yup, my bride and I live in this house.

We couldn't afford to dig it up from the outside because we didn't have the money and besides the "Historical Commission"³ wouldn't let us. They didn't want us to touch the appearance of the rubble foundation that extended above grade.

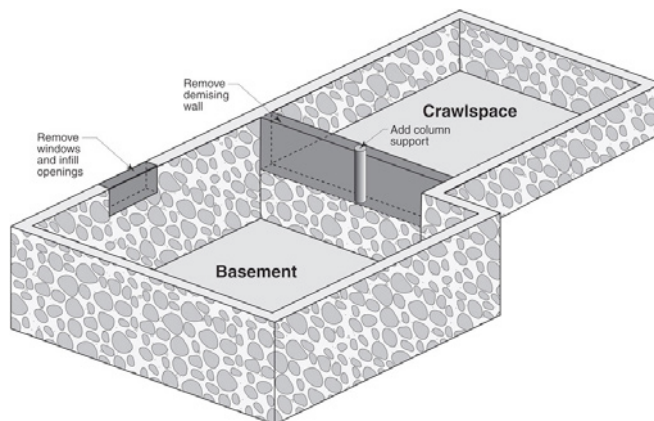
Figure 1: Make A Single Zone—Connect the short crawlspace to the basement by removing the short demising wall. Eliminating the rubble demising wall also eliminates two significant intersecting thermal bridges.

Figure 1 and **Photograph 2** illustrate connecting the two crawlspaces (or mini basements) to one another creating a single zone. Crawlspaces need to be either completely “outside” or completely “inside.” Completely inside is easier when a basement is also involved. The rubble demising wall separating the crawlspace from the basement was knocked out and replaced with a column. Eliminating the rubble demising wall also eliminated two significant intersecting thermal bridges. Note that we also removed and filled in the small crawlspace-basement windows with concrete. These basement windows were nothing more than primitive holes that were, in essence, water leaks, thermal leaks and rot factories.

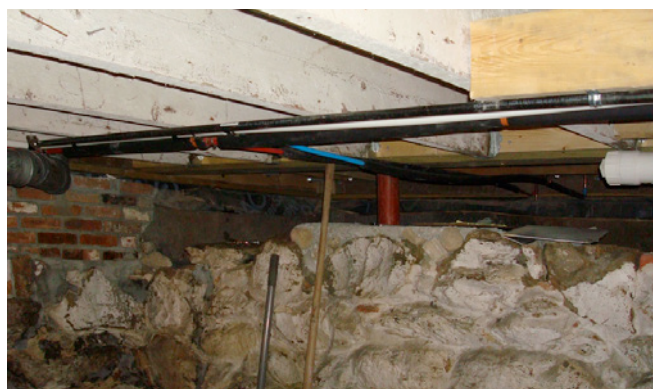
Photograph 2: Knocking Out the Demising Wall—Note the small short column that replaces the supporting demising that was removed to connect the crawlspace to the house basement.

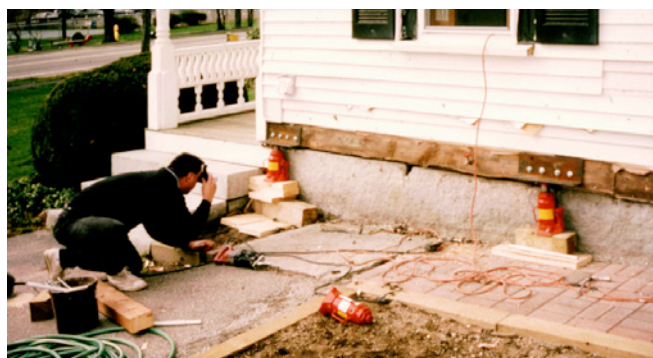
Photograph 3: Disbelieving Neighbor—Yes, you can actually lift a house off its foundation a section at a time with small hydraulic jacks and steel angles lag bolted into the bottom of the timber frame. We used 5 jacks rented from the local hardware store—three on the outside approximately 10 to 12 feet apart and two on the inside at the lifting mid points to keep the timber rim beam from rotating. A membrane capillary break was installed between the top of the rubble wall and the timber frame.

The entire house was then lifted 1 inch in order to insert a sheet plastic butyl membrane capillary break (**Photograph 3**). And then the house was set back down. This is not as hard as it seems. In fact it is pretty straightforward. Small 10 ton hydraulic jacks were used with steel angle iron brackets that were lag bolted into the perimeter foundation wood member. We used 5 jacks rented from the local hardware store—three on the outside approximately 10 to 12 feet apart and two on the inside at the lifting mid points to keep the timber rim beam from rotating.⁵

And no, the plaster did not crack. Old buildings have a great deal of flexibility. We did a section at a time and worked our way around the perimeter. It took two guys three days to do the entire perimeter of the house. Along the way we replaced rotted sections of timber as necessary. And here’s a news flash to the structural engineers—there were no anchor bolts. Yup, old houses don’t have them. And the buildings are still here. They don’t blow away because they are very heavy. This gravity thing apparently is working for them.

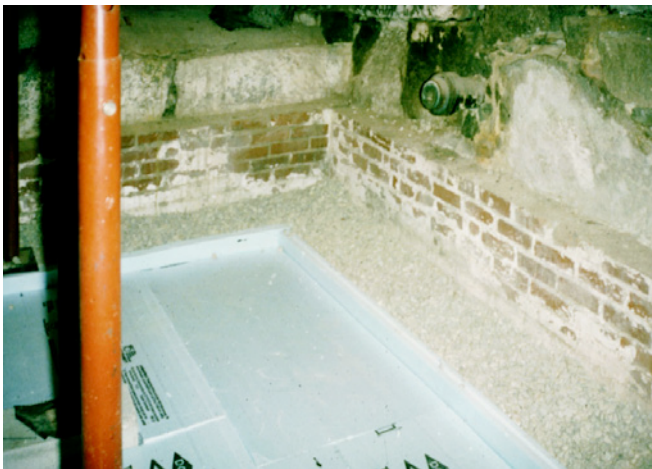
Photograph 4: Foam Bathtub—Extruded polystyrene foam on top of a gravel layer on top of the existing combination dirt and broken concrete slab floor. The perimeter drain was located in the space between the foam “bathtub” and the perimeter foundation wall in the granular layer perimeter drainage zone. A new concrete slab was cast inside the foam “bathtub.”

Next came the interior perimeter drain (**Photograph 4**). We installed a foam “bathtub” on top of gravel layer on top of the existing combination dirt and broken concrete slab floor. This foam “bathtub” did not extend to the inside perimeter of the foundation. The perimeter drain was located in the space between the foam “bathtub” and the perimeter foundation wall. A new concrete slab was cast inside the foam “bathtub.” A sheet polyethylene butyl composite membrane lining was installed covering the interior perimeter rubble foundation wall and the upper short crawlspace floor (**Photograph 5**). This membrane lining was sealed to the capillary break that was installed on the top of the rubble foundation under the timber frame and also sealed to the new concrete slab cast inside the foam “bathtub.” The perimeter foundation drain and sub foam gravel layer was connected to an airtight sump crock. The sump crock contained a pump that expelled water to the exterior above grade (hidden behind bushes so as not to attract the attention of a bunch of loonie tunes you have already been briefed about).

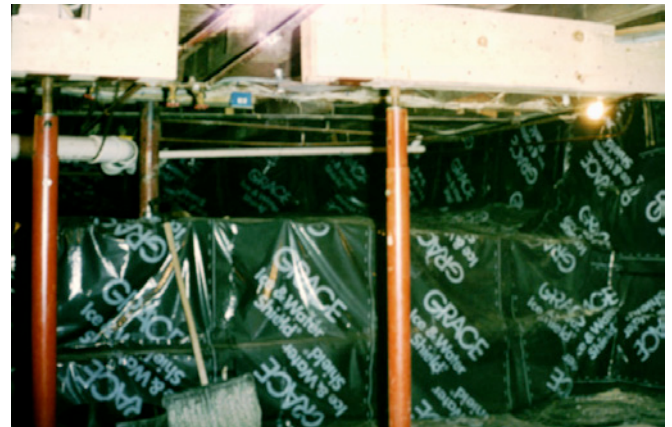
Photograph 5: “Pool Liner”—A sheet polyethylene butyl composite membrane lining was installed covering the interior perimeter rubble foundation wall and the upper short crawlspace floor. This membrane lining was sealed to the capillary break that was installed on the top of the rubble foundation under the timber frame and also sealed to the new concrete slab cast inside the foam “bathtub.”

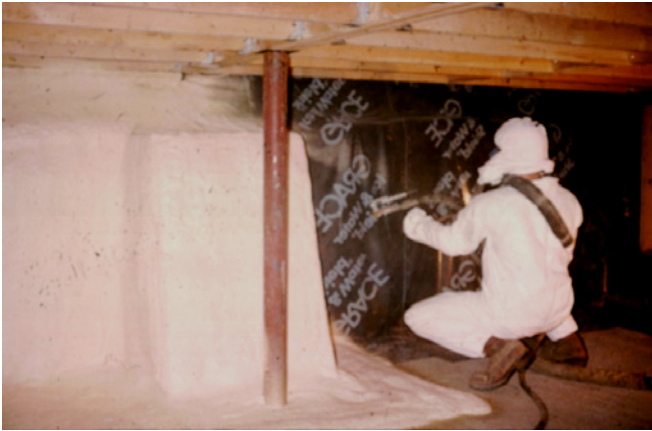
Photograph 6: Insulation Layer—The interior surface of the membrane lining was insulated with direct spray applied polyurethane foam – the high density closed cell stuff.

The interior surface of the membrane lining was insulated with direct spray applied polyurethane foam – the high density closed cell stuff (**Photograph 6**). The slab was subsequently painted to make it look pretty (**Photograph 7**). A liquid applied ignition barrier—an intumescent coating is recommended (it is now a code

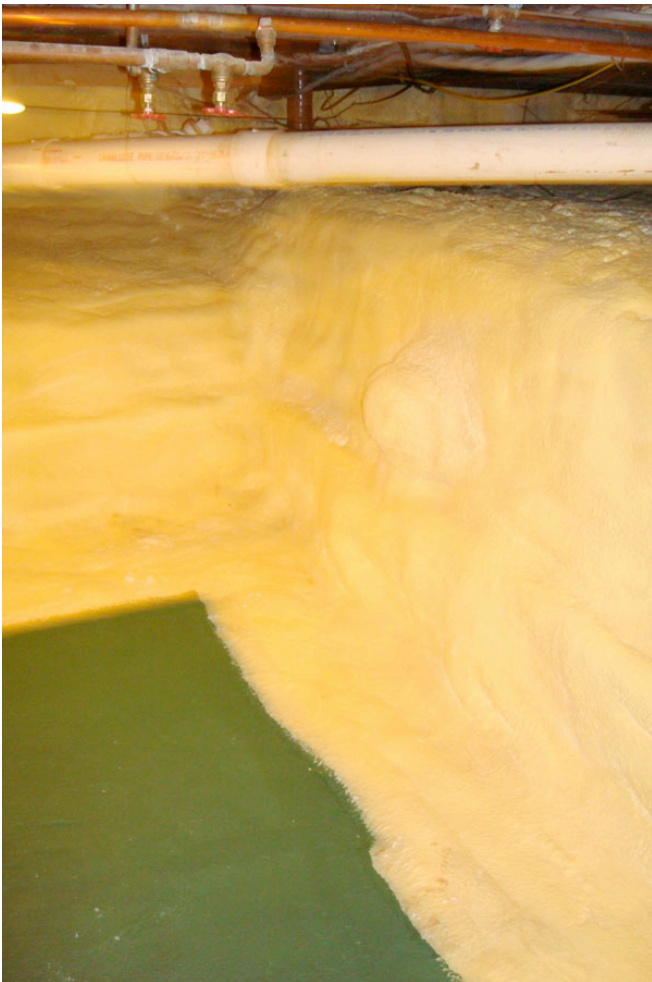
Photograph 7: All Done—The slab was painted to make it look pretty. Remember “green” means environmental.

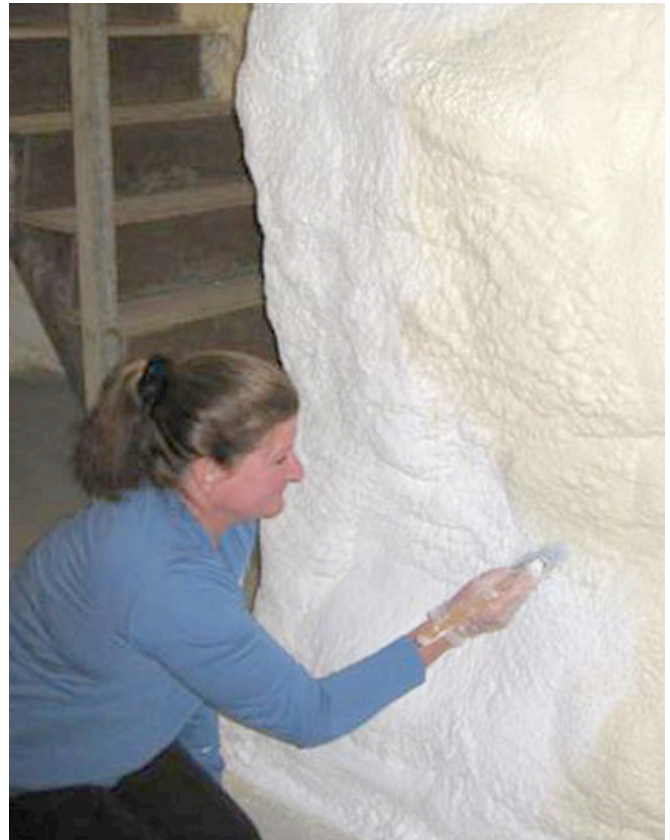
Photograph 8: Intumescent Coating—A liquid applied ignition barrier is recommended as minimum protection for exposed spray foam. I think that perhaps a bigger brush would have made it go faster – just a thought.

requirement) and will eventually be applied (**Photograph 8**).⁶

6 The house is just off the Westford Town Common a short walk from where the firehouse is located. I asked the Fire Chief what I should do with the surface of the foam? He walked down to the house with a blowtorch and a knife. He hacked out a hunk of foam from the foundation wall and took it outside to the driveway. He ignited the foam with the blowtorch. When he pulled the torch away, the foam charred and the flame went out. He did this a couple of times – each time the result was the same and then he told me to install a couple of smoke detectors and buy a ticket to the fireman’s ball and walked back to the firehouse. God, I love old guys. Eventually applied in this case means if we ever have to sell the house.

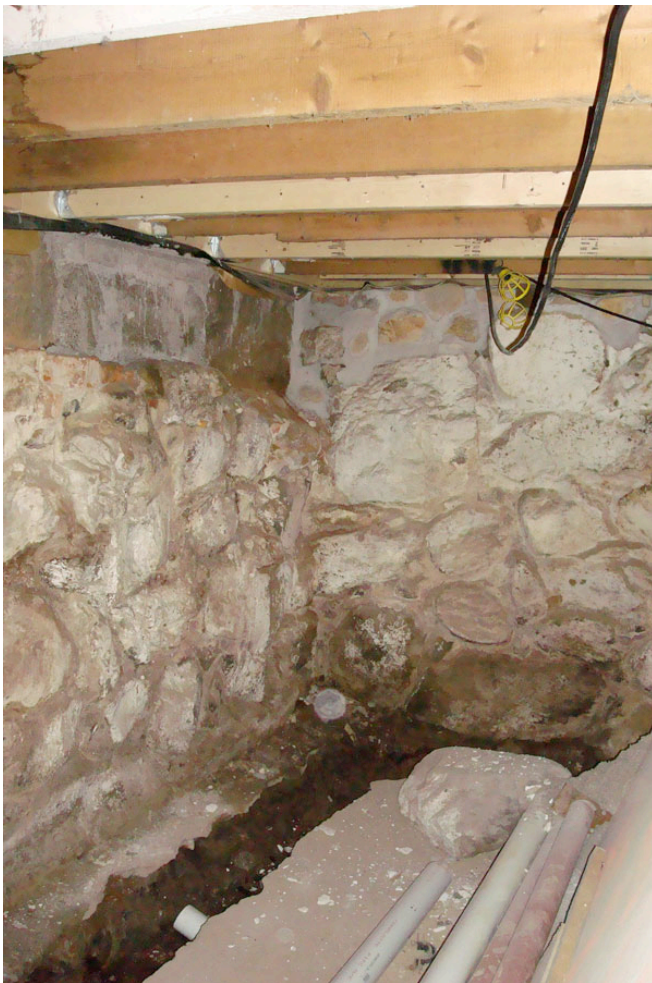
Photograph 9: Trenching For Perimeter Drain—Most rubble foundations have very thin and weak ground slabs – if they are anything at all besides dirt – that are easy to break through with simple tools such as a pick, a pike and sweat.

Most folks who don’t want to lose any headroom in basement foundations often install an interior perimeter drain in a trench (**Photograph 9**) rather than what we did at our house. This is also not as bad as it sounds. Most rubble foundations have very thin and weak ground slabs – if they are anything at all besides dirt – that are easy to break through with simple tools such as a pick, a pike and sweat. Occasionally, a concrete saw and an air hammer are required. This trench is lined with a geotextile filter fabric and contains a perforated drain and gravel with no fines. The drain tile is connected to a sump crock or to daylight. And then the interior membrane lining and spray insulation thing happens (**Figure 2**).

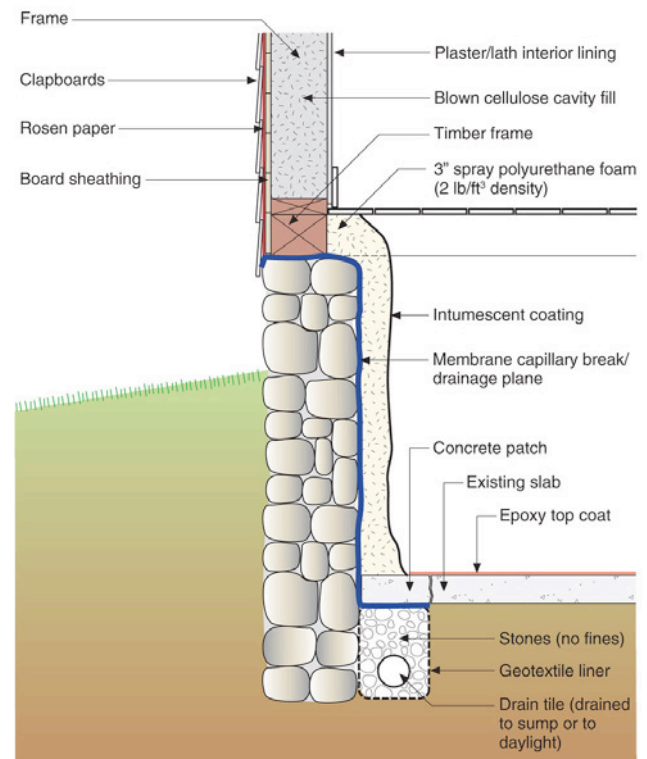
Figure 2: Interior Perimeter Drain—The trench is lined with a geotextile filter fabric and contains a perforated drain and gravel with no fines. The drain tile is connected to a sump crock or to daylight. And then the interior membrane lining and spray insulation thing happens. Epoxy coating over the top surface of the slab reduces vapor transmission into the space.

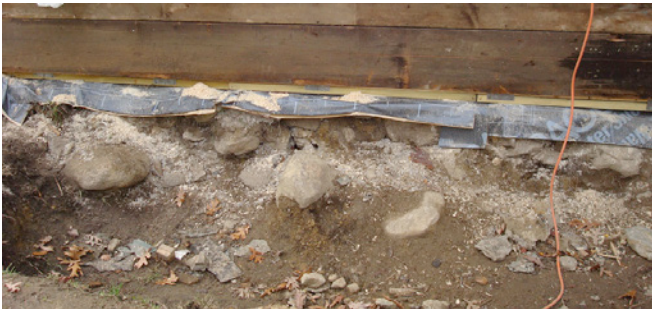
Photograph 10: Capillary Break Critical—Many rubble foundations do not project much above grade. The installation of a robust capillary break is a necessity along with lowering the immediate adjacent grade.

Many rubble foundations do not project much above grade. The installation of a robust capillary break is a necessity along with lowering the immediate adjacent grade (**Photograph 10**). Many of the bearing timbers typically have to be replaced due to serious rot

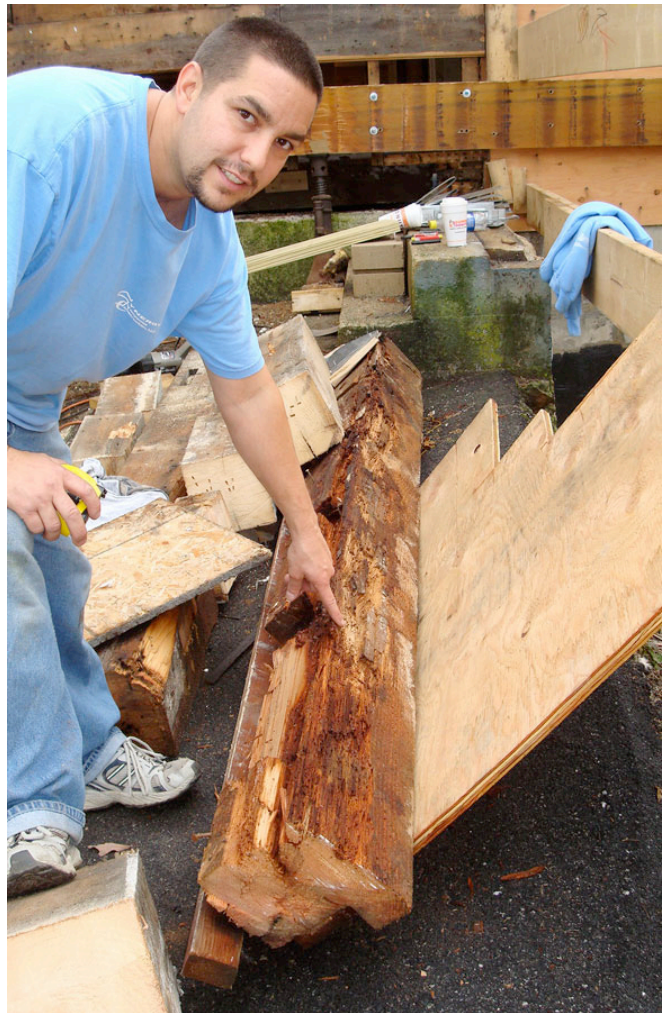
Photograph 11: Rotted Bearing Timbers—Many of the bearing timbers typically have to be replaced due to serious rot.

(**Photograph 11**) and the sills have to be rebuilt (**Photograph 12**). These are not options, especially when insulation is added from the interior. Energy and airflow is no longer going to be available to assist in drying. Wetting from underneath needs to be eliminated and wetting from the outside needs to be controlled—exterior drainage planes and back ventilated claddings—or at minimum a back-ventilated “water table” trim detail. Tell the Historical Commission that Grandma heard her Grandma say that the house used to have one.

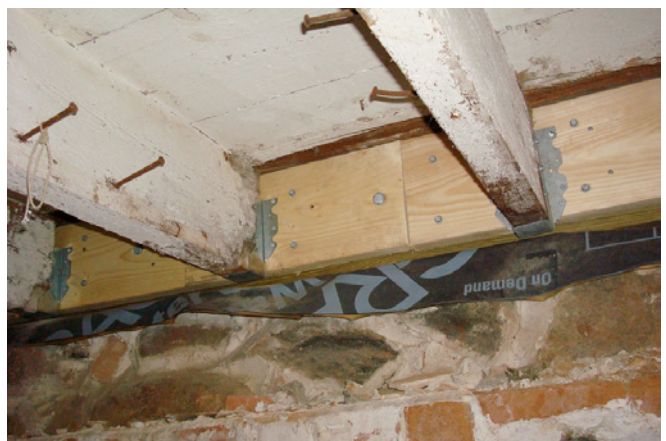
Photograph 12: Rebuilding Sill Assembly—Bolts and hangers and more bolts and hangers and still more...

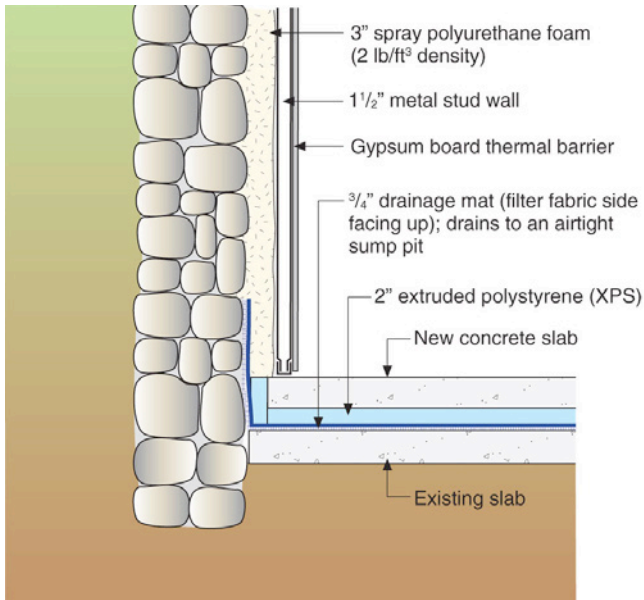
Figure 3: Insulating Basement Slabs—Where headroom allows insulating the top of the existing slab works well. Note the “foam bathtub.”

Where headroom allows insulating the top of the existing slab works well. Note the “foam bathtub” in **Photograph 13** and **Figure 3**—but also note the “twist” in the approach. The cleverness of this detail is that a granular drainage layer under the foam insulation and “yet-to-be-cast” slab has been replaced with a 3/4-inch

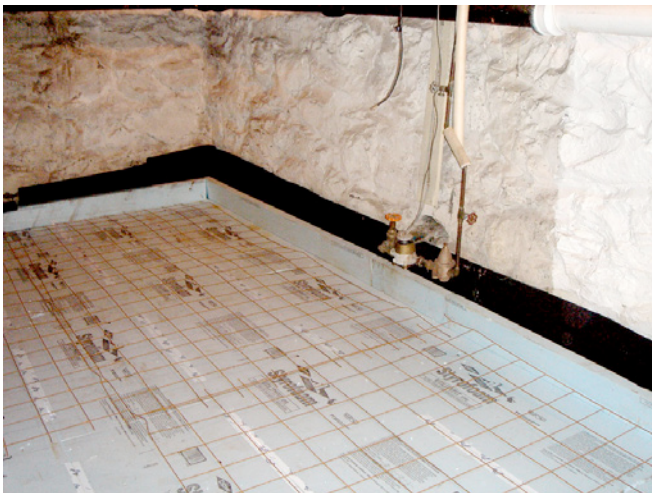
Photograph 13: Another Foam Bathtub—Note the “twist” in the approach. The cleverness of this detail is that a granular drainage layer under the foam insulation and “yet-to-be-cast” slab has been replaced with a ¾-inch drainage mat that extends up the walls about a foot. The ¾-inch mat does what 4 inches of stones used to do.

drainage mat that extends up the walls about a foot. The 3/4 inch mat does what 4 inches of stones used to do. Also note that the inside of the foundation wall is not completely lined with a membrane lining. There is only a membrane lining at the top of the wall acting as a capillary break. We are finding that the 2 lb/ft³ spray polyurethane foam works well as an interior drainage plane as long as drainage is provided at the bottom of the assembly. That’s where the drainage mat comes into play. The fabric on the drainage mat has to “face up” so that when it runs up the wall the fabric prevents the drainage matrix from being clogged by the spray foam when it is applied (**Photograph 14**). It also helps that the spray foam does not adhere to the rubble very well—especially if you don’t clean the wall before you spray. The lack of adhesion helps drainage. The foam itself is “structural” in that it is rigid enough to support itself if it is between 2 and 3 inches thick and if it adheres to the wood frame at the top of the foundation (which it does) and if it adheres to the edge of the foam bathtub at the bottom of the foundation (which it does).

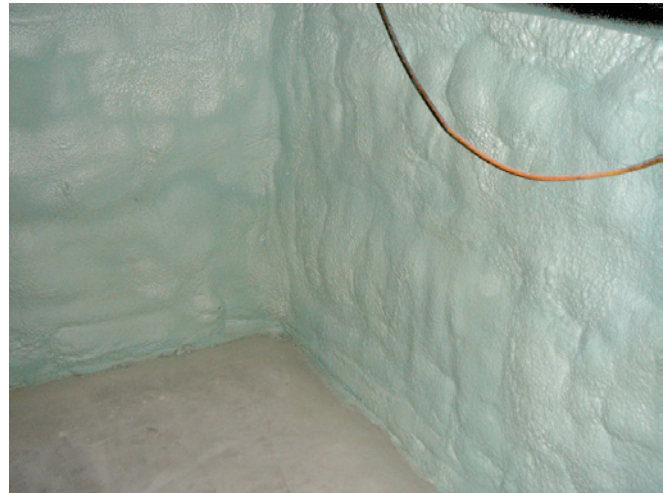
Photograph 14: Spray Foam Layer—The foam itself is “structural” in that it is rigid enough to support itself if it is between 2 and 3 inches thick and if it adheres to the wood frame at the top of the foundation (which it does) and if it adheres to the edge of the foam bathtub at the bottom of the foundation (which it does).

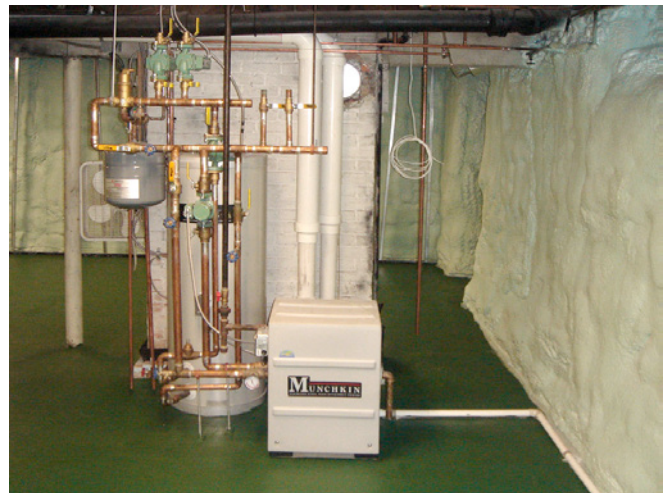
Photograph 15: Mechanical Equipment—Very nice home for some very happy mechanical equipment. This equipment is best when it is sealed combustion and power vented as the old air leaky foundation is now pretty much airtight.

The foam lining makes for a very nice home for some very happy mechanical equipment (**Photograph 15**). This equipment is best when it is sealed combustion and power vented as the old air leaky foundation is now pretty much airtight. As nice as the foam is to look at—notice the green color chosen for the concrete floor coating and the green tint to the foam itself—obviously very environmental—it really should be protected from mechanical damage and from ignition sources. That's where thin lightweight steel framing and gypsum board are ideal (**Photograph 16** and **Photograph 17**).

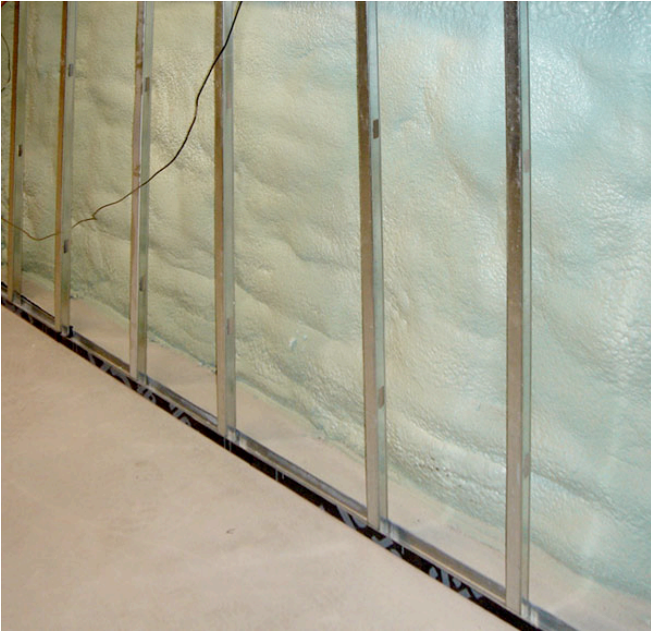
Photograph 16: Protection for Insulation Layer—As nice as the foam is to look at it really should be protected from mechanical damage and from ignition sources. That's where thin lightweight steel framing and gypsum board are ideal.

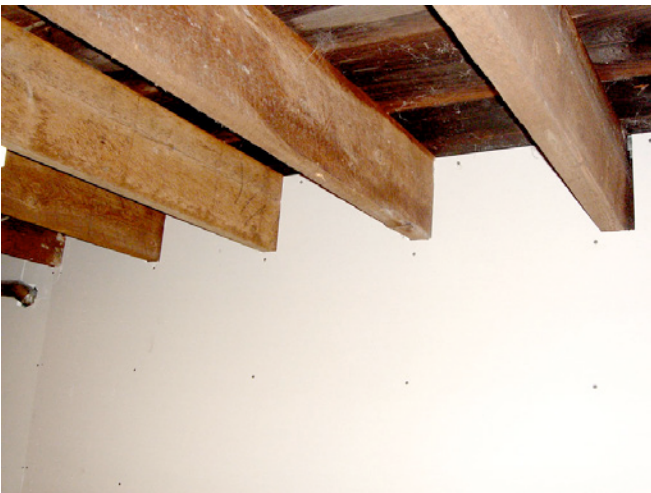
Photograph 17: Gypsum Board Protection Layer—Gypsum is made from a type of rock—and rocks don't burn—this is a good thing.
