BY TED CUSHMAN

## Moisture in Fat Walls—A Closer Look

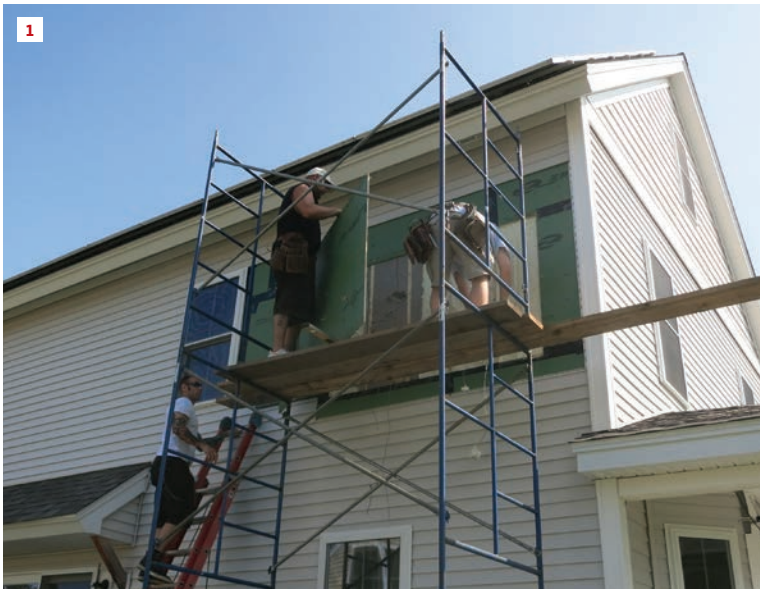
**1.** After three seasons of moisture and temperature monitoring, workers pull sections of Zip sheathing panels from the test wall section of a house in Devens, Mass.

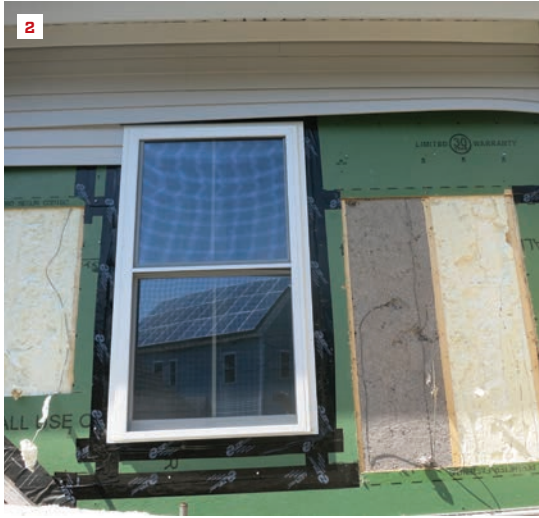
**2.** The wall system has good drying potential to both the inside (through the painted drywall) and the outside (through the permeable Zip sheathing), but the cold OSB on the exterior does suffer increased moisture and condensation during the coldest months of the winter.

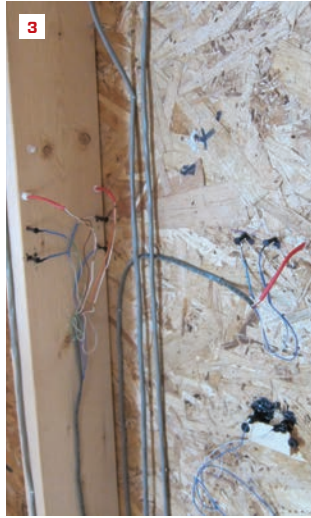
**3.** Moisture sensors in the building walls allowed the Building Science Corp. research team to remotely measure and record the moisture content of the framing and sheathing throughout three winters of house operation.

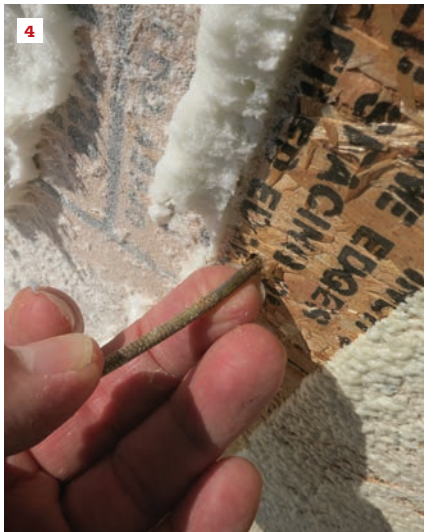
**4.** Nails rusted slightly after three seasons of moisture accumulation—clear physical evidence of moisture attack, but not as grave as the data had suggested.

“All the instrumentation and monitoring said that these walls got hammered in terms of moisture content, relative humidity, condensation, anything like that,” Ueno told *JLC* in a phone interview. “And the current analysis tools in the toolbox say this wall should be toast. But we opened it up and it was like, ‘Huh. Well, there’s a little bit of grain raise. The fasteners are a little bit rusty. That’s about it.’”

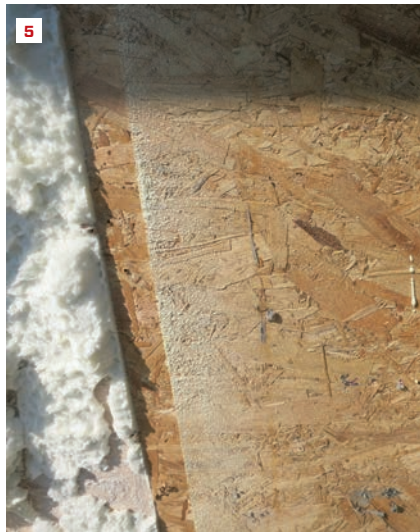
**5.** A close-up of the OSB sheathing removed from contact with the low-density spray foam of the insulated wall cavity shows no sign of fungal attack at all, much less any deterioration that might compromise the sheathing's function.

Says the BSC report: “Based on the data, calculations, and analysis, all three walls should be at high risk of failure; the analytic tools used indicate that these walls should have failed. However, disassembly showed that the walls were essentially undamaged by the monitored moisture exposure. This suggests that the walls, at least in the configurations tested, were far more
