Insight

If You Want to Save Cash...Flash...

By Joseph W. Lstiburek, Ph.D., P.Eng.,
Fellow ASHRAE

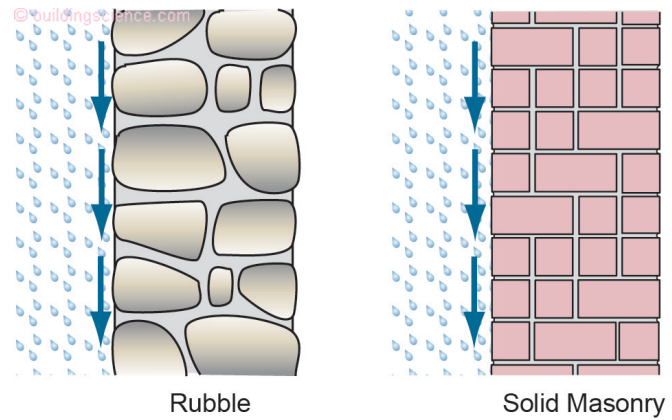
Figure 1: “Old Walls” - Old walls had multiple layers. Water that penetrated the outer layer was stored, absorbed, redistributed and subsequently dried to both the exterior and interior. They were called “mass walls”.

Here goes with the obvious. Brick and stone leak. They have always leaked, and they still leak. Here is the catch... old walls handled leakage differently than modern walls. Old walls had multiple layers..smooshed² together. Water that penetrated the outer layer was stored, absorbed, redistributed and subsequently dried to both the exterior and interior. They were called “mass walls” (**Figure 1**).

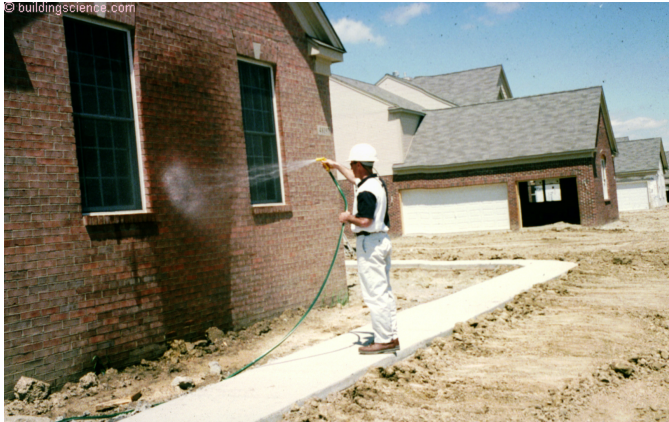
Photograph 1: Water Test - I have tricked a youngster into using an ordinary garden hose to spray water against a brick veneer. This field test follows no approved ASTM protocol.

First, I am going to conduct a field test that follows no approved ASTM protocol. Check out **Photograph 1**. I have tricked a youngster into using an ordinary garden hose to spray water against a brick veneer. This gentleman is clearly a “hosier”³ ... In about 20 to 30 seconds water can be seen penetrating and running down the back of the brick (**Photograph 2**)⁴. Turned the youngster and everyone else watching into “true believers”⁵. This should, of course, have been obvious, but folks are still stunned when they actually see it.

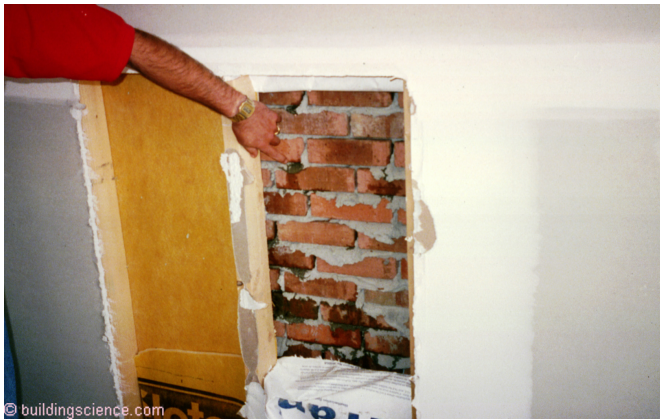
Photograph 2: Water Leakage - In about 20 to 30 seconds water can be seen penetrating and running down the back of the brick. The water penetrates the joints between the brick and the mortar. The water does not pass through the brick or pass through the mortar. The weak link is the connection between the brick and the mortar.

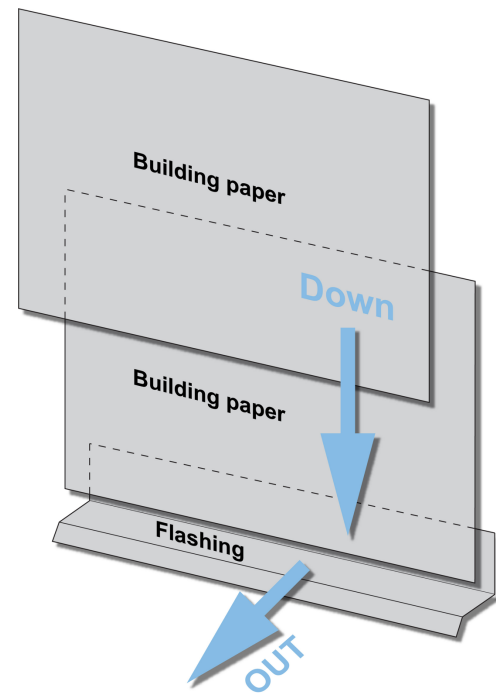
Figure 3: “Down and Out” - Drain penetrating water down and out of the wall. That flashing at the bottom of the wall is a big deal. One of its important functions is to direct the penetrating water back to the exterior.

OK, so what do we do with this penetrating water? Easy. Drain it down and out of the wall. Repeat after me “down and out”...”down and out”. The principle is obvious (**Figure 3**). Except not so obvious as we shall see. Folks forget the “out” part....ouch. That flashing at the bottom of the wall is a big deal. One of its important functions is to direct the penetrating water back to the exterior. Oh, one more thing...you shouldn’t forget to actually have a flashing....

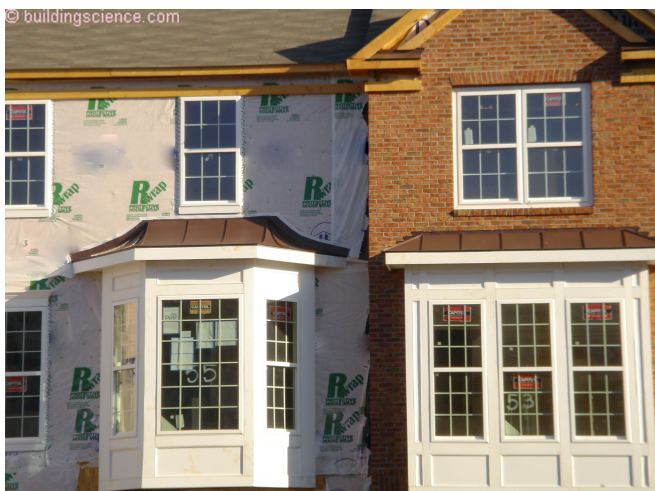
Photograph 3: Bay Bump Outs - Two bay bump outs are shown. The vinyl siding has not yet been installed above one bay bump out, but the brick has been installed above the other. The metal roof flashing is sealed to the plastic membrane water control layer in the wall where the vinyl siding is to be installed. In the brick wall, the metal roof flashing is sealed to the face of the brick veneer. The flashing does not penetrate through the brick and connect to the plastic membrane water control layer behind the brick.

Let’s look at **Photograph 3**. The conversation started like this...”our “bay bump outs” seem to be leaking...but not all of them”...”we don’t understand...we build them all the same way...we use the same roofer...” Whenever I hear the words “we build them all the same way” my “Spidey sense”⁶ tingles.... My response always is “let’s go and take a look at a bunch of them. Turns out that when the bay bump outs had vinyl siding above them they did not leak, but when they had brick they did. In **Photograph 3**, two

bay bump outs are shown. The vinyl siding has not yet been installed above one bay bump out, but the brick has been installed above the other. The metal roof flashing is sealed to the plastic membrane water control layer in the wall where the vinyl siding is to be installed. In the brick wall, the metal roof flashing is sealed to the face of the brick veneer. The flashing does not penetrate through the brick and connect to the plastic membrane water control layer behind the brick. Simple, obvious and very expensive to fix.

The metal roof has to come off. The framing supporting the metal roof has to come off to expose the steel angle supporting the brick. The brick has to come out above the metal roof. A through wall flashing has to be

installed to direct the water draining behind the brick to the outside of the wall/roof intersection. Ouch.

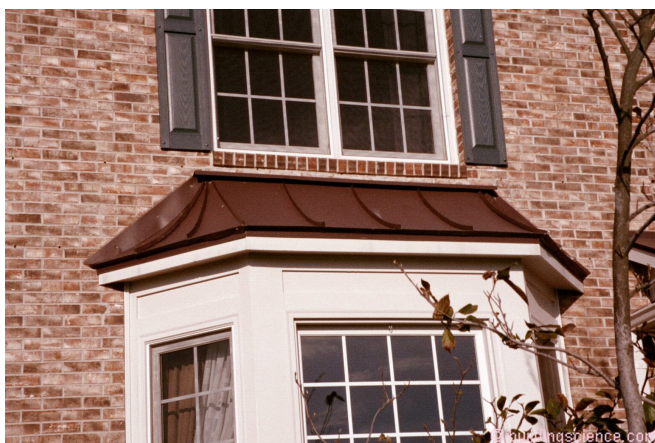
Photograph 4: More Bay Bump Outs - Same thing is going on here. The roof flashing is sealed to the face of the brick. It does not penetrate through the brick and connect to the water control layer behind the brick.

Same thing is going on in Photograph 4. The roof flashing is sealed to the face of the brick. I see this over and over again. So how should the flashing be installed? A couple of approaches. The first is shown in Photograph 5. The second in Photograph 6. The third in Figure 4 and Figure 5.

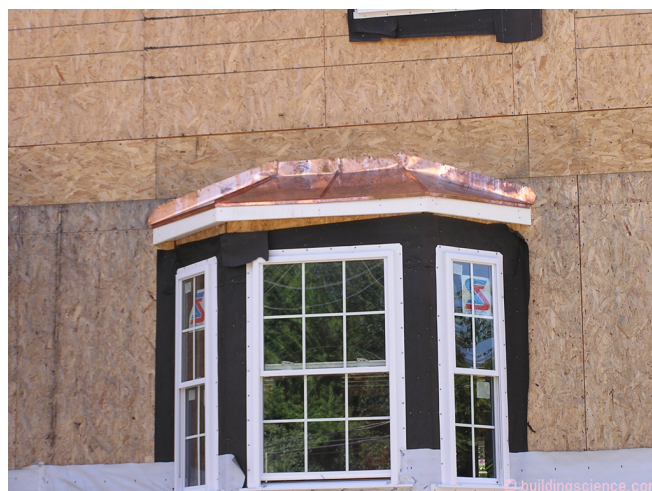
Photograph 5: Bump Out Approach One - Copper roof with an integral roof is installed first, before the brick veneer and before the water control layer. Easy, elegant and it works. So why not this approach all the time? Ah, it is a pain in the butt to protect the metal roof while the brick is installed. It tends to get damaged...and so the builders want to install it after the brick.

In **Photograph 5**, the copper roof with an integral roof is installed first, before the brick veneer and before the water control layer. Easy, elegant and it works. So why not this approach all the time? Ah, it is a pain in the butt to protect the metal roof while the brick is installed. It tends to get damaged...and so the builders want to install it after the brick.

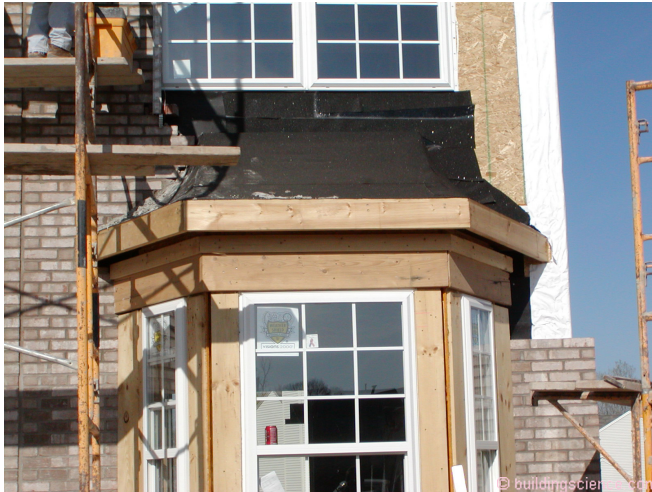
Photograph 6: Bump Out Approach Two - A fully adhered water control layer is installed prior to the installation of the brick and prior to the installation of the metal roof over the bay. This type of membrane is typically “robust” enough to survive the installation of the brick veneer. When the metal roof is installed over the top of this water control layer membrane, after the brick veneer is installed, it does not need to pass through the brick.

In **Photograph 6**, a fully adhered water control layer is installed prior to the installation of the brick and prior to the installation of the metal roof over the bay. This type of membrane is typically “robust” enough to survive the installation of the brick veneer. When the metal roof is installed over the top of this water control layer membrane, after the brick veneer is installed, it does not need to pass through the brick. The metal roof is in essence “decorative”. It provides UV protection to the membrane as well as physical protection to the membrane. It also looks good.

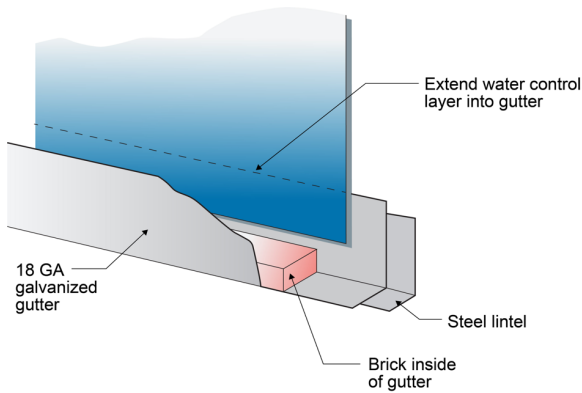
Figure 4: “Brick Gutter” - The brick veneer is supported by a metal angle and constructed within a metal “gutter”. The water control layer is lapped into this gutter and the water that drains down the water control layer into the gutter is drained out both ends of the gutter. The gutter extends past both sides of the bay and drains into the wall cavity of the main walls.

In **Figure 4** and **Figure 5** the brick veneer is supported by a metal angle – but with a “twist”... the brick veneer is constructed within a metal “gutter”. The water control layer is lapped into this gutter and the water that drains down the water control layer into the gutter is drained out both ends of the gutter. The gutter extends past both sides of the bay and drains into the wall cavity of the main walls. The metal roof is then sealed to the face of the brick.

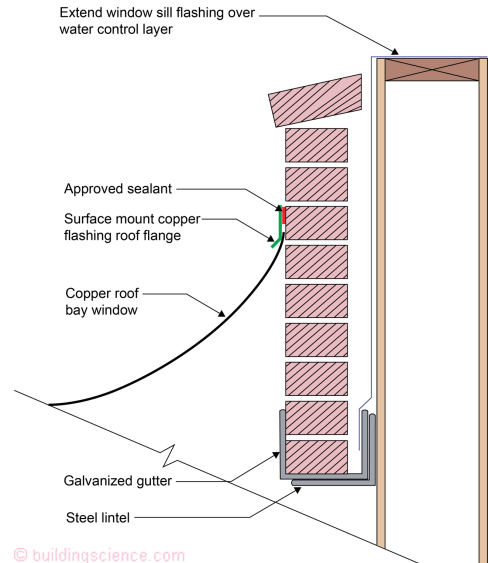
Figure 5: More Brick Gutter - The metal roof is sealed to the face of the brick.

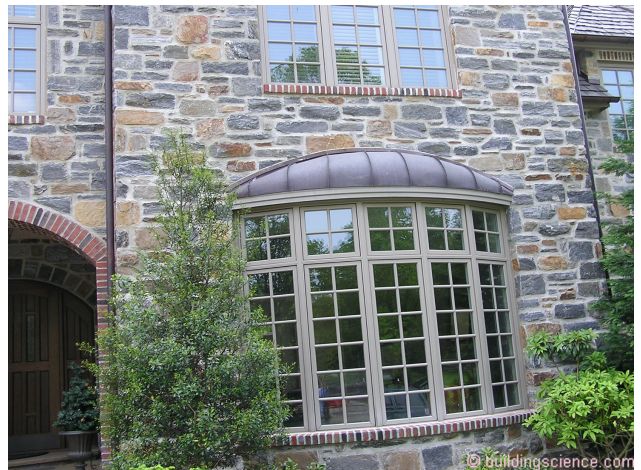
Photograph 7: Stone Veneer Bump Out - Metal roof sealed to the face of a stone veneer. Bad, bad, bad....

What about stone veneers? Same issues, same problems, same solutions. **Photograph 7** shows a metal roof sealed to the face of a stone veneer. Bad, bad, bad....

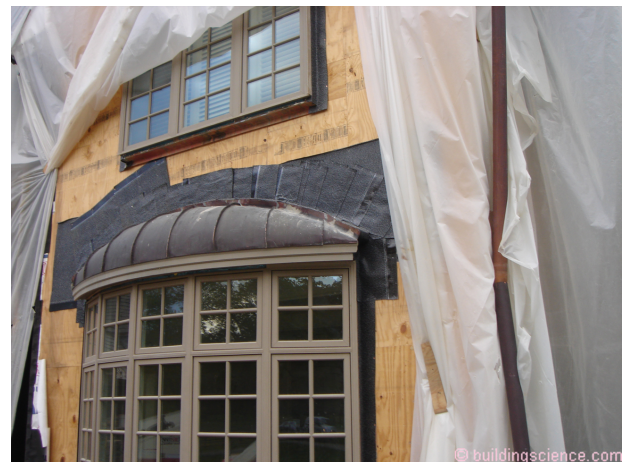
Photograph 8: Stone Veneer Bump Out Repair - The stone had to be taken down and a membrane installed to connect the water control of the metal roof to the water control of the wall.

Photograph 8 shows the repair. The stone had to be taken down and a membrane installed to connect the water control of the metal roof to the water control of the wall...in a manner similar to what was done in **Photograph 6** with brick veneer.

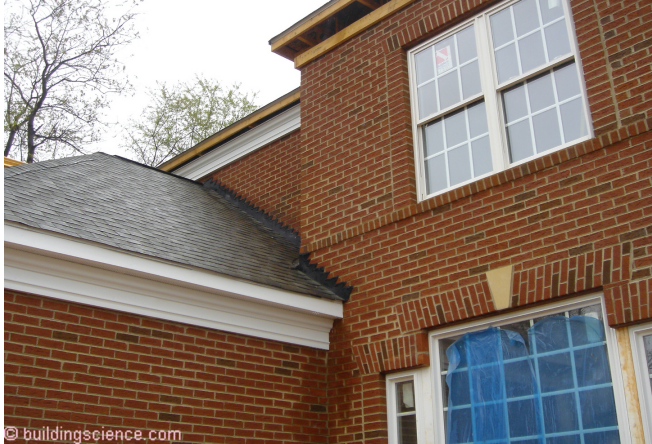
Photograph 9: Walls Meeting Roofs: Where we have the intersection of a sloping roof with a brick veneer wall the water control of the roof needs to connect to the water control of the wall. It is necessary to drain the back of the brick veneer to the exterior. This is not done here. The roof flashing is sealed to the face of the brick.

So much for bays....can it get worse? Yes, of course. Much worse... Let's now look at where walls meet roofs (**Photograph 9**). Here we have the intersection of a sloping roof with a brick veneer wall. How do we drain the back of the brick veneer to the exterior? In this photograph we don't... The roof flashing is only sealed to the face of the brick veneer. Happens all the time.

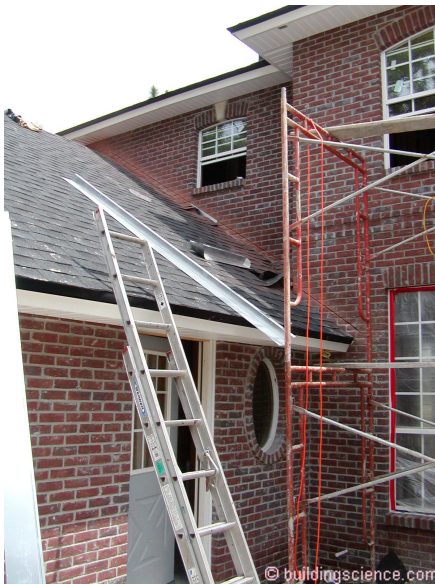
Photograph 10: Regletting Does Not Work - Saw cutting a “notch” or “reglet” into the brick and inserting a “counter flashing” will not do the trick. No chance.

Some folks believe that saw cutting a “notch” (the correct term is “regletting”) into the brick (**Photograph 10**) and inserting a “counter flashing” (**Photograph 11**) will do the trick. No chance.

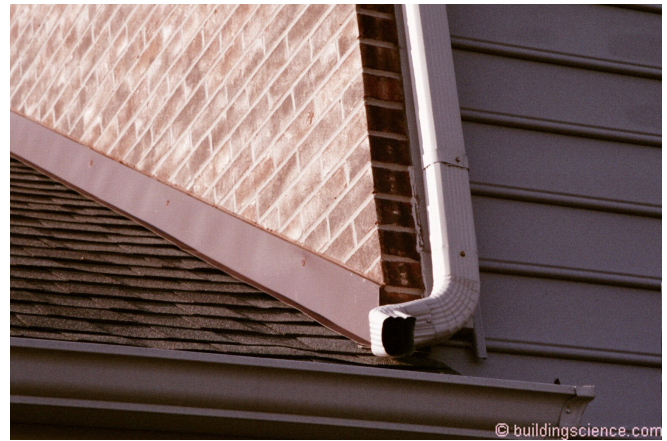
Photograph 11: Counter Flashing Does Not Work – For the counter flashing to work it has to be connected to a through wall flashing that then connects to the water control layer of the wall.

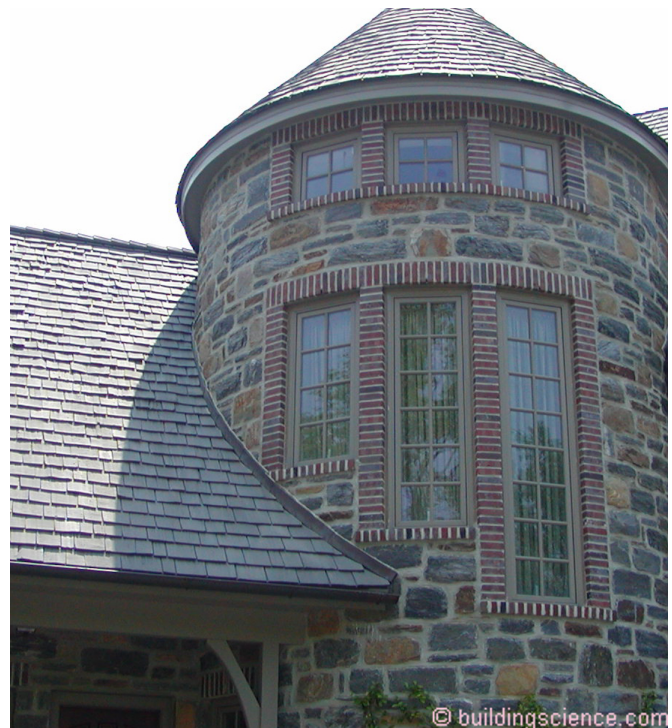
Photograph 12: Stone Veneer - Nothing like a stone turret meeting a roof to have fun with.

Let's try the same thing with stone. Nothing like a stone turret meeting a roof to have fun with (**Photograph 12**). Yup, a little bit of sealant will do the trick (**Photograph 13**). Hah!

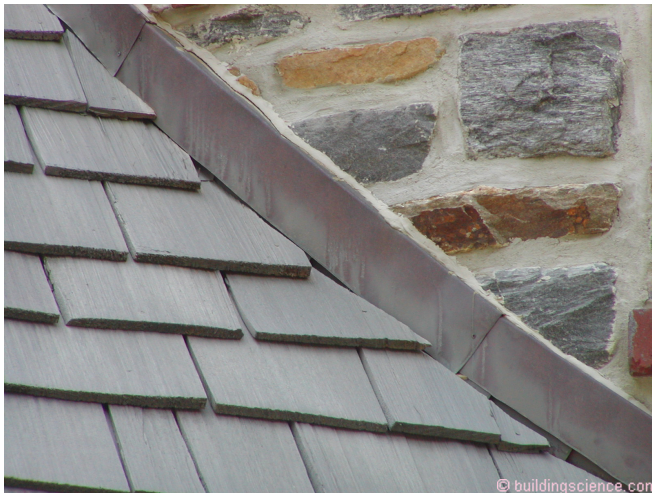
Photograph 13: Sealant Dreams - Yup, a little bit of sealant will do the trick. Hah! The stone has to be removed and through wall flashing installed.

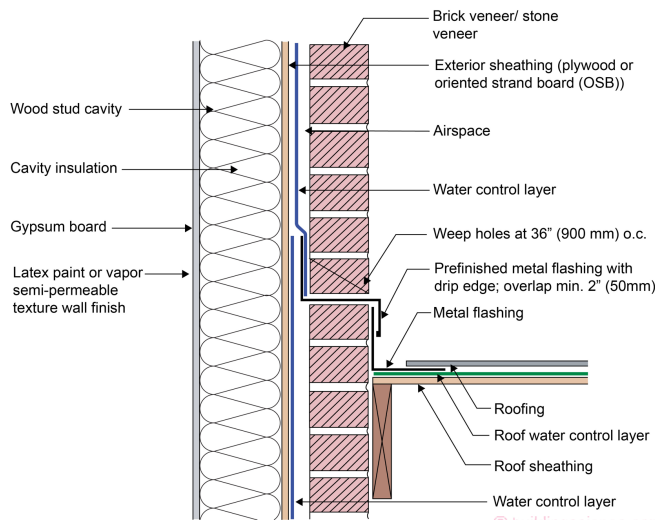
Figure 6: Roof to Wall Connection - The water control of the roof needs to connect to the water control of the wall and pass through the brick layer and stone layer.

The water control of the roof needs to connect to the water control of the wall and pass through the brick layer and stone layer. **Figure 6** and **Figure 7** show how it needs to be done. The flashing detail needs to be “stepped” upward and integrated into each course of brick. Note the end dam on each counter flashing segment in **Figure 7**. But this is hard...it is not easy... That is correct. Suck it up and do it...or stay away from brick and stone. Perhaps your future should be limited to siding and stucco.
