Kohta Ueno

Energy and Moisture in Sealed and Insulated Attics: Cold Climate Research

February 24, 2020

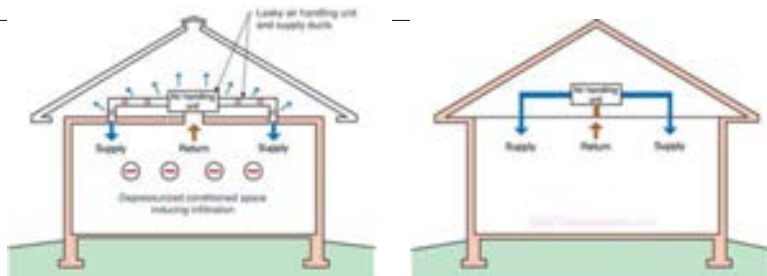
Unvented Roofs & HVAC Placement

- Ducts in unconditioned attic = huge energy losses
 - Industry reluctant to move ducts out of attic
 - Ice dam issues due to duct losses
- Solution: bring ducts into conditioned space
- Unvented/conditioned attic—keeps ductwork in conditioned space, duct leak issues eliminated

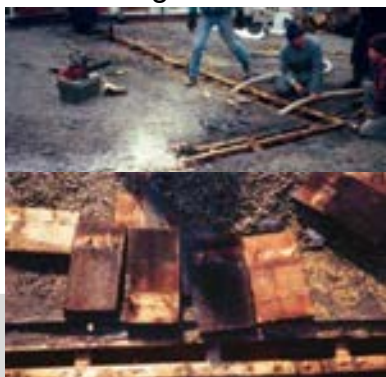
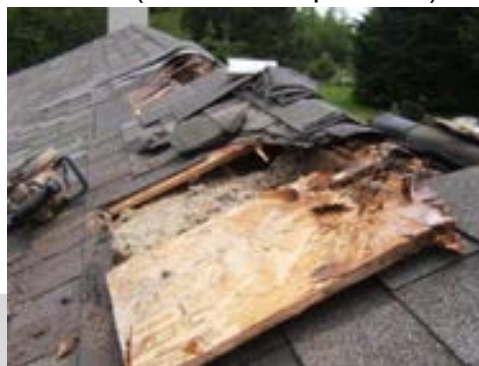
Fibrous Insulation Unvented Roofs

- Dense pack insulation of unvented roofs common in cold-climate retrofits
 - Moisture risks (see BSI-043 “Don't Be Dense—Cellulose and Dense-Pack Insulation”)—2 in 10 failure?
 - Violates I-codes (see IRC § R806.4/R806.5)
 - “Ridge rot”—localized problems (SIPS same problem)

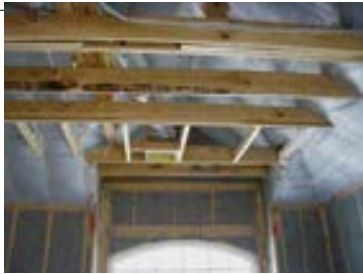
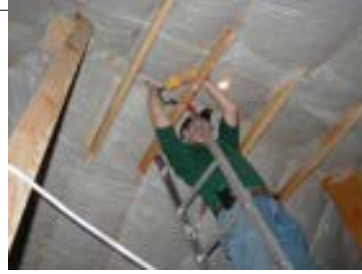
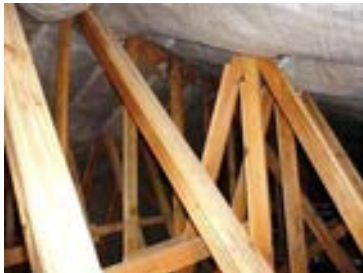
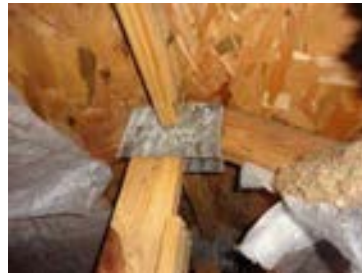
Houston and Jacksonville (CZ 2A) 2001

- Moisture concentrated at highest point in conditioned attic (ridge)
- Not a simple one-dimensional problem
- Not a straight-up air leakage problem
- Problem with open-cell spray foam (ocSPF) unvented roofs (high RHs in attic)-many climates
 - But not ccSPF—lower vapor permeance
- Concentration of interior-sourced moisture
- Moist air is lower density (“lighter”) than dry air
- Others: “system in equilibrium has same dewpoint in connected air space”

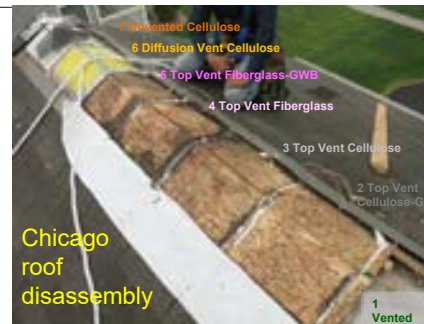
- Chicago (CZ 5A):
 - One winter, 50% RH
 - Unvented roofs-high risk
 - Cellulose lower risk than FG batt
 - Vented compact roof (chute) safe-but poor air leakage
- Houston/Orlando (CZ 2A):
 - 2 attics, multiple seasons
 - Diffusion vents allow greater drying, avoid moisture problems

Chicago roof disassembly

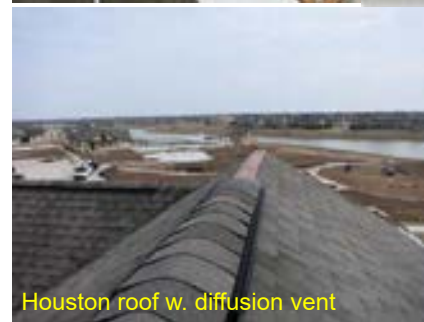
Houston roof w. diffusion vent

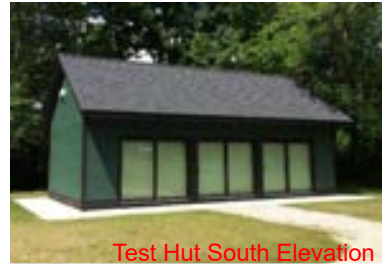
Test Hut Experimental Approach

- Climate Zone 5A test hut
- Eight north-south roof bays; guard bays
- ±R-50 (14-¾" framing, 2012 IECC)
- Test variables (changed year-to-year):
 - Vapor retarder: variable perm vs. fixed perm, various permeance curves
 - Diffusion vent at ridge: full size, none, "small," or "tight"
 - Fiberglass vs. cellulose
 - "Control" comparison § R806.4 spray foam + fibrous
- Varying interior boundary conditions
 - Winter 1: "Normal" interior conditions
 - Winter 2: Elevated RH (50% constant)
 - Winter 3: Air leakage into rafter bays

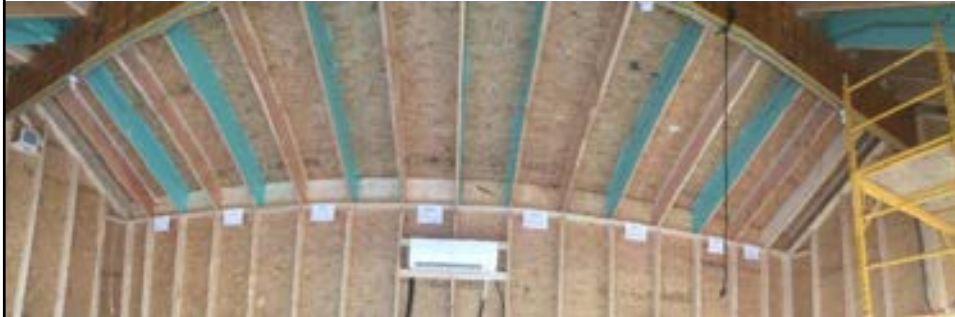
Test Hut Construction

- Instrumentation completion

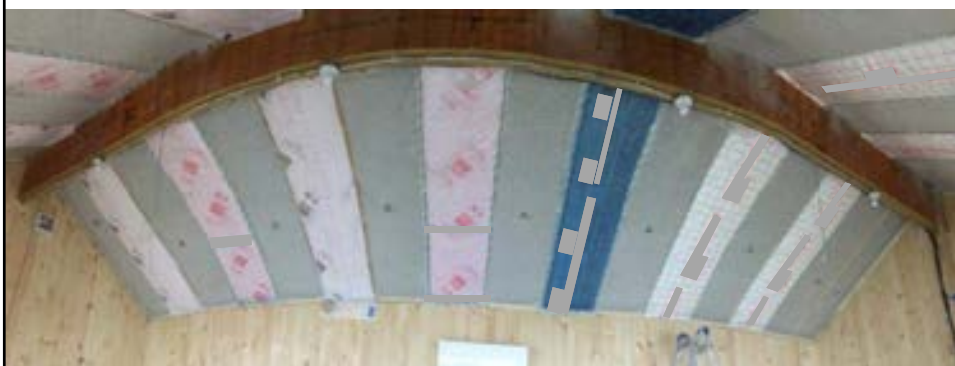
Test Hut Construction

- Interior air/vapor control installed

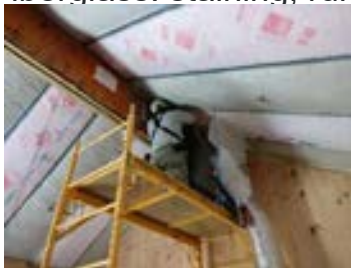
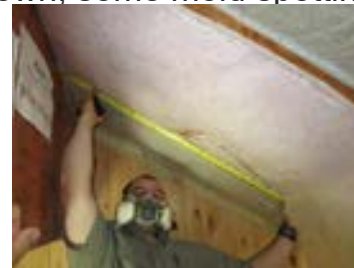
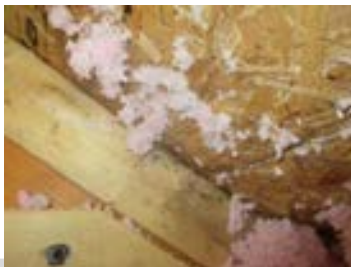
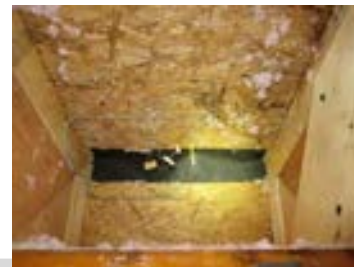
Summer 2 Ridge Disassembly Work

- Fiberglass: staining, rundown, some mold spotting

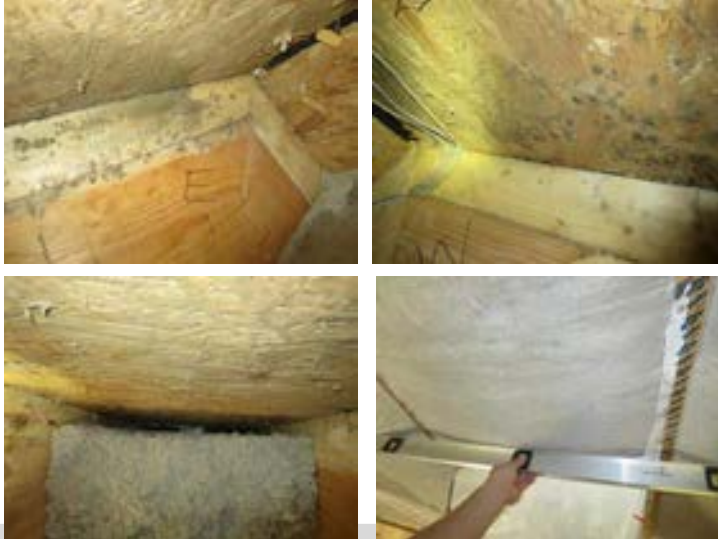
Summer 2 Ridge Disassembly Work

- Cellulose: worst mold, settling (greater at north)

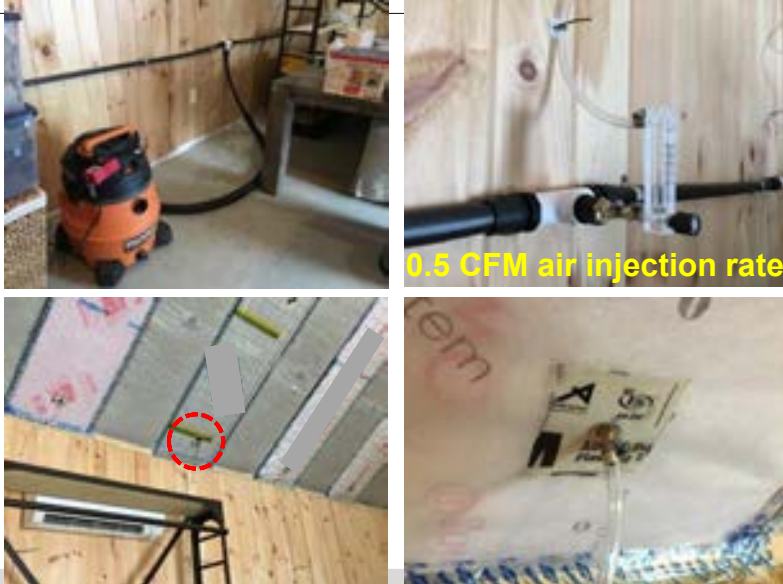
Air Injection System

- Early winter 50% RH, no air leak
- February onward-add air leak
- Air injection system
 - Interior-to-interior leak
 - Very small air leak, 0.5 CFM per bay
 - Comparable to very airtight construction
- Before air injection: much drier than Year 2
 - Repacking insulation suppresses convection?
- Air injection: severe spike in sheathing MC
 - Localized to injection site
 - Disassembly in summer: no visible damage
