Kohta Ueno  
March 1, 2021

## Care & Feeding of Brick: Interior Insulation Retrofits of Mass Masonry Buildings

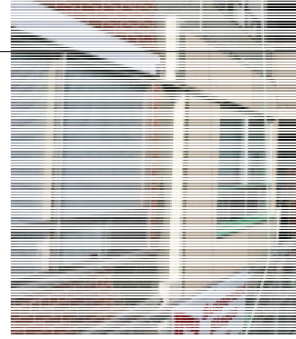
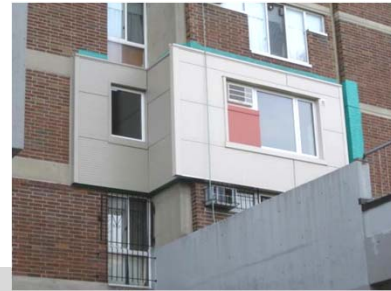
## Inside or Outside Insulation?

- Insulating on exterior always preferable (masonry durability, condensation risks, thermal performance)
- Interior insulation → historic preservation reasons
- Interior → potential durability risks

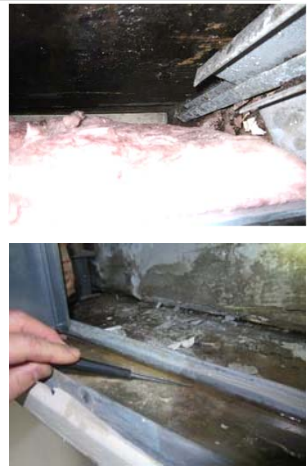
- Requires perfect workmanship at air barrier—around penetrations, etc.
- Made worse by air gap behind insulation (“chimney”)
- NOT RECOMMENDED**

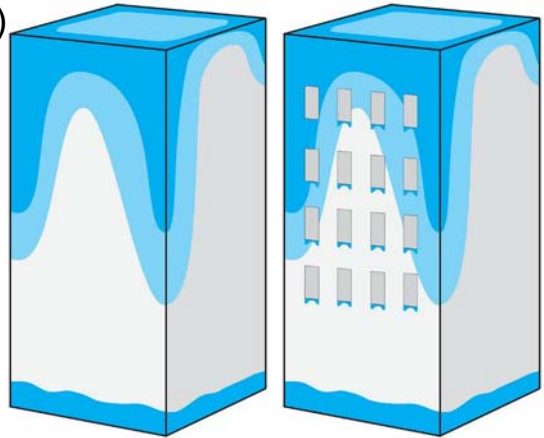
- Where to look at the building (damage)
- “Where the building touches the ground and the sky”
- Add windows
- Parapets—cold & wet
- Unheated conditions

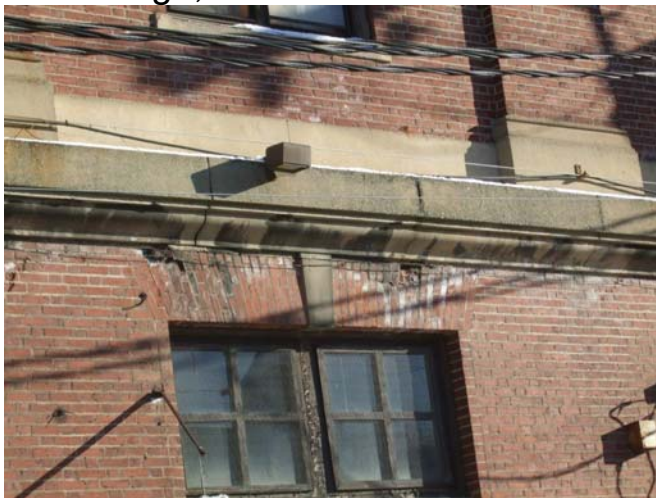
## Water Concentrations

- Damage, interior and exterior

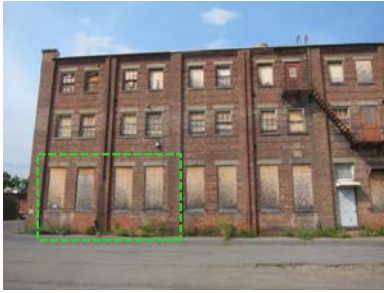
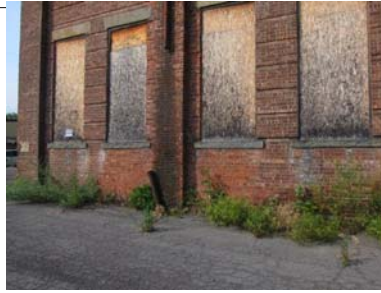
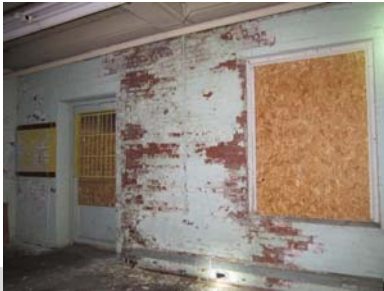
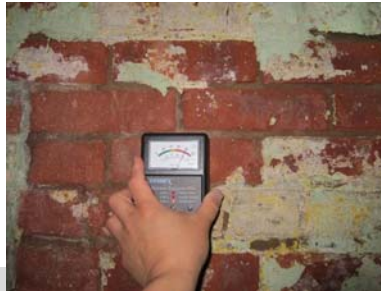
- Where is it? Still active or not?
- Moisture meters to look for active/ ongoing leakage

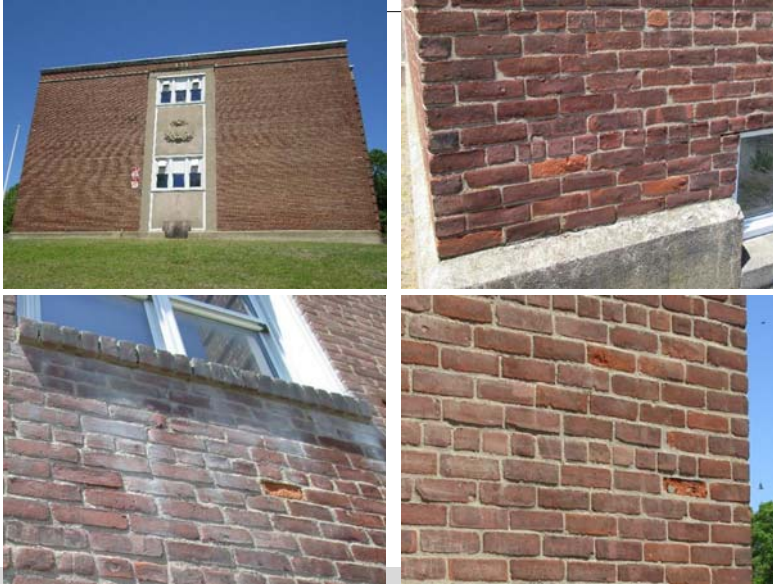
- Most of the brick looks great
- Selected brick have spalling surfaces
- No pattern matching exposure
- Poorly-fired brick?
- “Culling of the herd”

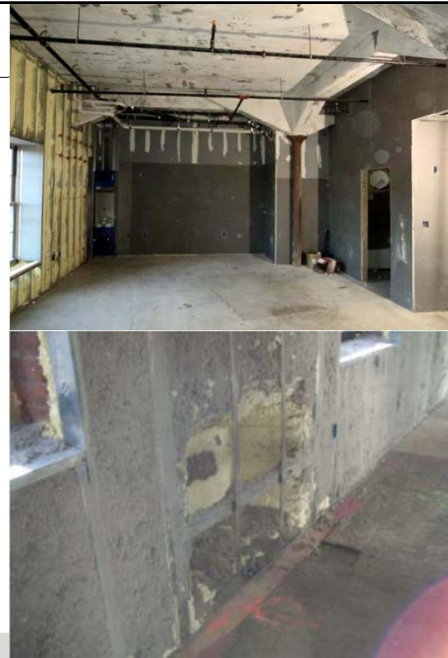
# Hybrid Wall Insulation Assembly

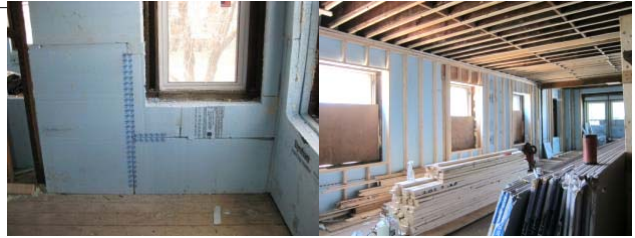
- Adhered, pin board to wall
- Much more labor (piece-work)
- Workmanship-sensitive
- Poor match for “bumpy” substrates

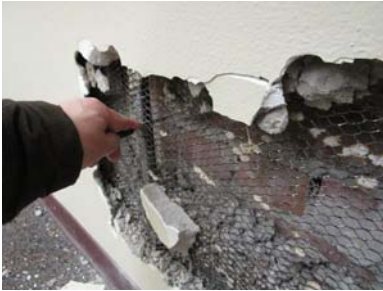
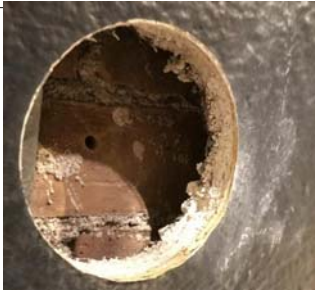
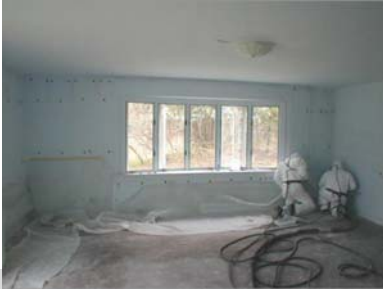
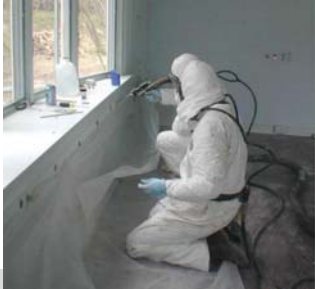
## Injection/Poured Foam Behind Existing Plaster

- Small ~1" holes
- Limited insulation thickness (~1")
- Need "slow rise" formula
- Airtightness improvement
- Interrupted by existing furring/framing
- Quality control (infrared camera for complete fill)
- Talk to Henri Fennell!

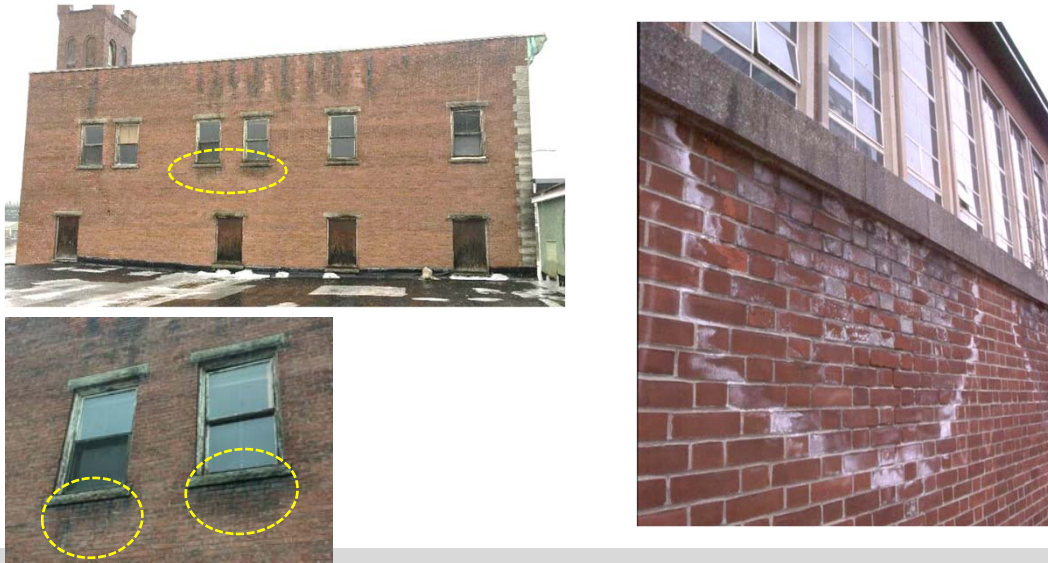
## Wetting Patterns: Windows

- Water squirt bottle testing
- Add infrared in some cases
- Often matches existing staining and damage patterns

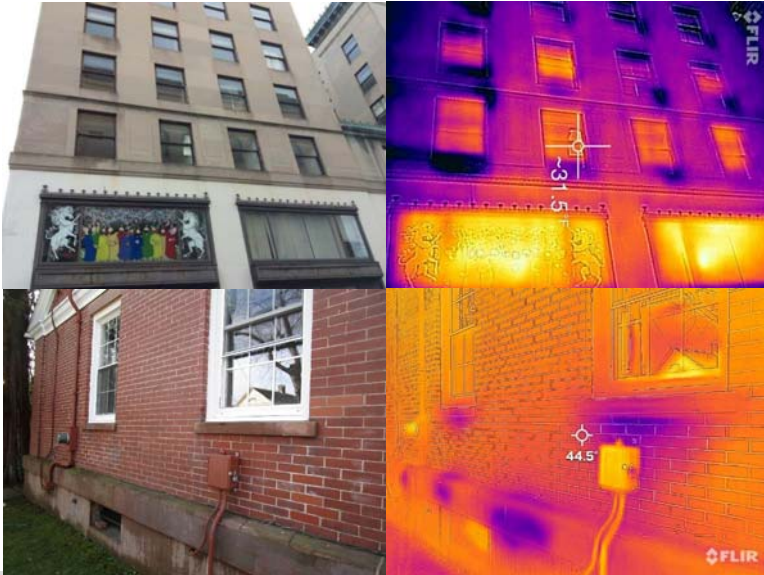
- Tricky part—catching building after the “right” amount of rainfall
- Outdoor temperature and sun too (T rising/falling)

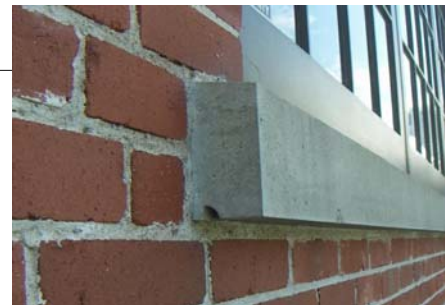
## Drip Edges

- Minimum projection of drip edge

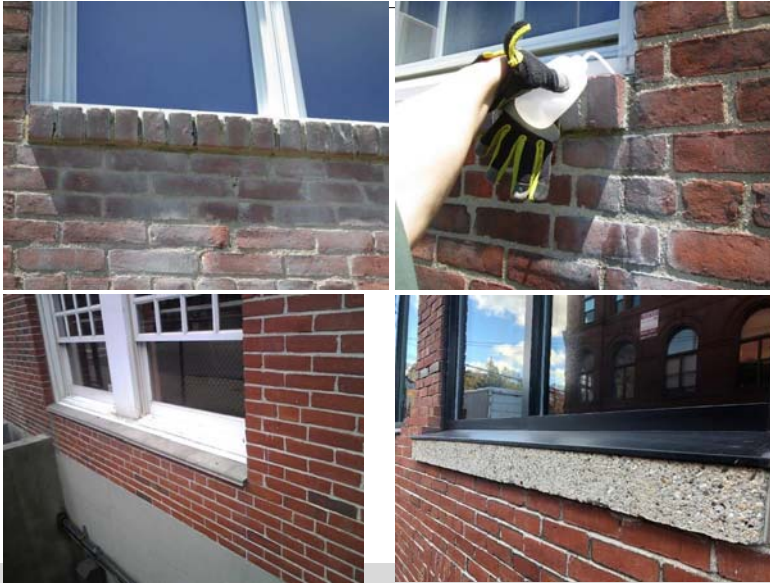
- Rowlock = many mortar joints, facing sky, taking window runoff
- Much worse water management than stone/cast stone sills
- Overclad with metal
- Add drip edge

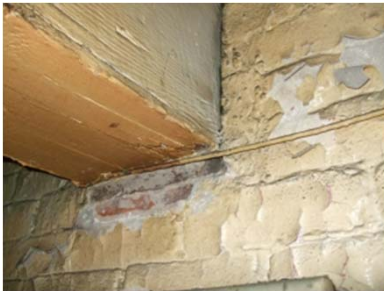
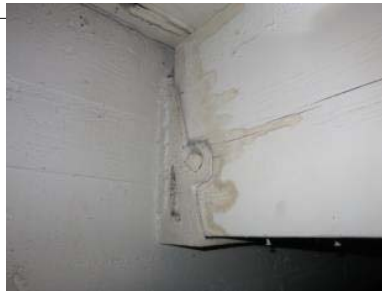
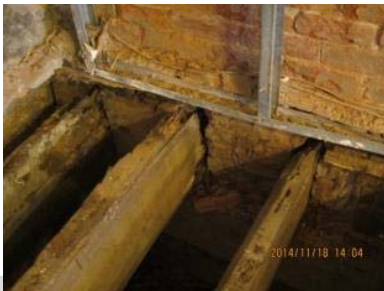
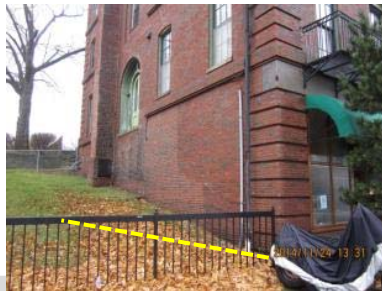
## Embedded Joists

- Steel or iron bearing plates, saddle connectors
- Connecting wood to below-grade masonry → composting your framing

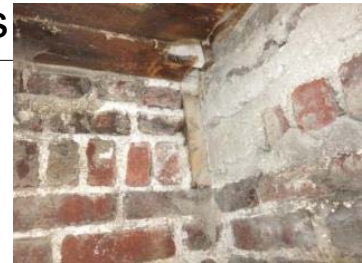
- Insulation makes wood wetter
- Heating dries wood
- Wood wettest in summer (!)
- Orientation-sensitive (N/S/E/W)
- Brick wall vs. hollow block wall
- Embedded wood is already wet (40%+ MC) & moldy in uninsulated walls
- Durability of old-growth timber
- **Damage reported only with macroscopic cracks at masonry**

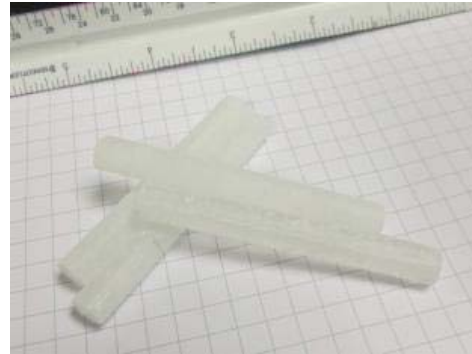
- Currently commonly used in outdoor wood/timber structures (bridges)
- Water soluble; dissolves into wood when wetted
- Drilling holes → is wood joist already punky?

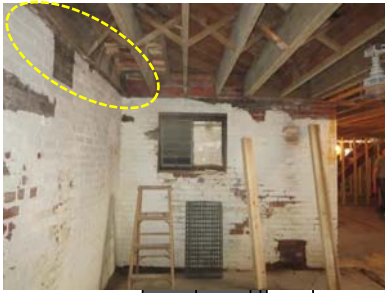
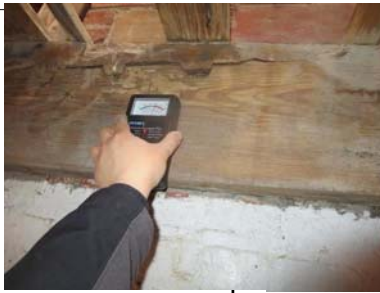
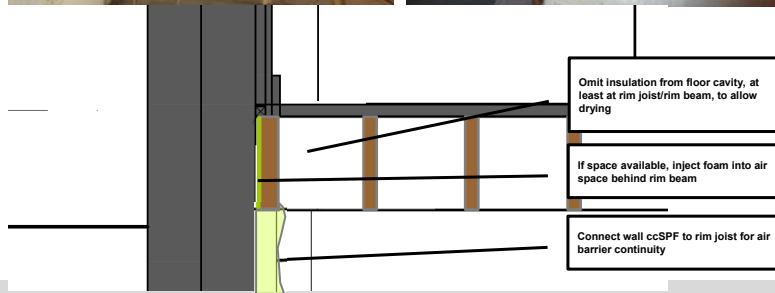
- Leaving parallel ledger uninsulated?
- Wood on “warm and dry” side, open drying to interior
- Sacrifice of thermal performance for moisture/durability performance

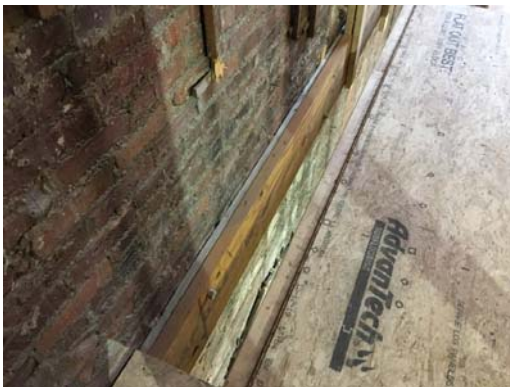
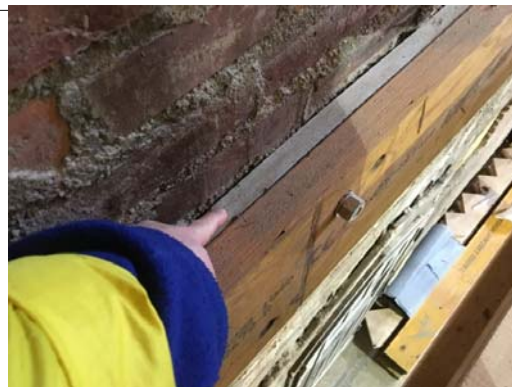
- Sandwich rigid foam between brick and wood ledger
- Wood is on “warm and dry” side, wicking from masonry
- Structural thermal break if conservative designers (Armatherm, etc.)

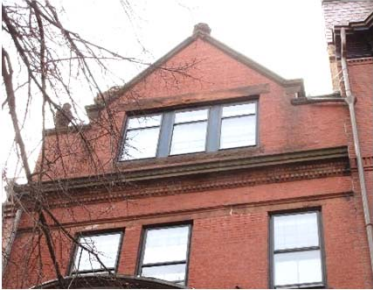
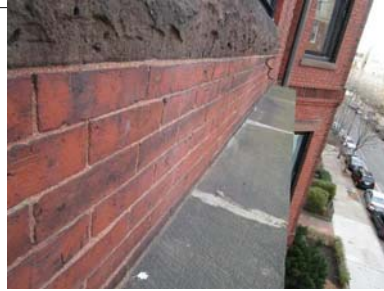
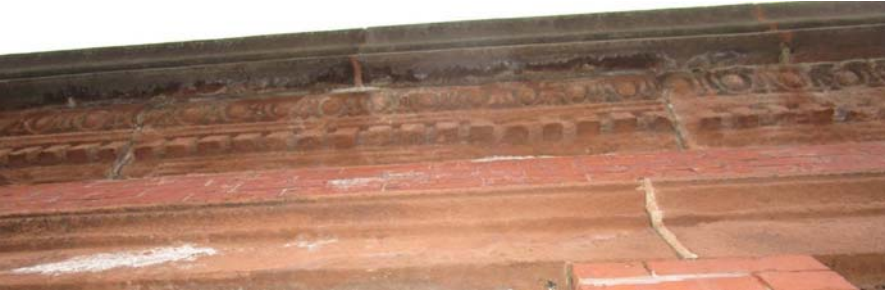
- Sky-facing mortar joints will leak over time
- Injects water deep into wall

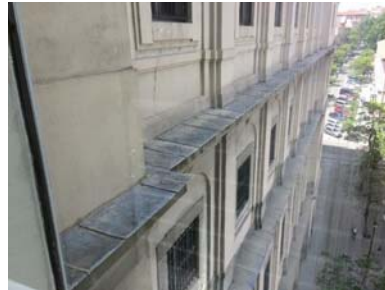
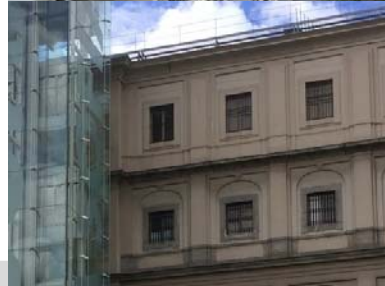
## Band or Cornice Overclad Option

- Metal overclad with drip edge
- Water control layer (membrane or fluid) on topside of sky-facing surface?
- Historical pushback?

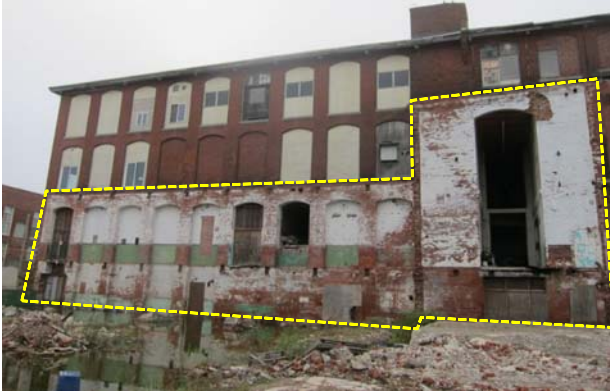
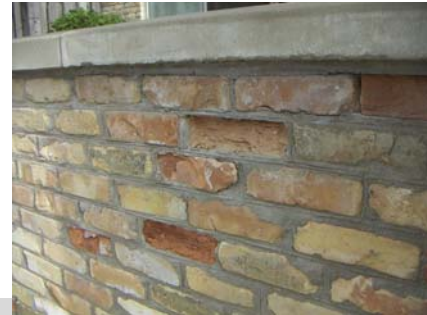
## Interior Brick Exposed to Exterior

- Or reusing salvaged brick

See Canadian Building Digest 138: On Using Old Bricks in New Buildings  
Detroit brick salvaging operations

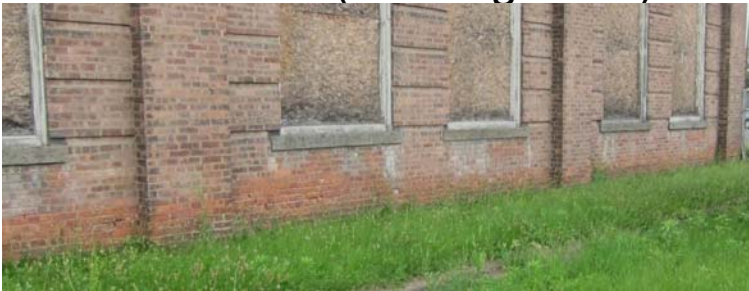
- Brick is a “dense sponge”
- Capillary wicking through brick
- Plants growing into brick = plants think your building is dirt

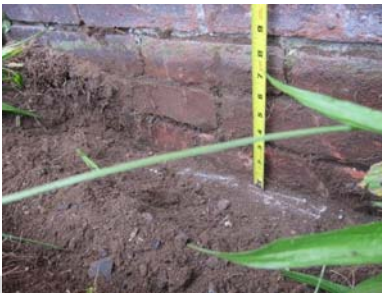
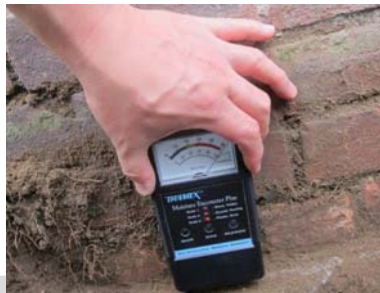
## Grade Contact (Wicking Brick)

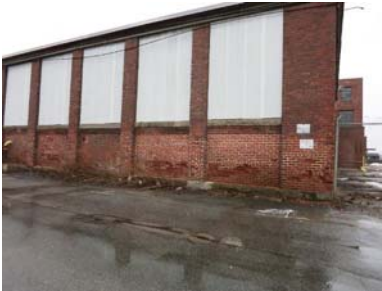
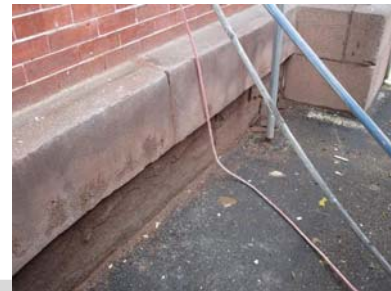
## Salt Effects on Stone & Masonry

- De-icing salts typical problem
- Localized around walking areas, steps, parking lots
- Massive F-T increase

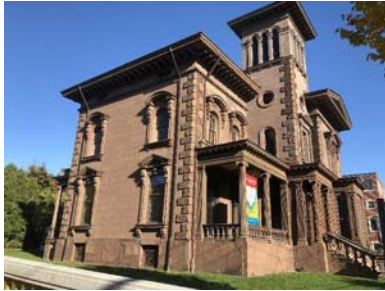
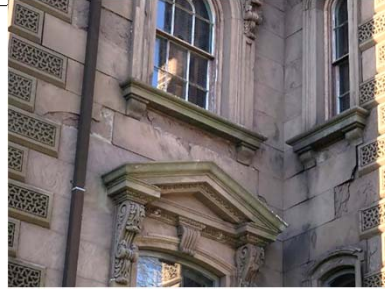
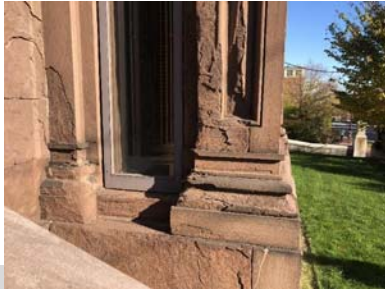
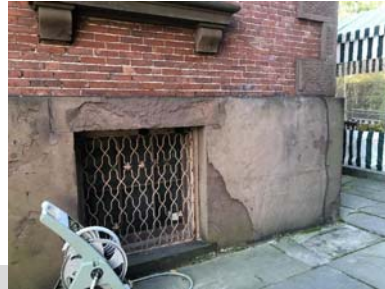
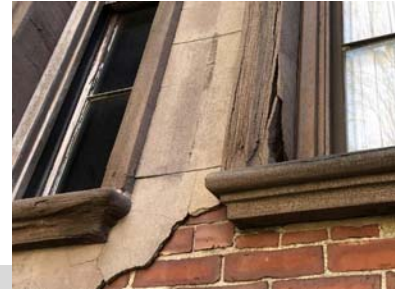
## Intrinsically Vulnerable Materials (Brownstone)

- NYC architects working in Maine
- Sandstone easy to cut & carve
- Weathers easily too!

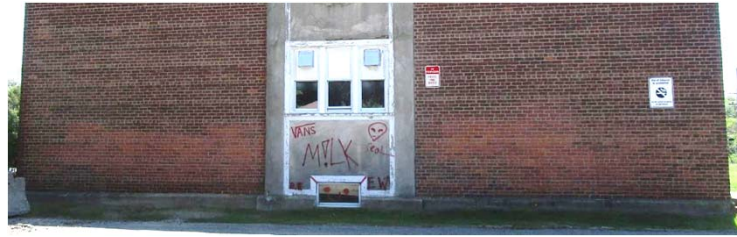
## Cleaning and Repointing

- Cleaning—"as gently as possible"
- Match cleaning agent to substrate type (brick vs. various stone types)
- Damaging cleaning—e.g., sandblasting; strips hard surface
- Repointing (as needed)
- Soft vs. hard mortars
- National Park Service Preservation Briefs 1 & 2

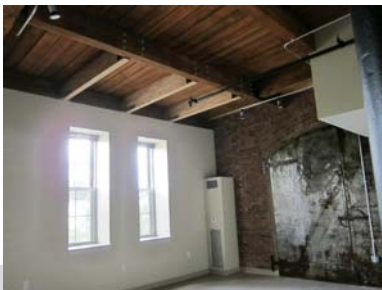
- Can't rely on masonry alone to be an air barrier
- 13" brick wall, 100 sf = **3.1 sq. in.** leakage EqLA
- Same with 3 coat plaster = **0.054 sq. in.** EqLA
- Source: CBD-23. Air Leakage in Buildings

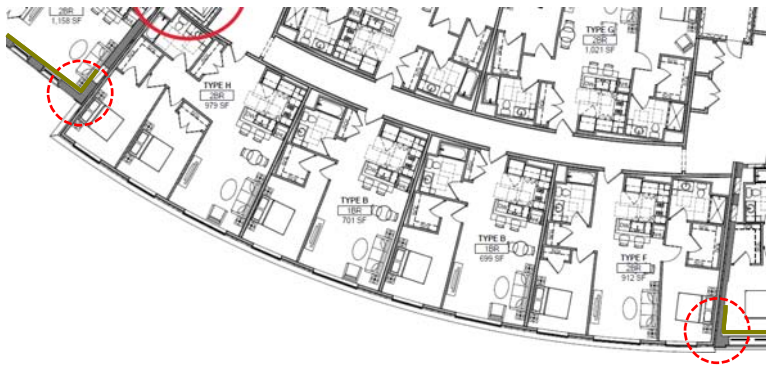
Add tee wall "wrap" for flanking loss

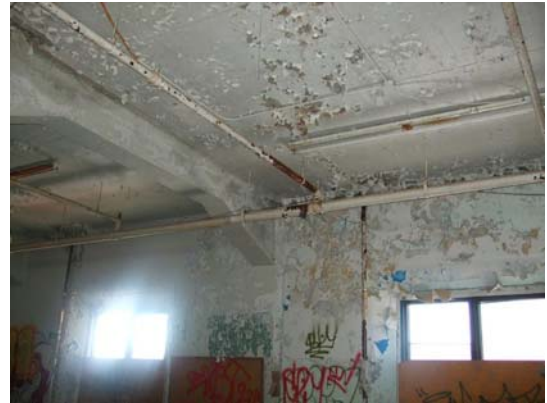
- Thermal bridge built into structure
- Can't remediate w/o "heroic measures"

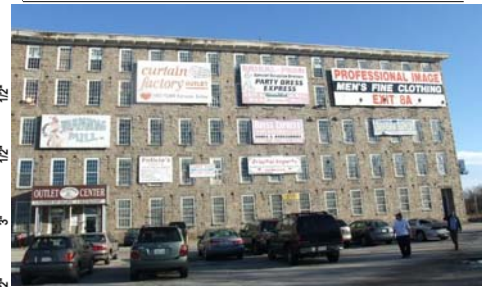
## Window Heat Loss in Context

- Large windows (4' x 8'), high glass %
- Can't change frame profile (historic)
- Aluminum, double, low E:  $U \approx 0.5$  (center of glass U-0.30)
- R-2 holes in R-20 walls

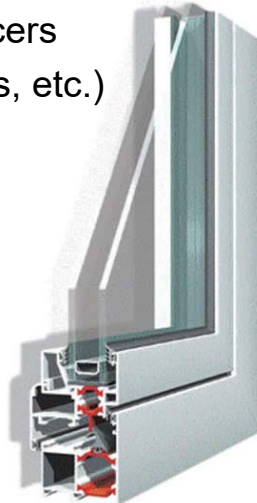
## Window Heat Loss in Context

- Improved thermal breaks, edge spacers
- Improved center-of-glass (triple, films, etc.)
- All add cost; not typical construction
- Alternate frame materials?
- Historic restrictions common

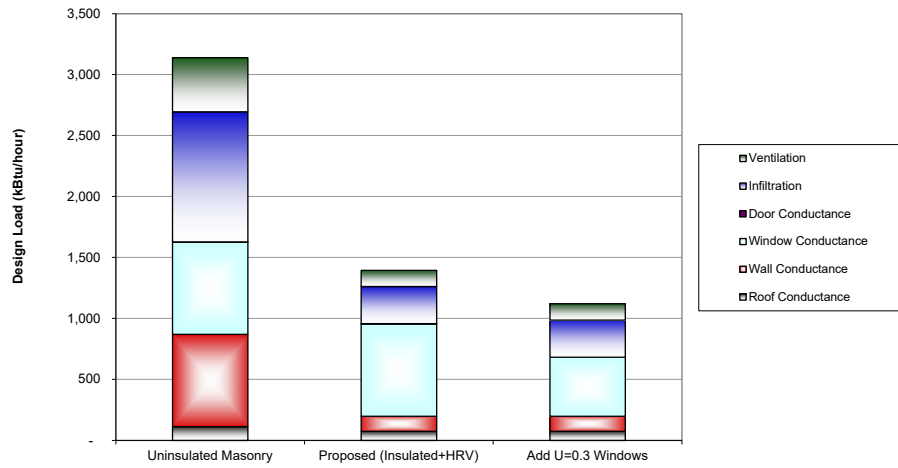
- Basic UA analysis (U-factor × area)
