BSC Information Sheet 701

What's Wrong With This Project?

Top Chord Bearing Truss

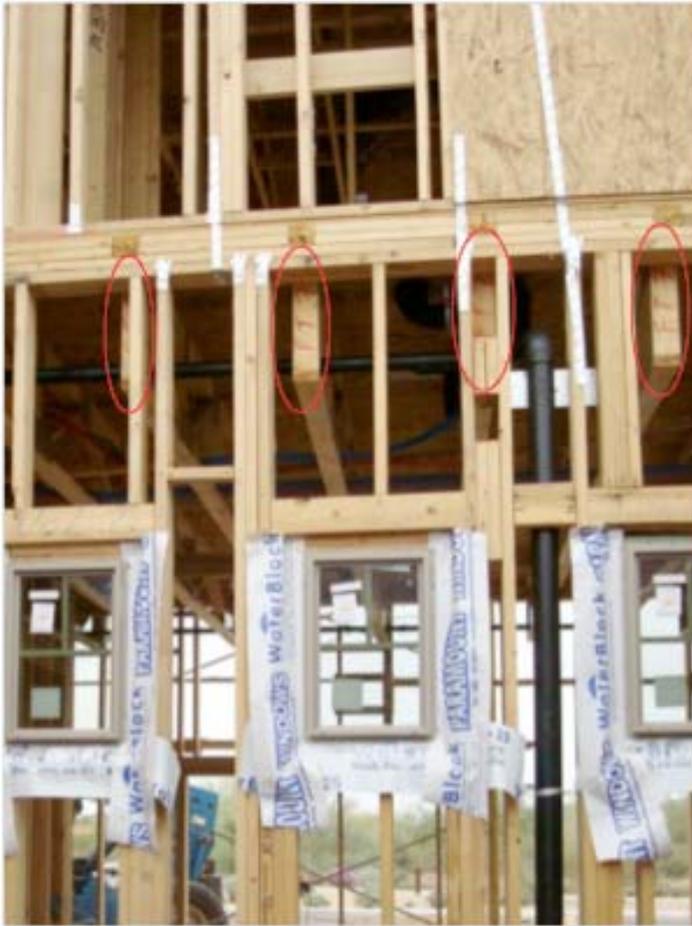
- A top chord bearing truss is used to support the second story floor assembly; the ends of these trusses are visible on the exterior.

Top chord bearing truss in conventional residential construction framing in Phoenix, Arizona, consumed considerably more wood than should have been used resulting in extra costs of both time and materials.

Between the floors, a top chord bearing truss is used to support the second story floor assembly. The ends of these trusses are visible on the exterior, and to support between them requires considerable wood blocking. In the past, this technique of “balloon framing” was used in combination with stucco cladding to minimize the risks of cracking in the stucco due to inter-floor framing shrinkage, but improved products such as OSB with dimensional stability, and stucco control joints can be used to alleviate issues with stucco cracking.

Had Advanced Framing techniques been used an overall savings of approximately \$2,000 per building would have been realized. The money could have been available to improve other building components to make them more energy efficient in addition to increasing the builder’s profit margin and improving the marketability of the product.

Replace industry standard wall construction with Advanced Framing techniques.
