The Pressure Is On

By Joseph W. Lstiburek, Ph.D., P.Eng., Fellow ASHRAE

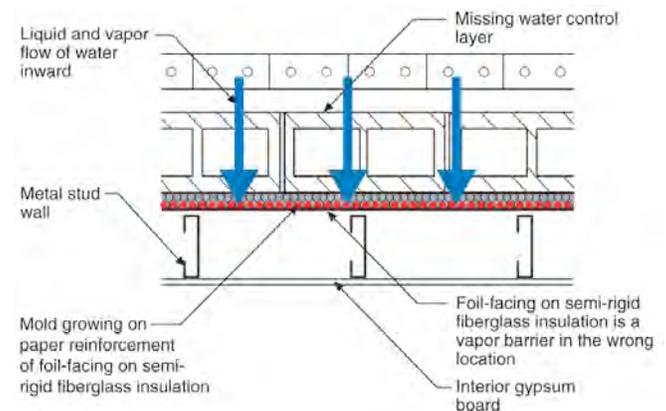
Figure 1: Hospital Wall—Classic reservoir-cladding-solar-driven-moisture-vapor-barrier-on-the-wrong-side-of-the-assembly problem.

It was a classic reservoir-cladding-solar-driven-moisture-vapor-barrier-on-the-wrong-side-of-the-assembly problem. But, it had a twist that changed my career direction. Check out **Figure 1**. The hospital building enclosure was a brick veneer with a masonry block backup wall. Mistake one: no water control layer on the exterior of the block backup wall (see *BSD-105: Understanding Drainage Planes*). The masonry block backup wall was insulated on the interior with semi-rigid fiberglass insulation. Mistake two: a foil-faced vapor barrier installed on the interior of the semi-rigid fiberglass insulation. Mold grew on the paper reinforcing of the foil vapor barrier. Guess what type of mold? Yes, *aspergillus fumigatus*. There it was: the mold reservoir and amplification site. But, how did the mold get from there and inside the patient?

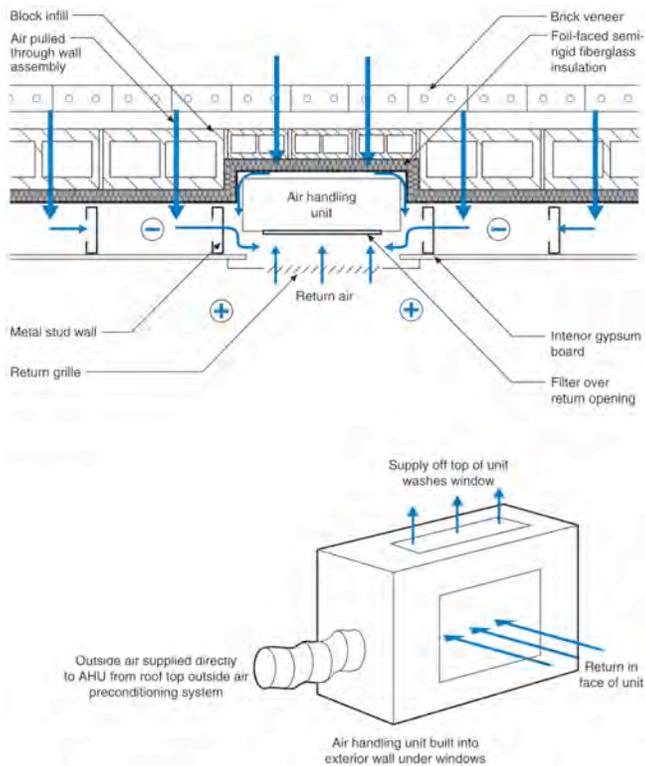
Figure 2: Air-Handling Unit (AHU) Depressurizing Wall—The AHU pulls air from both the room and the wall cavity. The air in the wall cavity was contaminated.

The patient rooms were positively pressurized relative to both the outside and the corridors. It was a beautiful system: continuous preconditioned air from rooftop units injected directly into each room. Wow. The pressure control was perfect, and continuously monitored. There was no way the mold in the interstitial cavity could have gotten into the room. Or, so I thought. Check out **Figure 2**. The room was pressurized relative to the outside but the exterior wall was negative due to the configuration of the room air-handling unit. The room air-handling unit extracted air from both the room and the exterior wall cavity, mixed this air with the outside direct ducted air and injected it back into the room. Unfortunately, the air in the exterior wall cavity was contaminated with *aspergillus*.

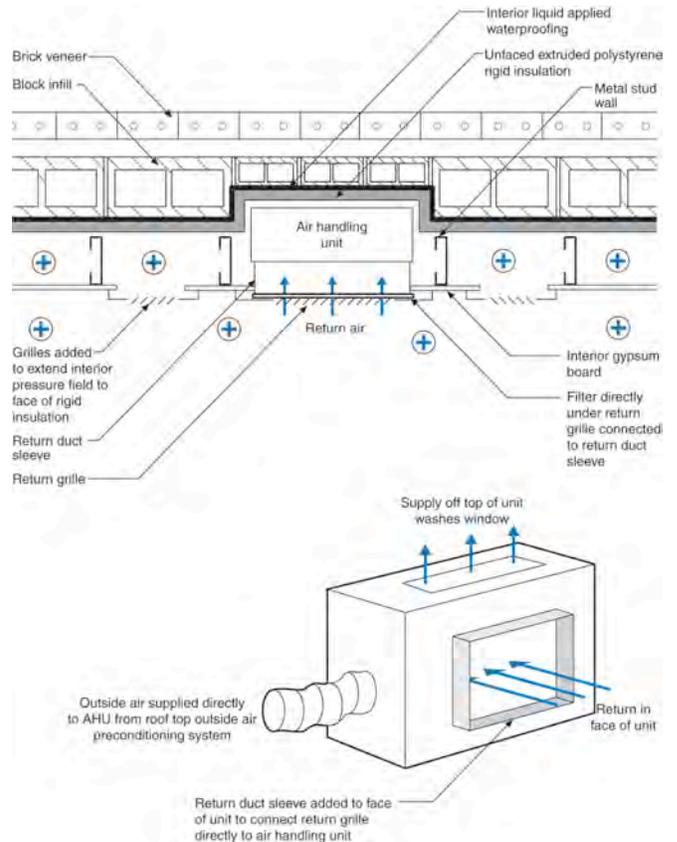
Figure 3: Uncouple the AHU—Sleeve added to the AHU to connect the return grille directly to the unit. Note the interior air pressure field extension into the wall cavity. Also, note the use of unfaced or unskinned extruded polystyrene rigid insulation—a semi-vapor permeable non-water sensitive material.

This was the first time “I got it.” Walls could suck while rooms could blow¹ (see *BSI-002: The Hollow Building*). The air-handling unit was depressurizing the interstitial cavity sucking the mold out the exterior wall and injecting it into the breathing zone of the occupied space. This was mistake three. The solution was pretty straightforward—disconnect or uncouple the air-handling unit from the exterior wall cavity, get rid of the interior vapor barrier, add some water and vapor control to the assembly and extend the interior positive pressure field into the wall cavity (**Figure 3**). Oh yeah, one more minor thing, clean up the rooms without killing anyone else. This was the first time I deliberately pressurized a wall cavity. It was not the last time, as we shall see.

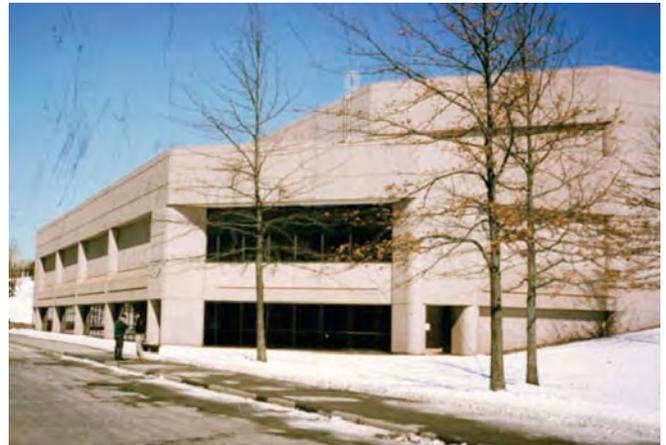
The next chance I got to do something with pressurizing cavities came along within a year: a data processing center in Connecticut (**Photographs 1 and 2**). It was a classic over-humidified-and-over-pressurized-building-in-a-cold-climate problem. You know what is coming. It was a precast building. It cried for help—literally. Condensed water leaked out at the joints and the tops of windows in cold weather (**Photograph 3**), or damaged interior finishes (**Photograph 4**).

Photograph 1: Data processing center in Connecticut.

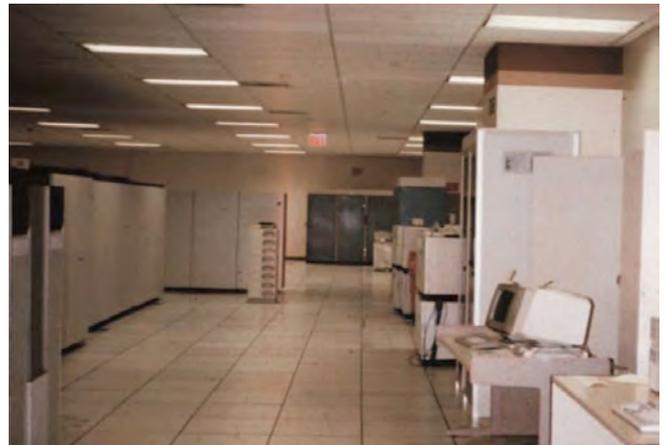
Photograph 2: Humidified and pressurized conditioned space.

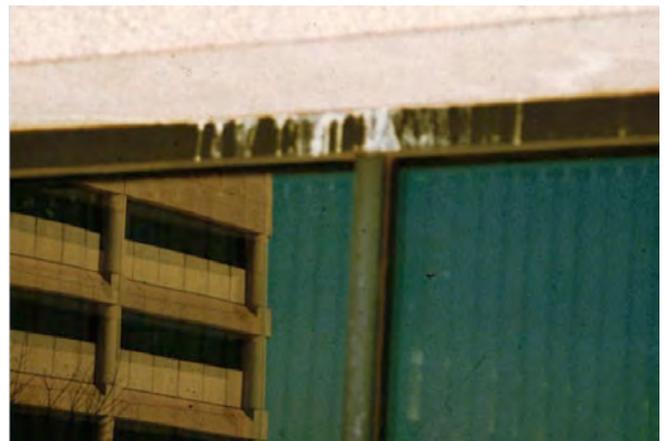
Photograph 3: Condensed water leaking out at window heads.

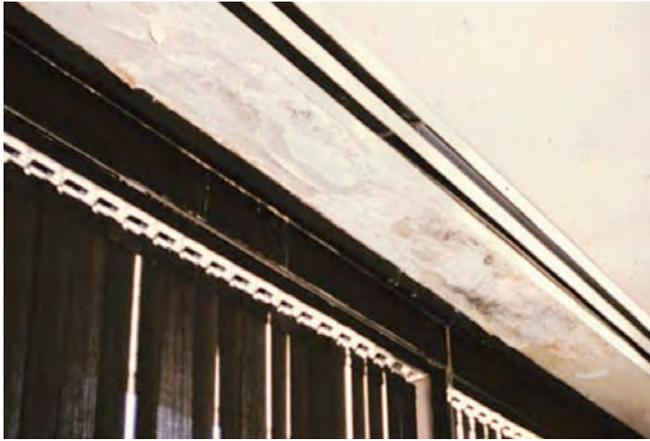
Photograph 4: Water damaged interior finishes at exterior walls.

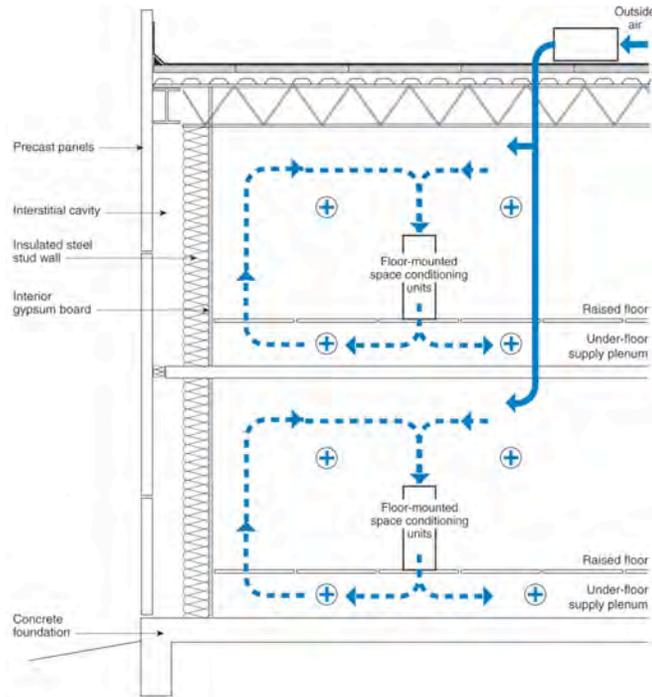
The HVAC system was a classic data processing center approach (**Figure 4**). A raised floor supply plenum with continuous preconditioned outside air. It was a beautiful system. Too bad the building enclosure was not matched to it (we still see these problems in modern underfloor air-distribution systems). The building enclosure was precast panels insulated internally with an insulated steel stud wall. The external concrete precast units were much

Figure 4: Classic Data Processing HVAC System—Raised floor supply plenum with continuous preconditioned outside air.

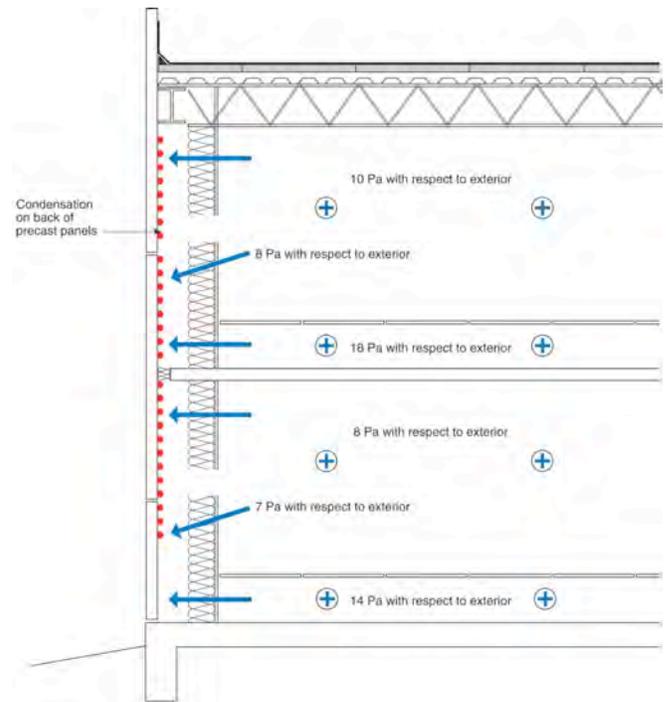
more airtight than the interior gypsum board lining—by a significant margin. Interior humidified air exfiltrated into the cavity between the precast and the steel stud framing condensing on the backside of the precast (**Figure 5**).

Figure 5: Precast Dehumidification System—The cold precast panels were the primary air barrier. This led to condensation on the back side of the precast.

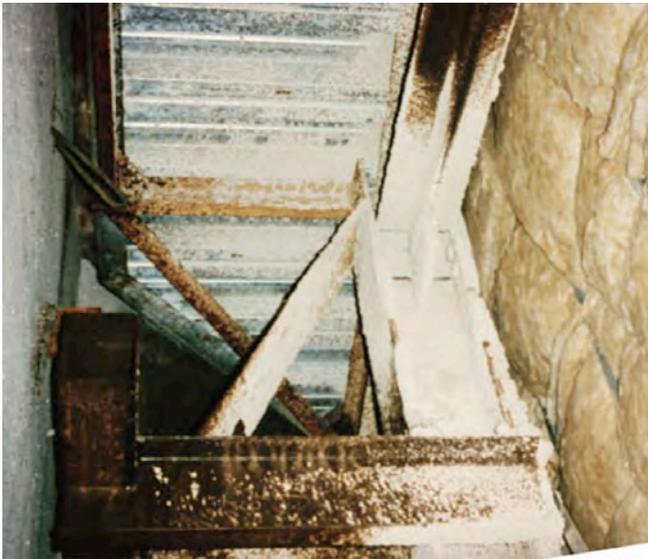
Photograph 5: Gift from the Engineering Gods—A continuous perimeter air gap between the precast panels and the interior insulated steel stud wall framing.

necessary cost and effort to turn this enclosure into the “perfect wall” was not going to happen. However, there was an air gap between the precast panels and the interior steel stud wall framing that varied between 2 in. and 18 in. (51 mm and 457 mm). (The reasons for this gap I still do not understand to this day. It was an architectural thing obviously beyond my humble engineering mind’s ability to grasp.) See **Photograph 5**. This air gap turned out to be a gift from the engineering gods. The solution was to pressurize the gap relative to the interior with outside air when outside temperatures dropped below the dew-point temperature of the interior air (**Figure 6** and **Photograph 6**). No recladding. No major expense. And fast to fix. I still get thank you cards from the client to this day.

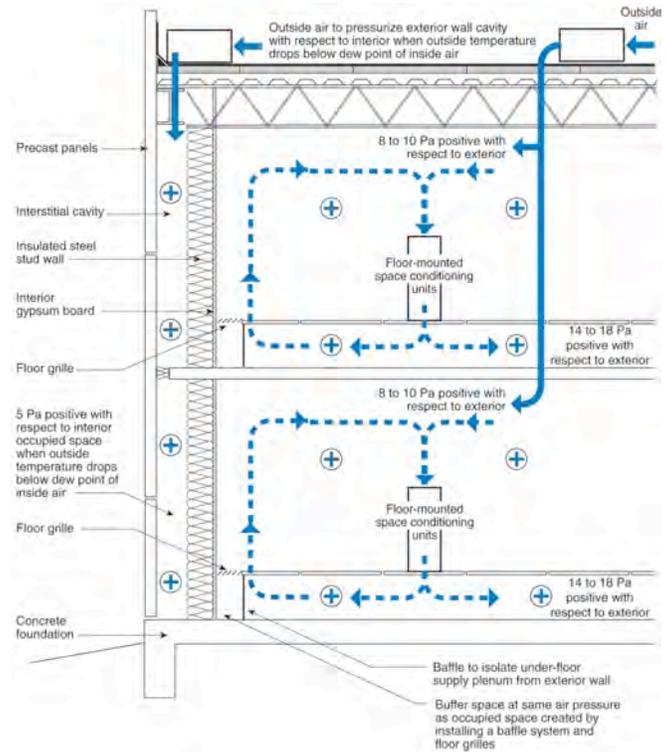
Figure 6: Pressurization of Exterior Wall Cavity—Note the baffle and floor grilles that prevent the extension of the positive pressure field of the supply plenum from extending to the exterior wall assembly.

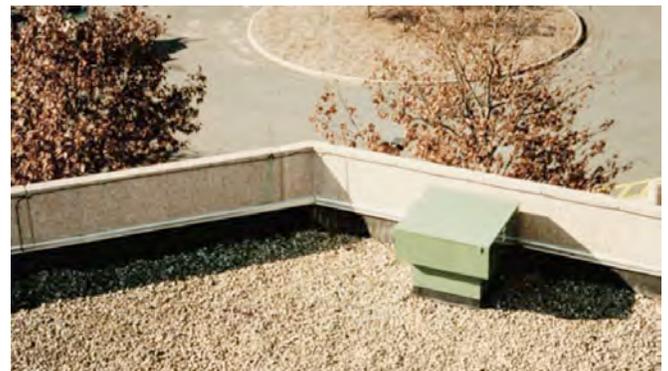
Photograph 6: Rooftop interstitial cavity pressurization system.

Figure 8 describes the solution. I sealed the ridge vents and soffit vents and added a fan (**Photograph 7**) to pressurize the roof assembly. Thank you, Dick Solvason and Gus Handegord. I also stripped a little bit of gypsum board at the interior of the ridge to create a manifold to distribute the air. The key was not to ventilate the roof with outside air, but just to pressurize it slightly. I did not want to chill down the interior gypsum board finish, as it could lead to potential condensation or mold. What pressure did I select? I guessed. 1 Pa (0.004 in. w.c.) was probably too small and too difficult to control to, and 5 Pa (0.02 in. w.c.) was probably more than I needed. So, I picked a range between 2 to 3 Pa (0.008 to 0.012 in. w.c.)

and it worked. The fan was controlled by an outside thermostat. Whenever the outside temperature dropped below 40°F (4°C), the fan would turn on.³ Today, we

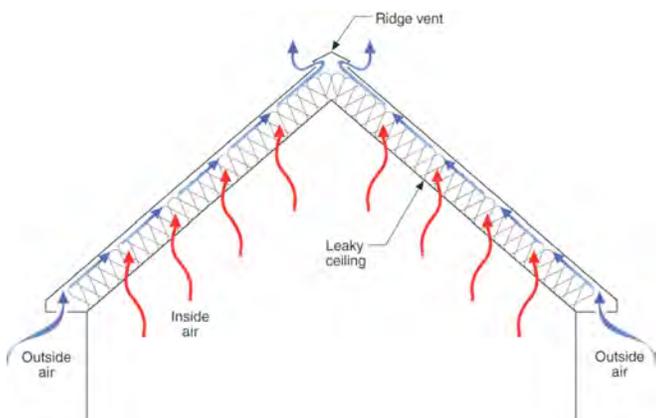
Figure 7 describes the problem. Even though the roof was ventilated the ventilation provision actually drew inside air into the roof cavity due to the leakage of the ceiling. The flow path resistance of interior air migrating into the roof assembly was less than the flow path resistance of the outside air being introduced at the soffits.

Figure 7: Ceiling Condensation Problem. Venting does not save you, it often makes it worse.

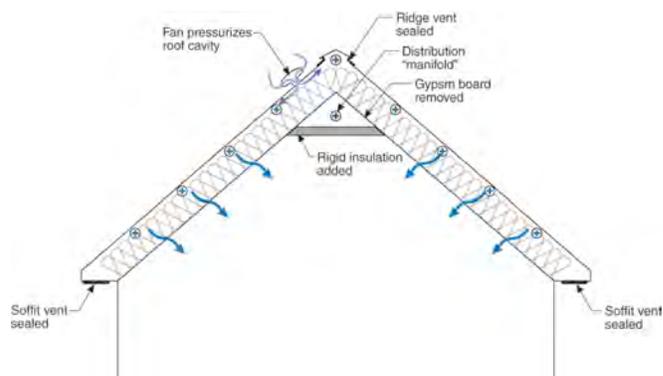
Figure 8: Non-Classic Cathedral Ceiling Condensation Solution. The key is not to over pressurize.

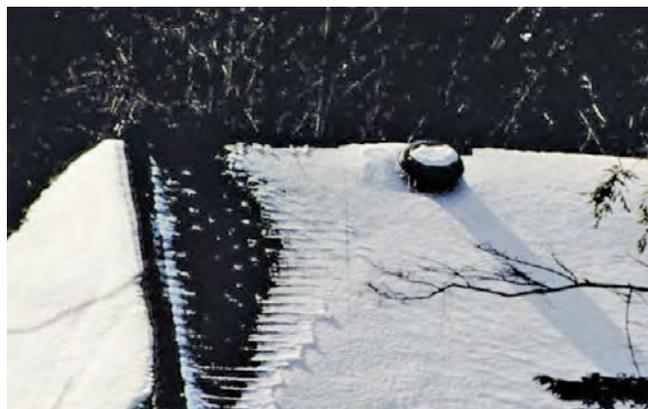
Photograph 7: Attic supply fan pressurizing roof cavity.

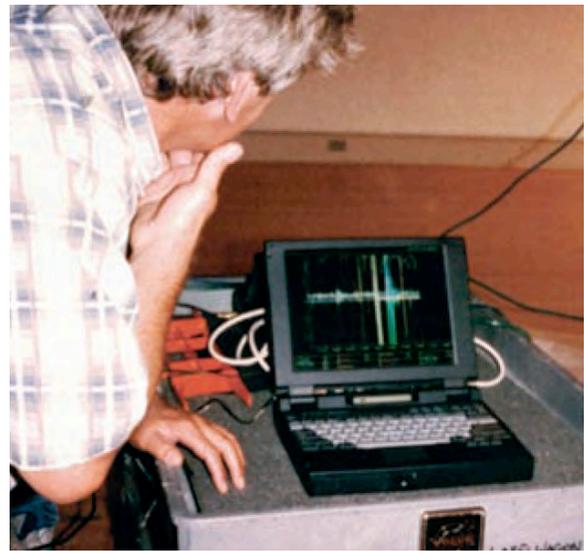
The first thing that we did was to install some pressure taps in the roof assembly and wall assembly and parapet assembly (**Photograph 9**), and connect everything to a multichannel digital manometer (**Photograph 10**). Then,

Photograph 10: Multichannel digital manometer.

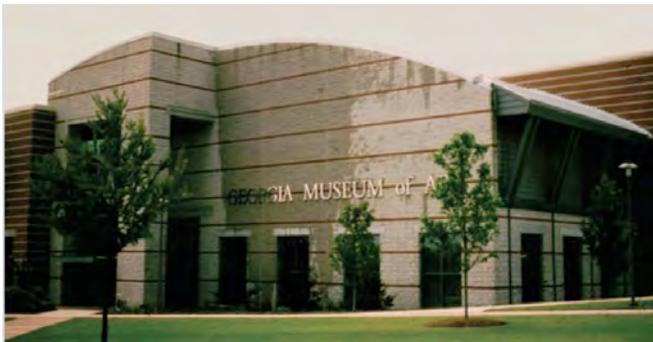
It wasn't the roof that was the problem. It was the wall that was the problem. The wall was a reservoir cladding that got wet when it rained. When the sun beat down on the wall to dry it the evaporated moisture got into the roof assembly and condensed and dripped out. The wall was in essence vented into the roof. How to prove it? Easy. Wet the wall with a fire hose (**Photograph 8**), and hope that it does not rain for a couple of days, and that it is sunny. Sure enough, we got the roof to "leak" when it didn't rain by wetting the wall and waiting a day. Awesome. Now what? We did not have time or money to rip apart the parapet (the roof-to-wall connection) and install a physical barrier (air barrier) that would prevent air from the wall from getting into the roof. But, we had toys.

Photograph 8: Fire hose wetted reservoir cladding.

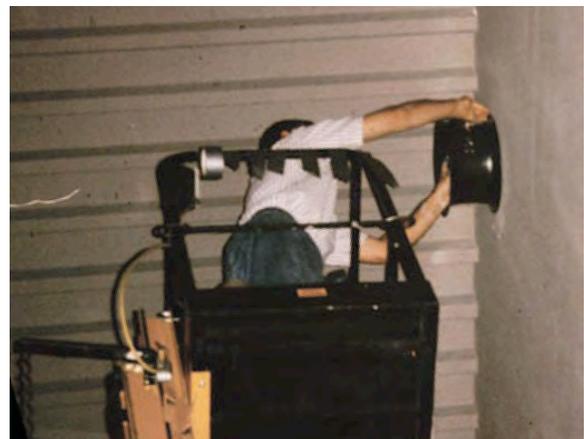
we cut a couple of holes in the interior walls up near the top at the underside of the roof, and used duct tape to hold a Duct Blaster® in place and figure out how much air needed to be added to pressurize the parapet to prevent air from migrating from the wall assembly into the roof assembly (**Photograph 11**). How much of a pressure difference did we need? You guessed it: 3 Pa (0.012 in. w.c.). Where did that come from? Experience. Final solution? Get ready for it... just leave the Duct Blasters® in place, and call it a day (**Photograph 12**). It was cheap, fast, and it worked. The collection came and went.

Photograph 11: Duct Blaster® pressurization of parapet assembly.

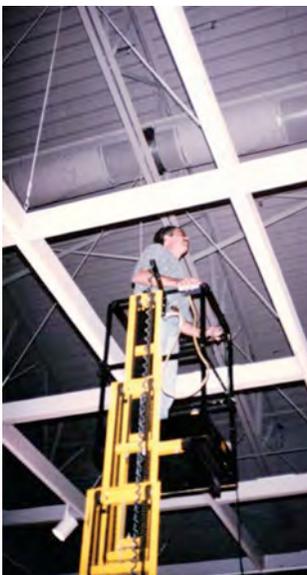
Photograph 9: Installing pressure taps.

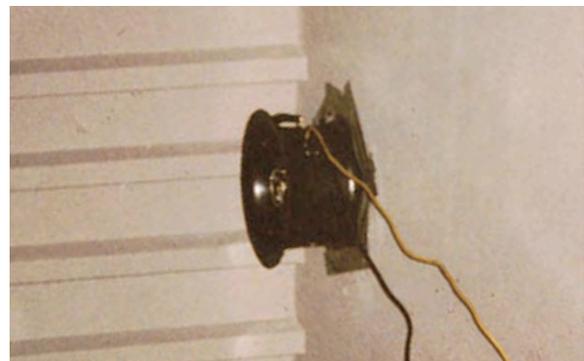
Photograph 12: Final Solution—Duct tape and a fan.
