BY JOSEPH LSTIBUREK

# Foam Shrinks, and Other Lessons

What we learned from updating a 16-year-old deep-energy retrofit

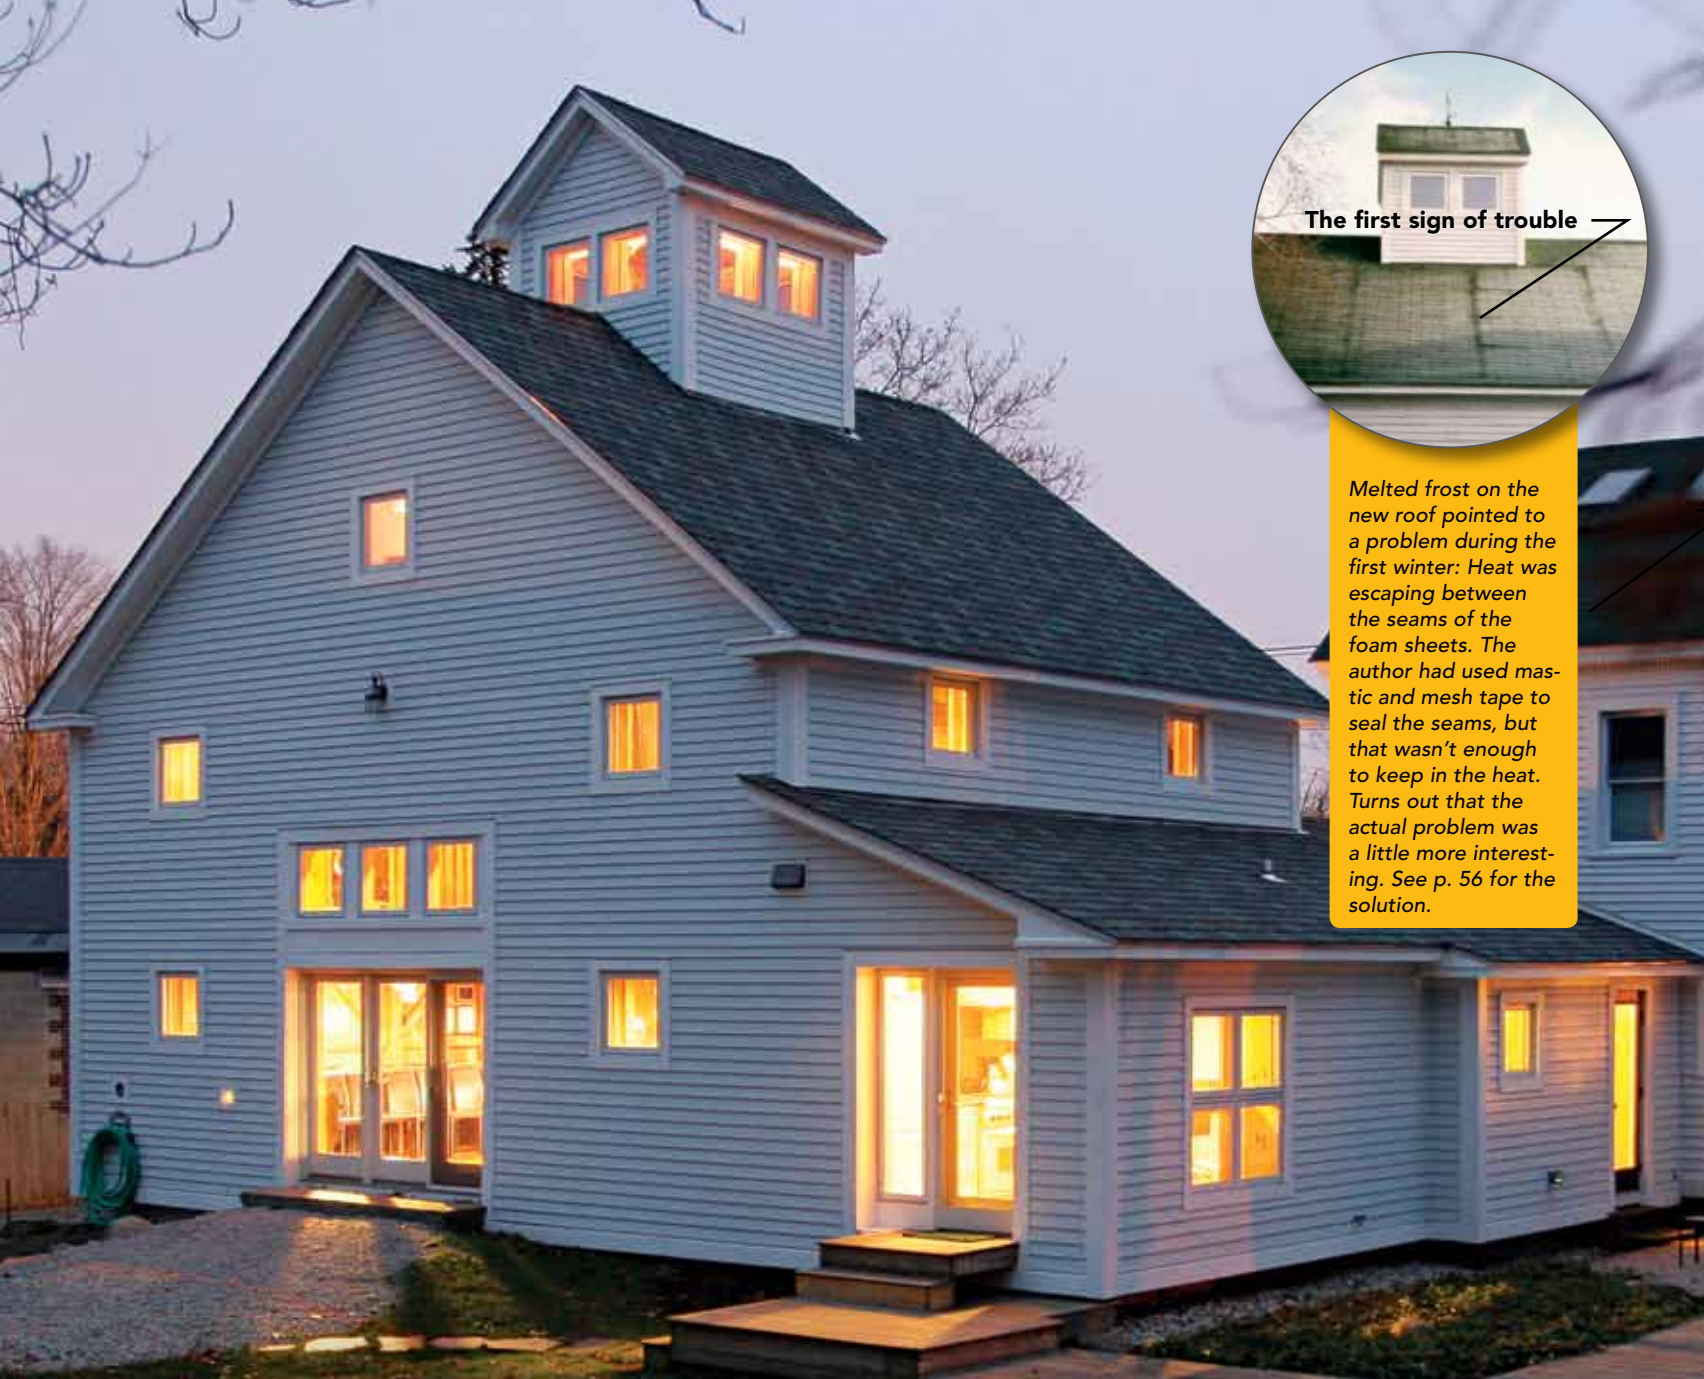
The first sign of trouble

Melted frost on the new roof pointed to a problem during the first winter: Heat was escaping between the seams of the foam sheets. The author had used mastic and mesh tape to seal the seams, but that wasn't enough to keep in the heat. Turns out that the actual problem was a little more interesting. See p. 56 for the solution.

Our first lesson came about four months after the retrofit was complete: When the first frost hit the roof, I discovered an obvious melting pattern. At the seams between the foam panels, warm air was escaping and melting the frost. Rather than installing one thick layer of foam, I should have installed multiple layers, offsetting the joints and staggering the seams. I decided to fix that when I replaced the shingles.

When I took the photo of my frosty roof on p. 55, I thought the heat loss was the result of using a single layer of foam, which meant that I couldn't stagger the sheets and offset the seams. That is what I've been telling people all these years in my confessional speeches about deep-energy retrofits. That, however, was only part of the problem. Now I know the rest of the story.

When we installed this foam, we covered the joints with mesh tape and mastic. Over time, the panels shrunk, and the tape/mastic combination cracked, opening the seams. This is where the heat came through to melt the frost on my roof.

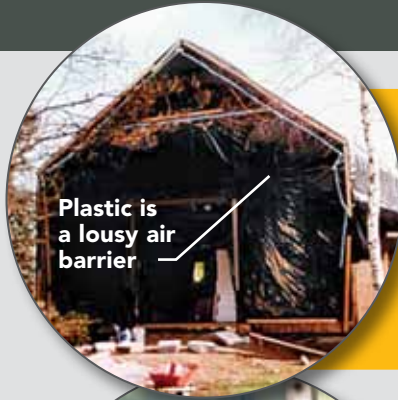
Peel-and-stick membrane was available when the author completed this retrofit, but it seemed like an excessive step when the air-control layer would be covered with foam anyway. Turns out that plastic, with its many holes, and a single layer of foam (that shrunk) didn't work so well at controlling air movement.

**Solution:** The author covered the entire barn with peel-and-stick membrane.

In the 1980s, I was preaching all over Canada about plastic being a dumb air barrier. What did I choose to wrap my barn with? Plastic. It was cheap, and I was overconfident. The blower-door test years later didn't specify where, but it told me that there were a lot of holes. Rather than try to figure out where all the holes were and detail the plastic layer better, I switched to covering the barn in peel-and-stick membrane as the first line of defense in my air-barrier system.

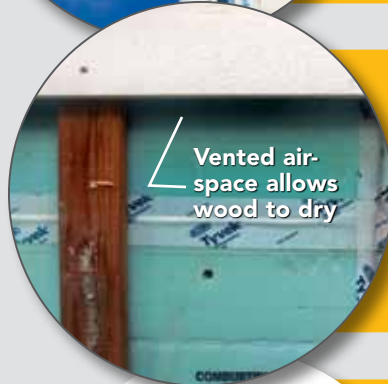
A common criticism of the author's wall assembly was that the furring strips needed to be pressure-treated or they would rot. Because the whole point of a vented airspace behind siding is to allow the siding to dry, the author reasoned that the furring strips ought to dry quickly, too. He was right. Not only did the paint job last 16 years, but the furring strips were in pristine condition as well.

I can't tell you how many times I have heard, "You've got to use pressure-treated furring strips," but it is absolutely untrue. When we took the walls apart, the furring strips looked brand new. Why does this detail work? Because the vent space is designed to dry. That is its whole job.

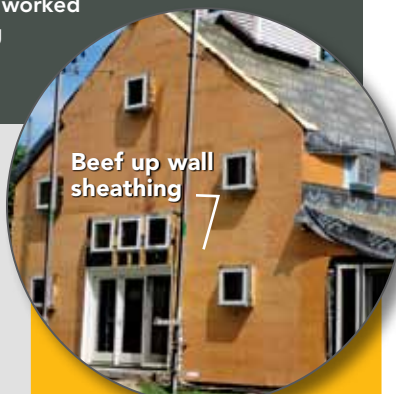
Beef up wall sheathing

To provide racking resistance to the vertical barn boards, the author added a layer of 1/2-in. plywood to the outside of the barn. He first put down a layer of felt paper so that the new plywood wouldn't be visible from the inside, where barn boards are the finished wall surface.

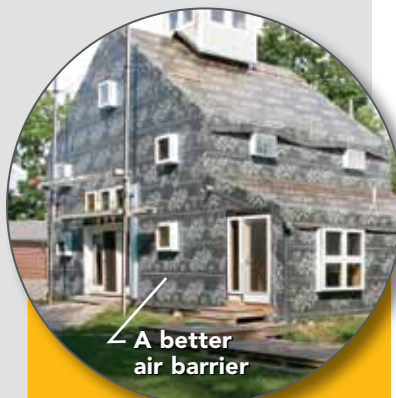
A better air barrier

Rather than wrap the barn in plastic again, the author chose to dig deep into his bank account and spring for peel-and-stick membrane as a first-line air barrier.

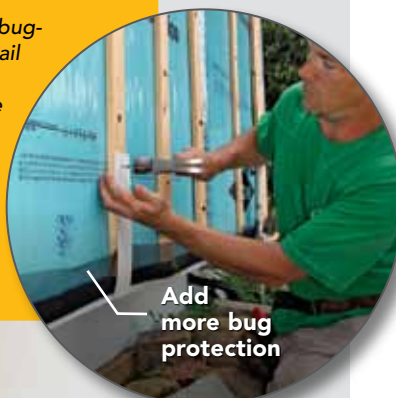
Add more bug protection

The original bug-proofing detail worked well, but builder David Joyce gave it an upgrade. Joyce added bug screen to the mesh and devised a better way to fasten the coil-stock bug barrier.

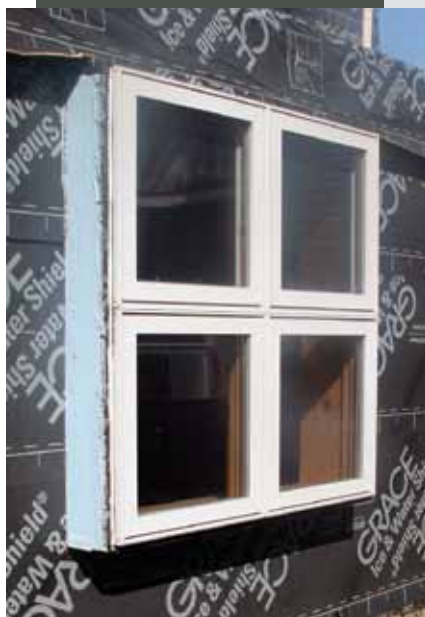
## CANTILEVERED PLYWOOD BOX DID NOT SAG

When thickening walls by 8 in., one of the difficult design details is how to install and trim windows. The author chose to cantilever plywood boxes past the frame and to install the windows with masonry straps. Naysayers cautioned that the boxes would sag under the weight of the windows, but time told a different story.

those window boxes sag? When I talk about this window detail (called *outies* by the energy nerds), I often get questions about whether the boxes will sag under the constant weight of the window. I have always answered this question by saying that the window boxes on my house hadn't seemed to sag so far. Now, after having had the barn stripped of its siding and foam, which gave me the opportunity to measure the deflection, I can say unequivocally, "No, they will not sag." □
