Measuring the Impact of Interior Insulation on Solid Masonry Walls in a Cold Climate

Research Report - 0910

MEASURING THE IMPACT OF INTERIOR INSULATION ON SOLID MASONRY WALLS IN A COLD CLIMATE

J. Wilkinson¹, D. De Rose¹, J.F. Straube², B. Sullivan¹

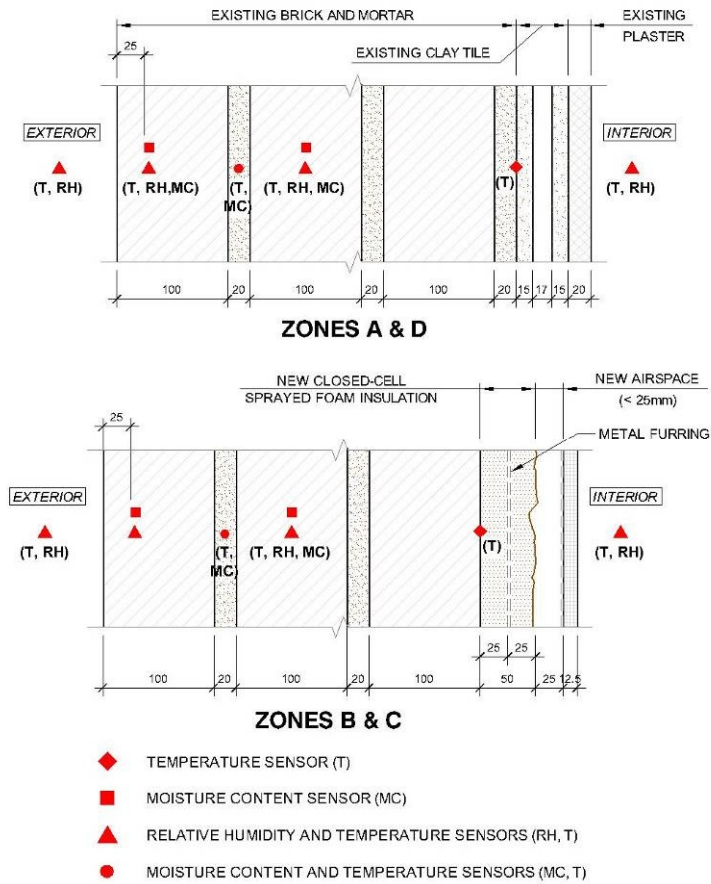
FIGURE 1: MOCK-UP WALL SECTIONS

Zones A&D: existing un-insulated wall assembly, zones B&C: modified insulated wall.

1. *Zone A*: Existing (Un-insulated) Wall Assembly, East Elevation:
Three wythes brick; 50mm hollow clay tile; 20mm plaster; 2 coats paint (likely oil);
2. *Zone B*: Modified (Insulated) Wall Assembly, East Elevation:
Three wythes brick; 50mm SPF insulation; 25mm air space; 12mm drywall; 1 coat primer; 2 coats latex paint;
3. *Zone C*: Modified (Insulated) Wall Assembly, South Elevation:
Three wythes brick; 50mm SPF insulation; 25mm air space; 12mm drywall; 1 coat primer; 2 coats latex paint;
4. *Zone D*: Existing (Un-insulated) Wall Assembly, South Elevation:
Three wythes brick; 50mm hollow clay tile; 20mm plaster; 2 coats paint (likely oil).

Nine sensors were installed in each wall to measure temperature, relative humidity and moisture content at various locations across the wall (see Figure 1). Exterior temperature and relative humidity were measured directly outside the test walls. Driving rain was measured on the exterior of the walls, at the bottom of Zones B and C (South and East). Interior temperature and relative humidity were also measured at two locations within the test room.

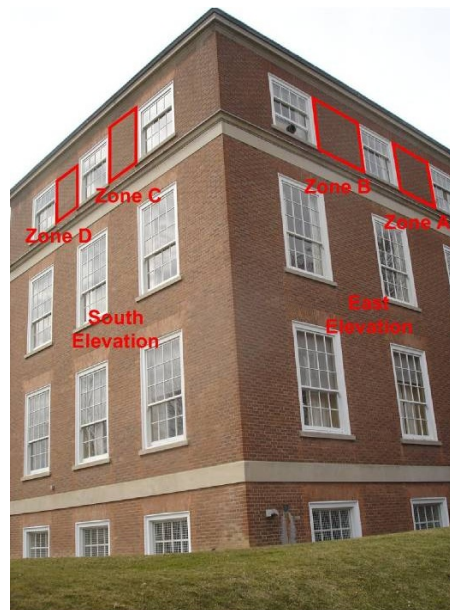
PHOTO 1: EXTERIOR SOUTH-EAST CORNER

All wall mock-up zones shown, zones A/B (East elevation), zones C/D (South Elevation).

Four mock-up walls were constructed. A room was selected on the top floor and at an outside corner facing South and East since this was expected to be the most severe climate exposure for this building. Figure 1 contains the wall sections and sensor locations. Photo No.1 shows the mock-up wall locations from the exterior. A description of the tested wall assemblies is as follows:

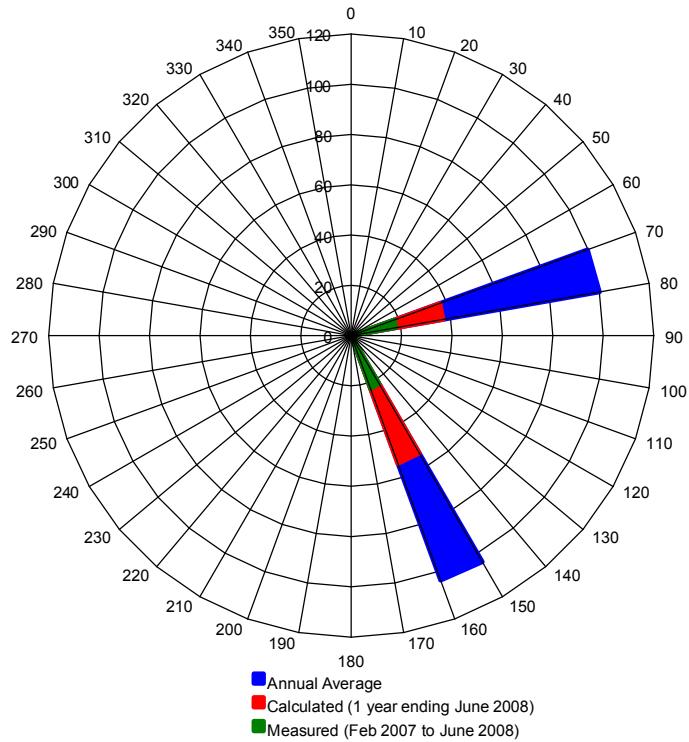
FIGURE 2: WIND-DRIVEN RAINFALL ON TEST WALLS

Wind driven rain shown is for various periods using Toronto Pearson airport and Queen’s Park weather stations. A rain deposition factor of 0.5 is used, as determined by on site wind-driven rain measurement.

Below-Average Wall Wetting: Expected driving rain at the site was calculated using publicly available vertical rainfall, wind direction and wind speed data from nearby Queens Park (calculated per procedures described in Straube and Burnett (2005)). A rain deposition factor of 0.5 was used, as determined by comparing calculated wind driven rain from the data noted above against measured wind driven rain on site. Based on this evaluation, the monitored walls were only exposed to about half the driving rain that occurs in an average year, as shown in Figure 2. While there was less-than-average driving rain on the South and East elevations over the period under review, there was significant vertical rainfall over this period. Unfortunately, most of this rain was driven onto the N, W and SW elevations. In fact, these elevations experienced 2.5 times the average rainfall. In short, this was an uncharacteristic year for driving rain, with less driving rain from typical directions and more from atypical directions. As the conditions on the monitored walls provide below-average conditions for evaluating freeze-thaw or corrosion risks, the monitoring results were used in combination with computer modelling to further evaluate deterioration risks.

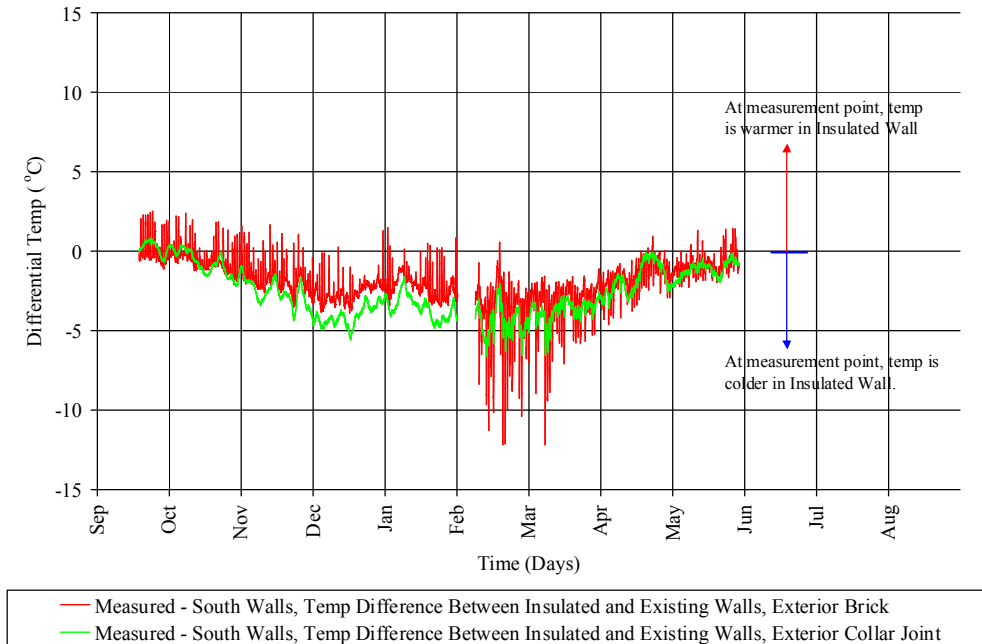
FIGURE 3: MEASURED TEMPERATURE DIFFERENCE BETWEEN INSULATED AND EXISTING WALLS
 Temperature difference between East mock-up walls at critical locations for freeze-thaw evaluation (exterior brick and exterior collar joint). Generally the insulated wall is up to 12°C cooler than the existing wall.

The measured insulated walls were cooler than the measured un-insulated walls throughout the winter. At wall locations critical for freeze-thaw damage (exterior brick and exterior collar joint), the insulated walls were up to 12°C cooler than the un-insulated walls (see Figure 3). This resulted in up to 5 times as many zero crossings in the insulated walls. The increase in zero crossings was most pronounced on the South exposure, where cooler walls were subject to increased daily heating from the sun (see Figure 4).

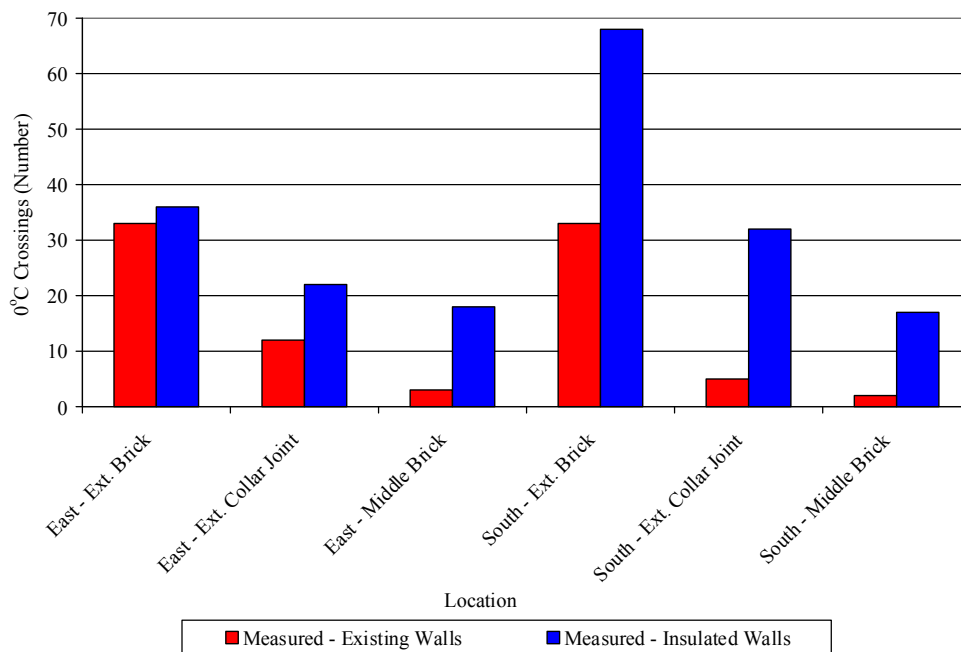
FIGURE 4: MEASURED ZERO-CROSSINGS IN INSULATED AND EXISTING WALLS
 This figure illustrates climate conditions relevant to freeze-thaw cycles. All insulated walls have an increase in the number of zero crossings, particularly the South elevation due to impacts from solar radiation. There were no hours when freeze thaw cycles were observed (when a zero crossing occurred and moisture contents were also above 85% of free water saturation).

Below-Average Number of Zero Degree-Crossings: The monitored walls were exposed to 70% of the zero degree-crossings that would result during the 3rd coldest year in 30 (10th percentile) from the computer model database. The number of zero-crossings is comparable to the amount seen in the 3rd warmest year in 30 (10th percentile) from the computer model database. As these are also below-average conditions for evaluating freeze-thaw risks, the monitoring results were used in combination with computer modelling to further evaluate deterioration risks.

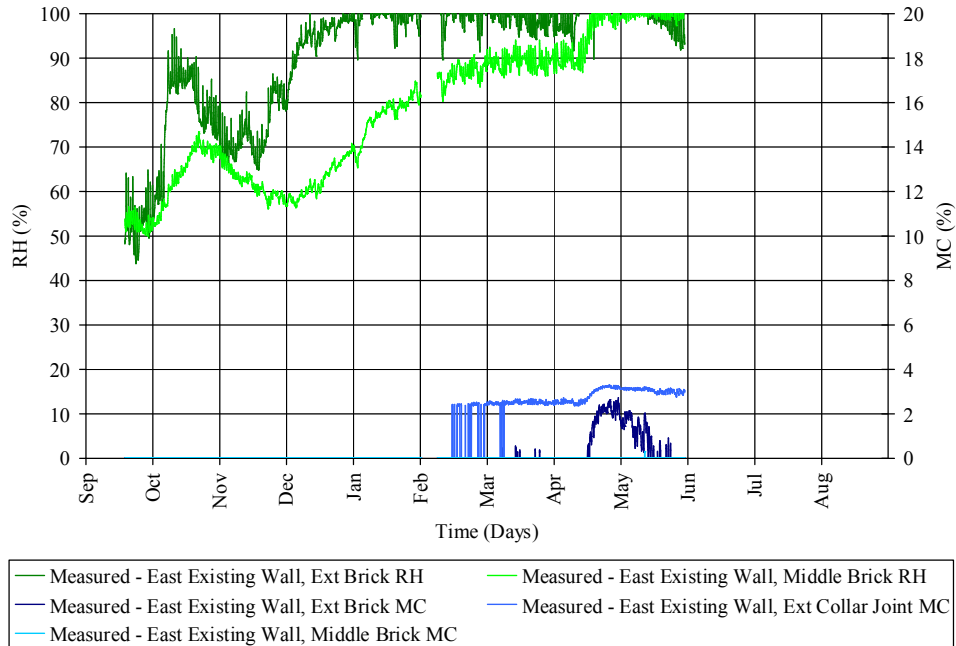
FIGURE 5: MEASURED RH AND MC IN EAST EXISTING WALL

Actual relative humidity and moisture content (wood wafer) measured in the existing East wall. The moisture content is well below thresholds for freeze-thaw. MC values shown are for the wood resistance sensors embedded in the brick, instead of the corresponding brick moisture content in order to increase measurement resolution (see Figures 11 and 12 for wood to brick correlation).

The moisture content in the measured walls was low throughout the monitoring period and, as a result, there were no hours where freeze-thaw damage was likely to occur (see Figures 5 and 6). The maximum monitored moisture content was 4% in the brick and mortar, which is below the estimated 12% threshold where freeze-thaw damage is expected to occur (this 12% threshold corresponds to 85% of the free water saturation). This threshold is expected to be conservative since there should be sufficient room remaining in the pores to alleviate pressures from freezing water.

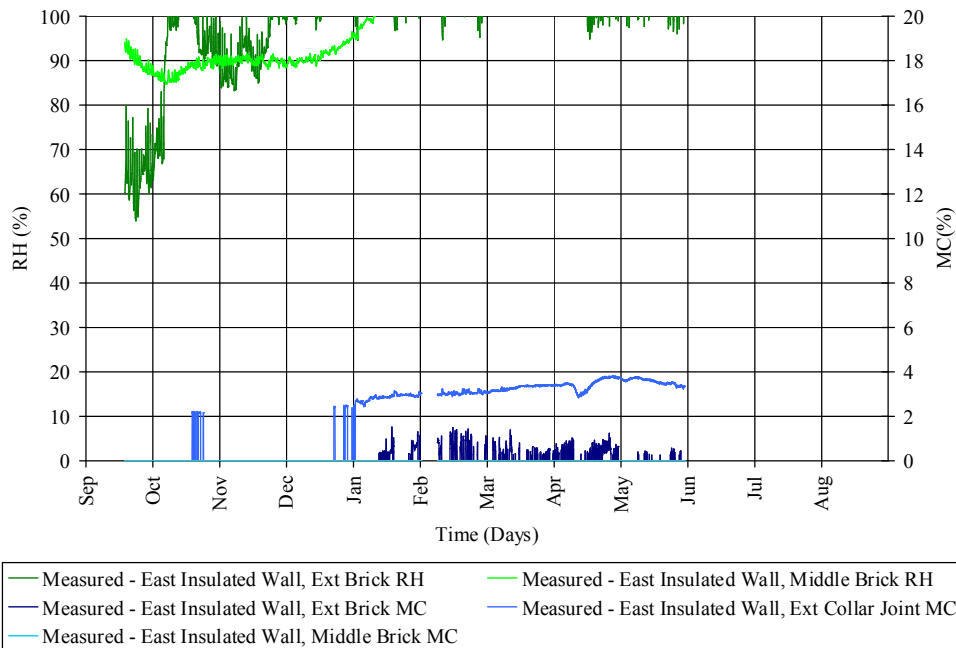
FIGURE 6: MEASURED RH AND MC IN EAST INSULATED WALL

Actual relative humidity and moisture content (wood wafer) measured in the insulated East wall. The moisture content is well below thresholds for freeze-thaw. MC values shown are for the wood resistance sensors embedded in the brick, instead of the corresponding brick moisture content in order to increase measurement resolution (see Figures 11 and 12 for wood to brick correlation).

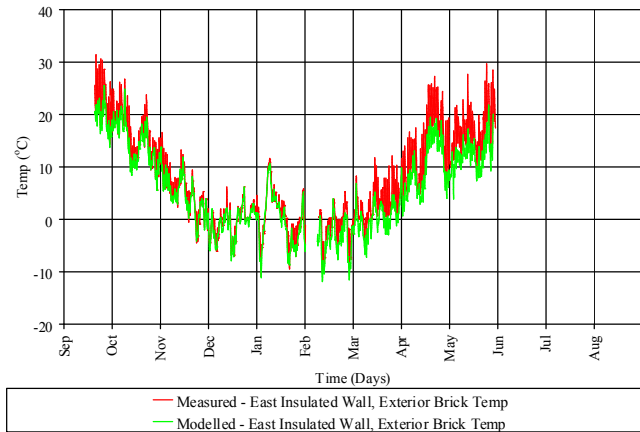
FIGURE 7: MEASURED AND MODELLED TEMPERATURES IN EAST INSULATED WALL
 Temperatures shown are similar between modelled and measured walls. Other locations also compare well.

The hygrothermal performance of the modelled and measured walls generally compared well. The temperatures across the modelled wall sections were within several degrees of one another (see Figure 7), particularly at locations sensitive to freeze-thaw (exterior brick and exterior collar joint). This indicates that the thermal properties of the components are well understood. The relative humidity trends are also consistent between the measured and modelled results, but the modelled values are typically within 10% of the measured values. These results seem reasonable given that a 1-dimensional model is being used to represent 2-dimensional moisture flow through the mortar and bricks. The moisture contents are generally comparable between the calculated/modelled and measured results (see Figure 8). However, there are spikes in the modelled exterior brick moisture content soon after rain events, which do not appear as significantly in the measured walls. This discrepancy is discussed in more detail in Section 4 below. The model was used to evaluate these peak moisture content values, as they are important to freeze-thaw performance.

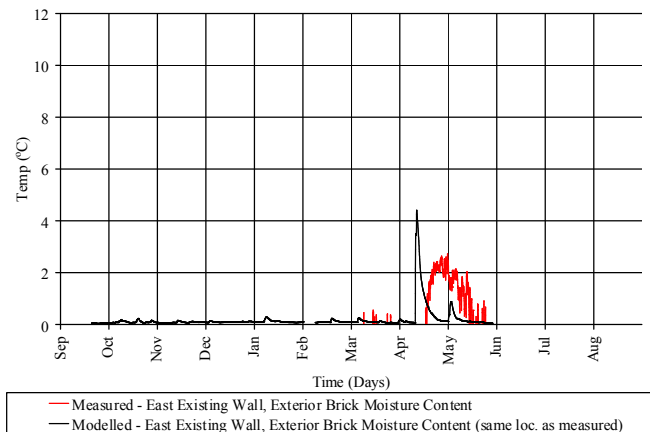
FIGURE 8: MEASURED AND MODELLED MOISTURE CONTENT IN EAST EXISTING WALL
 Moisture contents are generally similar, apart from severe spikes in modelled moisture content soon after rain events that are not observed in measured values. This discrepancy should be resolved with artificial wetting of the field sensors to test reaction time to wetting events.

The measured and modelled moisture contents (both over a 25mm slice at same location in wall) compare well outside of short-term peaks, where the measured values are less than the modelled values. The MC spikes are important to a freeze-thaw analysis, as this is the time when materials could be saturated enough to cause freeze-thaw damage when coincident with below 0°C temperatures. We speculate that the MC spikes are not as pronounced in the measured values due to slow sensor response, given sensor size and encasement in bentonite clay (which may impact capillary connectivity). After a rain event, the moisture may dry or be redistributed before the sensor can fully react.

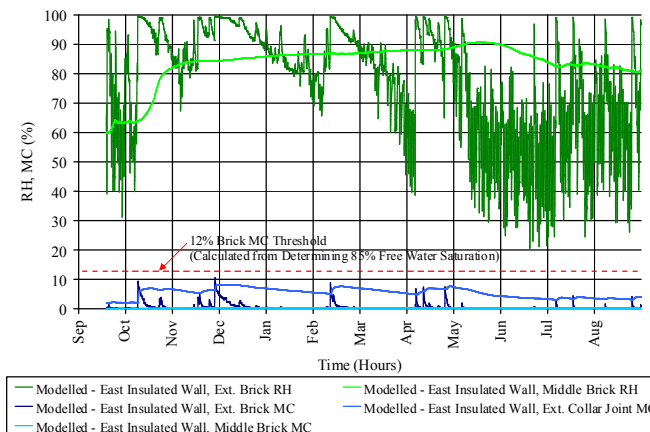
FIGURE 9: MODELLED RH AND MC IN EAST INSULATED WALL
 Brick moisture content in most severe modelled case is 10.6%, which is below the 12% MC freeze-thaw threshold.

In the modelled walls subjected to more severe weather conditions than those experienced in the field (using rain deposition factor of 0.5), there were no instances where freeze-thaw damage was likely to occur (see Figure 9). The maximum moisture content was 10.6% (peaking in the brick soon after rain events). The moisture content in the brick between rain events is typically near 0%. The mortar moisture content is fairly constant between 2-8%. These moisture contents are below the estimated threshold levels of 12% and 13% (brick and mortar respectively) where freeze-thaw damage is expected to occur.

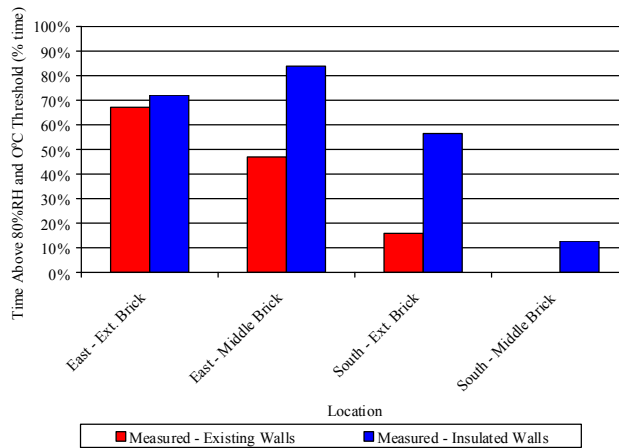
FIGURE 10: MEASURED TIME ABOVE CORROSION THRESHOLDS IN INSULATED AND EXISTING WALLS
 Insulated walls have significantly more time above corrosion thresholds than existing walls, increasing risks for embedded steel corrosion in insulated walls.

There may be a minor increase in embedded metal components corrosion risk for the insulated walls compared to the existing un-insulated walls. Figure 10 shows the time above corrosion thresholds. Corrosion threshold is Time of Wetness (i.e. hrs above 0°C and 80% relative humidity) as defined in ISO (1992).

The modelled walls show no increase in corrosion risk between un-insulated and insulated walls. However, the measured walls show an increased risk. We believe this discrepancy is, in part, due to the nature of the sensor installation, with a wood resistance sensor embedded in the parent material using bentonite clay (see Section 2.2). In addition, moisture transport in the model may occur by liquid transport, while moisture transfer to the sensors is predominantly by vapour diffusion (i.e. slower process). This may result in the sensors showing more time above thresholds after a rain event.

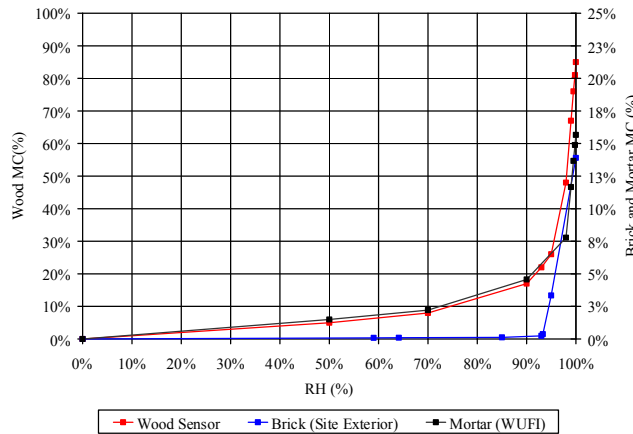
FIGURE 11: MOISTURE CONTENT CALIBRATION – WOOD AND BRICK
 Measurements taken during lab testing of wood sensor installed in brick, as done in the field.

The wood moisture content sensors used to evaluate the brick moisture content, operate accurately in the 20% to 50% wood MC range (corresponding to 0% to 8% MC in this brick), as shown in Figures 11 and 12. The wood moisture content did not exceed 30% (4% in this brick) over the monitoring period due to a lack of wetting, so the upper range of the sensors was not an issue in this case (see Figure 10). However, given that critical limits for freeze-thaw damage correspond to approximately 70% in wood (12% in this brick), these wood sensors would not adequately evaluate moisture content near the threshold in this brick.

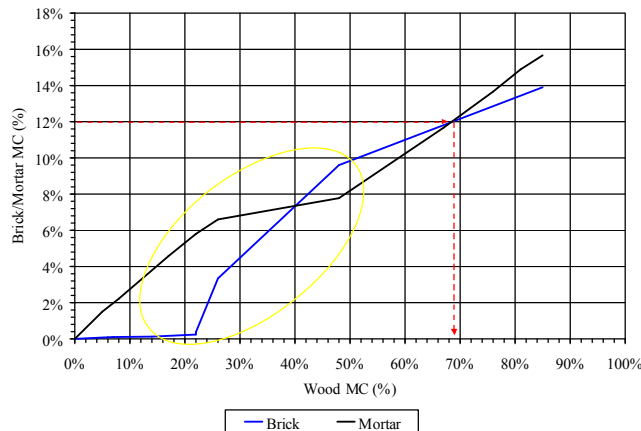
FIGURE 12: MOISTURE CONTENT CORRELATION – BRICK VS WOOD
 Corresponding Brick MC for given Wood MC reading. Wood sensors operate accurately in the range circled in yellow. Critical moisture content range for brick freeze-thaw analysis (and corresponding wood moisture content), shown with dotted red arrows.
