# Evaluation of Cladding and Water-Resistive Barrier Performance in Hot-Humid Climates Using a Real-Weather, Real-Time Test Facility

Research Report - 1011

15 December 2010

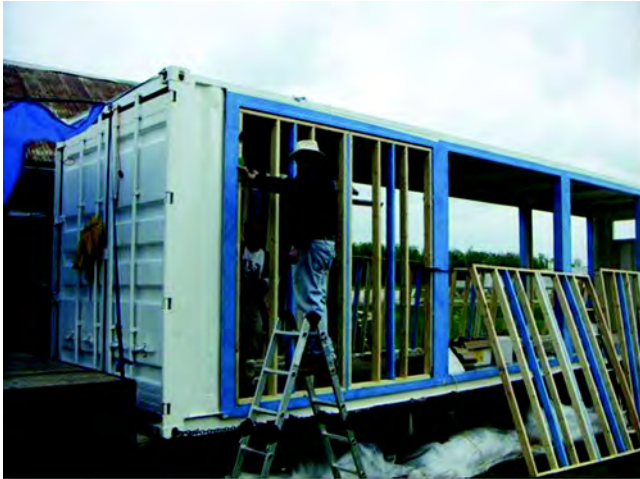
**Figure 1** Installation of specimen wall framing in container.

of the chamber. Figure 1 shows the installation of the stud walls in the sides of the container. The RBETS was placed in its test location in June 2006 and was orientated such that the opposing wall sections were exposed directly to the east and the west. This was done in order to take advantage of the local weather patterns. Once the unit was placed on site, construction of the wall assemblies was completed.

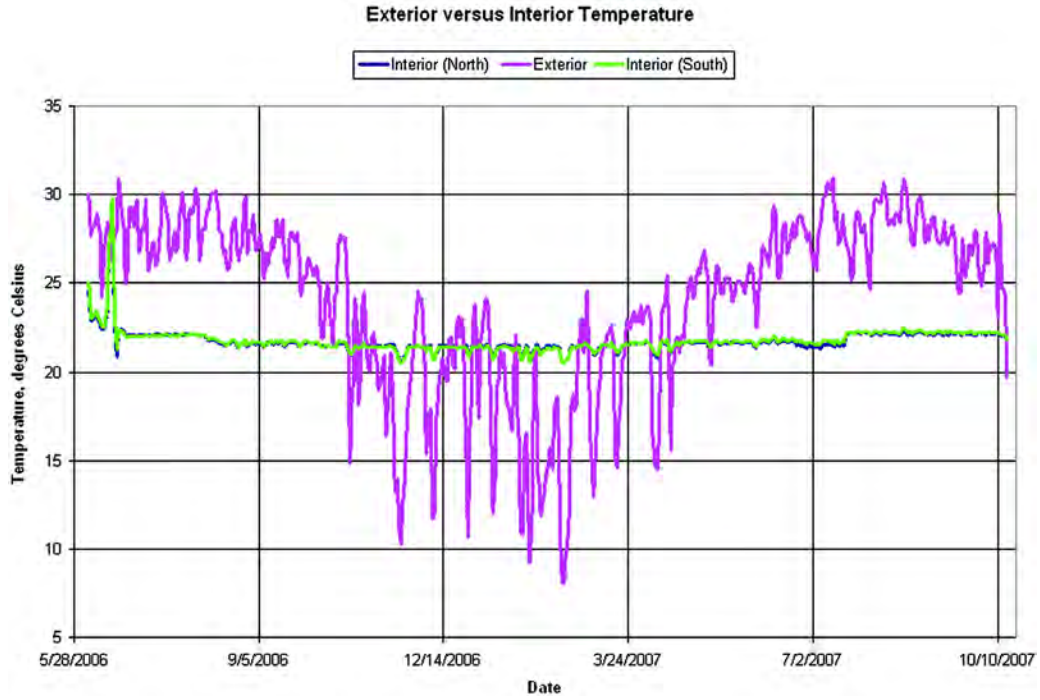
Figure 7 Measured exterior and interior temperature.

The weather conditions experienced during the 18-month test period were recorded by an on-site weather station. Interior temperature and humidity were controlled, with targets of 22°C and 60% RH. The interior temperature conditions were monitored at both the north and south ends of the chamber. The sensors were located approximately 10 ft from the north and south walls of the container. Monitored temperature and humidity results are summarized in Table 5. After an initial break-in period (when the equipment was equilibrating), the temperature remained basically constant throughout the test 18-month test period. The north and south temperature sensor measurements tracked each other almost exactly. The interior humidity was less controlled than the interior temperature. After the initial settling in period, the humidity was more controlled but drifted down. In the last portion of the test period, the humidity exhibited a short uncontrolled period followed by a drop to 50% RH as measured by the south sensor. The north sensor during this period exhibited instability, which may indicate sensor failure. This unstable period caused an increase in the overall measurement standard deviation, as seen in Table 5. Exterior and interior temperatures are shown in Figure 7. Exterior and interior humidity is shown in Figure 8.

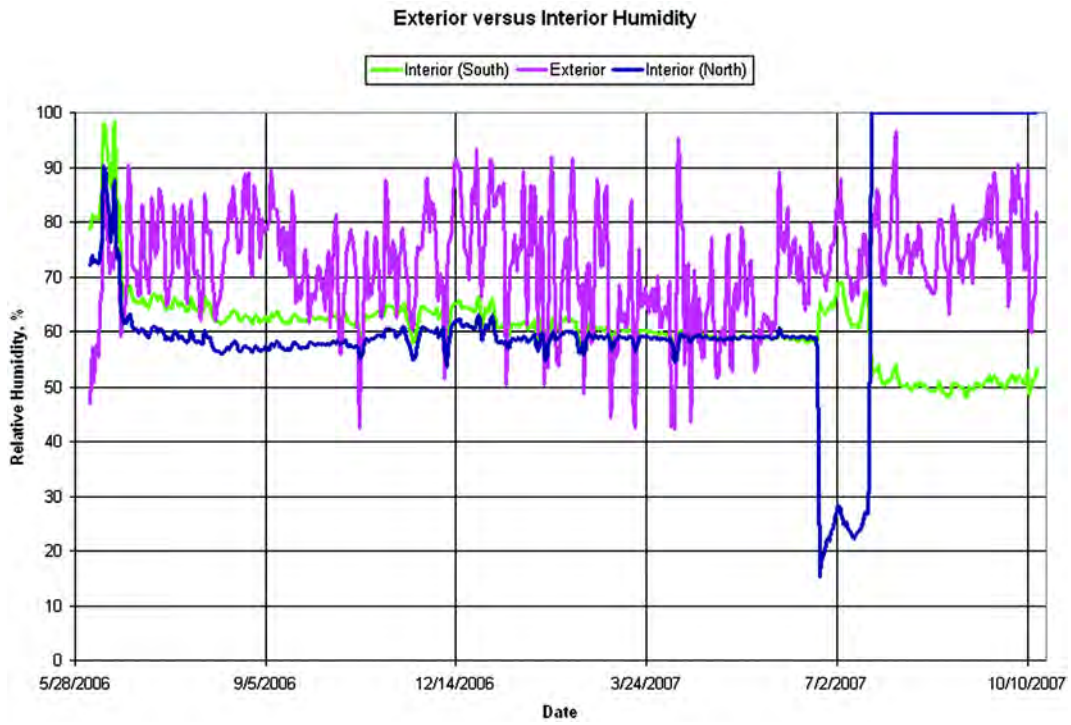
Figure 8 Measured exterior and interior humidity.

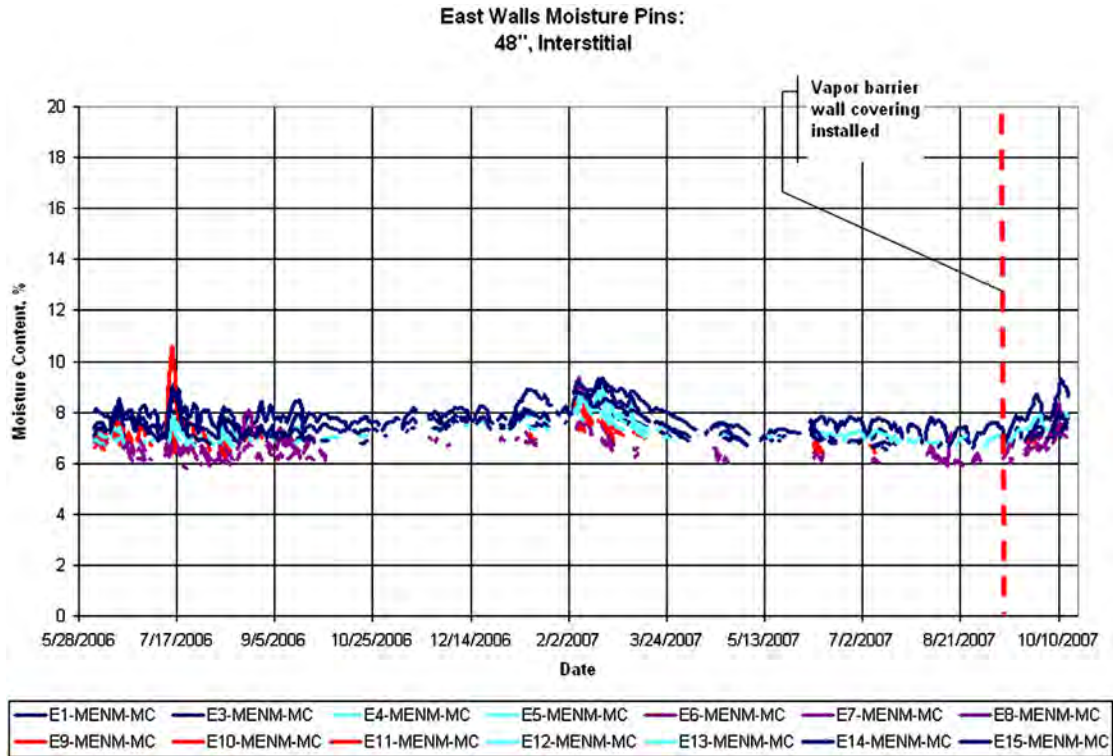
*Figure 9 OSB moisture content at 48 in.: east walls.*

*Figure 10 OSB moisture content at 48 in.: west walls.*

Figures 9 and 10 show the moisture content of the OSB (interior face) at 48 in. (above the water injection site) for all the walls. All the east- and west-facing walls show the same general behavior at this OSB site. The OSB moisture content stays below 10% with few exceptions during the experimental period. Several of the walls experienced periods in which the moisture content was below the sensor detection limits, and the walls have no reading for those periods. Slightly higher moisture contents appear initially and during the cooler winter months. In general, there does not appear to be a response to the water injected using the water injection system located below this area on the wall. The walls show an increase in moisture content at the end of the experimental period after the internal surface of the walls were covered with vapor barrier film.

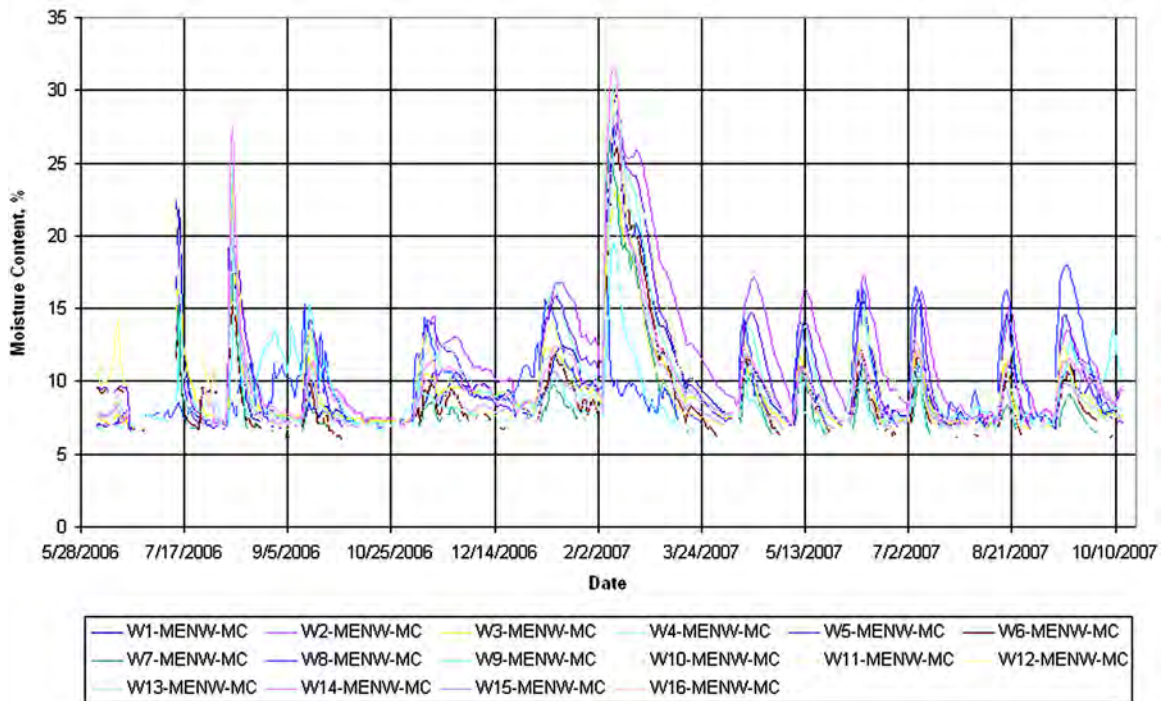
*Figure 11 OSB moisture content behind water injection system: east walls.*

*Figure 12 OSB moisture content behind water injection system: west walls.*

Figures 11 and 12 show the moisture content in the OSB behind the water injection system. Water injection peaks are

clearly visible. When water was injected in the interior or in both the interior and exterior, the peaks are substantially higher and sharper than when the injection was in the exterior side only. The OSB moisture content appeared to return to the baseline level between water injection events.

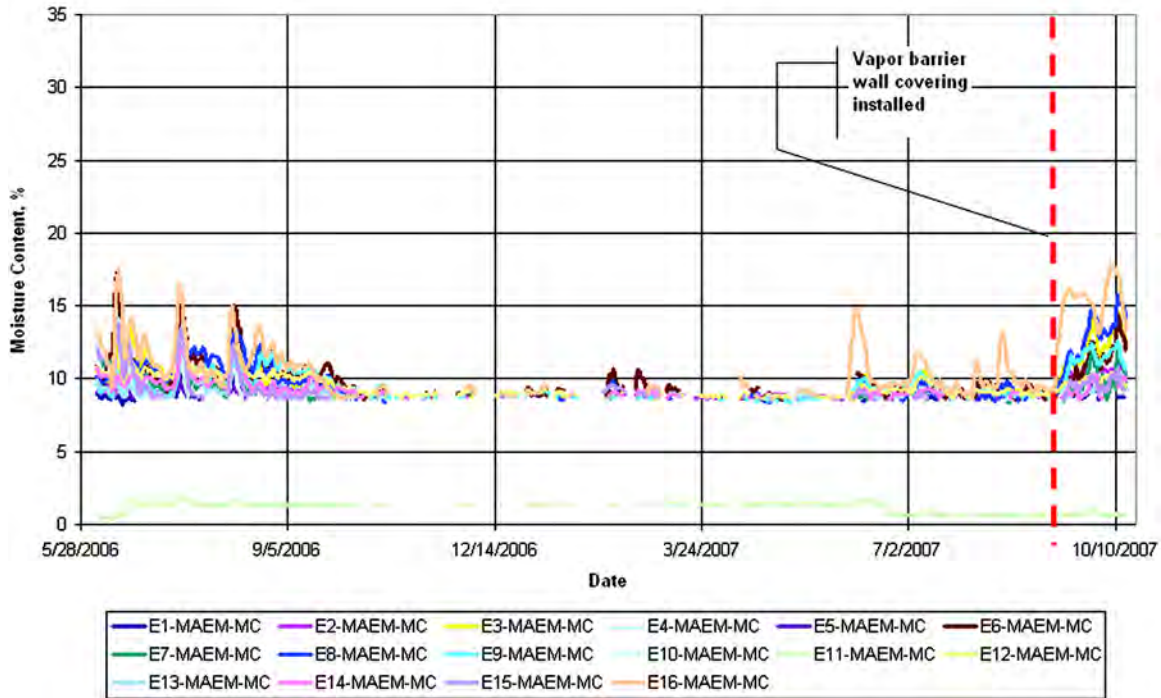
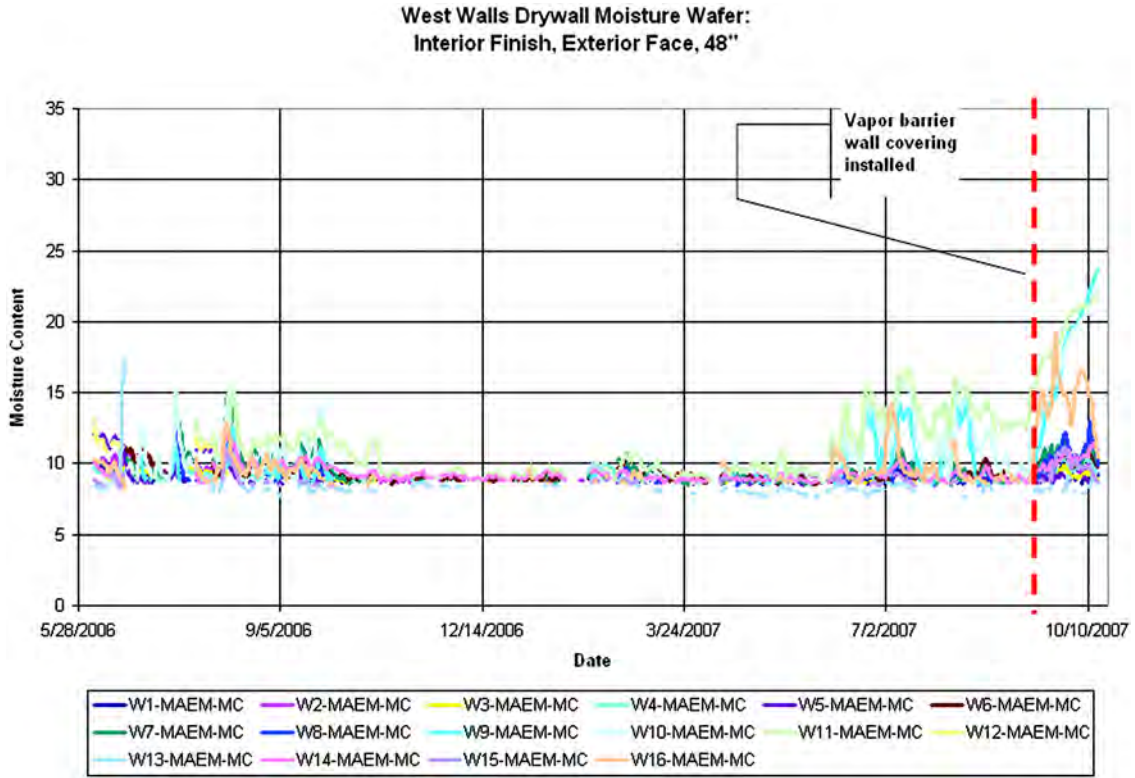
**Figure 13** Moisture content of gypsum wallboard wafer: east walls.

Figure 14 Moisture content of gypsum wallboard wafer: west walls.

Figures 13 and 14 show the moisture content of this wafer. The sensor in wall E11 failed. Although the moisture contents remain at modest levels throughout the experimental period, higher contents are seen in the warmer summer months, indicating moisture drive to the interior of the assembly. Water injection events are reflected in moisture content peaks, which return to the baseline level. This indicates drying to the inside is occurring, and the moisture appears to be handled well by all of the walls until the vapor barrier wall covering was installed. Once the vapor barrier interior covering was installed and water was injected through the system, the moisture content continued to increase. The experiment was terminated before the wallboard completely dried out. Wafer moisture content of all walls were in the same general level, except for the west-facing brick veneer walls (W9, W10, W11), which exhibited higher moisture content.

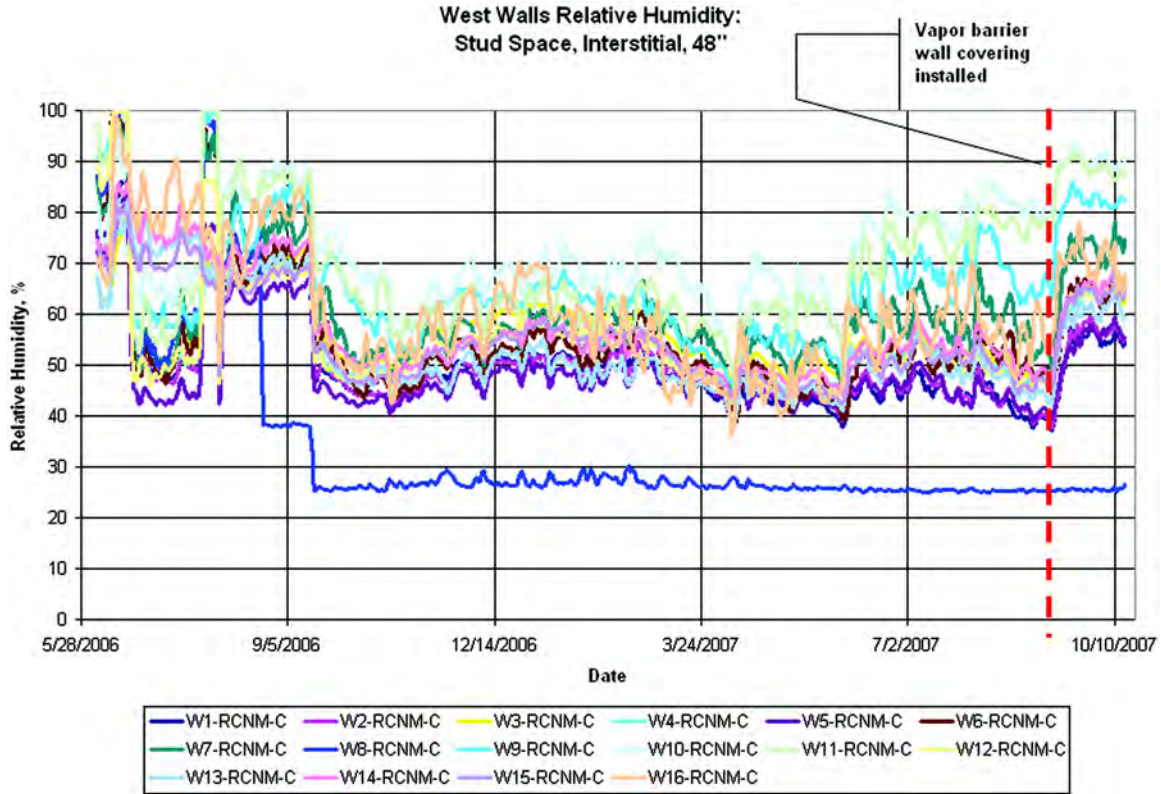
Figure 15 Relative humidity: east walls.

Figure 16 Relative humidity: west walls.

Figures 15 and 16 show the relative humidity of the insulation cavity. As previously discussed, the measurements should not be considered quantitatively, due to their calibration issues and drift of the sensors. Qualitatively, all the walls except for the west brick walls seemed to behave the same

way, showing a fairly constant RH. RH in the cavity increased after the installation of the vapor barrier covering on the interior walls.

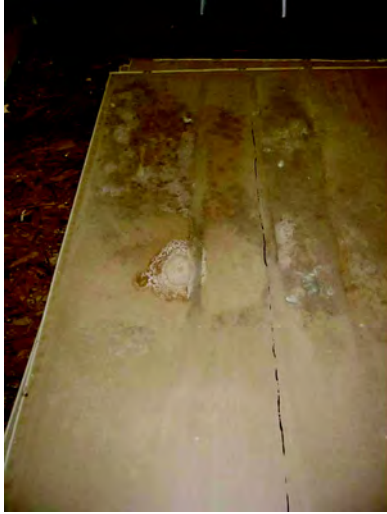
**Figure 17** *Mold on brick west wall gypsum wallboard.*

At the end of the experimental period, the walls were disassembled and examined for moisture and/or mold. The only significant moisture damage was seen in the west-facing brick walls (Figure 17). It was discovered that these had a leak at the top of the wall–roof interface and had seen a much higher moisture load throughout the experimental period. Indications of moisture was observed at the sill plates of several walls, and appeared to be associated with water runoff variations from the water injection devices (Figure 18). The water injection apparatus had worked well throughout the test period, but a few of the wall sections developed plugged tubes, and some degradation of the shop-towel distribution medium was seen (Figure 19).

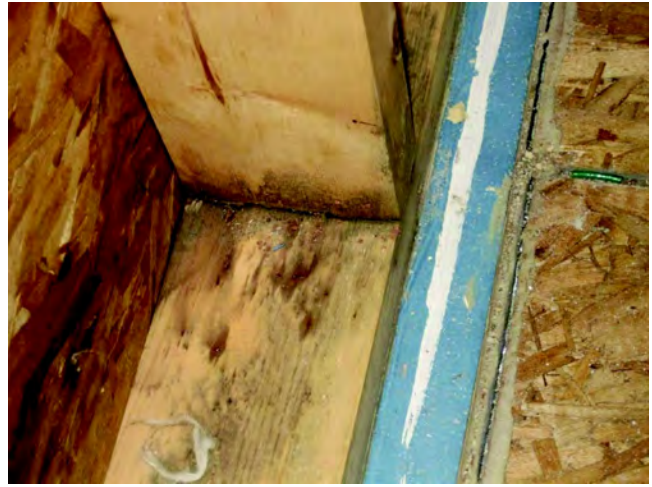
**Figure 18** *Moisture on bottom plate.*

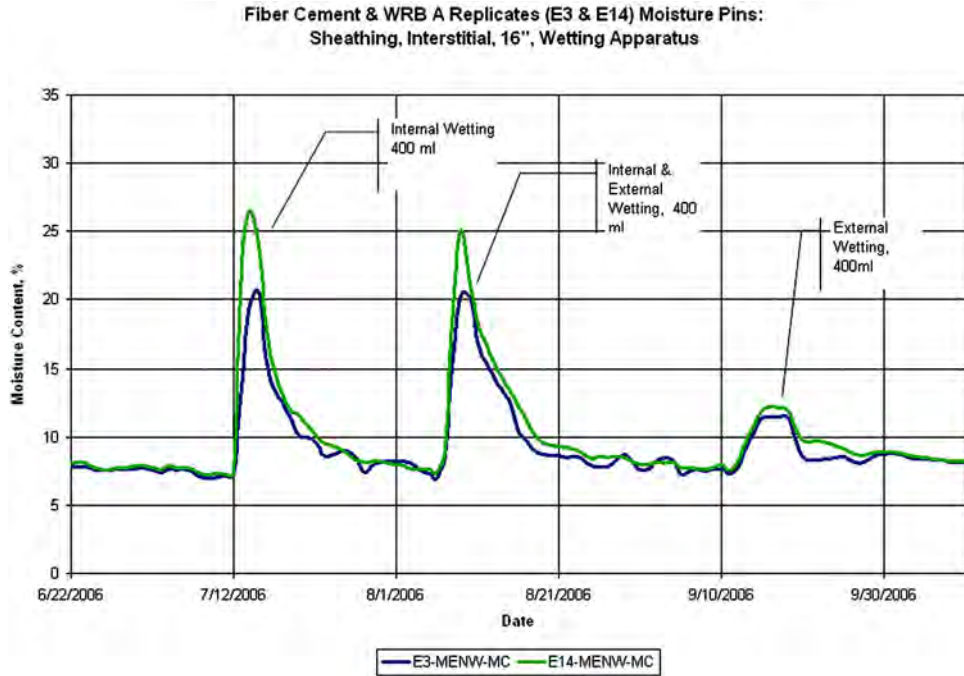
**Figure 20** Moisture content at water injection system; July, August, and September 2006 wetting events: fiber-cement siding and WRB A.

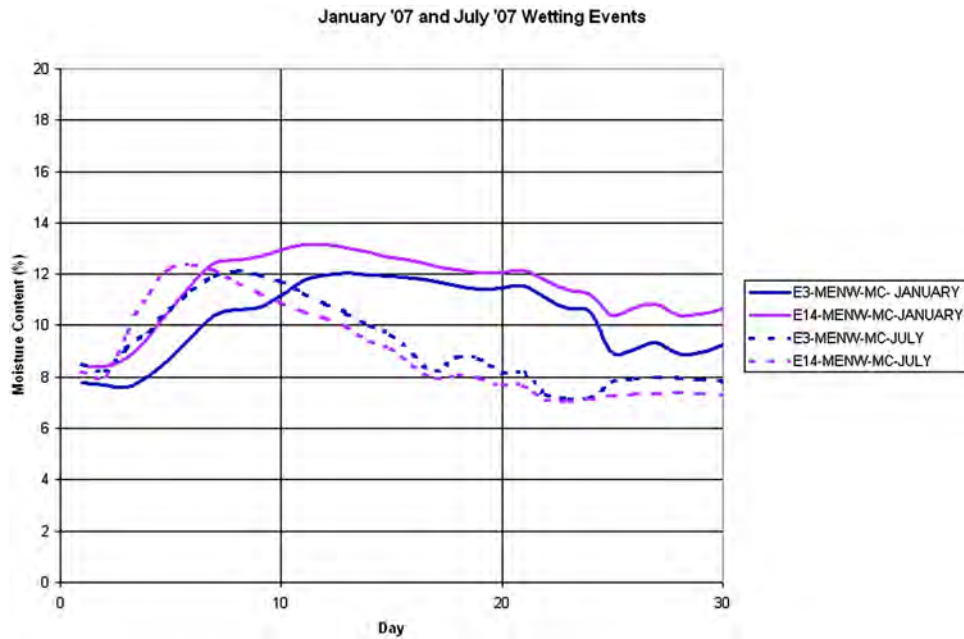
**Figure 21** Moisture content at water injection system; January and July wetting events: fiber-cement siding and WRB A.

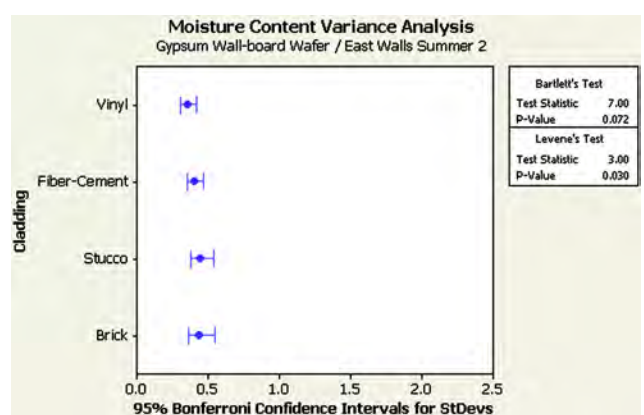
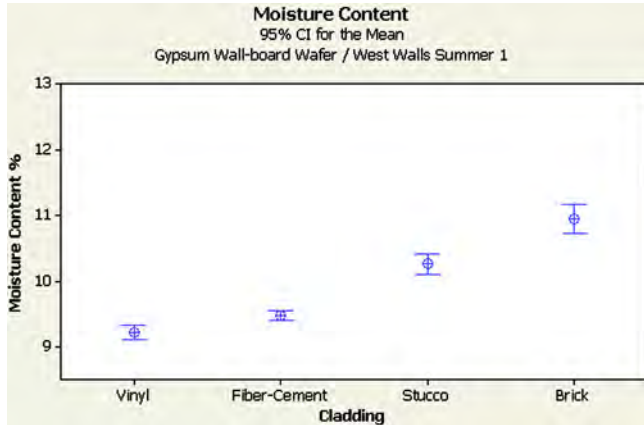
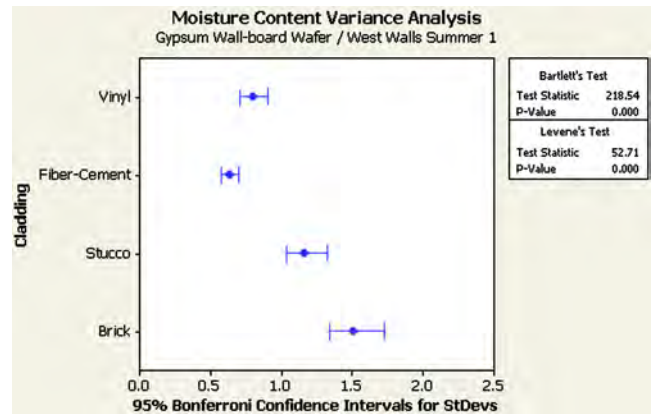
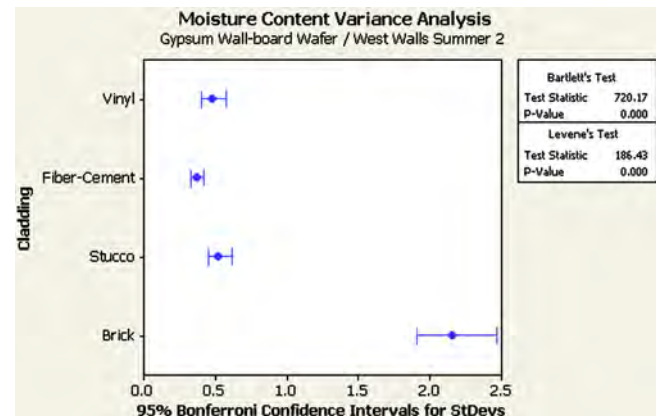
**Figure 22** Gypsum wallboard wafer moisture content: east exposure, summer season 1.

**Figure 23** Gypsum wallboard wafer moisture content variance analysis: east exposure, summer season 1.

**Figure 24** Gypsum wall-board wafer moisture content: east exposure, summer season 2.

**Figure 25** Gypsum wallboard wafer moisture content variance analysis: east exposure, summer season 2.

Figure 26 Gypsum wallboard wafer moisture content: west exposure, summer season 1.

Figure 27 Gypsum wallboard wafer moisture content variance analysis: west exposure, summer season 1.

Figure 28 Gypsum wallboard wafer moisture content: west exposure, summer season 2.

Figure 29 Gypsum wallboard wafer moisture content variance analysis: west exposure, summer season 2.

from construction of the wall assemblies elevating the moisture content during the first summer or because of differences in the water injections during these two periods. The first summer period had 600 mL injected at the internal side and 600 mL injected at the external side of the OSB. The second summer had 1400 mL injected at the external side of the OSB. The difference in the water injection site may have caused a difference in the direction of the drying, internal injections causing more moisture to move to the interior side of the wall and dry through the gypsum wall-board. Means and variances of gypsum board wafer moisture content are compared in Figures 22 to 29.
