## Insight Mold in Alligator Alley

## By Joseph W. Lstiburek, Ph.D., P.Eng., Fellow ASHRAE

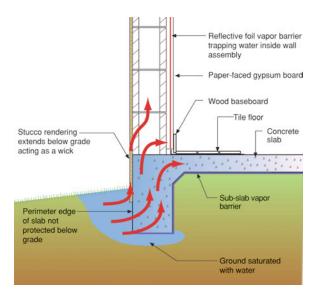
**Figure 1a: Maximizing Damage**—Wicking water inward at perimeter while trapping water in the assembly with an interior reflective insulation foil faced vapor barrier.

It's not like we don't understand the physics of building on wet ground. You build on top of it and you prevent water from wicking into the building by capillarity. But in Florida we seem to go out of our way to do it wrong. We use capillary active materials like concrete and block and stucco and configure them in such a manner as to maximize damage (Figure 1a). We don't wrap a sub-slab vapor barrier capillary break around the perimeter of the foundation and we extend a stucco cladding into the ground in order to suck every last available drop of water in the ground into the structure. But we're not done yet, we line the interior with a reflective insulation foil-faced vapor barrier reinforced with mold food (a.k.a. "kraft paper").<sup>3</sup> There's more. We rain on the sides of the structure (Figure 1b). We apply the stucco directly to concrete block and assume that the stucco (oh, I forgot, also the paint on the stucco) keeps the rain out. We call this "faith-based rain control." The stucco leaks, the paint leaks, the block leaks, and the wall can't dry to the interior because of the reflective insulation foil-faced vapor barrier.

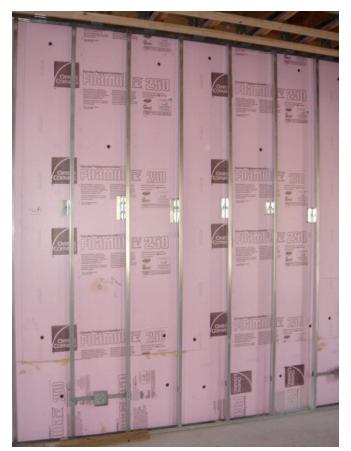
Photograph 3: Vapor Semi-Permeable Rigid Insulation— Note the steel stud interior wall framing is supported by brackets that do not penetrate the foam insulation but are installed over the top of the foam insulation.

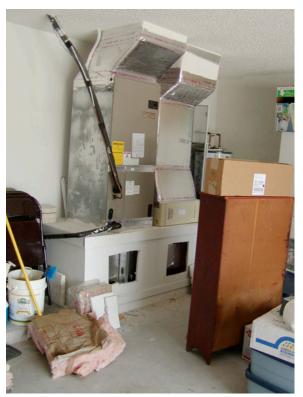
**Photograph 6: Garage Return Platform**—After a vented attic what is the worst possible place to locate an air-handler? Yes, you guessed it, the garage. Florida HVAC at its best.

What other innovative technology is available to hurt us in Florida? My absolute favorite because it is so subtle and nefarious is the return platform in the garage (**Photograph 6**). The return platform encloses the return duct. The return duct within the return platform leaks leading to a negative pressure within the return platform (**Photograph 7** and **Figure 5**). You get to suck air out of the garage and you get to suck air from under the slab the return platform creates an elegant

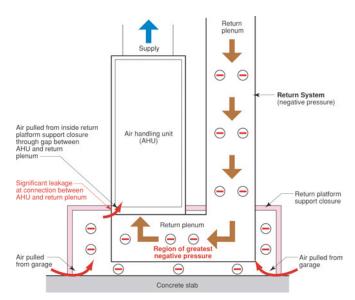
Figure 5: Nefarious Return Platform—The fix for this is to make the return side tight and "bleed" the pressure in the return platform enclosure by installing a "grille" through the enclosure connecting the platform enclosure to the space it is in.
