What's Wrong With This Project?

Supporting Framing Around Windows

Sheet 706

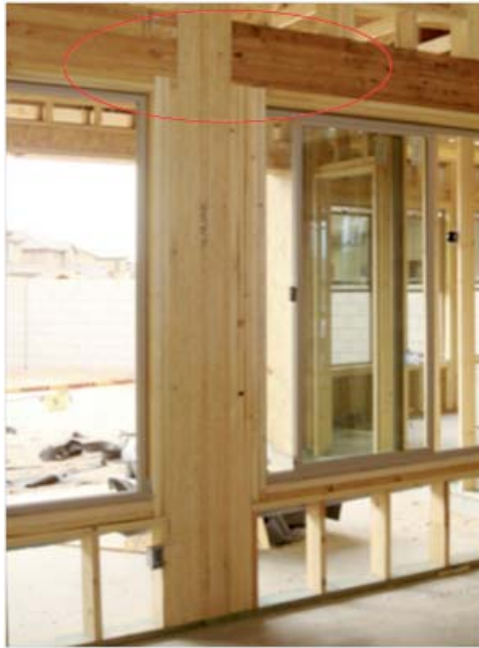
- Supporting framing around windows

Supporting framing around windows.

Framing used to support and distribute the load around the windows.

Incorporating Advanced Framing techniques around the windows would greatly reduce the wood required below the top plate of the upper story, and it's estimated that between \$500 and \$750 in material costs could be saved in this example alone had a single beam been used directly under the roof trusses.

The amount of wood could be reduced using the same wall design, but even more significant savings could be had if the wall was redesigned with a single upper beam that supports the roof above the upper windows shown in the second photograph below left.

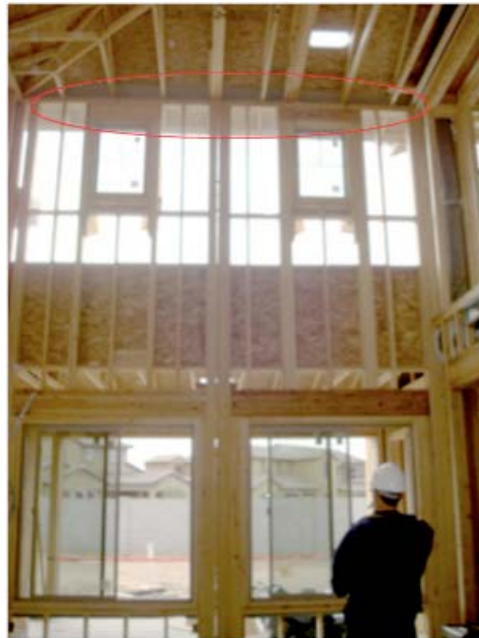
- Additional savings could be realized by redesigning the wall with a single upper beam supporting the roof above the upper windows
