Building Science Digest 135

Ice Dams

2006-10-30 by John Straube

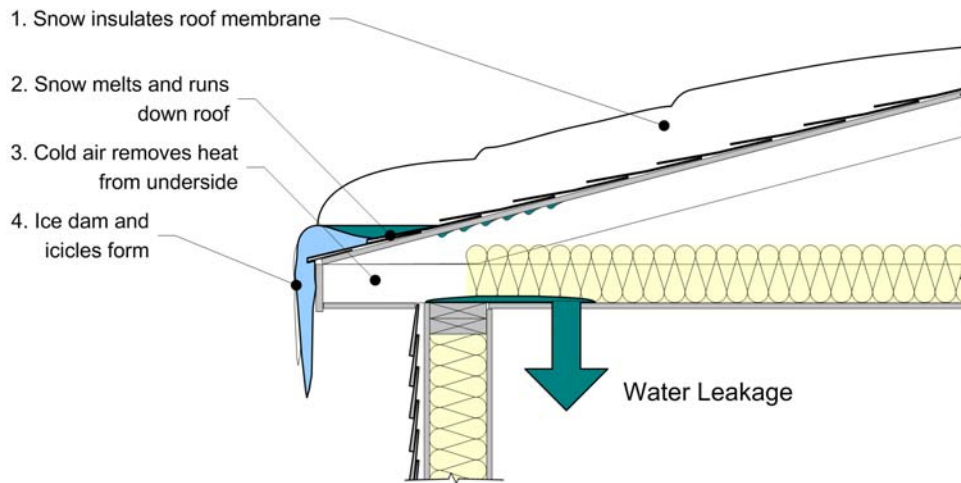
Figure 1: Ice Dam at a Typical Roof

Simply put, ice dams are ridges of ice and icicles caused by meltwater from further up the roof re-freezing lower on the roof. The “dam” created by the ridge of ice along the eaves can trap further meltwater and result in significant leakage under and through the roofing, especially shingles and metal roofing. This leakage can cause damage to the sheathing, the roof structure, or the ceiling and walls below. Large icicles along the eaves can become a danger to people below if they fall.

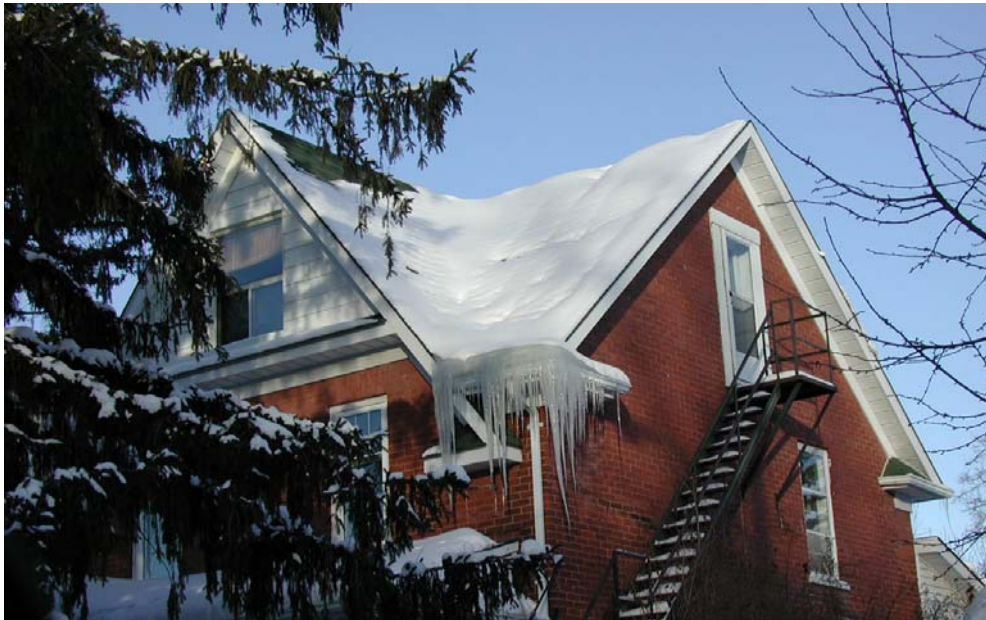
Photograph 1: An ice dam - note the snow melting on the slope above the ice dam.

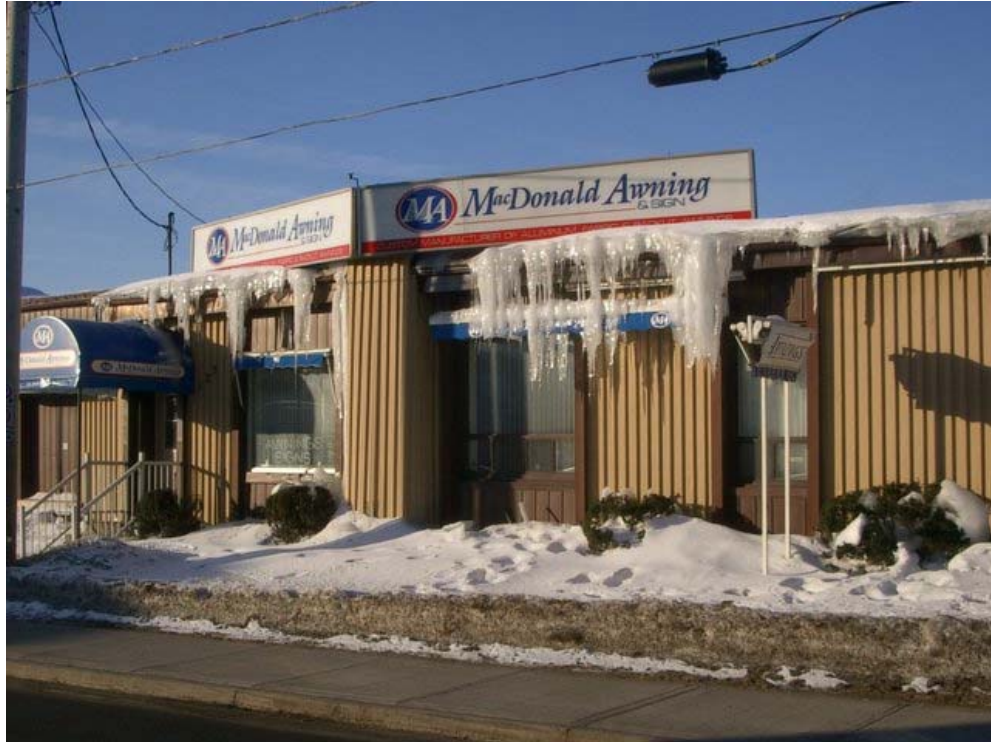
Photograph 2: Not just a problem for sloped roofs

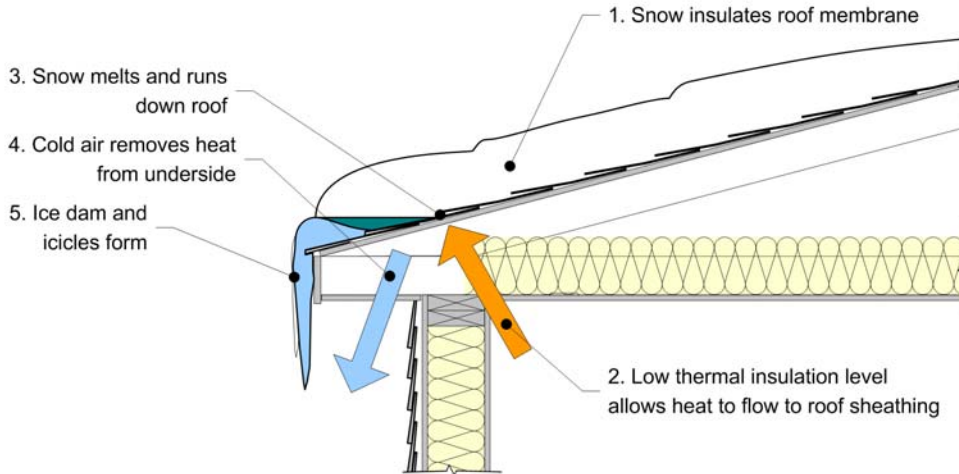
Figure 2: The Process of Ice Dam Formation Caused by Poor Insulation

If there is insufficient insulation between heated space and the roof sheathing, significant amounts of heat can flow to the underside of the sheathing. Snow also insulates the roof membrane, increasing its temperature. This scenario will raise the temperature of the roof-snow interface above the melting point even at cold outdoor temperatures. The result is many hours of snow melting with sufficiently low temperatures to ensure rapid freezing (Fig 2).

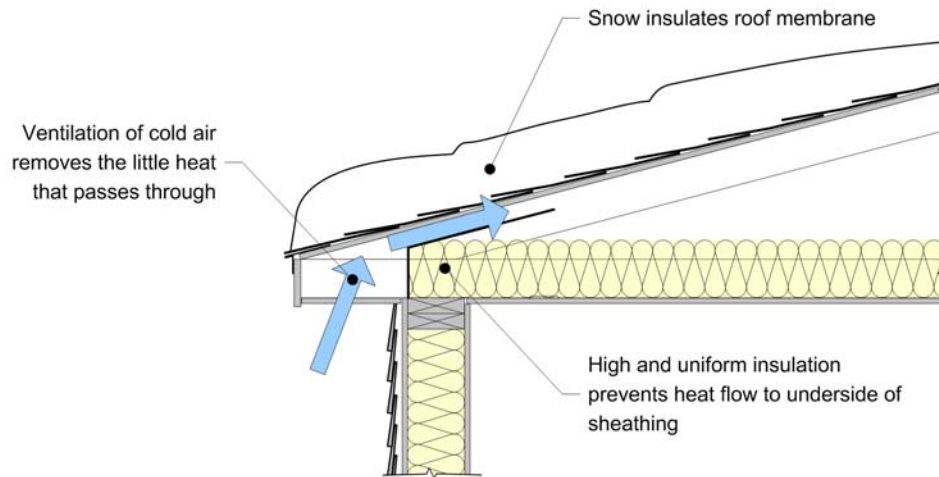
Figure 3: Solutions to Poor Insulation

Another way to keep the sheathing cold is to ventilate with outdoor air (Fig 3). Although ventilation will remove some of the heat that passes through the ceiling, very low levels of insulation and thermal bridging cannot practically be offset by ventilation. Ventilation is best used as a supplement to good insulation as ventilation can be used to remove the little heat that flows through a well insulated roof.

Better framing practises and high-heel trusses can be used to reduce the likelihood of local areas of poor thermal performance. Alternatively, in cathedral ceilings for example, adding exterior rigid insulation to the framing members (but below any ventilation) can be used to blunt thermal bridges and increase the total thermal insulation level. For example, 2x8 rafters filled with cellulose insulation (>R30) plus 50 mm (2") of extruded polystyrene insulation in an unvented cathedral ceiling will meet the R40 minimum recommendation and avoid thermal bridges at the rafters.

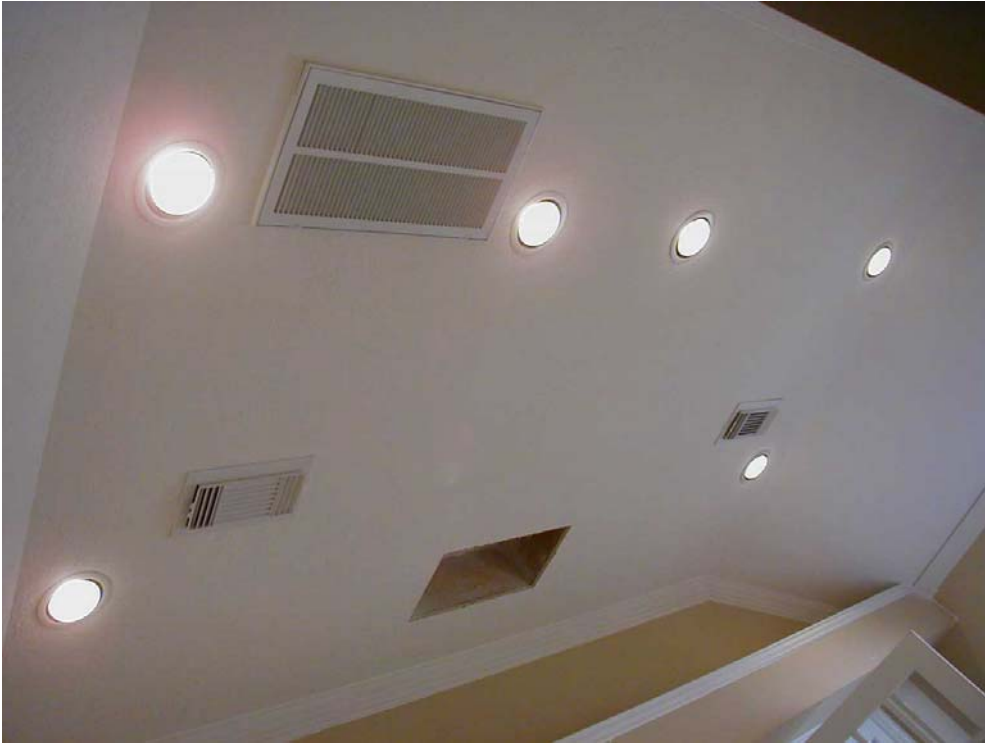
Photograph 3: Ceiling penetrations in a cathedral ceiling

Plumbing stacks, recessed lights, chimneys, electrical service penetrations in partition walls, and attic hatches all can on their own, or in combination, allow sufficient air leakage into the ceiling space (cathedral or attic) to cause serious condensation and ice damming problems (Photograph 2 below).

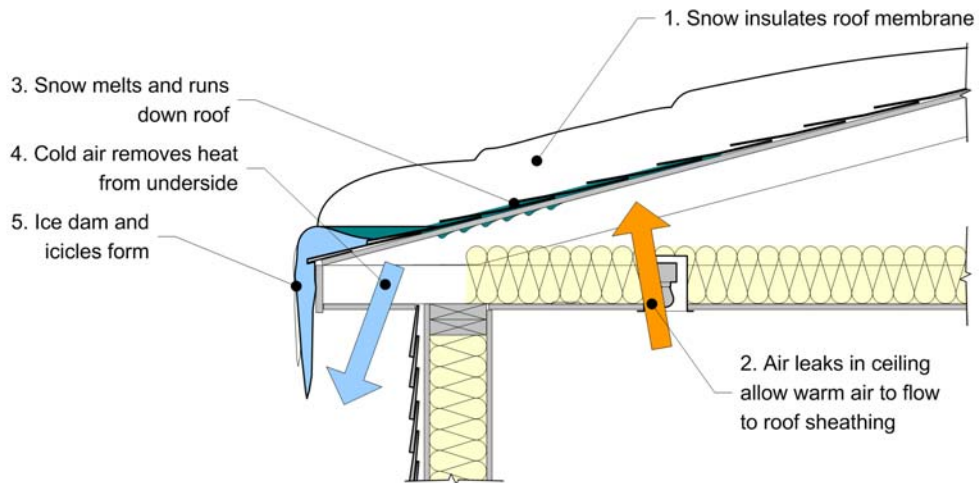
Figure 4: Ice Dam Formation Process Caused By Air Leakage

Not only does air leakage into the roof cause warming and melting of snow, in colder weather it often causes condensation on the underside of the roof sheathing. The two processes combined can cause serious wetting and decay of the sheathing and roof structure as well as leakage into the space below (Fig 4).

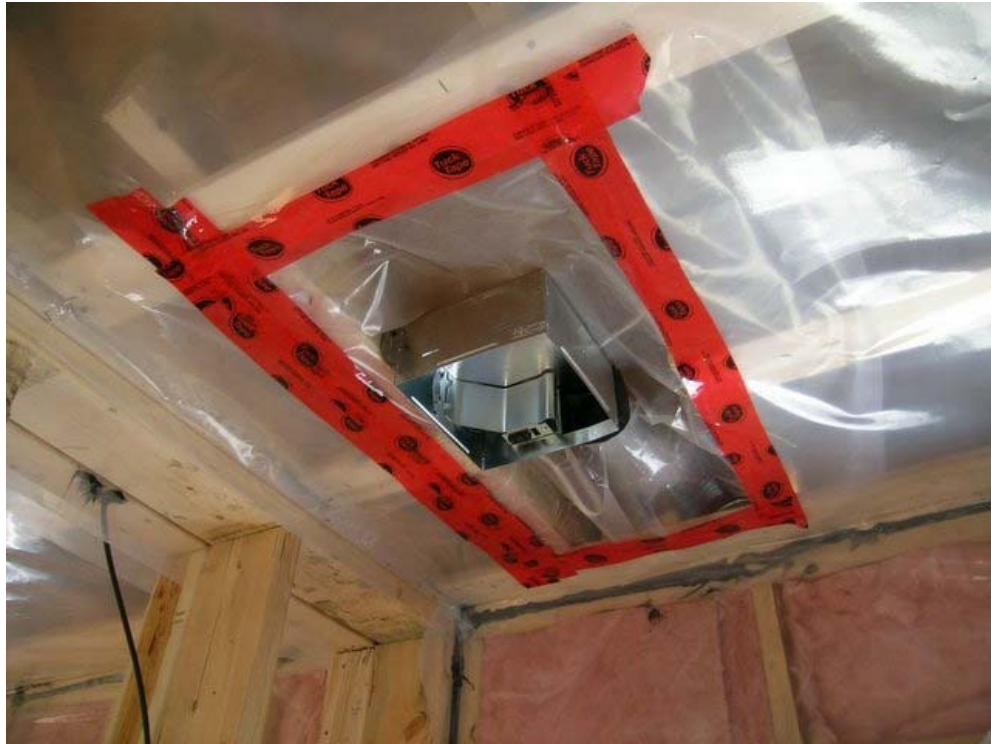
Photograph 4: Polyethylene sheet sealed as air barrier around bathroom fan housing

Although the solution is rather simple to state, it is quite difficult to achieve in practise. Great care must be taken to seal the ceiling air barrier (often the polyethylene vapor barrier is used as an air barrier or the drywall – see Photograph 3 below). Table 1 provides a list of air leakage locations and means to ensure they are sealed.

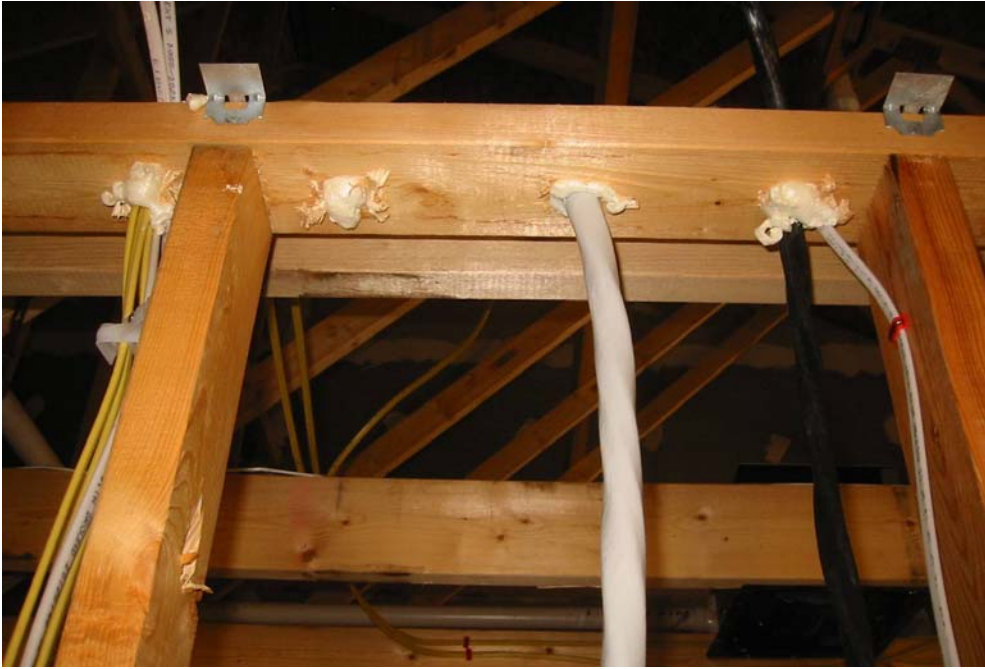
Photograph 5: Air-sealing with expanding polyurethane foam – much easier to do before the interior finishes are installed.

Caulking can be used around small openings and gaps, but expanding polyurethane or acrylic foam should be used around openings more than about 1” (see Photograph 4 below). For large openings, drywall can be used as the air barrier with taped or caulked joints used to complete the seal. Great care and attention to detail is essentially the only solution to air leakage, although expensive answers such as spraying the entire ceiling with expanding foam (NOT dense-pack cellulose, or blown in batts) can provide the required airtightness quite easily.

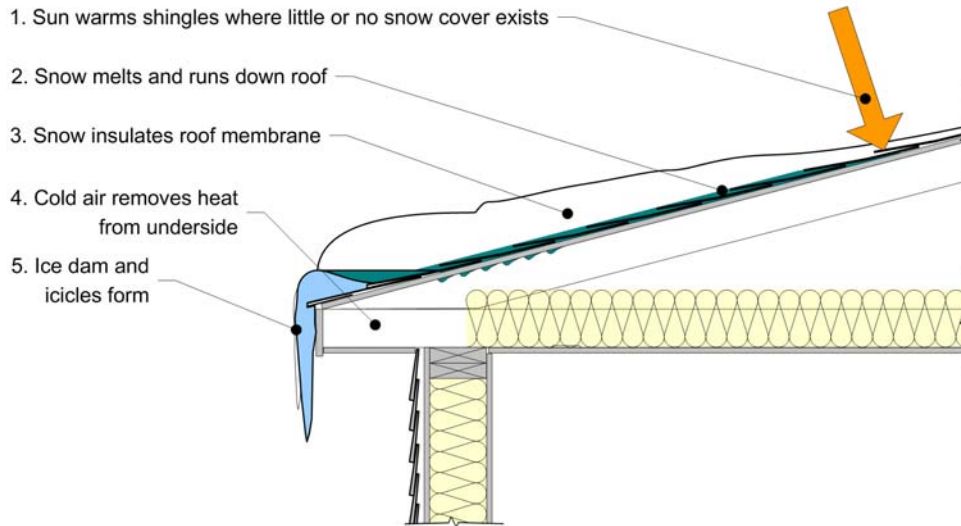
Figure 5: Ice Dam Formation Process Due to Uneven Snow Thickness

Wind speeds are often higher near ridge lines and scour snow from the roof. Snow catchers at the base of metal roofs hold back sliding snow near the eaves. Exposed shingles or metal can easily be heated to 70 F (40 C) above ambient air temperature and cause melting of the snow immediately next to the exposed roofing. Water will run down the roof and can freeze at the eave, which is cooled from the underside (Fig 5). If the temperature is cold enough and the snowcover thin enough the meltwater

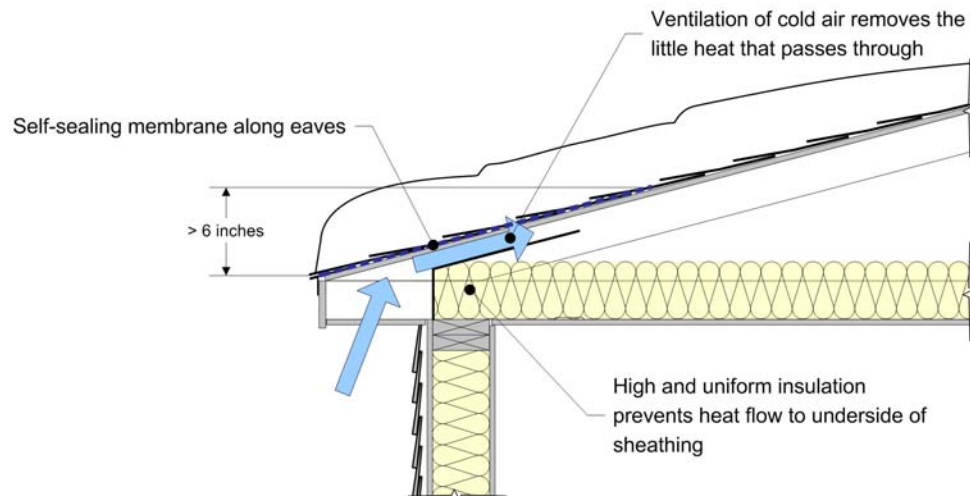
Figure 6: Waterproof "eaves-starter" or "peel and stick"

Even if all good design practices are followed this process can still occur. For this reason it is recommended that a waterproof membrane (preferably self-sealing to accommodate roofing nails) be provided. This membrane should come up the roof high enough to resist a 6 to 8" height of water above the edge of the wall insulation below (Fig 6). Hence, steep pitched roofs will require narrower strips of this membrane than shallow roofs.

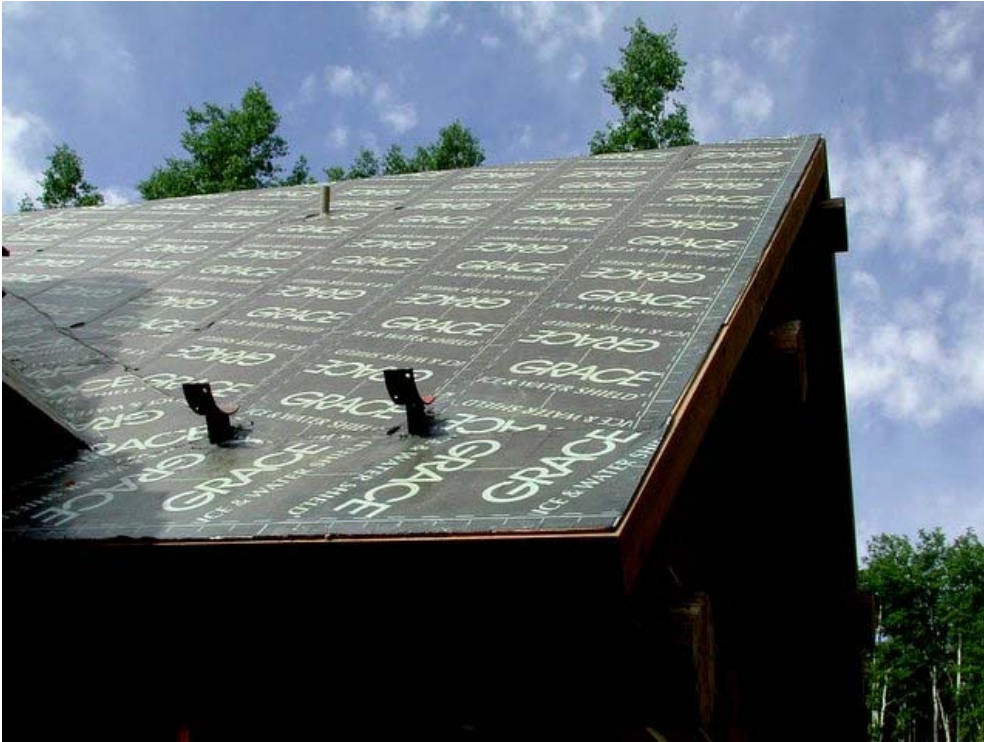
Photograph 6: Self-adhering membrane over the entire roof surface – an appropriate solution in some climates
