OLD MEETS NEW

Westford Symposium on Building Science

July 31, 2017

Presented by: JD Stenner, Superintendent, United Building Envelope Restoration

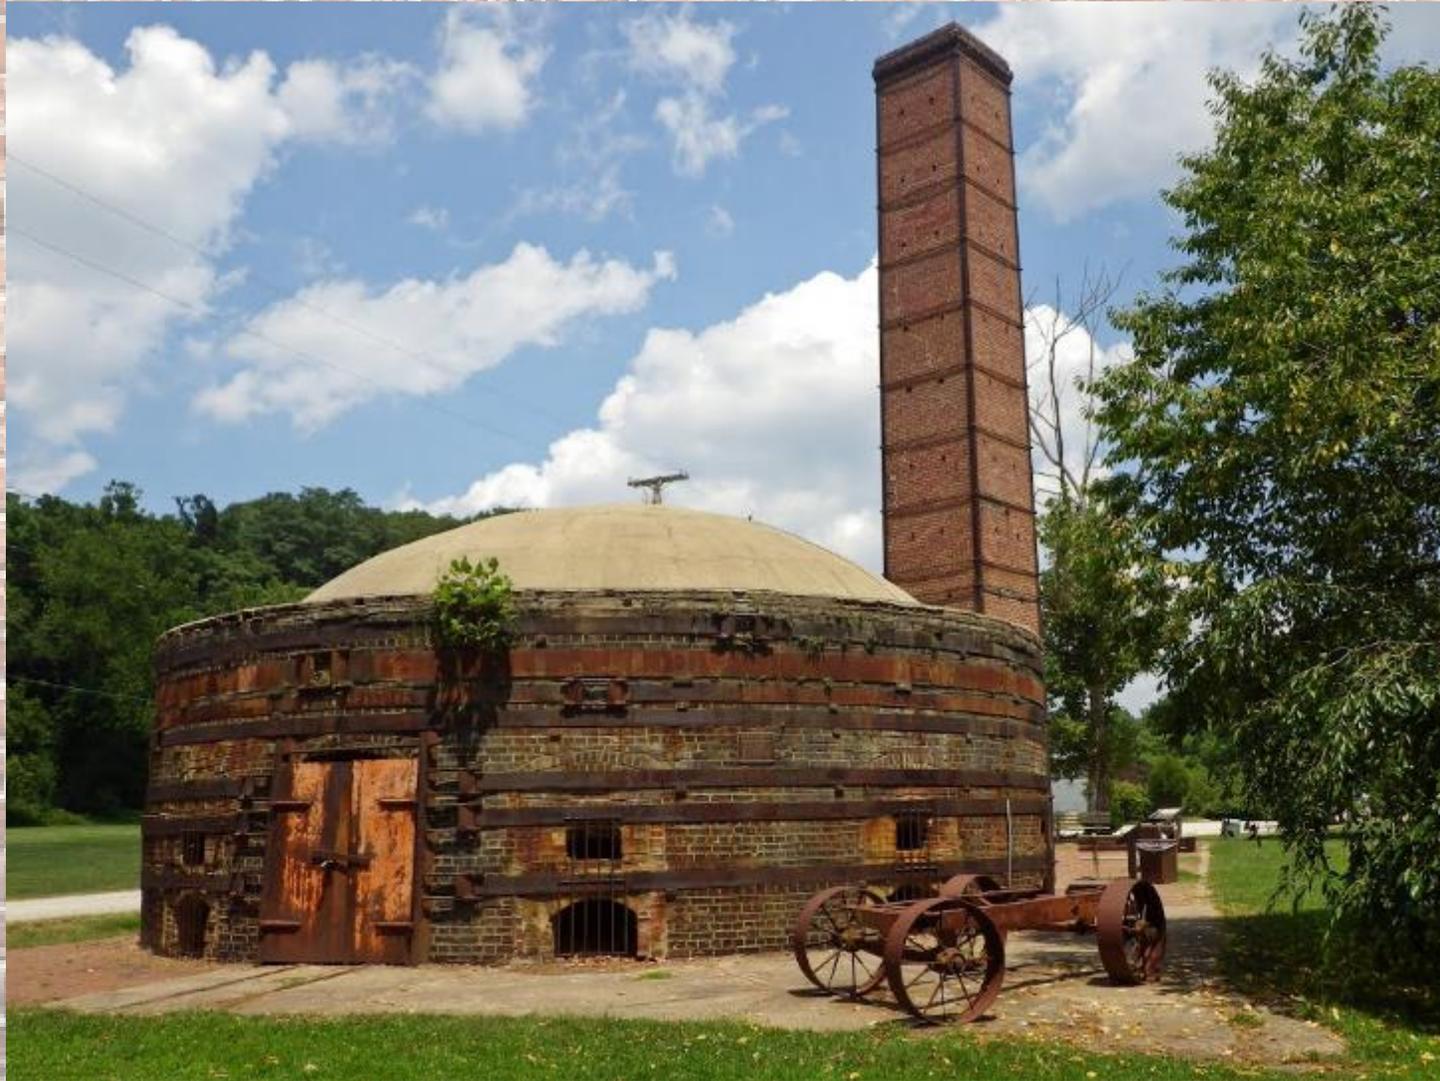
Early 20th century beehive kiln, Occoquan, VA
photo credit <http://www.panoramio.com>

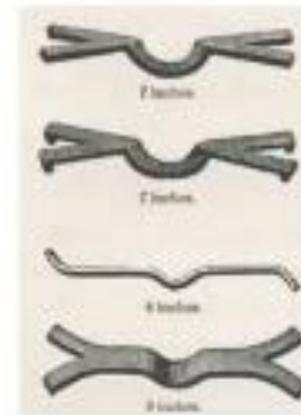
Ties from the late 1890s.
The top two are cast iron,
the bottom two wrought iron

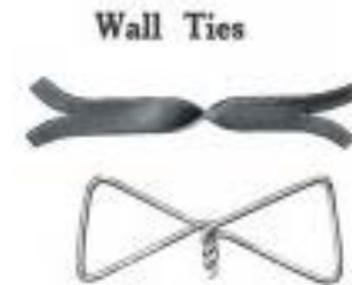
Galvanised steel ties
from the mid 1920s.

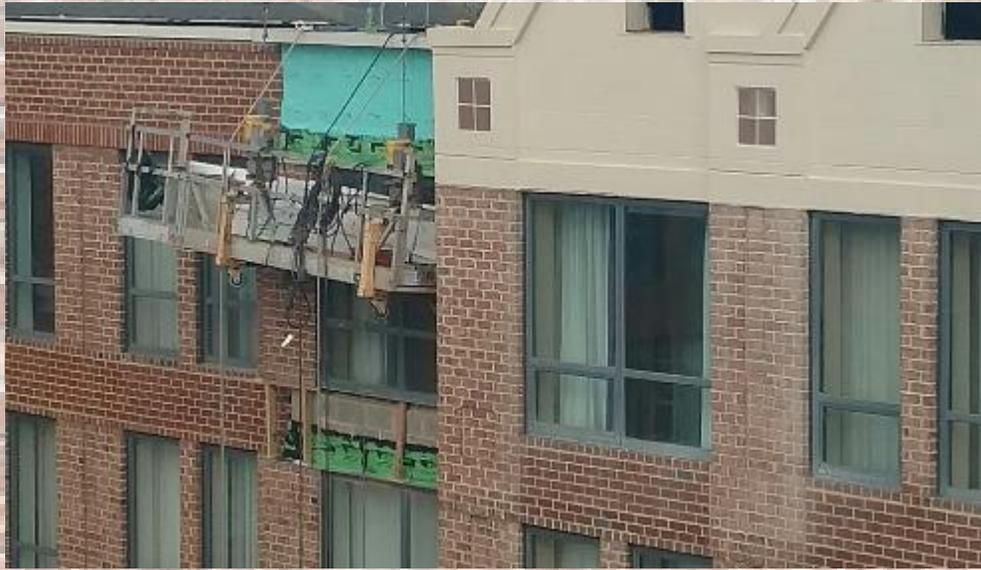
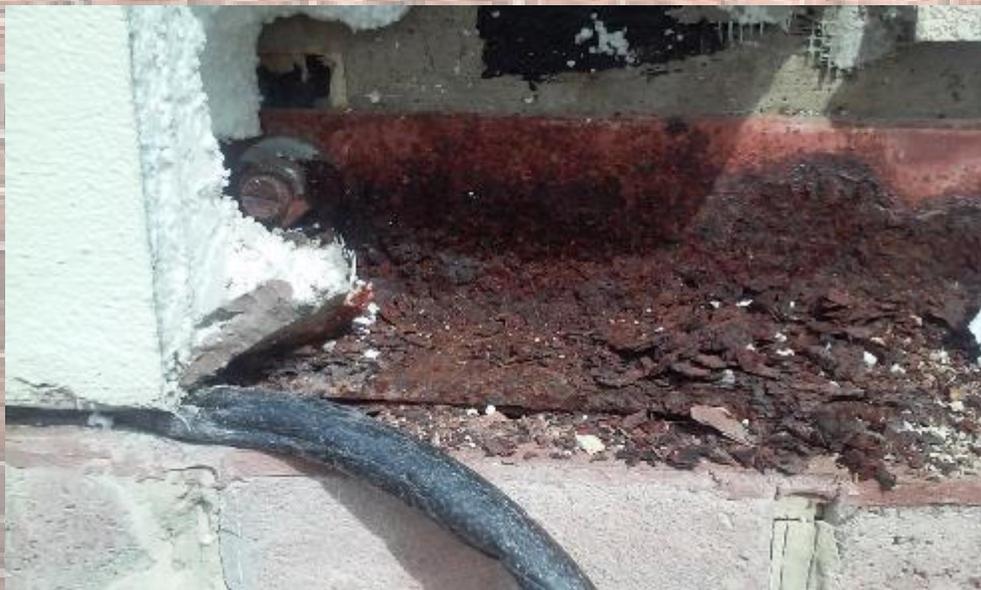
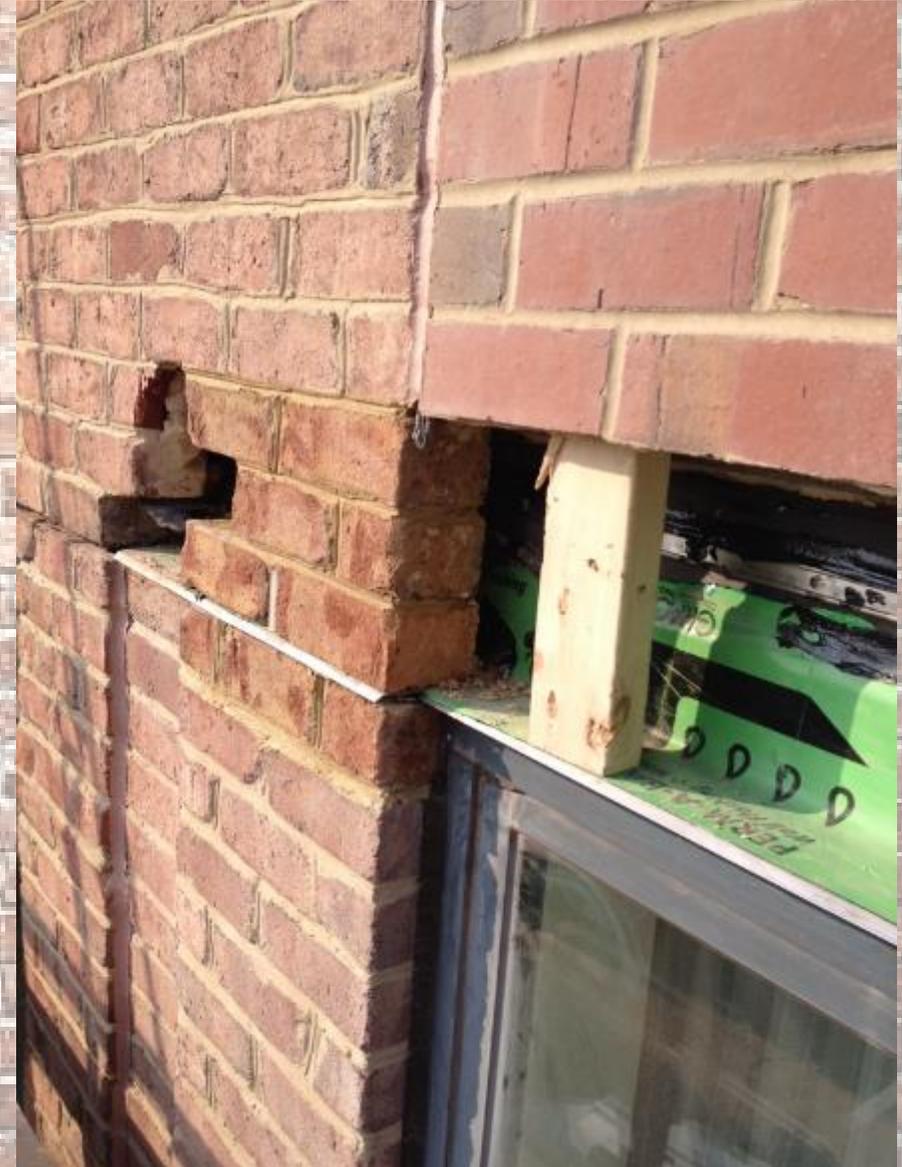
Failures in Modern Masonry Construction

- **Corrosion of veneer ties and other steel elements leads to rust jacking, cracking, water infiltration, and even structural failure of outer wythe of cavity wall**
- **Complex systems with multiple materials with different rates of expansion and contraction**
- **Stone veneers installed as thinly as possible, often leading to warping and failure of the material**
- **Water intrusion at overlapping flashing/sealant interfaces**
- **Polymers and synthetics that do not hold up to UV radiation**
- **Failures of reinforced concrete including corrosion of reinforcement and deterioration due to alkali-aggregate reaction**
- **Failures of modern materials that do not have the durability of traditional masonry materials**

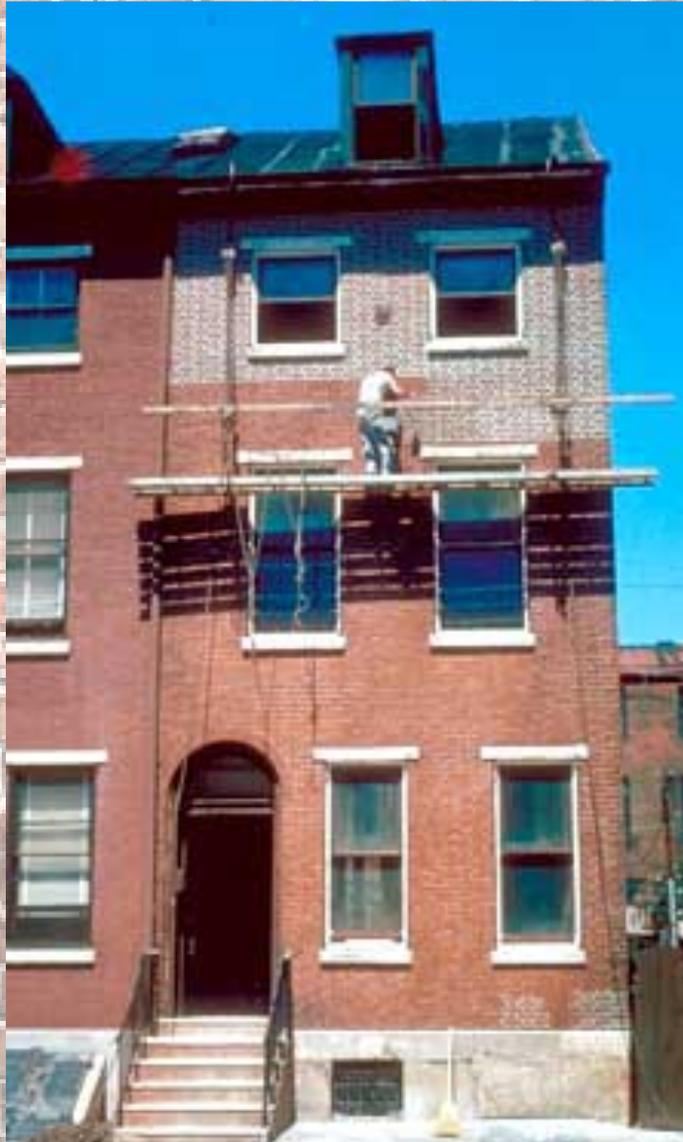
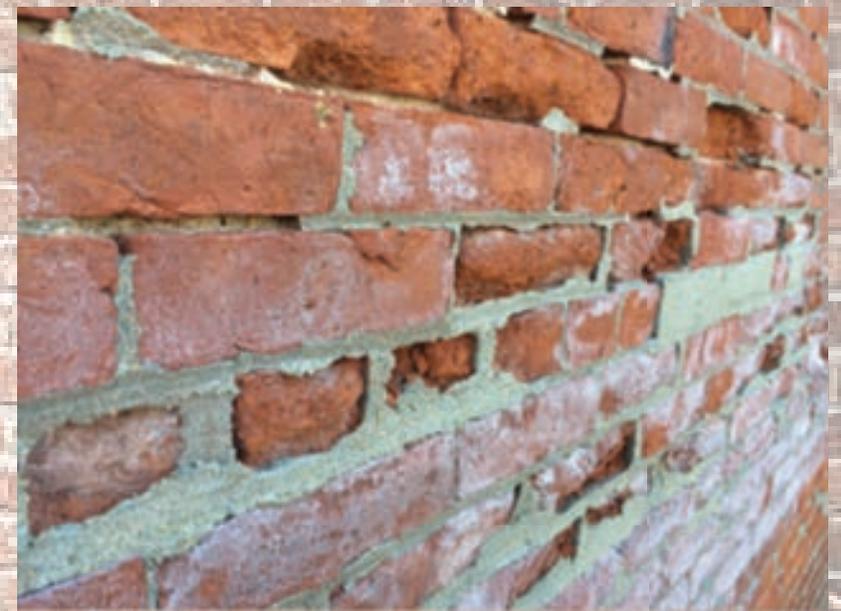
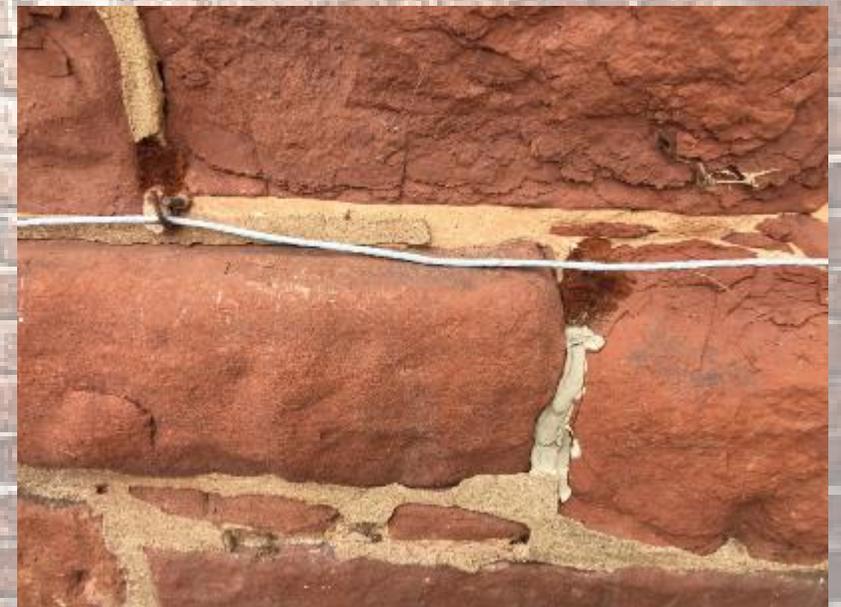
Improper Repointing

- **Improper repointing of historic masonry can cause both visual and physical damage to a building**
 - **Freeze thaw damage**
 - **Efflorescence**
 - **Spalling of masonry units**
 - **Inconsistent appearance**
- **Avoid Portland cement-based mortars**

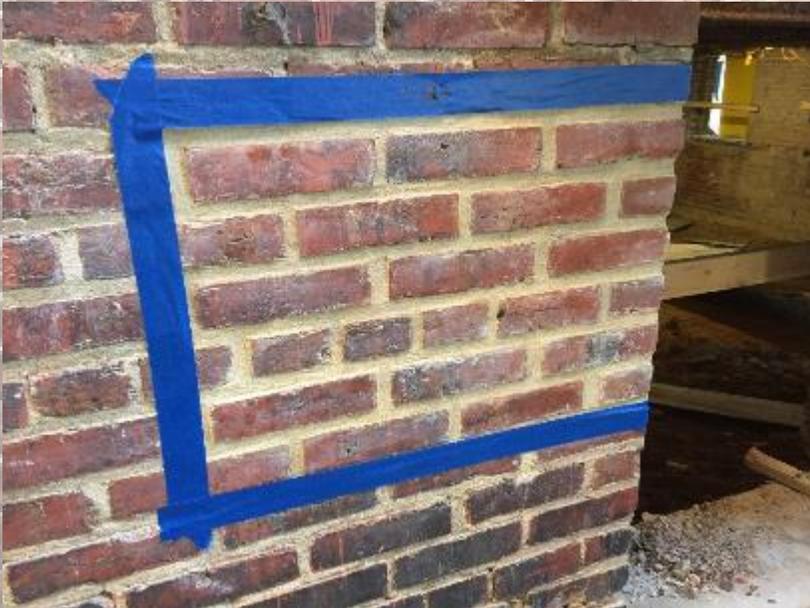
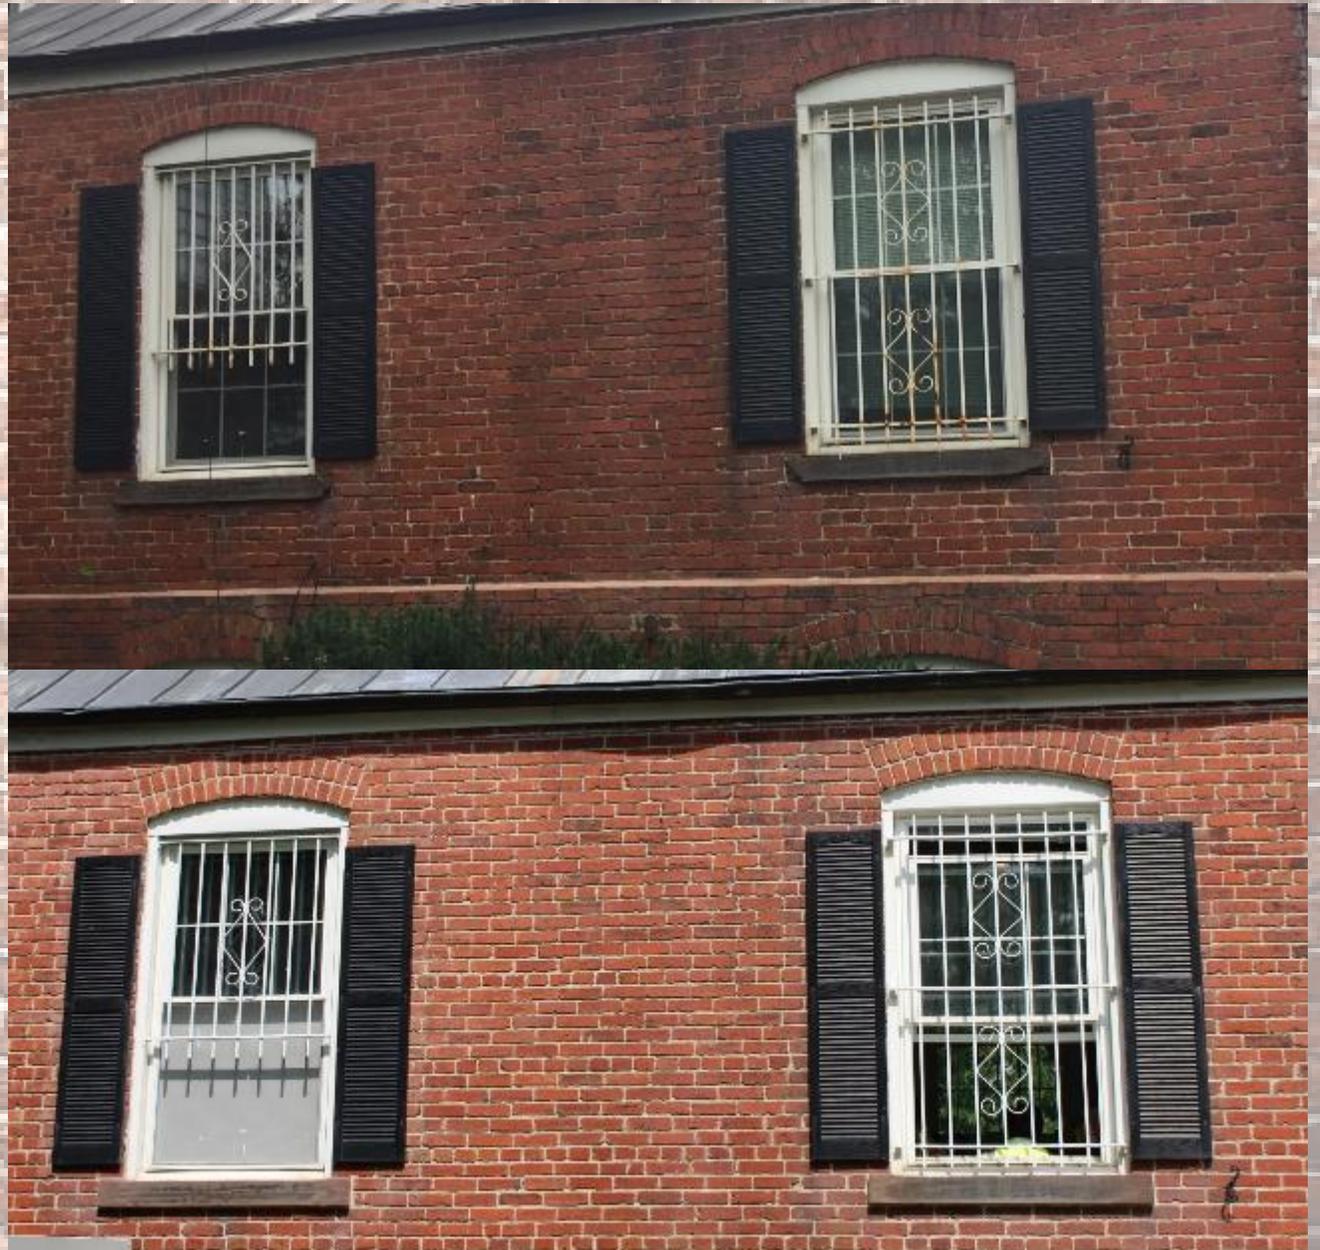
Appropriate Repointing

- Match existing mortar in terms of physical characteristics and appearance
- Perform mortar analysis create samples/mockups
- Tool joints to match historic profile
- Follow proper curing techniques required for lime mortars

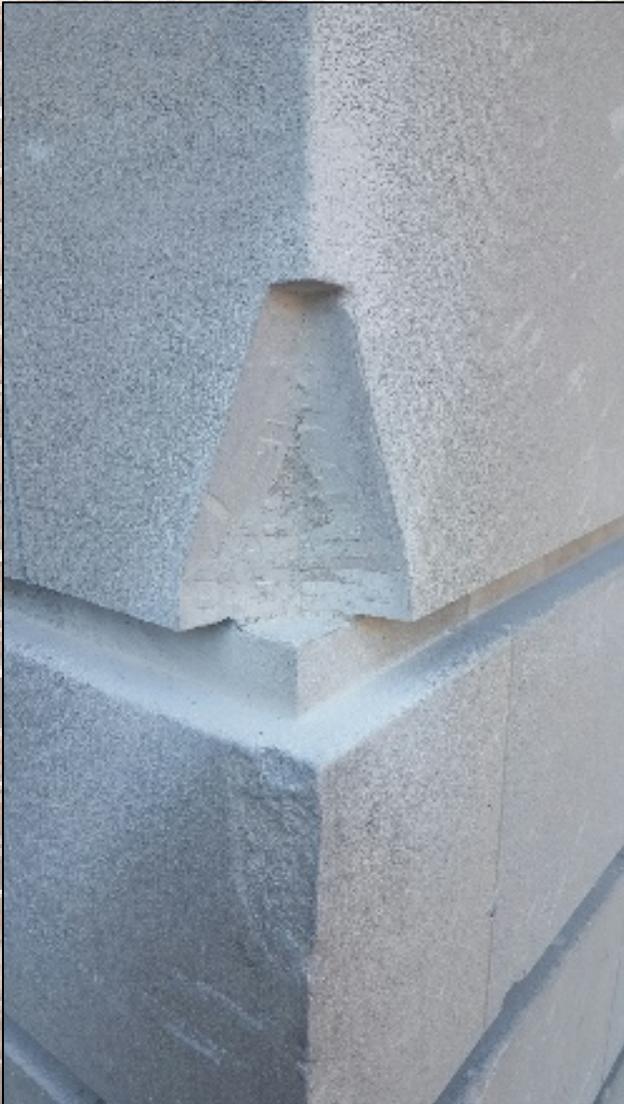
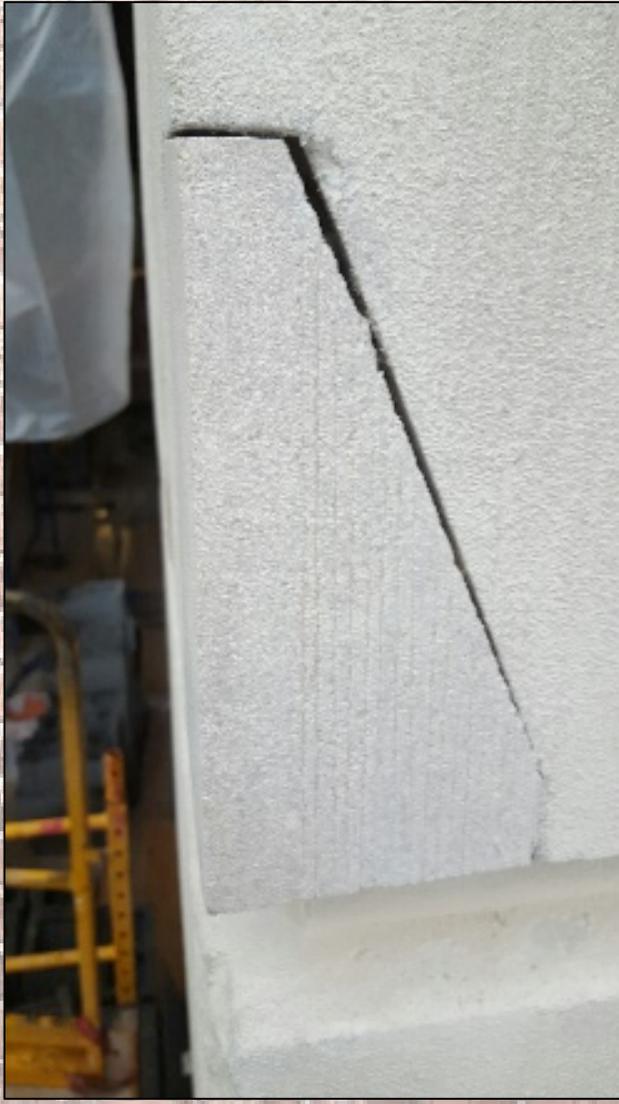
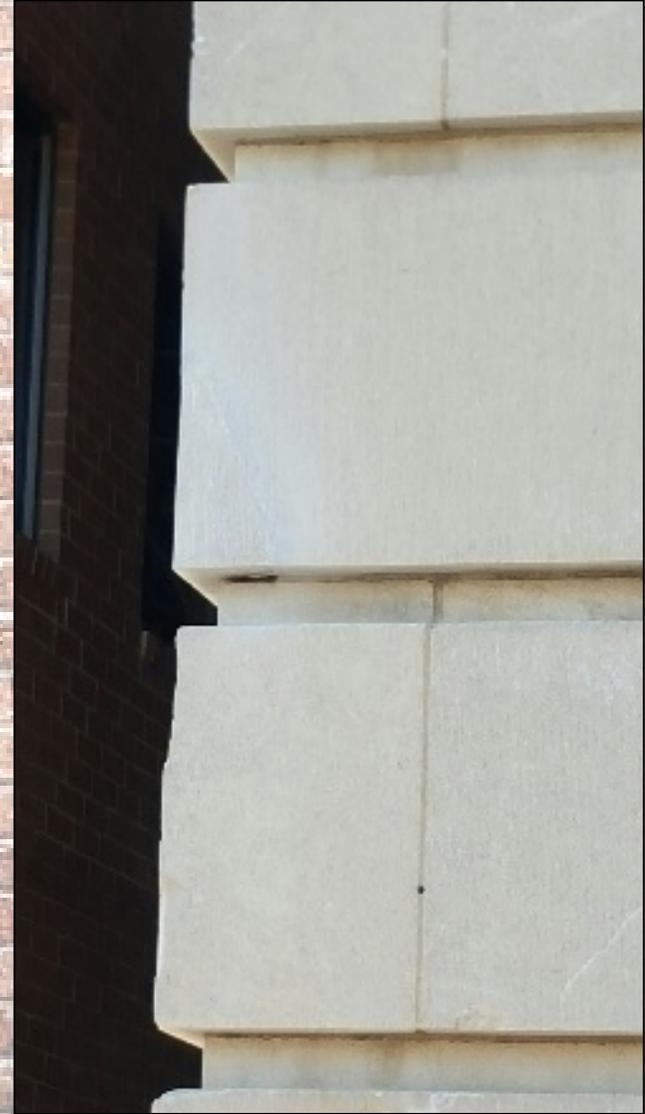
Stone Repair: Dutchman

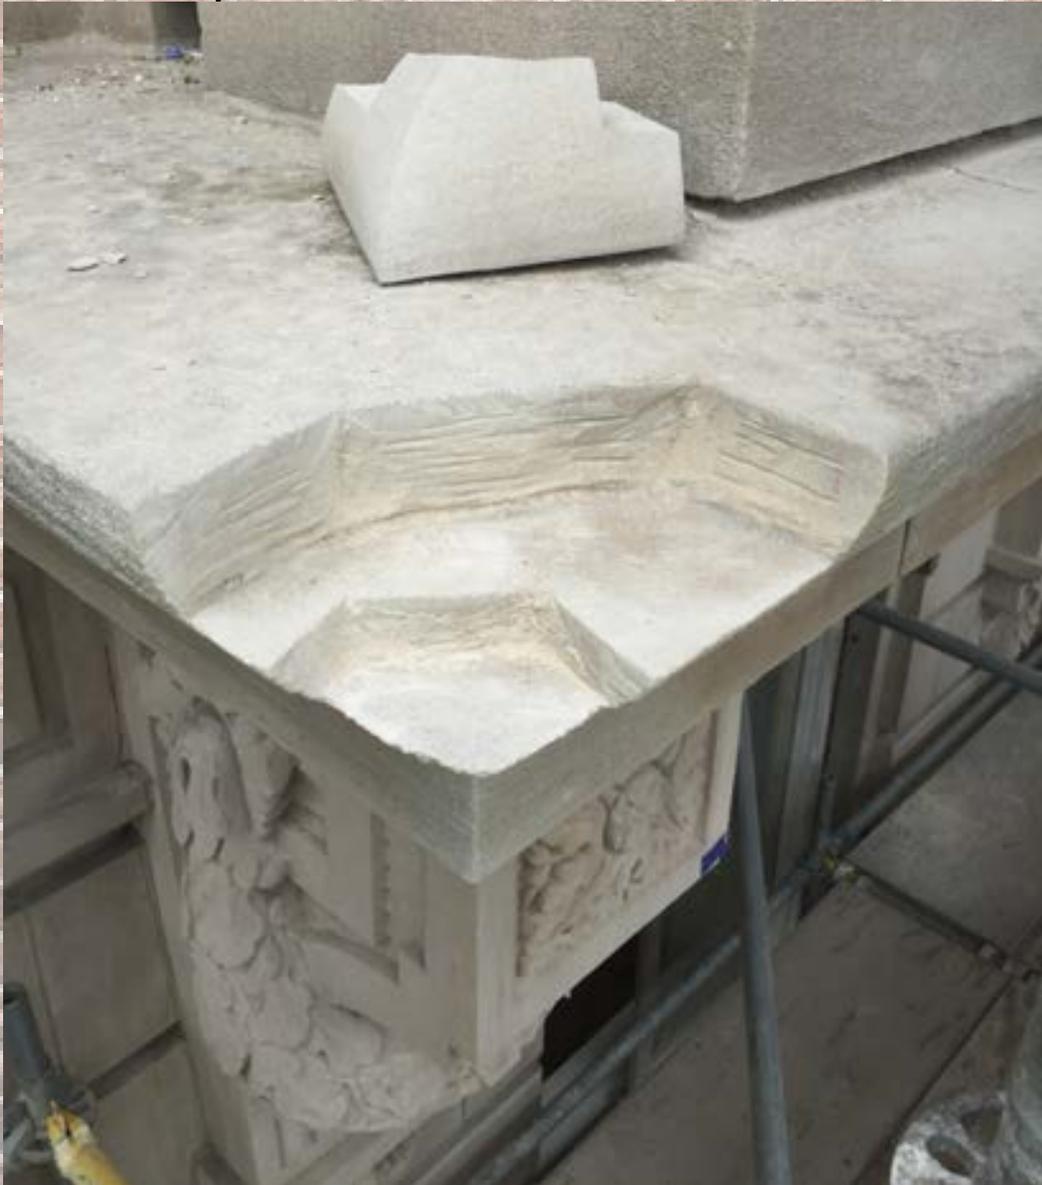
Stone Repair: Dutchman

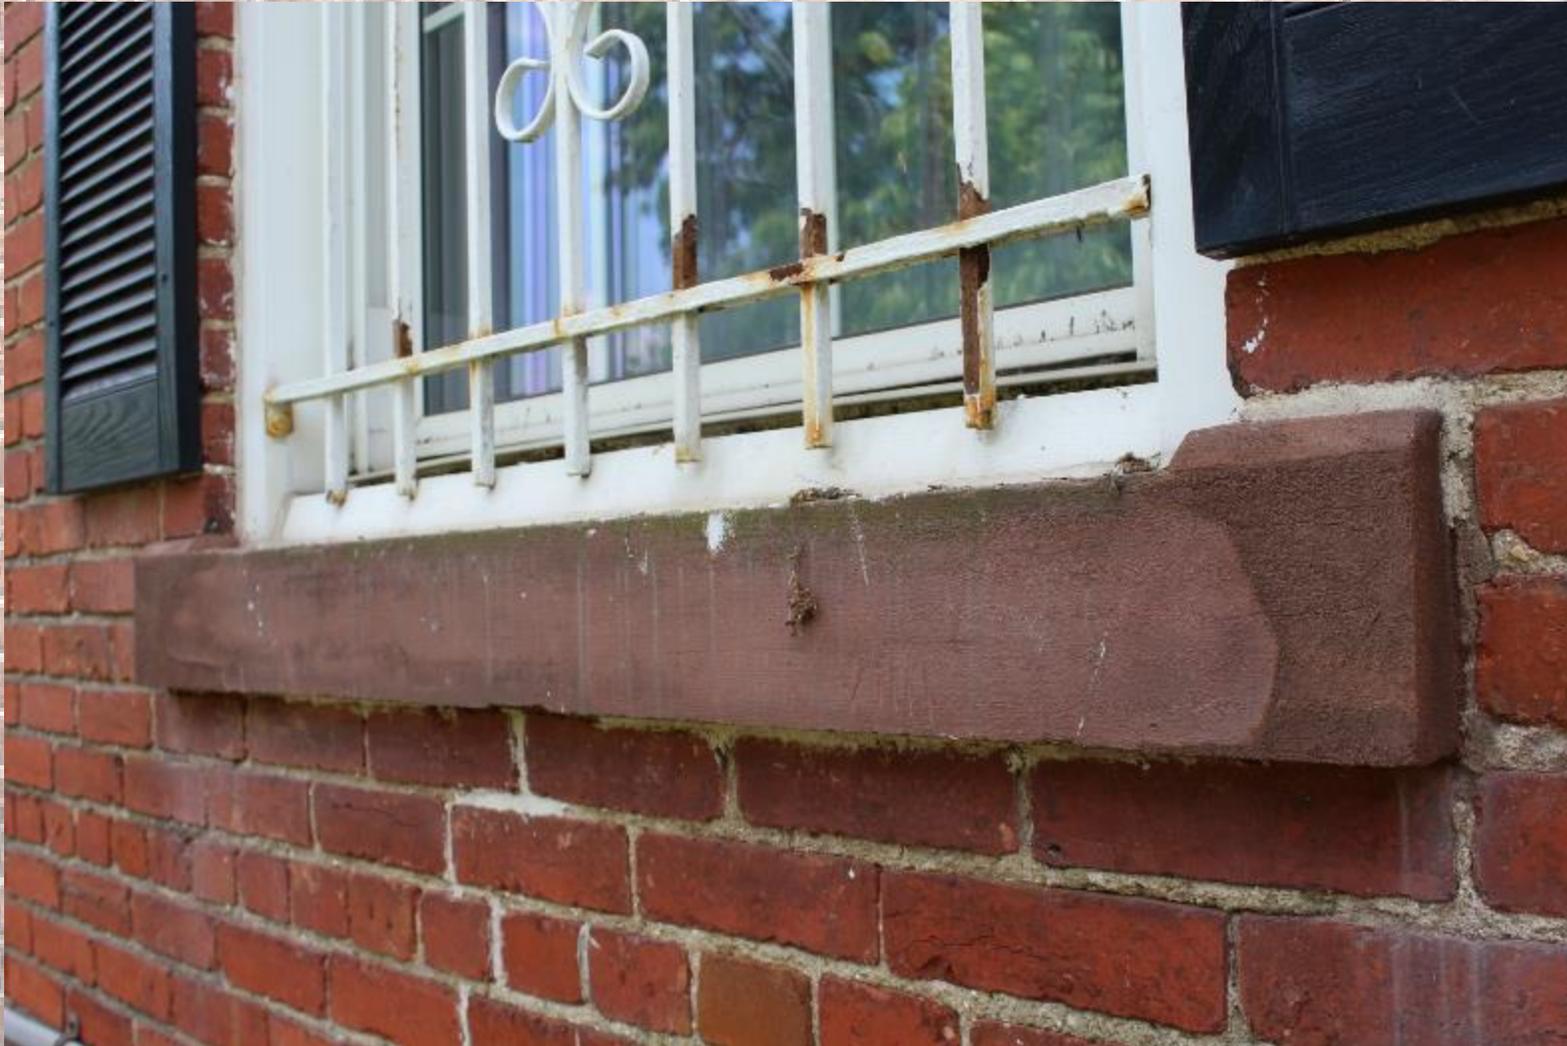
Stone Repair: Patching
