Monitoring of Two Unvented Roofs with Air-Permeable Insulation in Climate Zone 2A

ABSTRACT

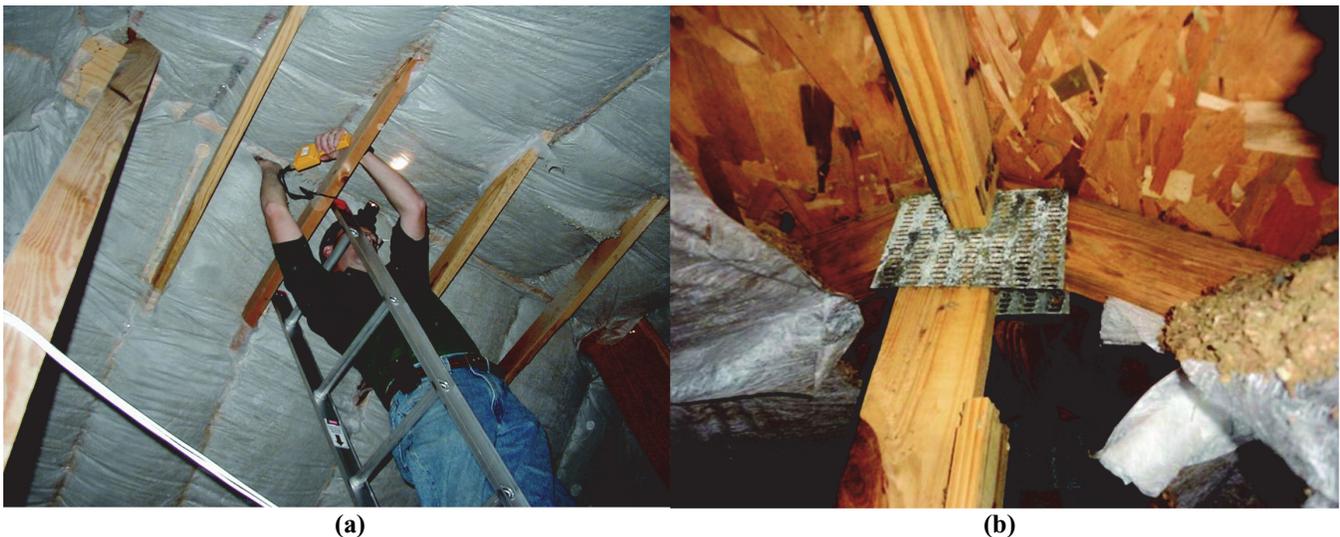
Figure 1 (a) Unvented cellulose roof ridge moisture content measurements in Houston, TX and (b) corrosion of ridge truss plate in Jacksonville, FL.

The authors made discoveries on the hygrothermal behavior of unvented roofs in hot/humid climates during field implementation; several of these roofs were built in Houston, TX circa 2001 (CZ 2A). The typical roof assembly was asphalt shingle, roofing felt, oriented strand board (OSB) sheathing, and netted and blown cellulose insulation. During the first fall season of operation, a homeowner reported seeing moisture condensation and dripping from the ridge of the unvented attic, from the interior. Field investigation (Figure 1, left) revealed elevated wood moisture contents (MCs) at the ridge and evidence of previous condensation (i.e., rusted staples). The cellulose insulation at the peak had a noticeably “packy” or compactable texture as opposed to the fluffy texture of dry

cellulose, indicating previous wetting (Rose and McCaa 1998). This failure was localized at the peak/ridge of the roof. These moisture issues were remediated by removing the insulation at the roof ridge, which solved the problem, but with an associated thermal penalty.

A similar issue arose in two production homes in Jacksonville, Florida (CZ 2A) circa 2000. Again, the roof assembly was asphalt shingles, roofing felt, OSB sheathing, and netted and blown cellulose insulation. During a site visit, the cellulose and roof sheathing were wet to the touch, and the steel truss plate was corroded; however, the wood had not decayed (Figure 1, right). In response, the insulation was removed near the ridge (roughly 2 ft [610 mm]) to increase surface temperatures of the roof sheathing. This roof has been rechecked in 2003 and 2014; roof sheathing conditions remain dry.

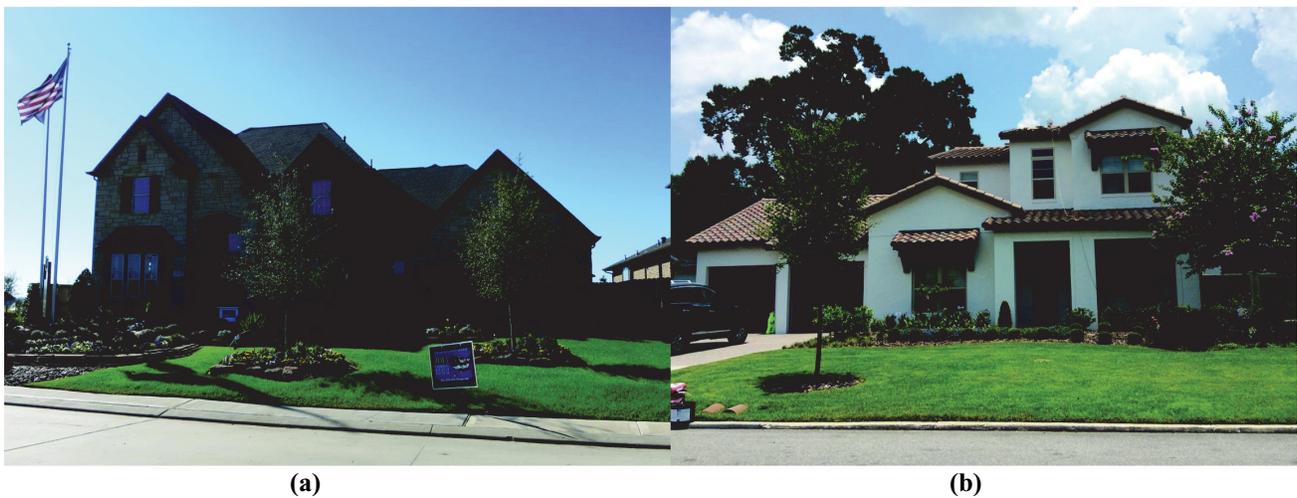
Figure 2 Front views of (a) Houston, north elevation, and (b) Orlando (west elevation) test roof houses.

Two unvented test roofs were built and instrumented (Figure 2). One was in Friendswood, TX (Houston area, CZ 2A); it is a two-story, 4028 ft² (374 m²), slab-on-grade model house that was unoccupied during testing. The other was a two-story, 3600 ft² (334 m²) slab-on-grade house in Orlando, FL, and was occupied after completion of construction.

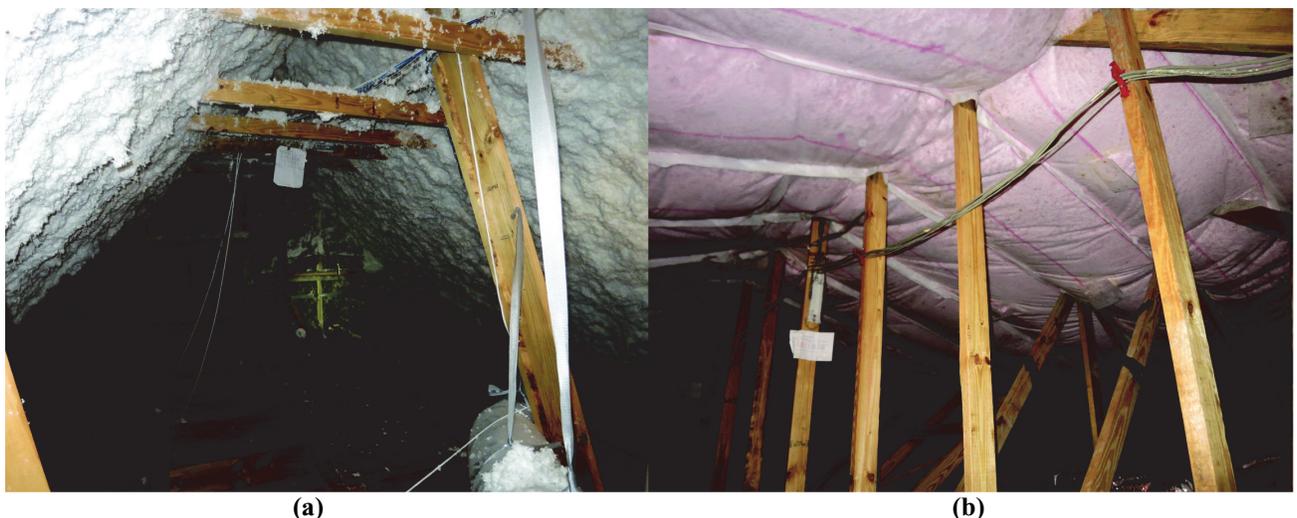
Figure 3 Attic interiors: (a) spray-applied fiberglass in Houston and (b) netted/blown fiberglass in Orlando.

The Orlando roof (Figure 3, right) roof assembly consists of concrete barrel tile screwed down to the sheathing, self-adhered modified asphalt 60 mil roofing underlayment with a woven polyester surface, ½ in. (12 mm) plywood sheathing, and blown fiberglass insulation (R-38/RSI 6.7) supported by netting stapled to the roof truss top chords (Owens Corning 2015).

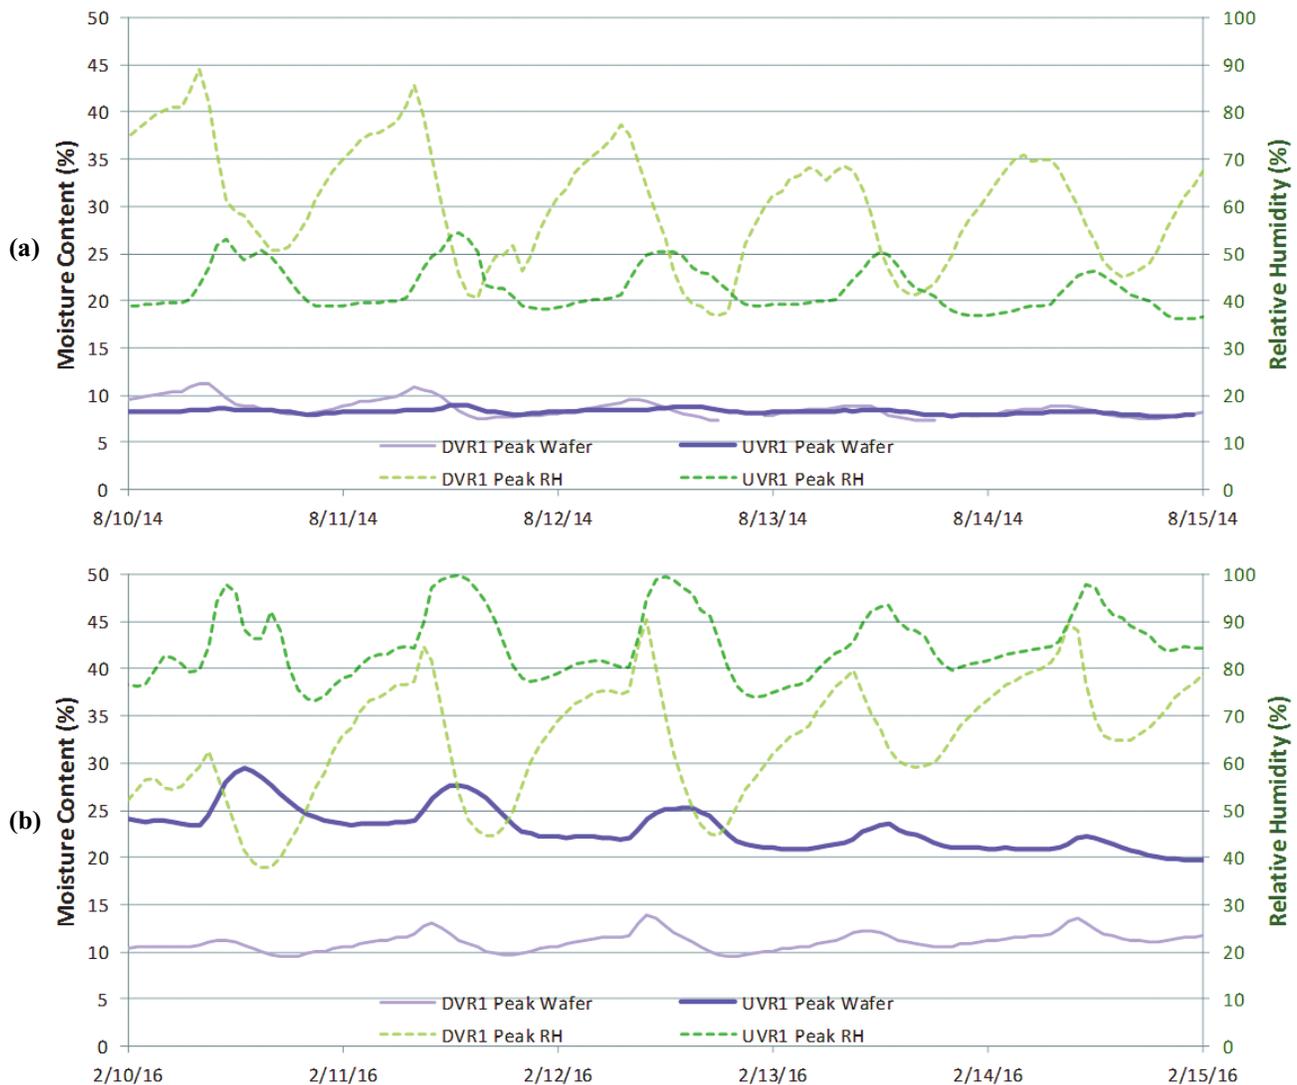
Figure 12 Houston unvented and diffusion vent wafer MC and RH in (a) summer and (b) winter, five-day details.

These patterns are shown Figure 12, which shows five-day details of summer behavior (August 2014, Figure 12a) and winter behavior under humidified conditions (February 2016, Figure 12b).

During the summer, unvented RHs are lower (35%–55%) than diffusion vent RHs (40%–90%). The greater diurnal cycling of the diffusion vent roof is evident, due to the coupling to exterior conditions at the vapor-open membrane. It results in greater drying during daytime heating and moisture uptake at night. However, the ridge wafers show that overall accumulation at the ridge is negligible in both roofs, with MCs in the 8% to 11% range.

In contrast, in winter, the unvented roof shows greater long-term moisture accumulation at the ridge wafer (20%–30% MC), while the diffusion vent ridge remains in the safe 10% to 14% range. Unvented roof RHs show peak levels hitting 100% rh at midday conditions, likely due to trapped moisture being desorbed from the sheathing.

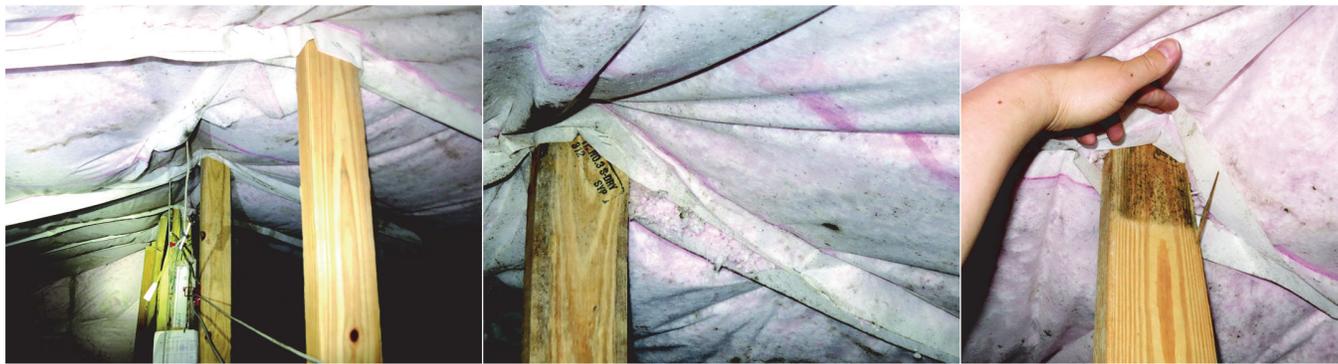
Figure 23 Orlando tile roof interior conditions showing spotting on insulation netting and truss vertical member.

In the Orlando (tile roof) house, spotting (likely mold) was seen on the interior insulation netting at the peak/ridge, tapering in intensity coming down the roof, extending roughly 4 ft (1.2 m) downslope (Figure 23). This issue was only seen at the highest ridge (upper attic, or UVR1/DVR1). Spotting was also seen at the top end of the wood truss vertical member, typically where covered by insulation netting (Figure 23a). The truss spotting was only seen at the

unvented roofs, and not at the diffusion vent roofs. This growth is entirely consistent with measured moisture accumulation in the upper attic during the first winter, due to construction moisture. This moisture then became vertically stratified in the attic, resulting in condensation on upper netting and truss surfaces. Truss spotting occurred only in the unvented attic, due to greater local accumulation than the diffusion vent roof. Infrared observations showed that truss spotting is consistent with thermal bridging. The monitored data show the problems occurred in the first winter but did not recur in the second winter. These observations are entirely consistent with previous field observations of unvented attics with fibrous insulation.
