Long-Term Monitoring of Mini-Split Ductless Heat Pumps in the Northeast

Building America Report - 1407

Kohta Ueno and Honorata Loomis

K. Ueno and H. Loomis
Building Science Corporation

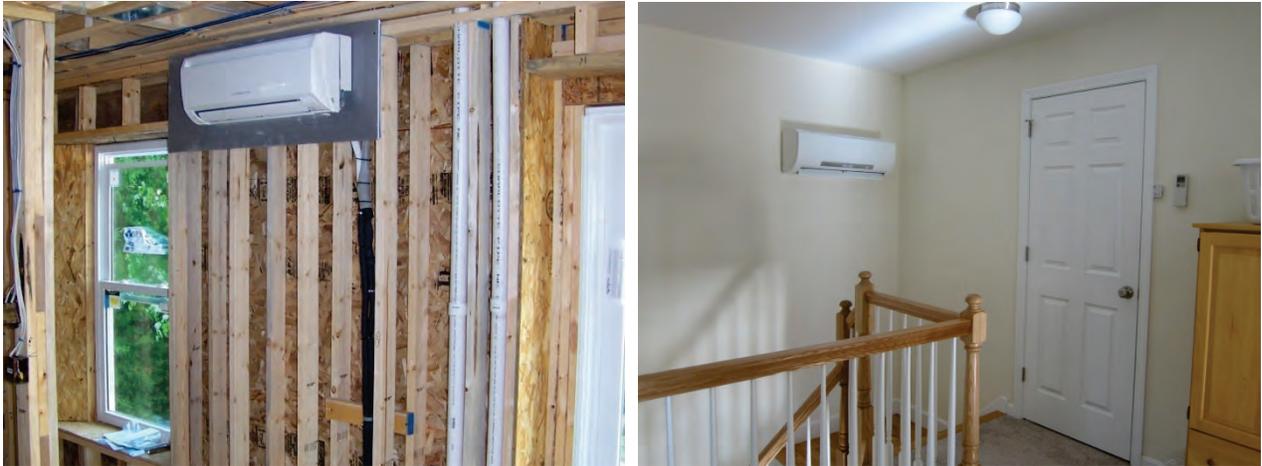
The typical installation of the interior ductless wall-mounted head is shown in Figure 5; note that for rough-in, the indoor head is installed on a small section of gypsum board. This is done so that the installation of the interior unit can be completed prior to drywall, and therefore the mechanical contractor needs only one trip to the jobsite (resulting in cost savings). After rough-in (refrigerant lines, electrical and control wires, drain lines), open-cell spray foam insulation is installed in the wall cavity behind the gypsum board, when the unit is mounted on an exterior wall.

Figure 5. MSHP installation at house rough-in (L), and completed installation (R)

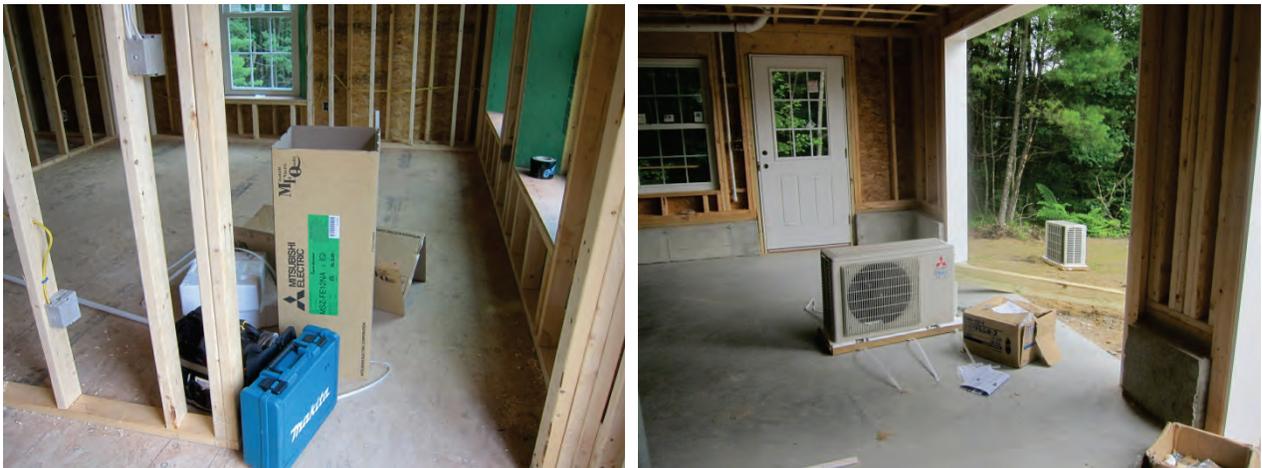
Additional photos during installation (Figure 6) show the “plug and play” nature of the equipment.

Figure 6. Unboxing and installation of MSHP equipment (Townsend, Massachusetts)

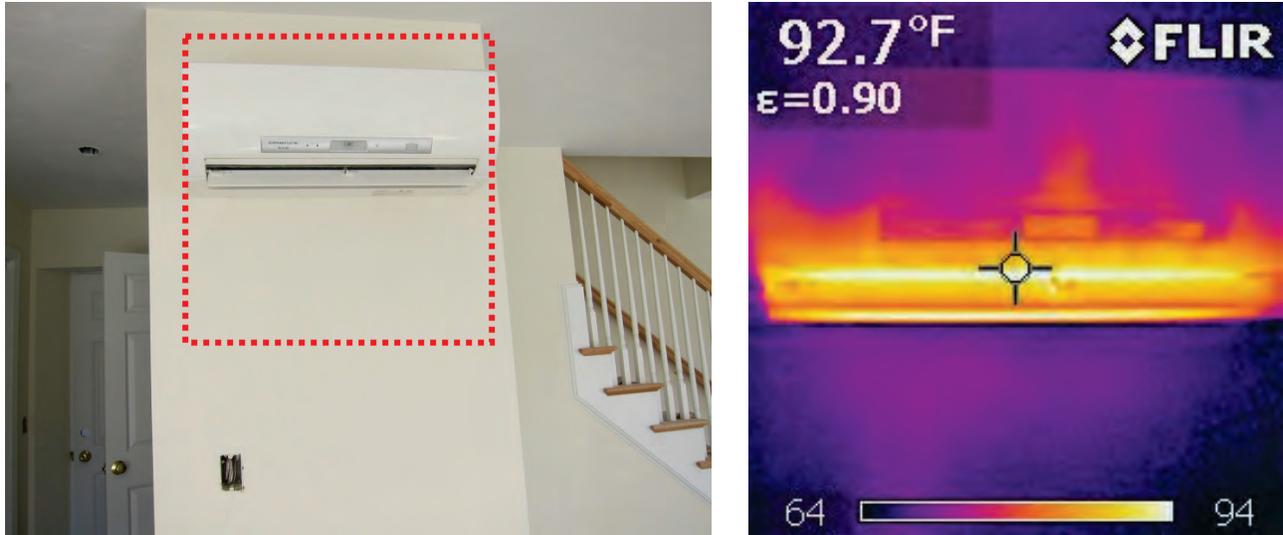
Infrared images of the indoor (Figure 7) and outdoor (Figure 8) units in heating mode are shown below. In Figure 7, the indoor units had an output temperature in the mid-90°F range (per infrared measurement) during mild outdoor conditions. Even though this might be considered in the risk range for “cold blow” complaints (cold perceived temperatures on skin), it felt sufficiently warm. This is consistent with Transformations’ experience over time. Output temperatures change with fan speed and outdoor temperature; other practitioners report higher output temperatures at colder outdoor conditions (i.e., higher output required).

Figure 7. Indoor MSHP unit in heating mode, showing delivery temperature

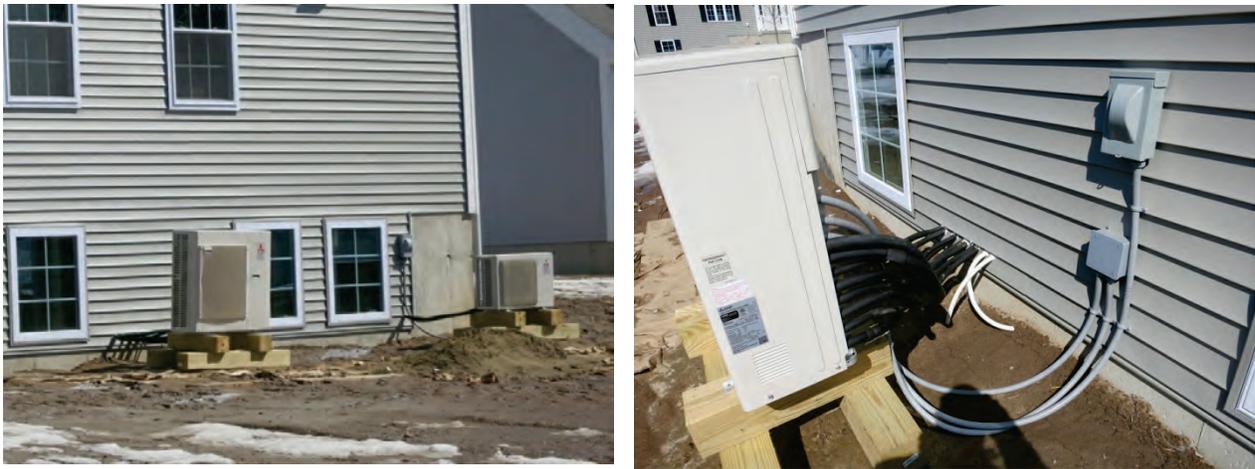
Figure 9. 3:1 multi-split DHP (Mitsubishi MXZ series) installed at Easthampton

One negative consequence of this switch was the cost increase; based on retail equipment prices, this would be a 50% increase, not counting the increased installation costs.

A larger negative, though, was that the lower efficiency of the 3:1 MSHP (per official ratings) penalizes modeled energy performance. With this new equipment, HSPF drops from 10.6 to 9.3, and SEER drops from 23 to 17.5 (see Table 7). The rated efficiency penalty is due to the operating conditions for the test procedure (AHRI 210/240); the peak summer operating efficiencies (energy efficiency ratios) are closer for the two products (12.9 versus 12.5) (Sooy 2014). In addition, cold weather capacity and efficiency suffer, as it is not a cold ambient condition (Mitsubishi “H2i”) unit.

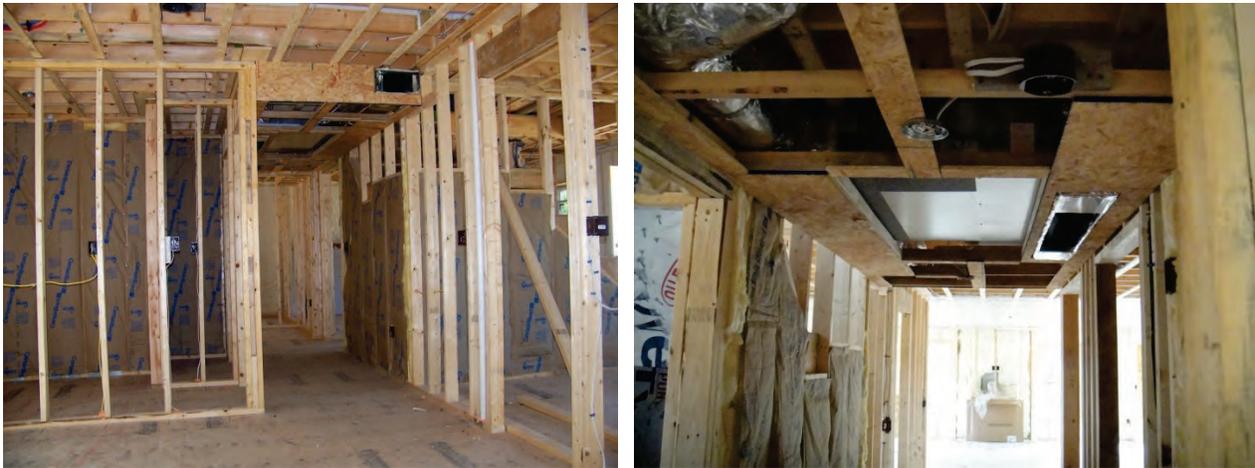
One excellent solution to the bedroom conditioning problem is the use of a small ducted air handler, recessed into the dropped ceiling of a second-floor hallway. This was used previously in Transformations work (circa 2010) at the Townsend development (Figure 10). Rosenbaum (2014b) listed the advantages of these small ducted systems, which include improved air filtration, possible integration with ventilation (including distribution of ventilation air), reduced noise, and (most importantly) even distribution of temperatures. There is a cost increase associated with ducted air handlers: Rosenbaum (2014b) estimated a cost increase of \$2500–\$5000; this is consistent with Transformations’ increase in the \$2000 range (circa 2010). This is a substantial proportional difference compared with the \$6000 installed cost of two MSHP non-ducted heads.

Figure 10. Ducted air handler MSHP indoor unit, at Transformations’ Townsend development

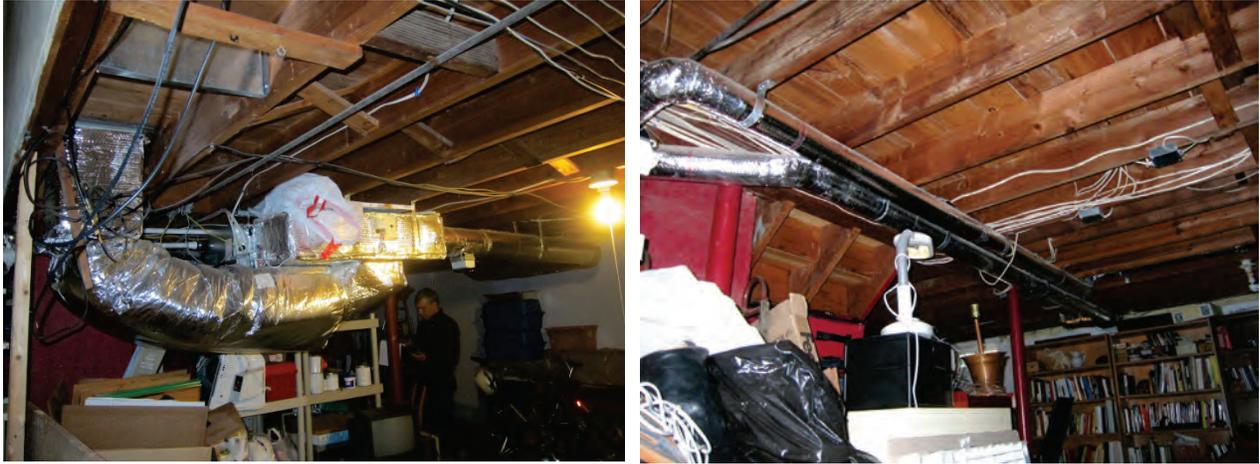
multi-head MXZ series (as an example), switching to a mixture of ductless and ducted indoor units reduces SEER by 1.25–1.5, and HSPF by 0.2–0.5. Switching to all ducted units is a further penalty, reducing SEER by 2.5–3, and HSPF by 0.4–1.

Figure 11. Ducted air handler MSHP indoor unit, with excessively long/restrictive ductwork

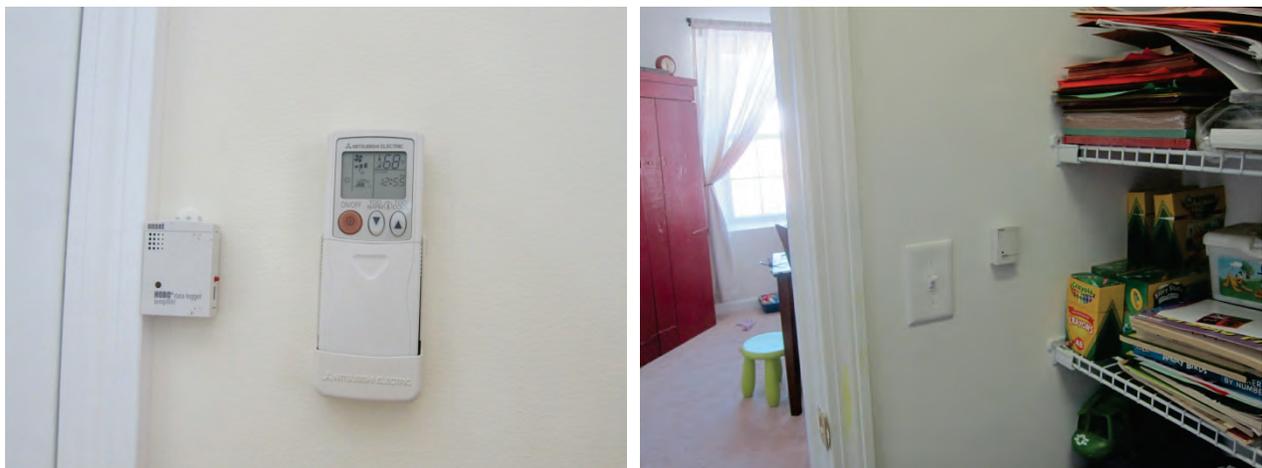
Interior T/RH measurements were taken with battery-operated loggers, attached to the walls typically 45 in. above finish floor. Logger locations are shown in the floor plans in Appendix C; they were typically located behind the entry door so that they would be concealed in most cases.

Figure 15. Interior T/RH measurements

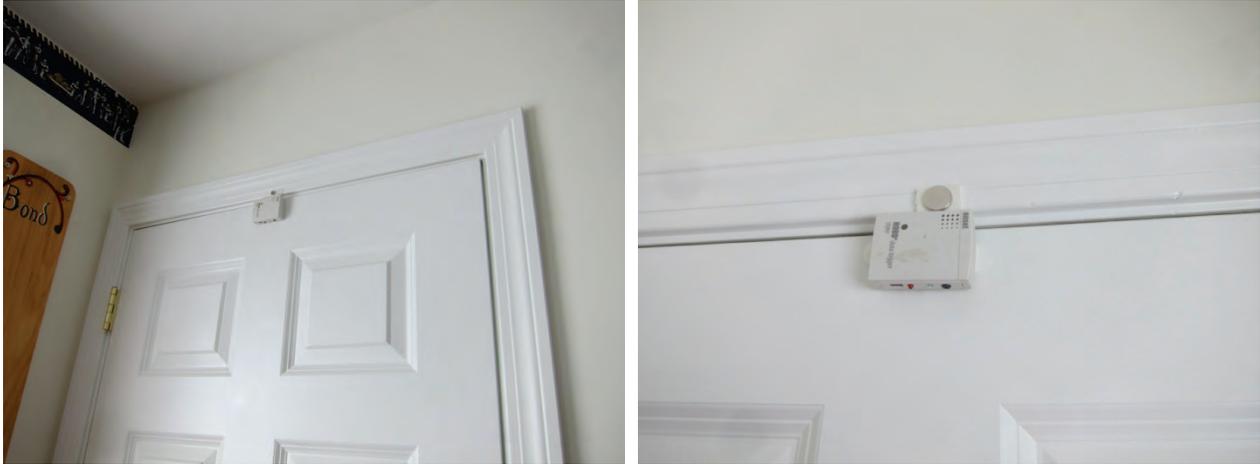
Door open/closed status was measured with a battery-operated state logger, which utilizes a reed switch to sense a magnet mounted to the door frame (Figure 16). The system registers door closed status when the magnet is close to the logger. However, this system does not register a door being partially closed: only “open” (which could include mostly closed) or “fully closed.”

Figure 16. Door open/closed sensors

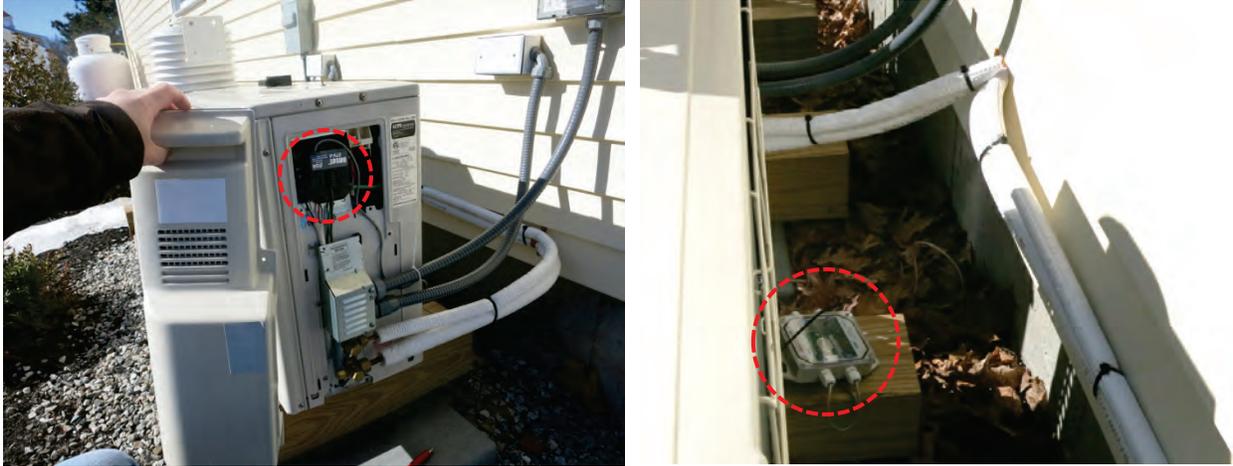
At Devens Lots 4, 7, 8, the MSHP was monitored using a battery-operated multi-channel logger set to measure amperage from a split-core current transducer, logging one of two electrical legs at the outdoor unit (Figure 18). Note that this is only a measurement of amperage or electrical current, and does not include power factor correction.

Figure 18. MSHP electrical power monitoring at outdoor unit

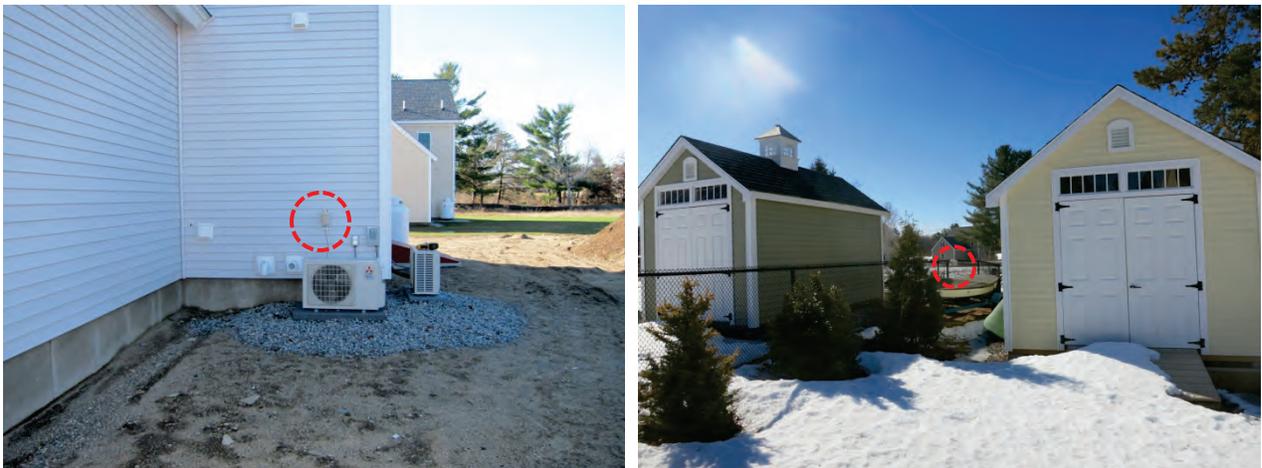
Exterior conditions (T/RH) at the Devens site were measured at two locations: one on the north-facing side of Lot 3 (Figure 19, left), and the other within a radiation enclosure between Lot 7 and Lot 8 (Figure 19, right).

Figure 19. Devens measurement of exterior conditions (T/RH)

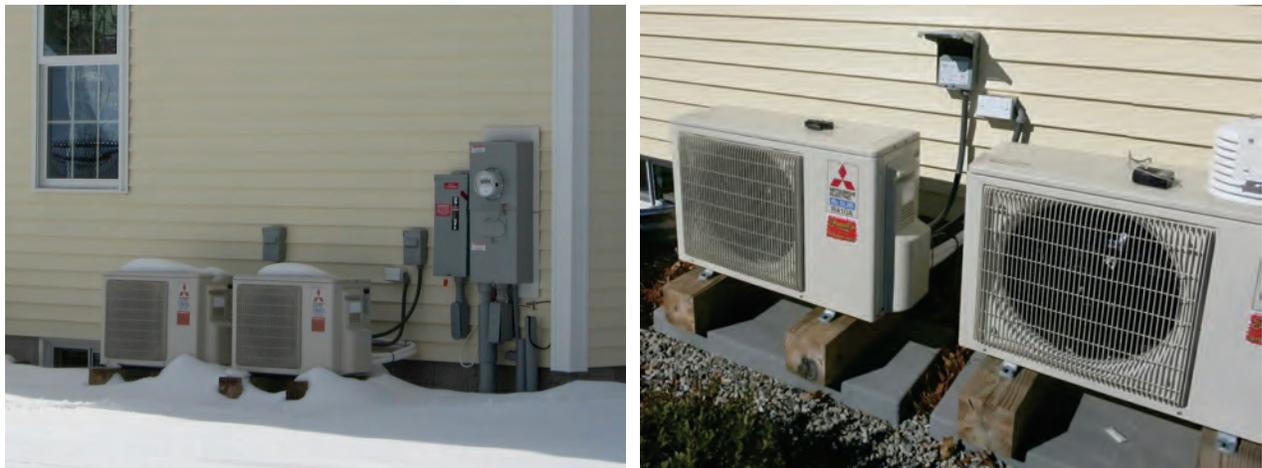
The data did not indicate any sign of a lack of capacity during snow events. In addition, when the site was examined after a snowfall (Figure 34), the MSHP outdoor units were clear of the snow level, and it is plausible that fan operation blows away snow that obstructs the face.

Figure 34. Outdoor units raised on wood block risers

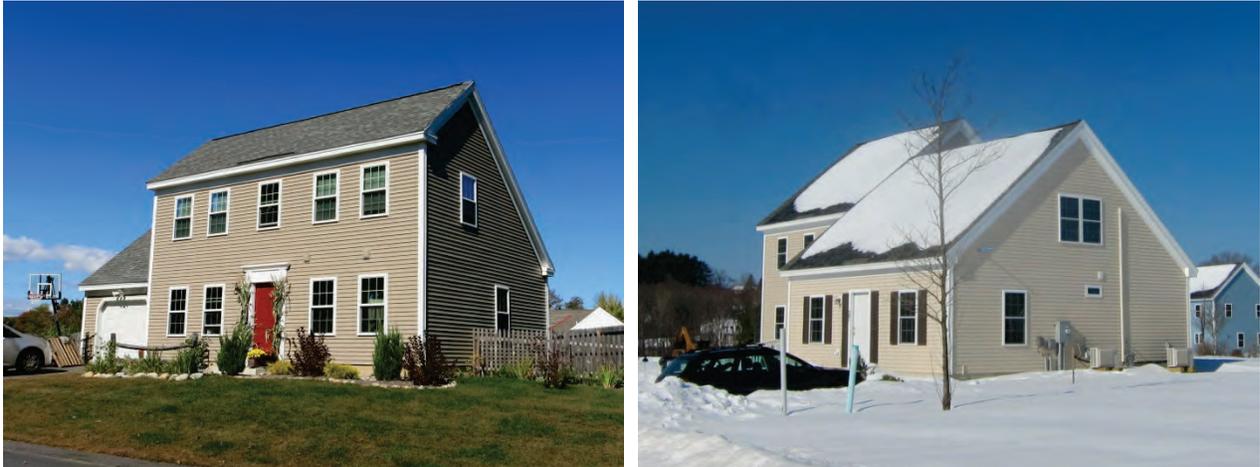
Two houses at Easthampton provide a valuable lesson on the effect of thermal buoyancy on temperature distributions. The two plans were relatively small (1239 and 1132 ft²), two-story, slab-on-grade houses (Figure 76). Design heating load calculations indicated that they could be heated with a single 12 kBtu/h MSHP head, even at winter design temperatures (Table 11).

Figure 76. Easthampton Lots 17 Small Saltbox (L) and 23 Cottage (R)

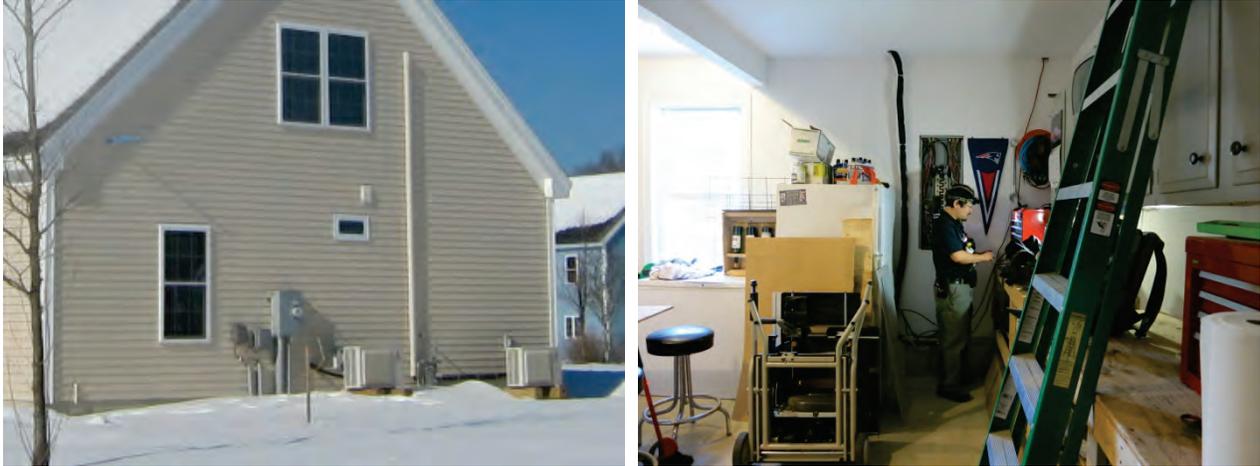
Therefore, the builder chose to retrofit a second MSHP unit to the second floor to address cooling issues; the drastic effect is apparent in August, as second-floor temperatures drop to the first-floor set point. Line sets were retrofitted on either the exterior (with a line set hide) or inside the garage (Figure 79).

Figure 79. Retrofitted unit and line set for second-floor MSHP on exterior (L), and in garage (R)

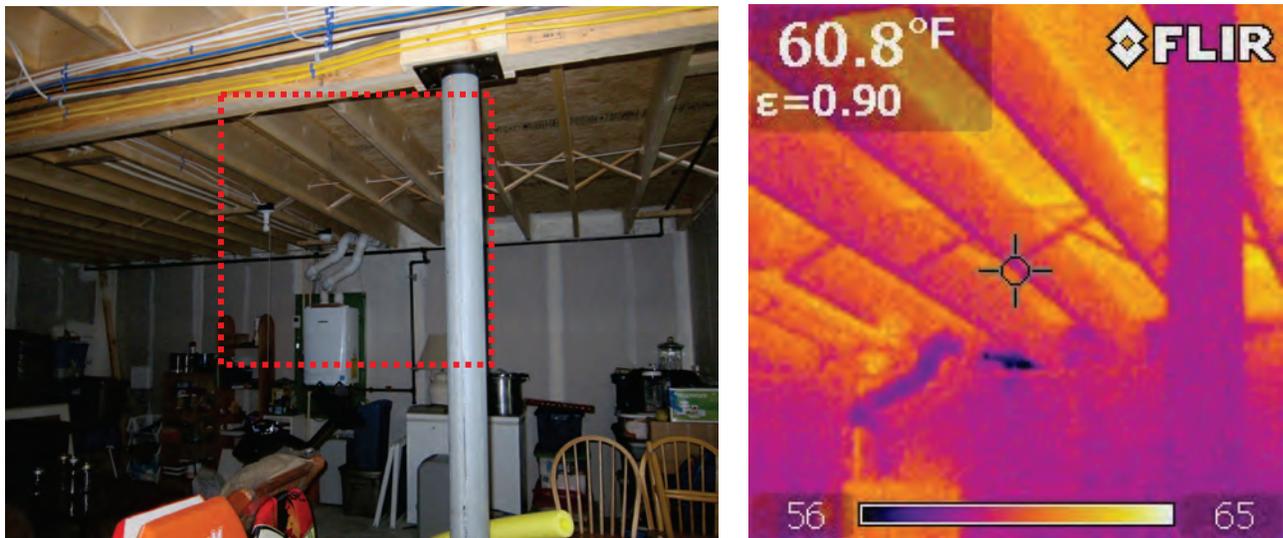
An infrared image of an insulated basement (Figure 97) shows that the basement ceiling/first floor is warmer than the basement, and emitting heat to the basement.

Figure 97. Ceiling of first floor from basement infrared image, Easthampton Lot 30
