# Field Monitoring and Simulation of a Historic Mass Masonry Building Retrofitted with Interior Insulation

## ABSTRACT

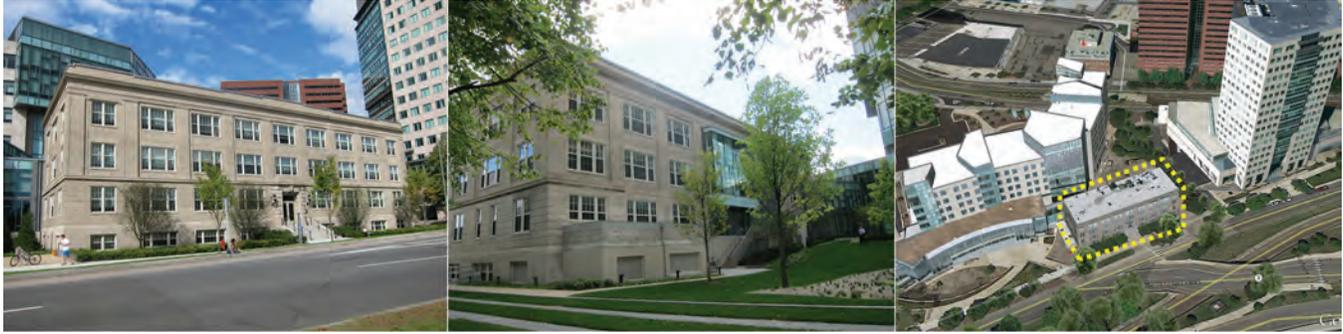
**Figure 1** Exterior views of the Arthur D. Little Building (left to right): front/south elevation, partial rear/north elevation, and overhead rendering from the south, showing surroundings.

A research project was initiated by a Boston-area academic institution to monitor the in-situ hygrothermal performance of a mass masonry building retrofitted with interior insulation. The test site for this research is the Arthur D. Little Building, which is a three-story (with basement) building (overviews in Figure 1; close up of north and south façades in Figure 2) located in Cambridge, MA (DOE Zone 5A). The building was constructed in 1917, and is on the National Historic Register. The structural elements are site-cast reinforced concrete; the existing walls included (from exterior to interior) face brick, fill brick, hollow clay block, an asphalt-based dampproofing coating, and a direct-applied cementitious interior plaster rendering (see Figure 3 for representative wall sections). A major renovation project in 2010–2011 included the installation of insulation on the interior side of the mass masonry assembly. The interior plaster was removed, and open cell polyurethane spray foam (ocSPF) was applied to the interior face of the masonry wall. Insulation was approximately 3 to 3 ½ in. (75 to 90 mm) thick, partially encasing the 2 ½ in. (63.5 mm) steel studs, which were spaced approximately 1 ¾ in. (44 mm) off the masonry wall. This interior wall retrofit assembly addresses air leakage condensation risks; spacing the framing members off the wall reduces the impact of thermal bridging associated with the steel studs. The overall R-value

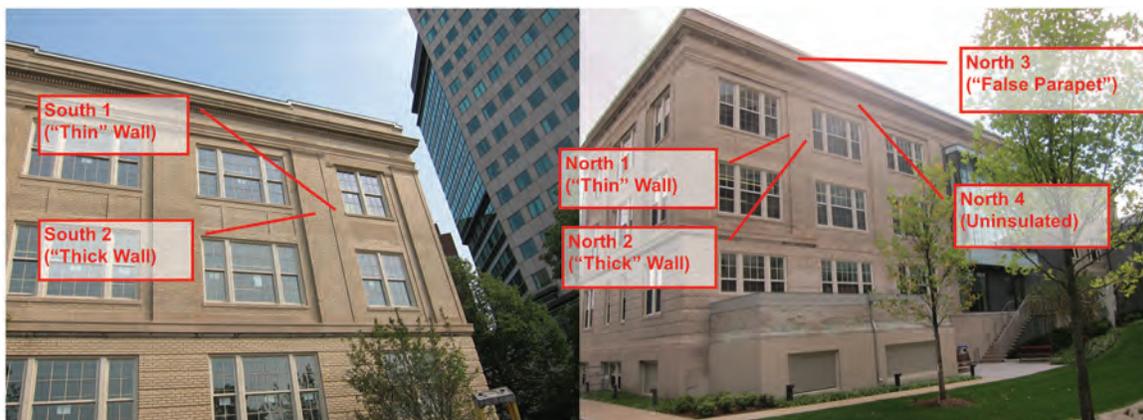
**Figure 2** South (front) and north (rear) monitoring locations and wall type nomenclature.

The wall instrumentation has been clustered into the following test walls; they are shown on the building elevation in Figure 2. Instrumentation was installed on north and south orientations; project north and south are the rear and front elevations of the building, respectively; actual orientations are 335° and 155°. Greater emphasis was placed on the north-facing walls, given the colder conditions, which results in greater risks of freeze-thaw damage.

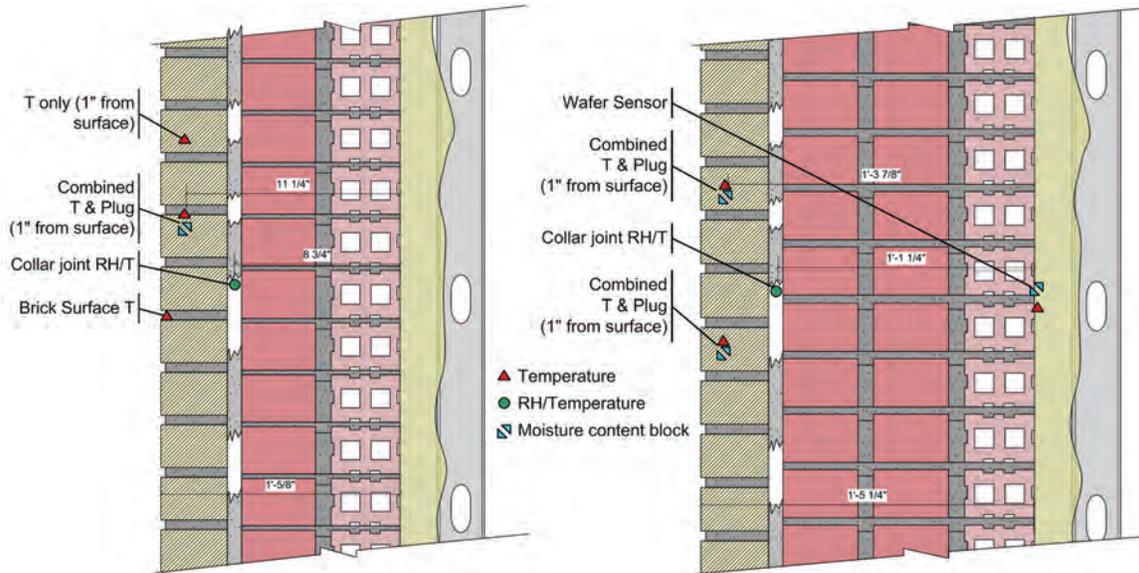
**Figure 3** Sensor package for “thin” wall (N1/S1) left; “thick” wall (N2/S2) right.

A variety of sensors were embedded through the thickness of the test walls; the layout varies depending on wall configuration (Figure 3). The sensors included temperature sensors ( $\pm 0.2^{\circ}\text{F}$  [ $0.1^{\circ}\text{C}$ ] NTC thermistor), relative humidity sensors (thermoset polymer capacitive based sensors;  $\pm 3\%$  between 10% and 90% rh), and “moisture content blocks.” The latter sensors are wood-based relative humidity surrogate sensors, described in detail by Ueno and Straube (2008); the moisture content of the wood (eastern white pine) is measured via electrical resistance.

Temperatures were measured through the thickness of the wall, including at the exterior surface, in the exterior brick wythe, in the collar joint (inboard of the exterior wythe), and at the masonry-insulation interface (see Figure 3). Selected temperatures for north-facing insulated walls are shown in Figure 8; it shows that the wall temperatures basically follow exterior conditions (within several degrees) regardless of position within the wall (albeit with some damping due to thermal mass, especially at the innermost wafer temperature).

A typical wall section is shown in Figure 14, which models the wall layers pictured in Figure 3; the image also shows the location of temperature/relative humidity monitors, which mostly correspond to site measurements.

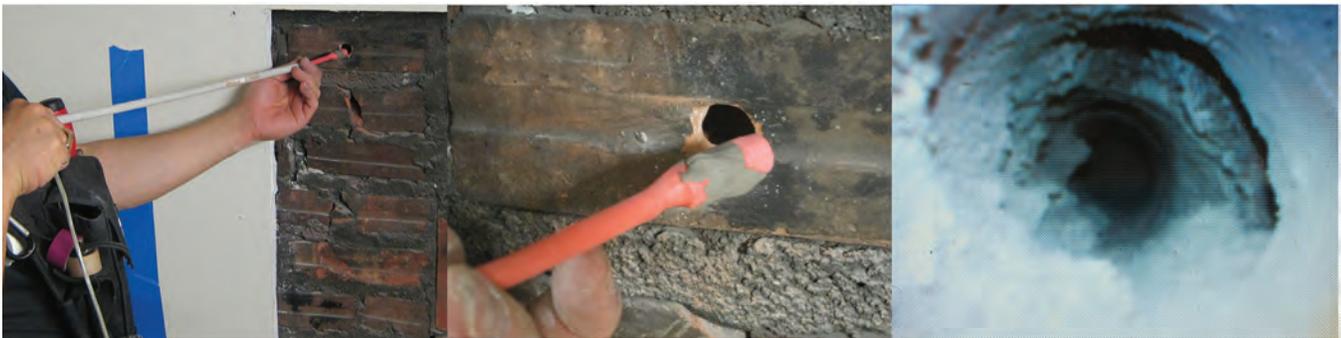
**Figure 4** (Left) Installation of combined temperature and “plug” (wood cylinder) sensor; (middle) sensor encapsulated in clay for capillary contact; (right) boroscope image of installation hole.

this ensures consistent capillary contact, but adds an initial moisture signal to disaggregate from the wall behavior. The conditions of the installation hole were typically examined with a boroscope before sensor installation, to identify anomalies (Figure 4, right). The installation locations included in masonry joints (i.e., higher rainwater absorptivity), within the solid brick body, and intersecting with the air-filled brick cores (which could allow some drying). The lateral location of the sensors within the masonry wall could not be tightly controlled due to this “blind” (interior side) installation.

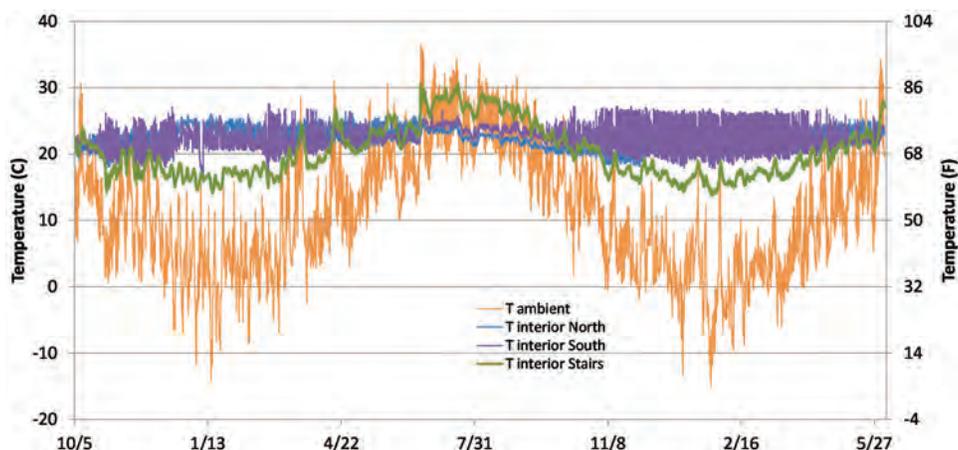
Figure 5 Exterior and interior temperatures.

Exterior and interior boundary conditions were recorded; exterior and interior temperatures are shown in Figure 5. Interior conditions were measured in the north-facing room, south-facing room, and the north-facing stairwell with uninsulated walls. North and south interior temperatures were typically controlled to the 70°F to 77°F (21°C to 25°C) range, but with some excursions to the high side in the south-facing room (likely due to solar gain and/or thermostat setup control issues). The stairwell was semi-conditioned (heating-only), with temperatures between interior setpoints and exterior temperatures.

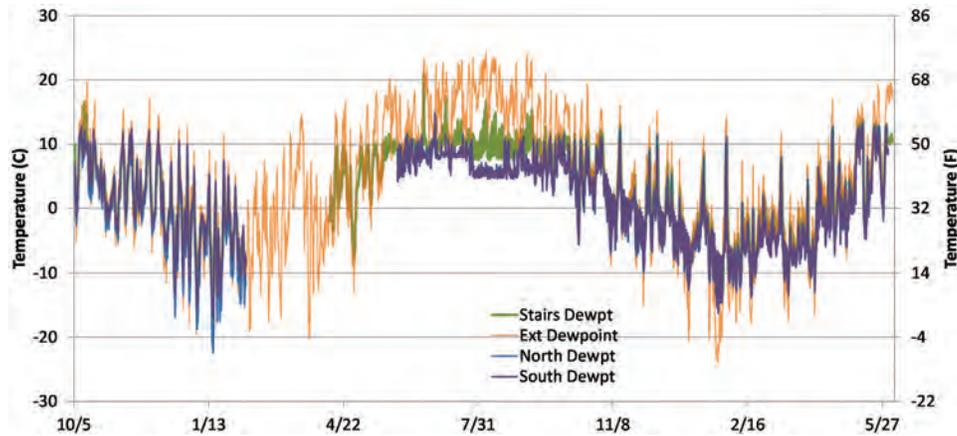
Figure 6 Exterior and interior dewpoint temperatures.

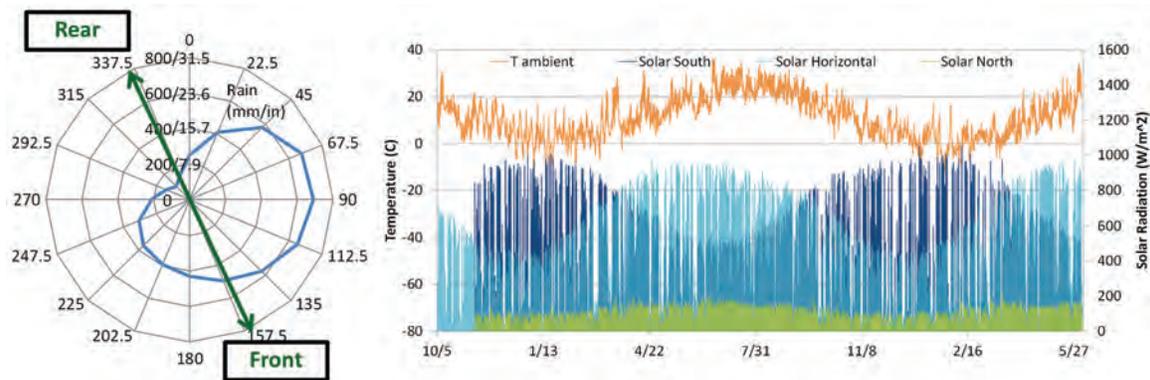
Figure 7 (Left) Driving rain rosette in mm (in.) (calculated from Boston airport data), with building faces shown; (right) solar radiation at building for horizontal, north wall, and south wall.

Figure 7 (left) shows driving rain, as calculated from Boston airport (KBOS) data, using methods described by Straube (2005). Site-measured weather station rainfall data appeared to be missing significant rainfall events, so it was not used in this analysis. The plot shows the cumulative driving rainfall for the monitored period. The test wall orientations are superimposed on the driving rain rosette for reference. The plot clearly shows that the test walls were not at the highest exposures to driving rain, and that the rear/project north side had much lower rainfall than the front/project south side.

Solar radiation was plotted with exterior temperature for reference including horizontal, north wall, and south wall data (Figure 7 right). It shows the expected pattern of a seasonal rise and fall with higher solar gain on the south wall in wintertime (due to low sun angle). The north wall experiences consistently low solar gain (diffuse radiation only).

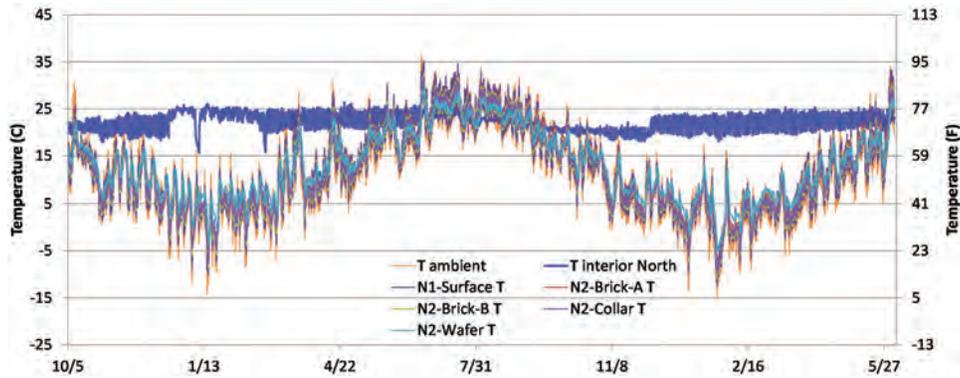
Figure 8 North insulated wall representative temperatures, with interior and exterior temperatures.

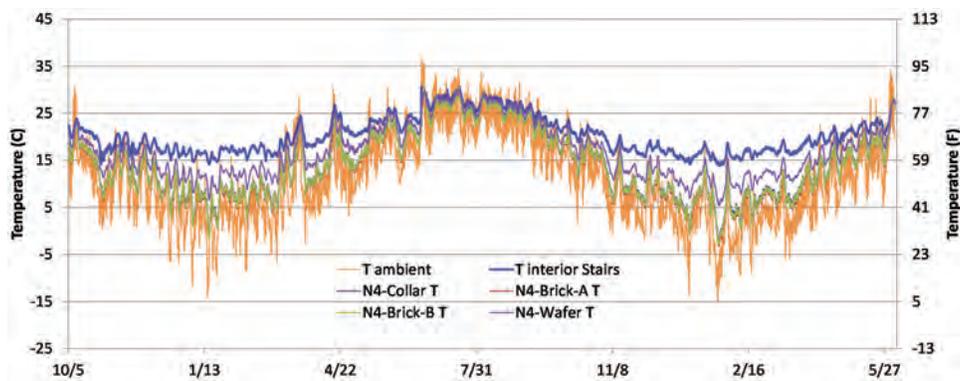
Figure 9 North uninsulated wall representative temperatures, with interior and exterior temperatures.

The north-facing uninsulated wall is markedly different from the north-facing insulated walls. Instead of tracking outdoor conditions, the temperatures fall in a range between indoors and outdoors, depending on position through the assembly thickness (Figure 9). The sensor at the interior surface of the masonry (but hidden by drywall) is roughly half-way between indoor and outdoor temperatures. The wintertime temperatures within the uninsulated masonry wall are warmer than the insulated case.

The temperature behavior of these walls is consistent with a steady-state calculation of the temperature gradient through the wall. In the uninsulated case, the masonry provides the majority of the insulation value of the wall, so the temperature drops gradually through the thickness of the masonry. In contrast, post-insulation, the interior insulation (spray foam) layer provides the majority of the insulation value in the wall. Therefore, the entire thickness of the masonry wall operates close to exterior temperatures.

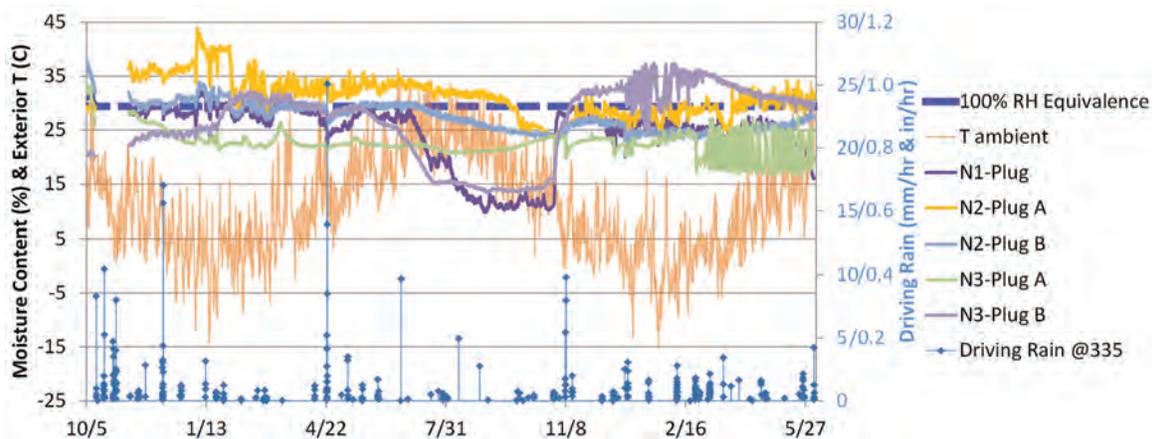
**Figure 10** North insulated wall plug sensor moisture contents with exterior temperatures and driving rain.

The north-facing insulated wall responses (Figure 10) vary widely, and are not necessarily correlated with location. For instance, most sensors start within a similar band of moisture contents (MCs), but over the summer, the “thin” wall and one “false parapet” sensor dry down to 10%–15% MC (55%–80% rh equivalent). But other walls stay much wetter, and/or dry only at the end of the summer (“thick” wall sensors, N2). There was no indication that the “false parapet” sensors (N3) consistently experienced more wetting than other portions of the wall.

Most plug sensors show a response to some driving rain events; for instance, Hurricane Sandy (October 29, 2012) resulted in a major increase in moisture content across all sensors. However, some significant driving rain events did not result in a noticeable wetting response. This might be expected, given the complication of calculating and predicting driving rain on the face of a building in an urban environment. The general pattern for most of the north-facing sensors was in the 22%–35% MC range (93%–100% rh equivalent).

However, the simulated behavior contrasts sharply with the measured data (see Figures 10, 11, and 12). For instance, very few driving rain events caused discrete responses in measured data but were evident in the simulation. The general trend in the measured data was consistently high humidity levels in the wintertime, followed by drying (in some cases) in the summertime.

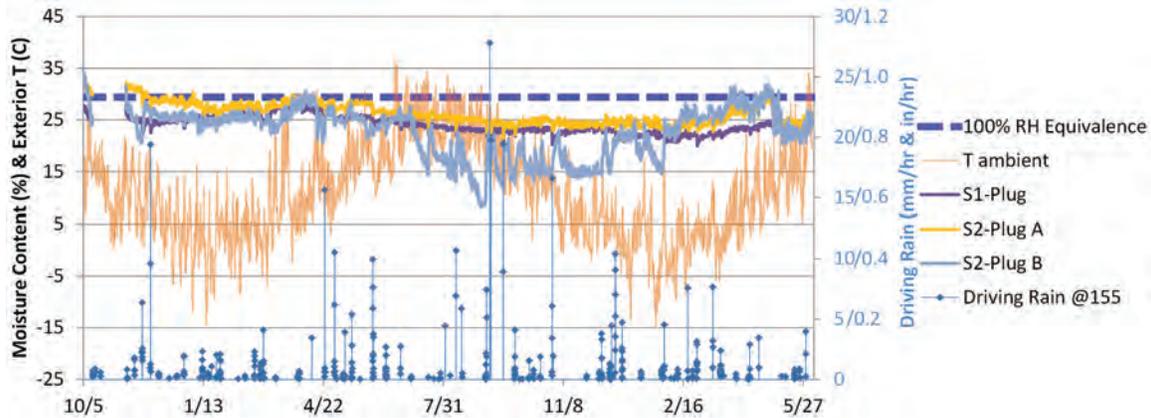
Figure 11 South insulated wall plug sensor moisture contents with exterior temperatures and driving rain.

15%–28% MC (78%–100% rh equivalent). The moisture contents appear to rise higher in winter/spring 2013, which is not directly correlated to greater amounts of calculated driving rain.

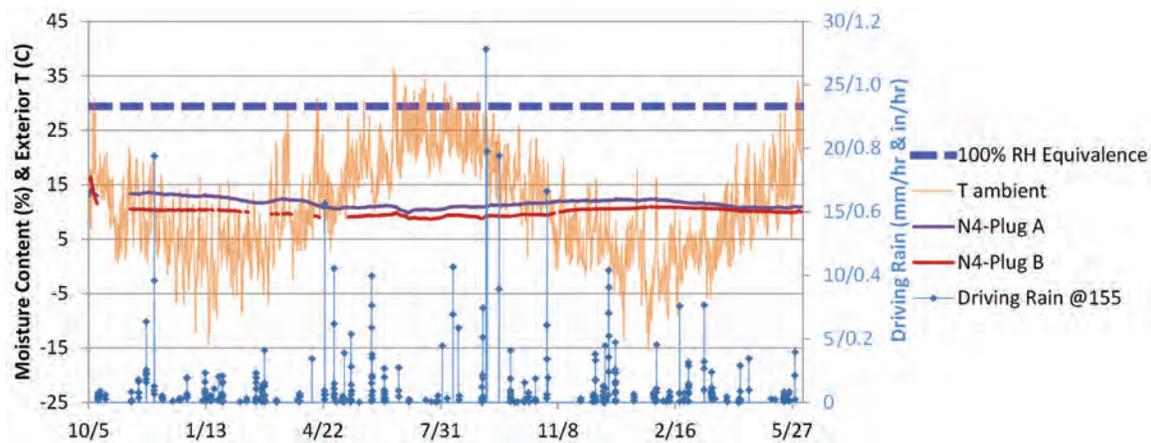
Figure 12 North uninsulated wall plug sensor moisture contents with exterior temperatures and driving rain.

The sensors in the north-facing uninsulated wall (Figure 12) have a markedly drier response than the insulated walls, typically in the range of 9%–13% MC (50%–70% rh equivalent). There is a slight seasonal rise and fall (greater moisture in winter), but the response is small compared to the insulated walls.

been installed close enough to the exterior cornice detail that they are largely shielded from driving rain. This would explain both the lack of response as well as the exceptional dryness of the masonry wall. Overall, it is unclear how much of the sensor patterns can be attributed to the lack of thermal insulation, compared to the lack of rain deposition on the wall.

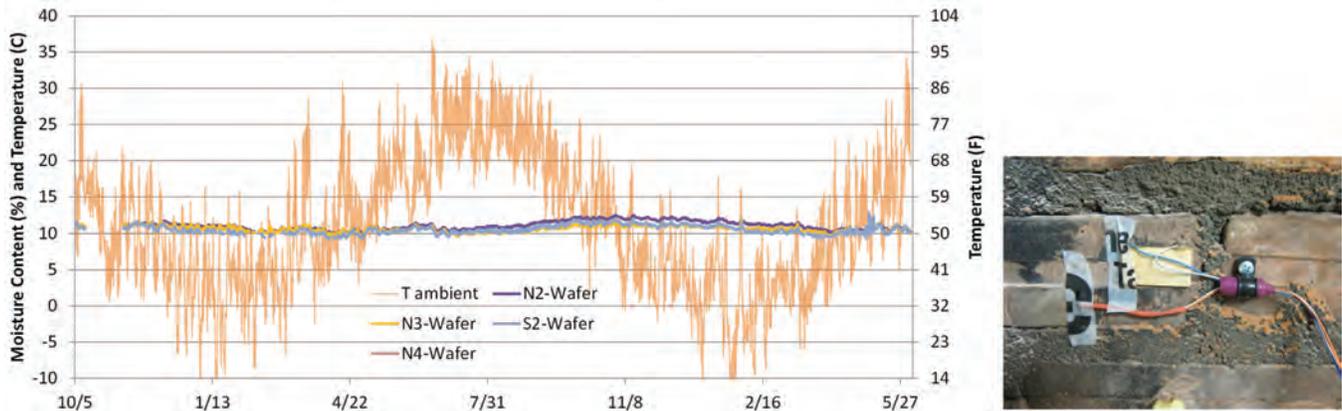
**Figure 13** (L) Moisture wafer results, with exterior temperature for reference; (R) example of wafer sensor.

Temperature and surrogate relative humidity sensors (wafer sensors) were installed at the interior surface of the masonry to measure conditions at the insulation-masonry interface (Figure 13, left). The intent of these measurements is to capture the occurrence of interior-sourced moisture that may be transported by diffusion and condense on the cold ma-

The measurements (Figure 13, left) remained in the 10%–13% MC range (50%–70% rh equivalent), which is a safe range for avoiding moisture-induced degradation of building materials. Before concluding that this retrofit wall assembly is safe from interstitial condensation, it must be noted that interior relative humidity levels were exceptionally low (5%–20%) during both winters, which reduces the risk of wintertime condensation.

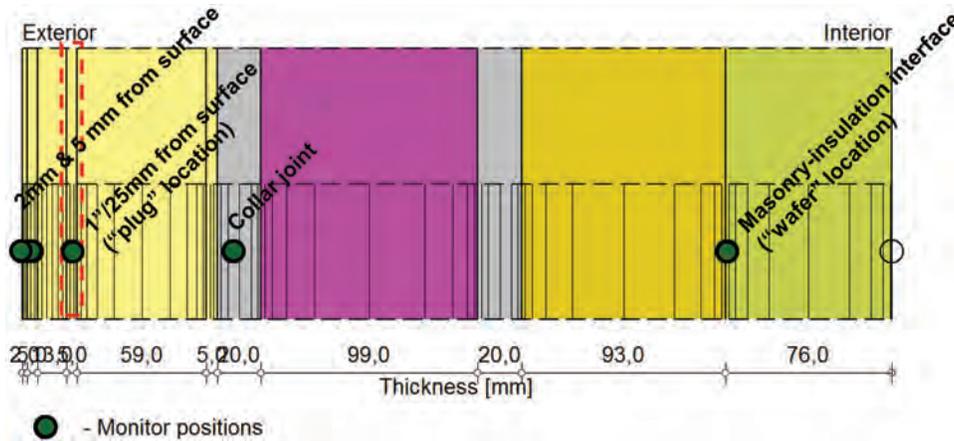
Figure 14 WUFI model of Wall S1/N1 (insulated “thin” wall) with materials and monitor positions.

The collar joint and the joint between the face and fill bricks were modeled as solid mortar; in reality, these joints are incompletely filled with mortar, with a variety of cracks and voids in the fill. In addition, the hollow clay block is shown as solid (as per the block’s web condition), as opposed to having an air space (hollow core).

The modeled response of the outer layer of brick, 1 in. (25 mm) from the surface (layer highlighted in Figure 14) was examined closely as its position corresponds to the plug sensor in the monitored wall. The response is plotted in Figure 15 in terms of relative humidity (as opposed to moisture content) to allow a simpler comparison to the plug sensor response.

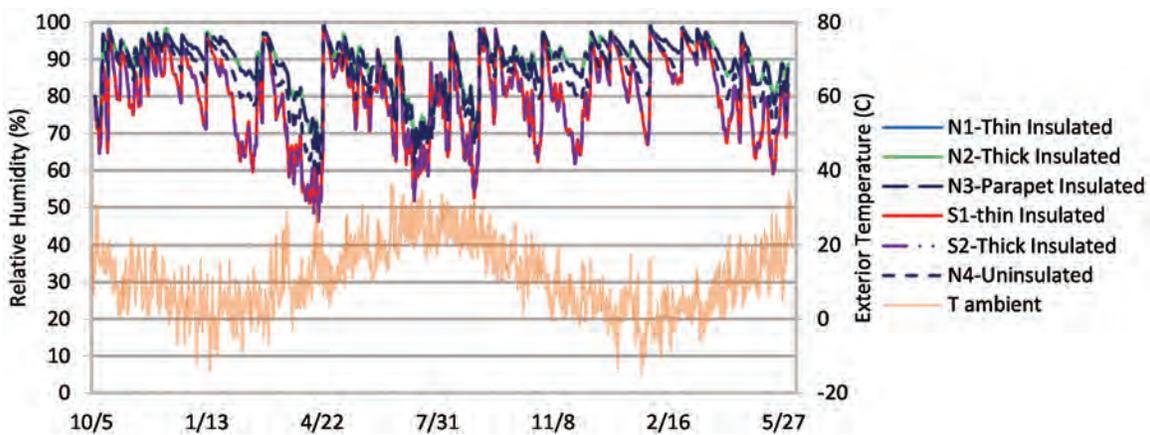
Figure 15 Simulation brick layer 1 in. (25 mm) from exterior face relative humidity; exterior temperature for reference.

The response of the model is a common pattern seen in hygrothermal simulations of mass masonry assemblies. Moisture conditions rise sharply (to the 90%–100% range) in response to driving rain events and then dry slowly over time. Further driving rain events cause additional jumps in RH.

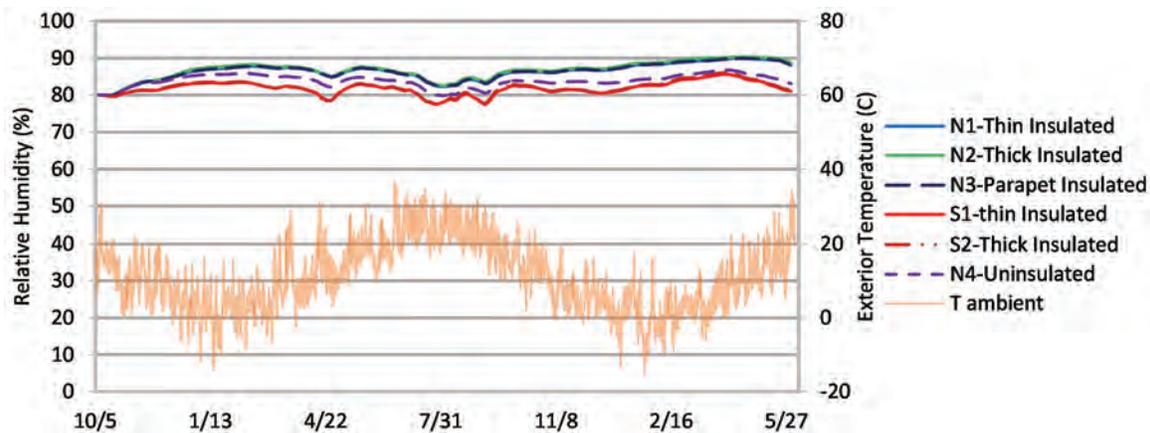
Figure 16 Simulation collar joint (mortar layer) relative humidity; exterior temperature for reference.

Another comparison is to the relative humidity levels at the collar joint between the face brick and the backup wall. The simulated response at this layer is shown in Figure 16. The order of the responses is consistent with the order seen in the measured plug data. In addition, the RH levels are roughly

consistent with the limited measured collar joint RH data, although measured RHs in the uninsulated wall (N4) are drier (45%–67% rh) than in the simulation (80%–85% rh). This difference may be ascribed to the rain sheltering caused by the overhanging cornice detail at the N4 monitoring location.

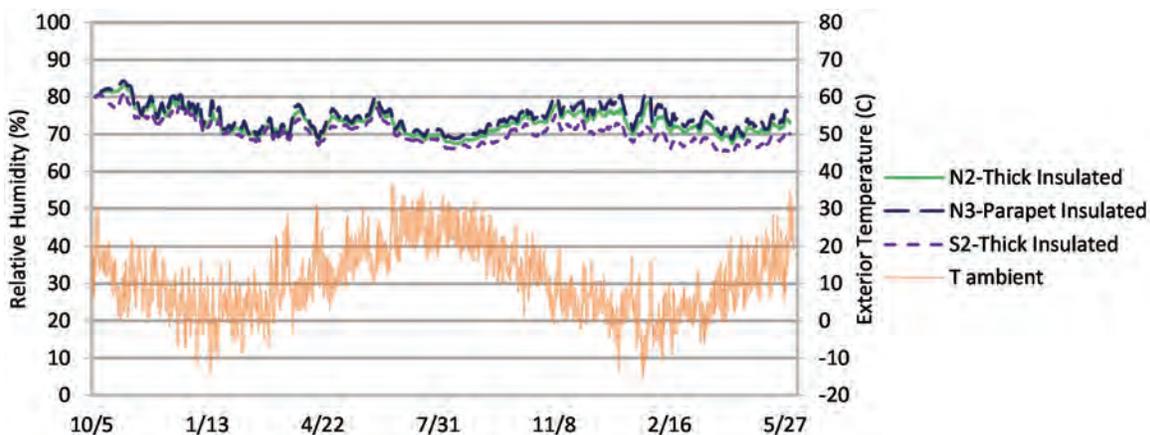
Figure 17 Simulation wafer (masonry-insulation interface) relative humidity; exterior temperature for reference.

Simulation results for the relative humidity at the masonry-insulation interface (equivalent to the wafer placement) are shown in Figure 17. The simulation results show RH levels in the 65%–85% range, with variations correlating with outdoor temperature. In comparison, the measured data showed a more damped response, as well as drier conditions; the measurements centered at 50%–70% rh equivalent (10%–13% MC).

Part of the difference between simulation and measured responses may be due to the slow response of the wood-based surrogate humidity sensors. However, the cycles seen in these simulations are not simple diurnal variations; they are variations over the course of multiple days. It is plausible that the simulation does not correctly capture the vapor permeance characteristics of the wall assembly

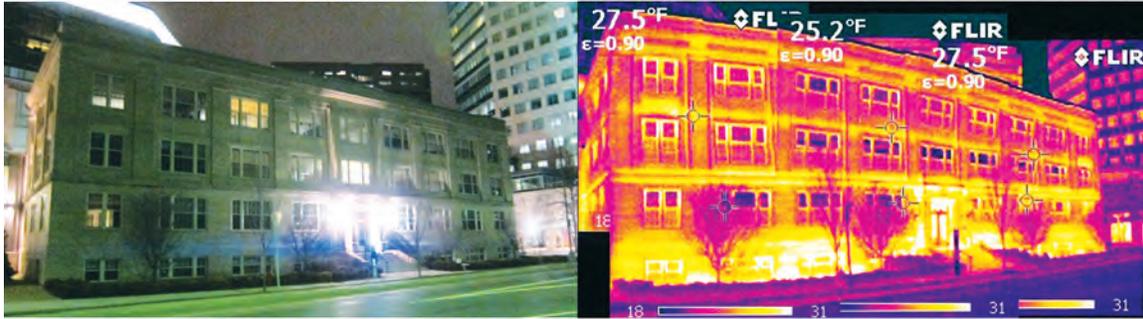
**Figure 18** Front (south) elevation visual and infrared images (composite infrared image). There is a significant thermal anomaly (indicating heat loss) at the entryway; this is consistent with the heated but uninsulated (due to historic finishes) entryway, and possibly air leakage around the entry doors.

In addition to the measured data and hygrothermal simulations, cold-weather infrared thermography was conducted at the building in January of 2012; the exterior temperature at the time of these measurements was roughly 25°F (–4°C). The front/south elevation is shown in Figure 18.

There is conspicuous evidence of thermal bridging through the exposed floor slab edges. Due to the construction of the building, interior insulation of the masonry walls does not address the thermal bridging through the slabs (including

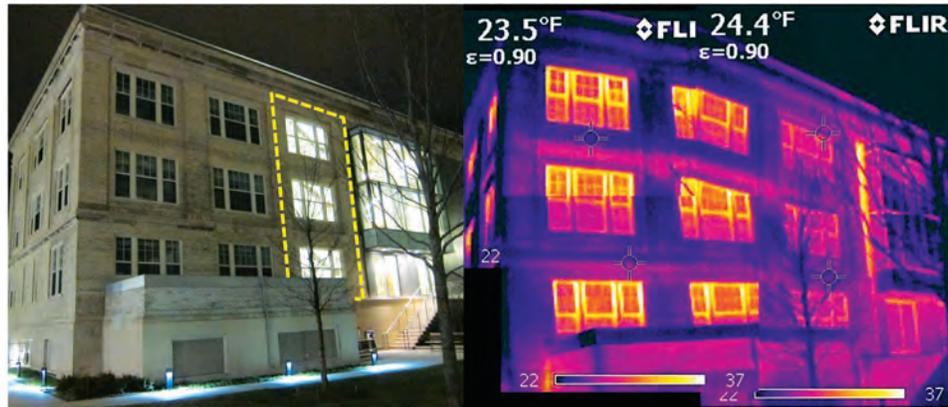
**Figure 19** Rear (north) elevation visual and infrared images (composite infrared image) with uninsulated stairwell wall highlighted.
