Unvented Roof Research:

Research and Reality

March 10, 2016

Building Science Corporation
© buildingscience.com

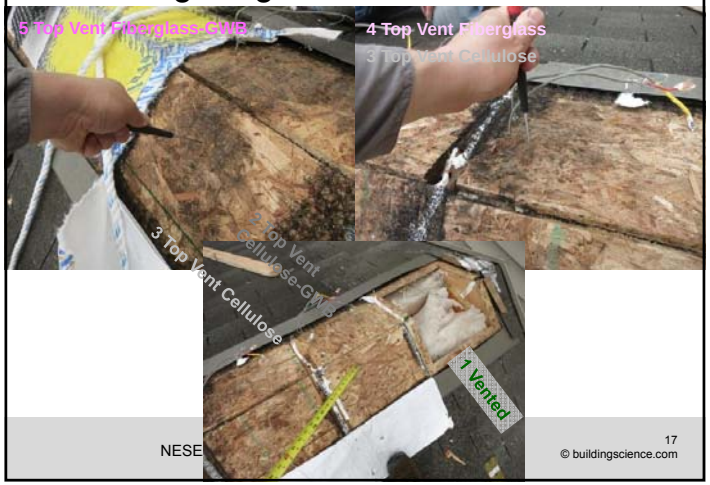
Sheathing Ridge Condition

- Vented roof=great performance—even @50% RH!
- Unvented cellulose assembly driven to failure (high RHs, high sheathing MCs, condensation)
- Cellulose + diffusion vent helps, but not enough
- Top venting not enough to save roofs in:
  - Zone 5A climate, 50% RH interior
  - With a small (~1/2" vent space)
  - With OSB sheathing
- In top vent roofs, fiberglass roof much worse than cellulose

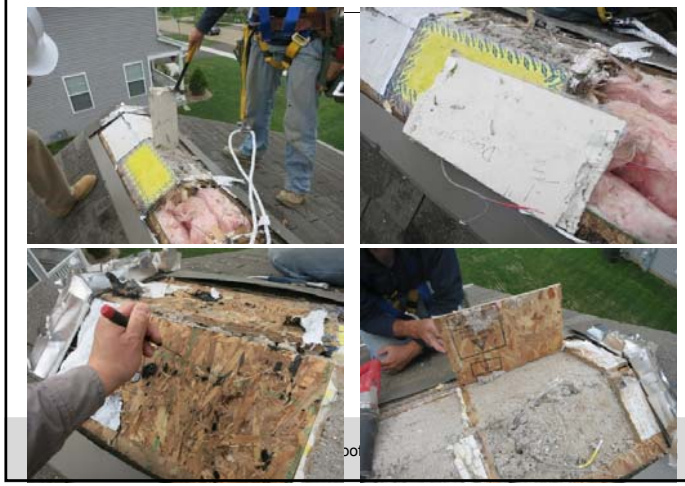
Diffusion Vent & Unvented

- No roof except for “control” vented roof showed “safe” performance in Zone 5A @ 50% RH
- Cellulose roofs generally showed lower MCs than fiberglass roofs, less damage to structure
- “Top vent” configuration not effective
  - OSB too restrictive for diffusion drying, even with outward thermal gradient? (part of the time)
  - Ventilation space too small?
- Diffusion vent: “helpful, but not enough”
  - Allowed greater drying than conventional unvented
  - But still higher MCs than generally considered safe

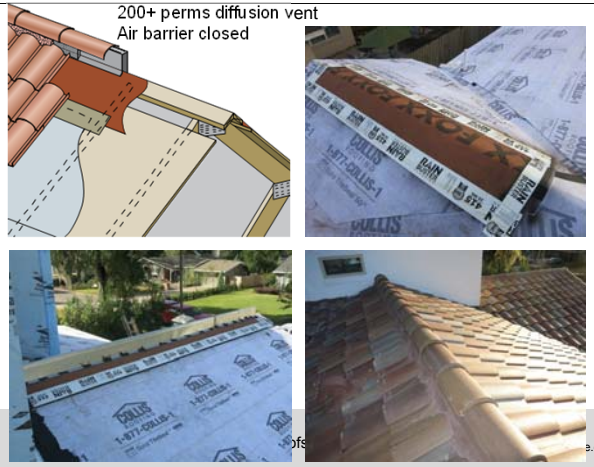
Diffusion Vent Prototype (Orlando-Tile)

- Diffusion vent avoids wintertime ridge accumulation problems (ridge peak RHs/MCs)
- No failures at low interior RH, bigger difference at higher RH (interior humidification)
- Airtightness disappointing in some cases-no SPF
