Air Pressure and Building Envelopes

Research Report - 9905

Joseph Lstiburek

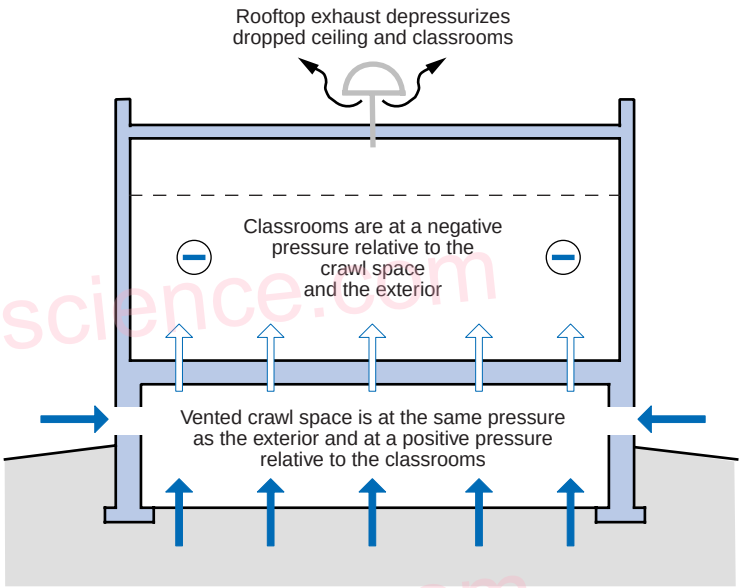
Upon entering the classroom which the affected teacher and students occupied, visible deterioration of plaster and baseboard surfaces were observed along interior and exterior walls. The deterioration was most intense at the baseboard level, and decreased in intensity with height. Paint had peeled from the plaster at many locations. Water markings were observed on the plaster surfaces. The plaster was soft to the touch and disintegrated when probed. When the plastic covering over the wood baseboard trim was removed, noticeable musty odors were encountered. The wood was soft and "punky". Significant decay of the wood was observed. When the wood baseboard was pulled away from the wall, the intensity of the musty odors increased significantly.

Visual observations revealed a joint between the concrete floor slab and the masonry perimeter wall. Other joints were observed in the concrete floor slab at the interior concrete foundation walls. Smoke pencil testing indicated substantial air flow between the crawl space and the classroom through these exposed joints. Readings taken with a digital

micromanometer indicated that the classroom was operating at 4 Pascal's negative with respect to the crawl space (Figure 1). Furthermore, interior wall cavities were found to operate at 1 Pascal negative with respect to the classroom.

The complaints from the teacher and students were due to musty odors resulting from the deterioration of wood trim and other building materials. These odors and deterioration were due to excessive moisture migrating from the crawl space under the classrooms into the interstitial spaces of interior and exterior walls as a result of the air pressure relationship between these spaces and the crawl space.

Figure 1
Problem Pressure Relationship
- The classrooms in this school operate at a negative pressure with respect to the crawl space

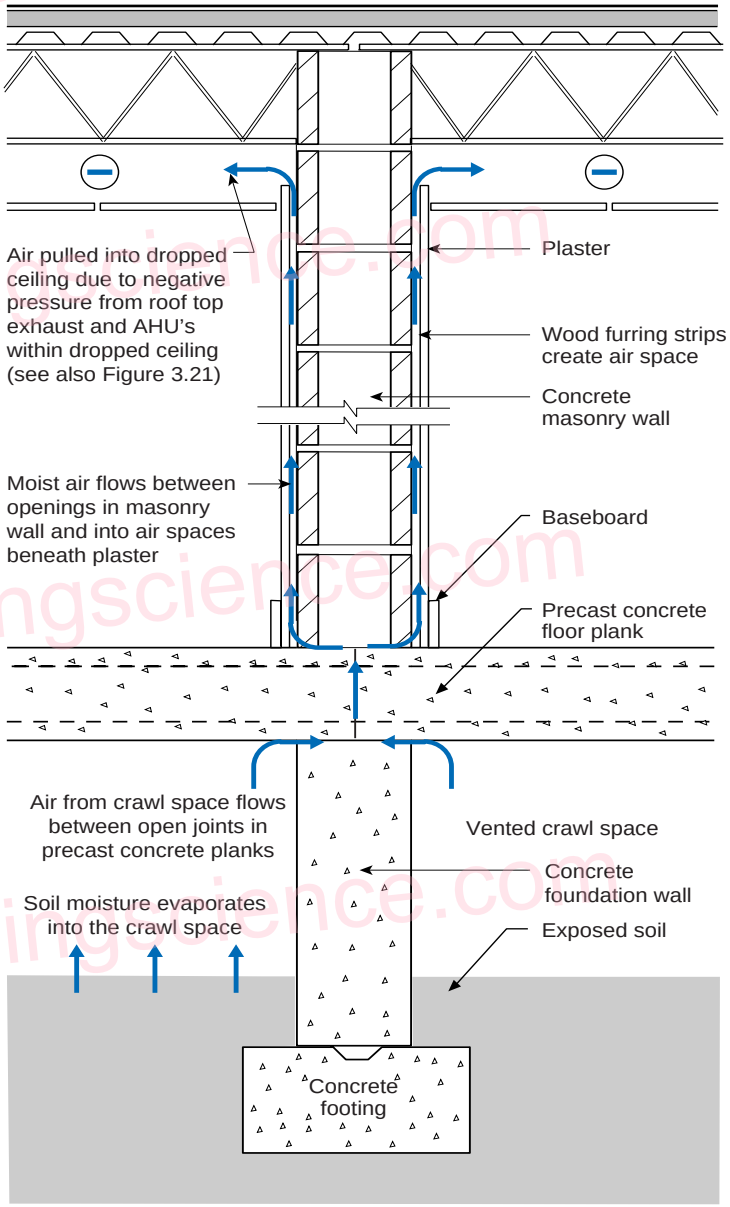
Removal of deteriorated plaster revealed the wall construction. Interior plaster was installed over wood furring strips creating an air space (or channels) between the plaster and the masonry wall. Removal of ceiling tiles indicated that the plaster finish extended just above the dropped ceiling level and that the air space (or channels) between the plaster and the masonry wall was open at the top and connected to the air space above the dropped ceiling. This wall geometry created "chimneys" which extended from the crawl space to the air space above the dropped ceiling.

Moisture (the primary pollutant) in the soil in the crawl space is evaporated due to the elevated temperatures in the crawl space. Warm moisture saturated air migrates through openings in the floor slab into the air space created by the plaster and wood furring (the pathway). The air is pulled into the air space between the plaster and wood furring as a result of the operation of the roof top exhaust fans and the operation of the air handling units (the pressure “drivers”). The moisture saturated air cools once it is in the furring space leading to condensation and saturation of the building materials at this location. The saturation of the building materials leads to their deterioration and the creation of odors and other biological agents (the secondary pollutants). These secondary pollutants enter the classroom and come in contact with the teacher and students (the receptors).

Figure 2
Moisture Movement
- This wall section illustrates moisture movement from the crawl space into the wall cavities and dropped ceiling

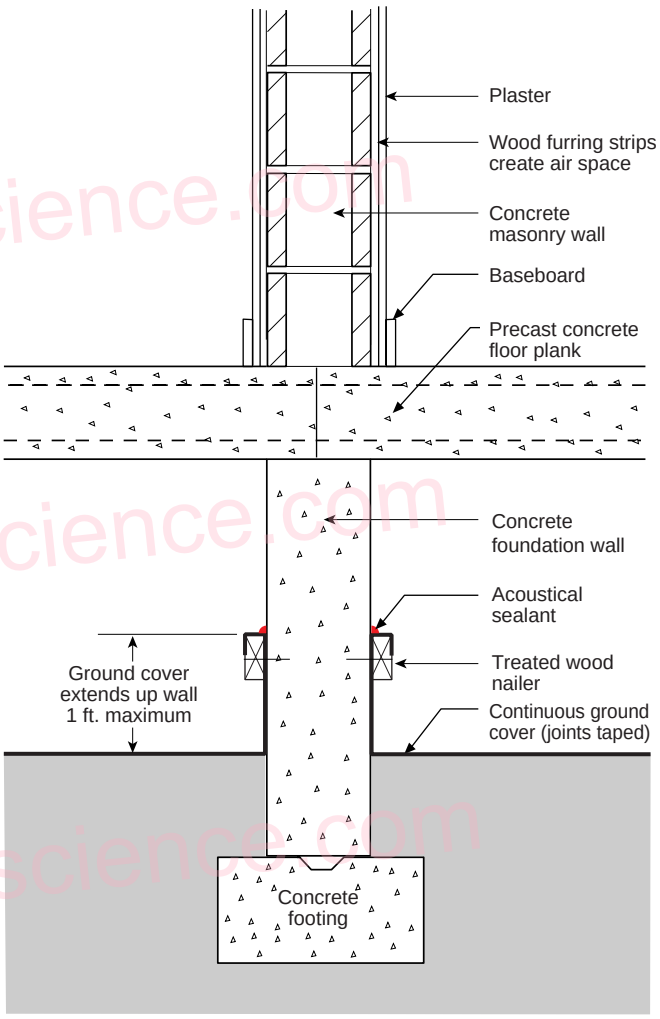
Figure 3
Ground Cover Installation
- This wall section illustrates proper installation of the polyethylene ground cover

The primary pollutant, airborne moisture from the crawl space, was controlled at the source. Crawl space enclosure moisture levels can be reduced only two ways, by limiting moisture source strength (moisture entry) or by dilution (moisture removal by ventilation or dehumidification). A desired result is where the rate of moisture entry is lower than the rate of moisture removal, or where moisture accumulation in building materials does lead to deterioration. In order to achieve this desired result, the control the source strength (moisture entry by evaporation from the ground) was selected rather than dilution (moisture removal by ventilation).

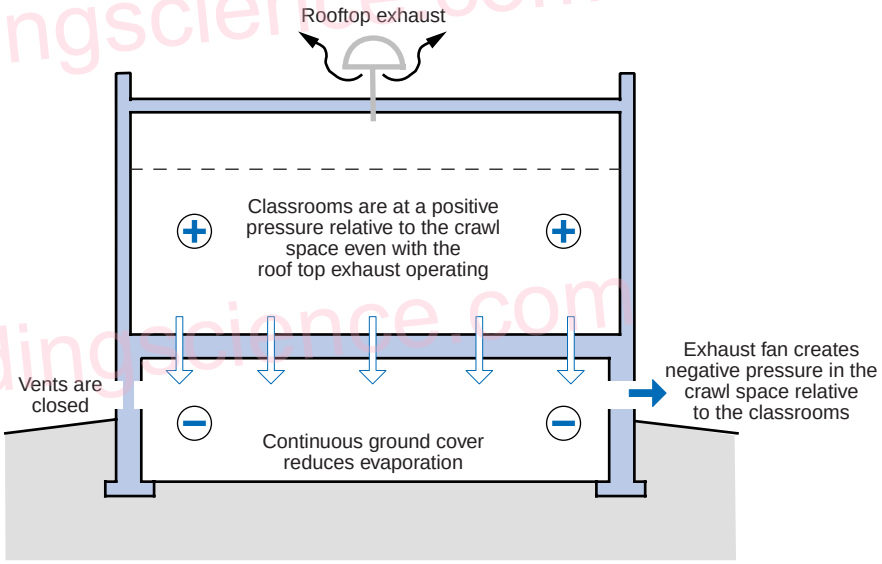
Figure 4
New Air Pressure Relationship
- Closing the crawl space vents and using an exhaust fan in the crawl space depressurizes the crawl space relative to the classrooms

Finally, the driving force for pollutant transfer, specifically the air pressure relationship between the crawl space and the classrooms, was altered by the installation and operation of an exhaust fan (Figure 4). This exhaust fan runs continuously. In order to facilitate air pressure control the crawl space vent openings were permanently closed. Crawl space perimeter walls were insulated creating a conditioned crawl space that is permanently maintained at a slight negative pressure with respect to the classrooms via the operation of the crawl space exhaust fan.

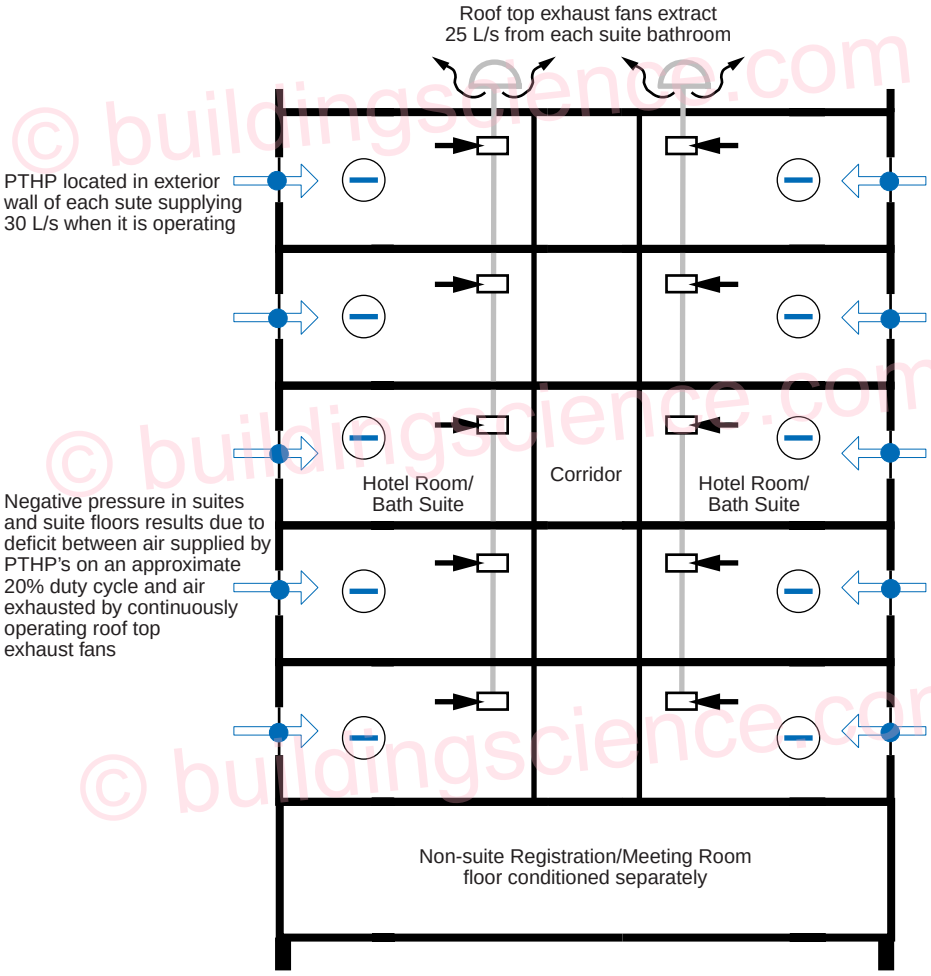
The typical duty cycle of individual PTHP units was found to be about 20 percent. It was estimated that only three suite PTHP's plus the corridor PTHP operate at any one time per floor supplying only approximately 190 L/s of outside air per floor. This yields a deficit of supply to exhaust of approximately 285 L/s per floor.

The deficit of exhaust to supply air flow is responsible for the negative air pressure within the facility. The negative air pressure causes the infiltration of exterior unconditioned air. This unconditioned air is responsible for the high interior humidity except during the winter months when the exterior air has a low moisture content. Additionally, the negative pressure field developed in interior partition walls connected to service shafts is due to leakage of exhaust ductwork contained within the service shafts. This negative pressure field causes the infiltration of exterior unconditioned air into the interior wall cavities leading to mold growth and discoloration of the interior vinyl wall coverings.

Figure 5
HVAC System for Hotel

- 25 L/s is extracted from each suite
- 15 suites per floor plus 100 L/s extracted from each corridor
- 475 L/s extracted per floor
- 2,850 L/s extracted from 6 floors with suites
- Each suite's PTHP supplies 30 L/s when it is operating. One additional PTHP serves each corridor supplying 100 L/s of outside air. A total of 550 L/s is supplied per floor when all the PTHP's on a floor are operating.
- However, the typical duty cycle of a PTHP is approximately 20%, i.e. 80% of the units are off at any one time.
- When 3 suite PTHP's and the corridor PTHP are operating only 190 L/s supplied to a floor. If 475 L/s is extracted per floor, a deficit of 285 L/s exists per floor or 1,710 L/s for all the suite floors combined.

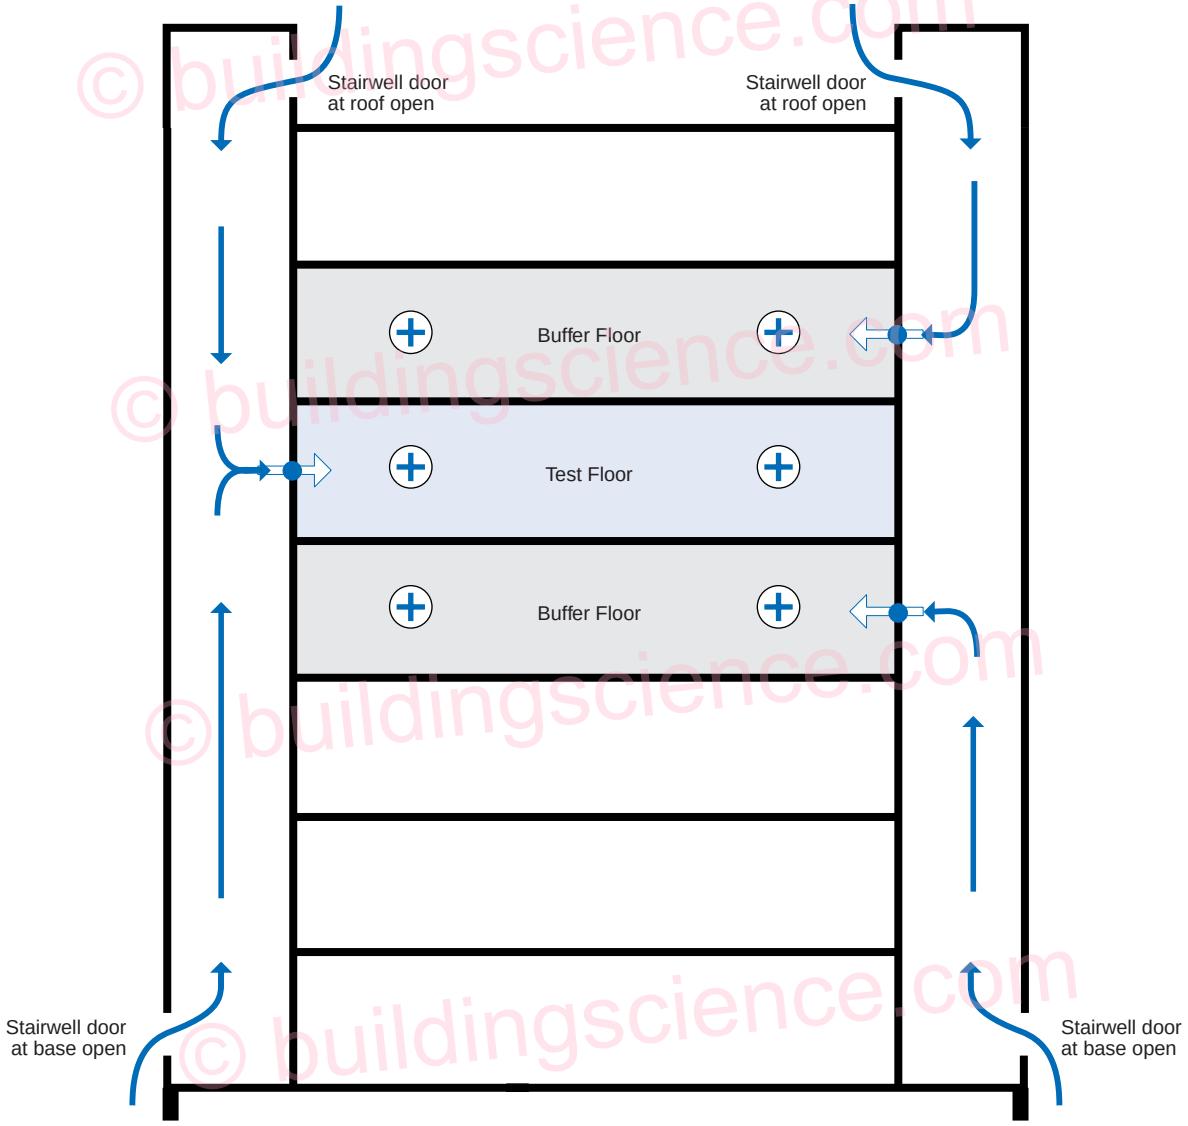
Leakage testing of individual floors was conducted using variable speed pressurization fans. Two types of measurements were taken. The first involved pressurizing an individual floor by extracting air from a stairwell whose exterior doors were opened to the exterior. The floors above and below the floor being tested were maintained at exterior pressure by opening all windows and corridor doors. The second type of measurement involved pressurizing the floors above and below the test floor as well as the elevator shafts to identical pressures to the test floor thereby providing isolation of test floor leakage to floors above and below. The experimental set-up is presented in Figure 6.

Figure 6
Air Leakage Test Zones

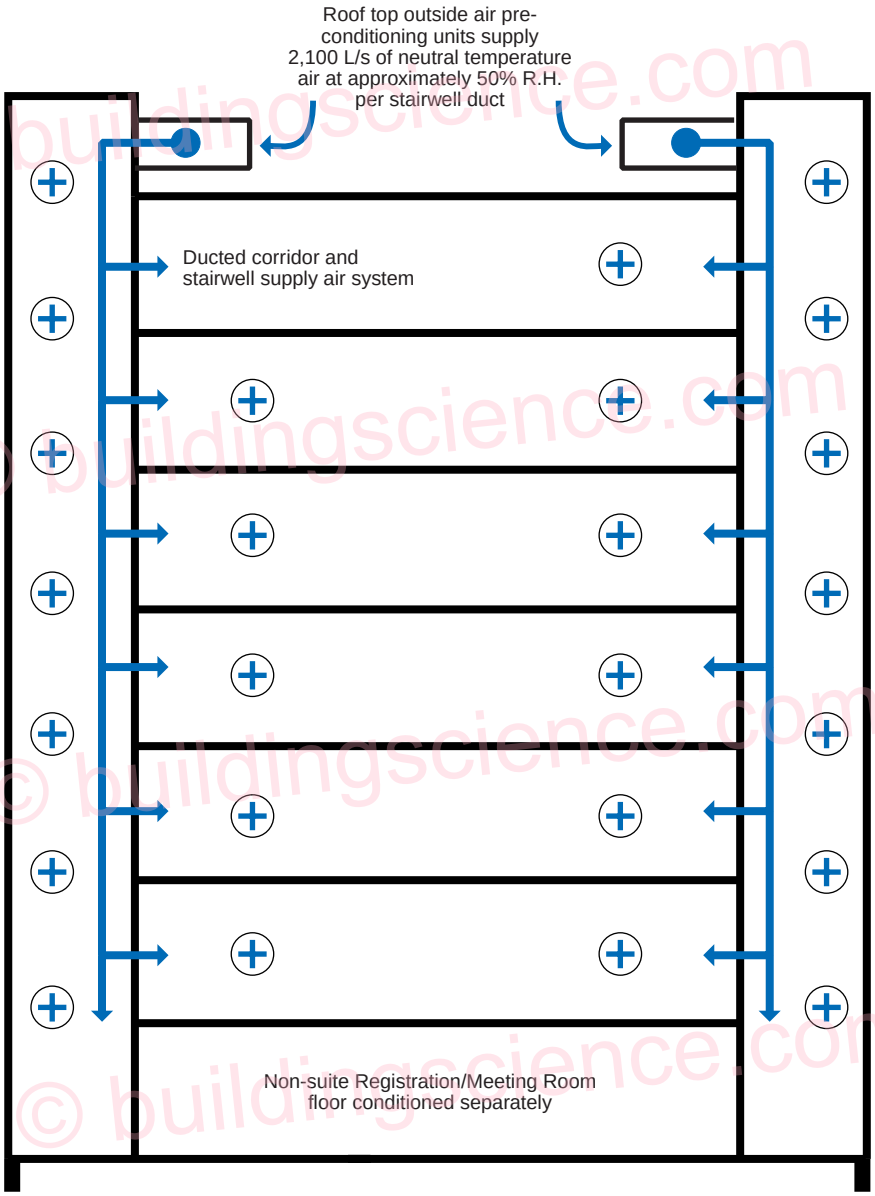
Figure 7

New Air Pressure Relationships

- Hotel suite floors supplied with 4,200 L/s of preconditioned air
- Hotel suite floors are exhausted to a total of 2,850 L/s
- Surplus of 1350 L/s pressurizes suite floors
- Stairwell held open with magnetic latches

- In order to achieve pressurization, the existing supply air vents in each PTHP unit are permanently closed.
- Two roof top units supplying 2,100 L/s of neutral temperature air at approximately 50 percent relative humidity are used to supply 700 L/s of air to each floor (Figure 7).
- The existing exhaust system is balanced to extract 475 L/s from each floor.
- The supply excess of approximately 225 L/s per floor pressurizes each floor approximately 2 Pascal's relative to the exterior.
- A grill is installed between the corridors and each service shaft at each floor to allow the extension of the corridor air pressure field into the service shafts at each floor thereby eliminating the previous negative pressure field that extended from the service shafts within interior partition walls to the exterior (Figure 8).

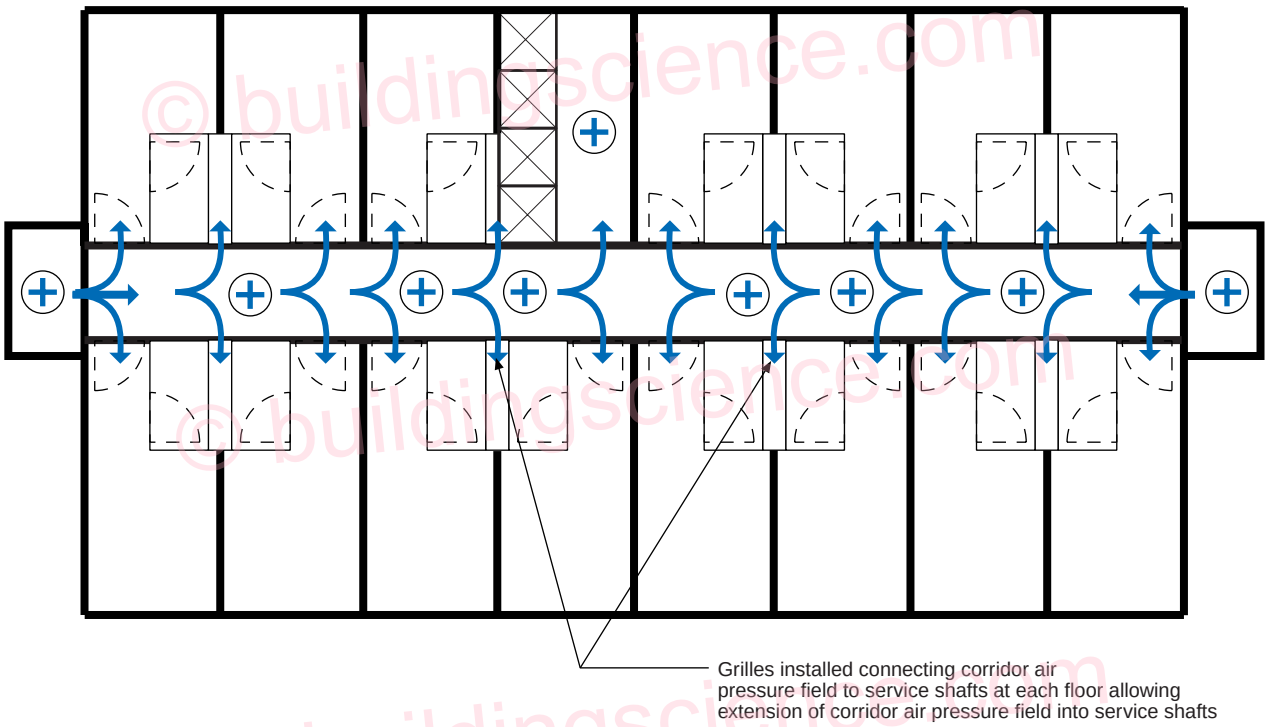
Figure 8
Supply Air Approach
Plan View

- 700 L/s supplied to each corridor from ducted system in each stairwell
- A total of 4,200 L/s is supplied for all suite floors combined via two stairwells (or 2,100 L/s per stairwell)

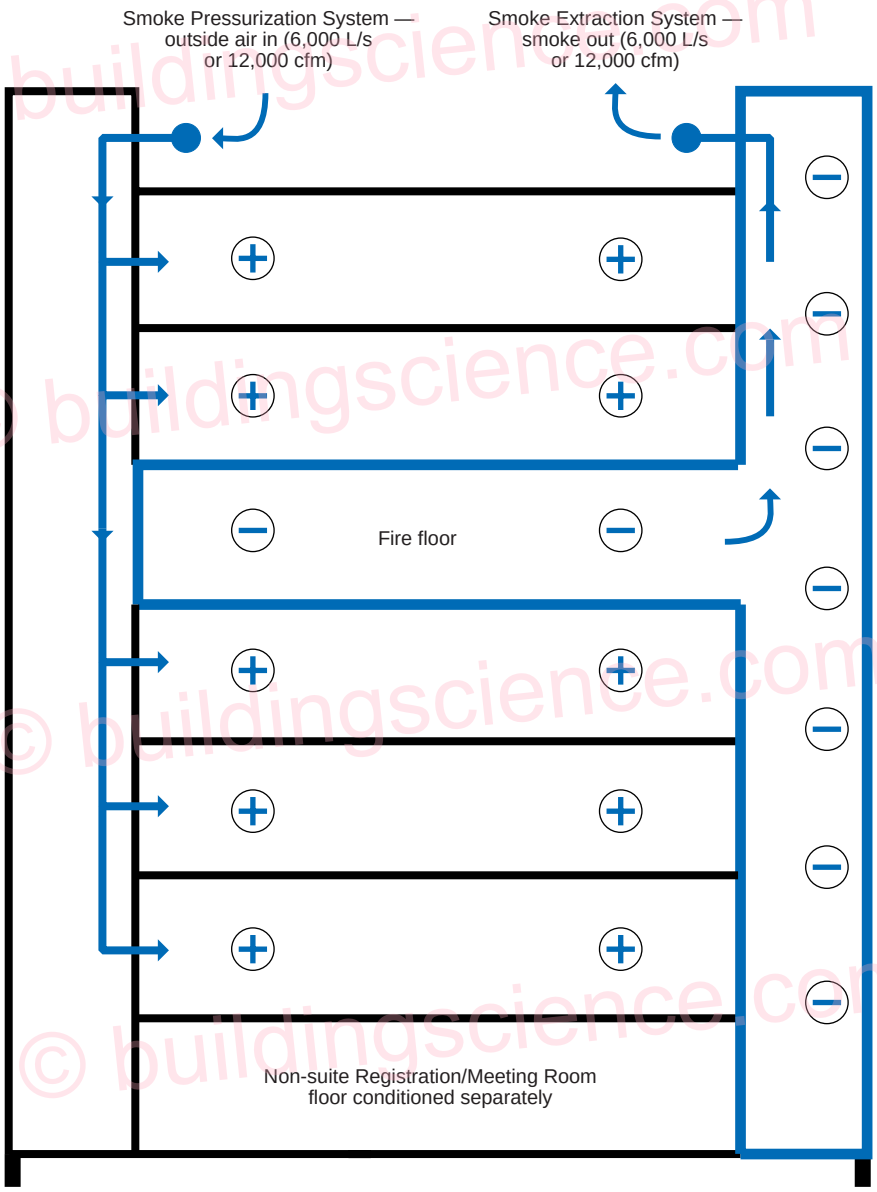
Figure 9

Smoke Extraction System

- If hotel is pressurized 25 Pa and smoke floor/floors are depressurized 25 Pa, net minimum smoke control pressure difference is greater than the design specified 25 Pa
- Approximately 1,000 L/s per floor is required to pressurized each floor 25 Pa relative to the exterior or approximately 6,000 L/s to pressurize the 6 hotel floors with suites when the roof top exhaust systems are not operating

A smoke pressurization and smoke extraction system was also designed using the pressurization test results (Figure 9). A minimum 25 Pascal pressure difference between fire floors and non fire floors was specified as a design criteria. Approximately 1000 L/s was found to pressurize each floor approximately 25 Pascal's relative to the exterior when the roof top exhaust fans are not operating. Conversely, an approximate exhaust flow of 1,000 L/s was found to depressurize each floor 25 Pascal's relative to the exterior when the corridor supply system is not operating. By supplying 1,000 L/s to non fire floors and extracting 1,000 L/s from fire floors when the supply and exhaust systems are de-energized a greater than 25 Pascal pressure difference can be maintained.

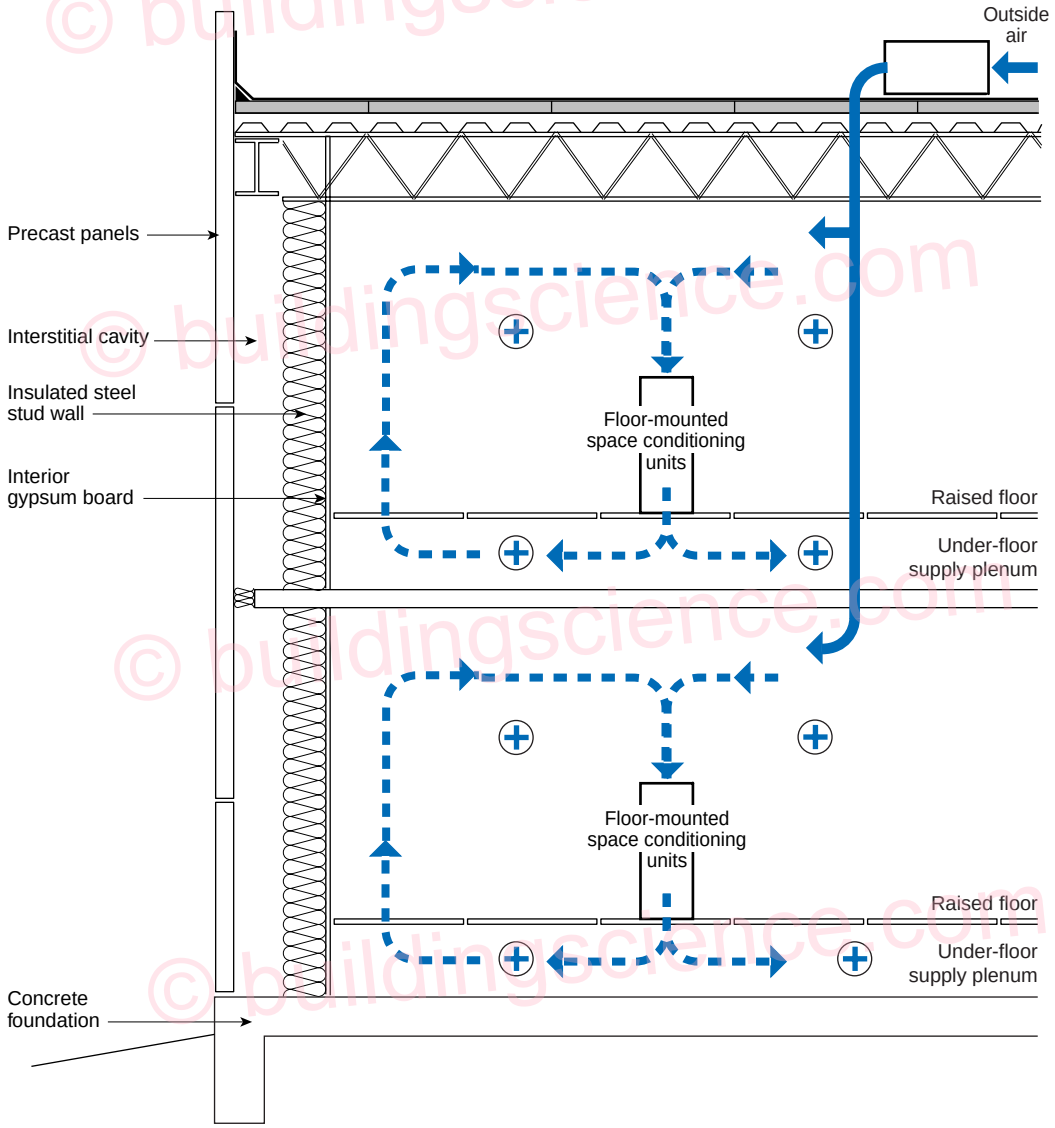
The space conditioning and outdoor air systems (Figure 10) create a pressurized enclosure that is maintained at 24 degrees C., 50 percent relative humidity year round.

Figure 10
HVAC System as Designed

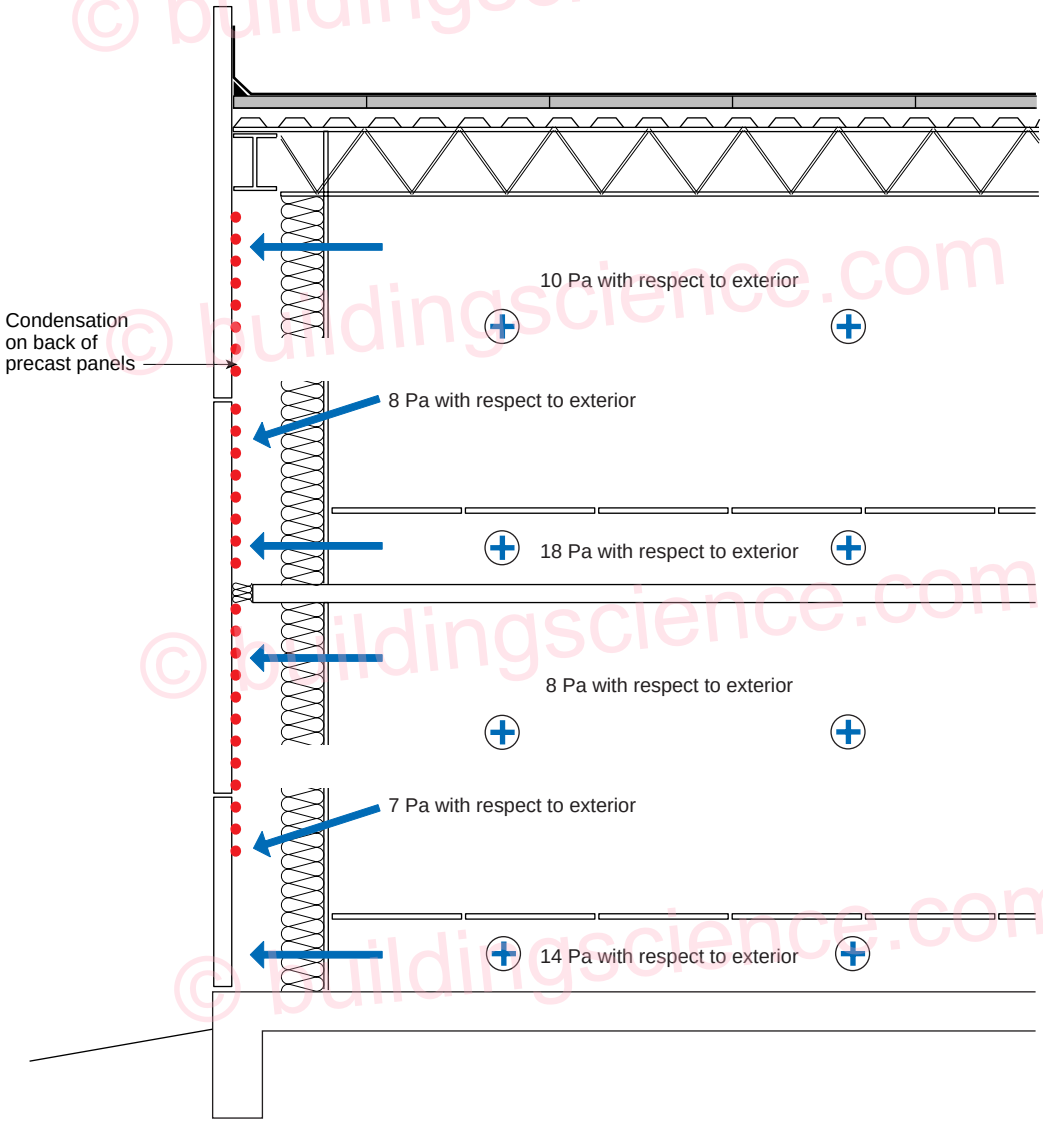
Air pressure differential measurements of the facility and interstitial cavities ("pressure mapping" of the facility) were taken when exterior temperatures were approximately 15 degrees C. Wind conditions were dead calm. The air pressure differential relationships as measured are presented in Figure 11.

The pressurization of both the occupied space and the area under the raised floors leads to the exfiltration of interior moisture laden air into the interstitial cavities between the precast panels and the interior insulated steel stud walls.

Condensation on the cavity side of the precast panels occurs whenever the exterior temperature drops approximately 5 degrees C below the dew point temperature of the interior air/vapor mix. Based on interior conditions, the exterior temperature at which condensation typically occurs is approximately 10 degrees C.

The precast panels are significantly tighter than the interior insulated steel stud wall assembly as can be seen by examining the ratio of air pressures across the assemblies (approximately 80 percent of the air pressure drop across the exterior wall assembly occurs across the precast panels). The rate of moisture entry into the wall cavities via air flow is greater than the rate of moisture removal by air flow.

Figure 11
Unintended Pressurization of Interstitial Cavity

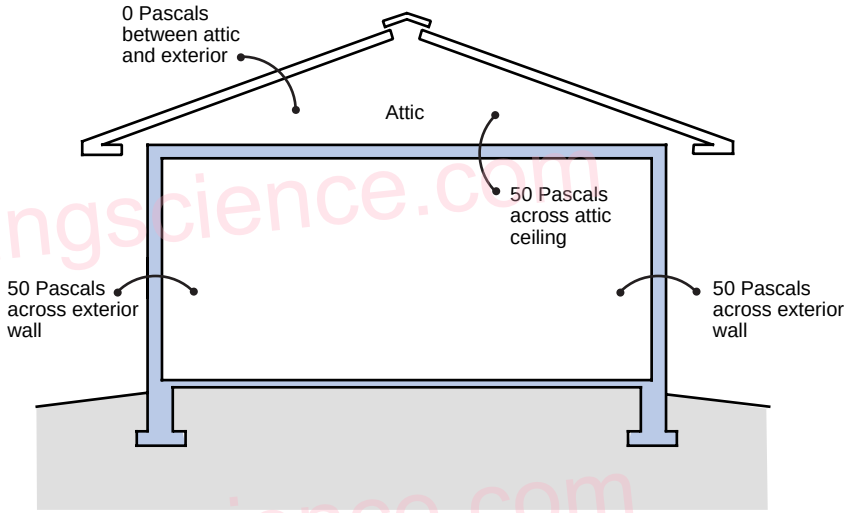
A tightly constructed attic ceiling with a well vented attic cavity would be expected to have an air pressure drop approaching 50 Pascal's, and an extremely leaky attic ceiling would have an air pressure drop much lower than 50 Pascal's. In residential construction, with code compliant attic ventilation ratios (i.e. 1:300), insulated ceiling air pressure drops greater than 40 Pascal's are viewed as providing acceptable performance by the author when a building envelope is depressurized 50 Pascal's. In other words, acceptable performance requires that more than 80 percent of the air pressure drop should occur across a well-defined pressure boundary (the attic ceiling gypsum board in this example). Acceptable performance being defined arbitrarily as buildings with vented attics in cold climates not experiencing ice damming, roof sheathing moisture induced deterioration or upper floor thermal comfort complaints.

In this condominium development, air pressure measurements were taken across insulated ceilings when units were depressurized 50 Pascal's relative to the exterior. Measurements ranged between 25 and 35 Pascal's in the dozen units tested. These values signify extremely leaky attic ceiling construction, extremely poor attic ventilation or some combination of both.

Figure 14
Poorly-Defined Pressure Boundary
- Pressure boundary poorly defined — ineffective at ceiling
- Pressure boundary not continuous at ceiling

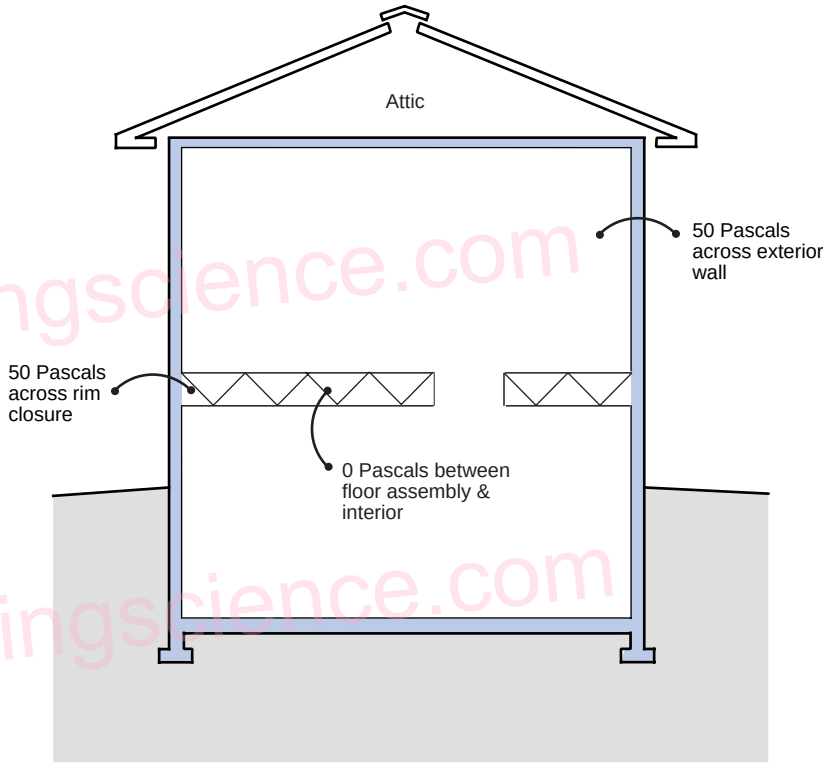
Figure 16
Leaky Rim Closure

- Floor assembly “outside” pressure boundary
- Pressure boundary not continuous at rim closure
