Field Testing of an Unvented Roof with Fibrous Insulation, Tiles, and Vapor Diffusion Venting

Building America Report - 1511

November 2015

Kohta Ueno and Joseph Lstiburek

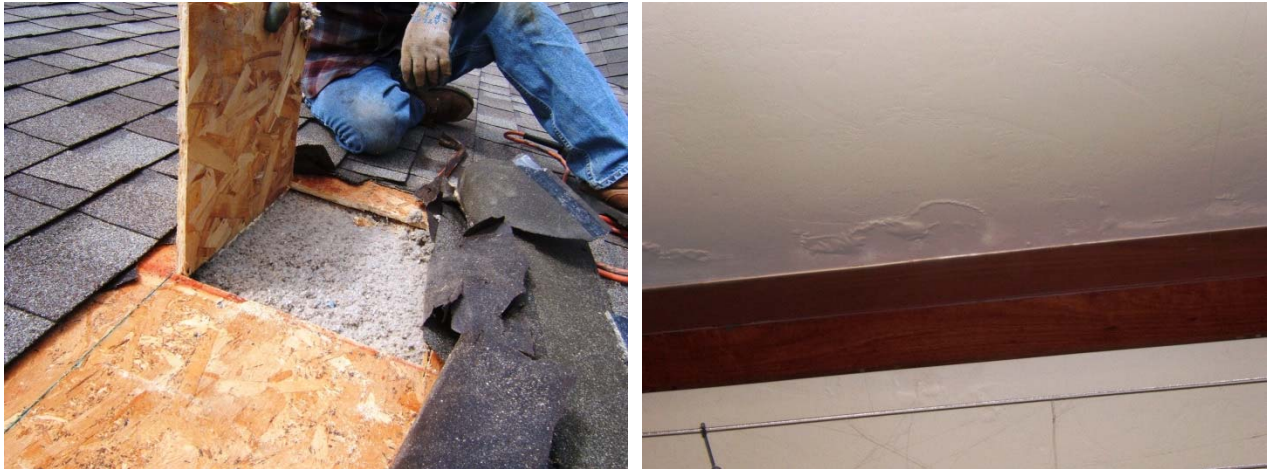
Figure 12. Dry sheathing lower at roof (left); interior ridge conditions (right)

These issues arose soon after construction (during the first winter); the problems were manifested as paint blistering at the interior gypsum wallboard (GWB) near the roof (Figure 12, right), because the accumulated condensation dripped. The issue was definitely localized at the ridge of the roof; disassembly at a lower section of the roof showed dry sheathing conditions (Figure 12, left). Air barrier imperfections at the interior GWB (especially at the ridge board interruption) were contributing factors.

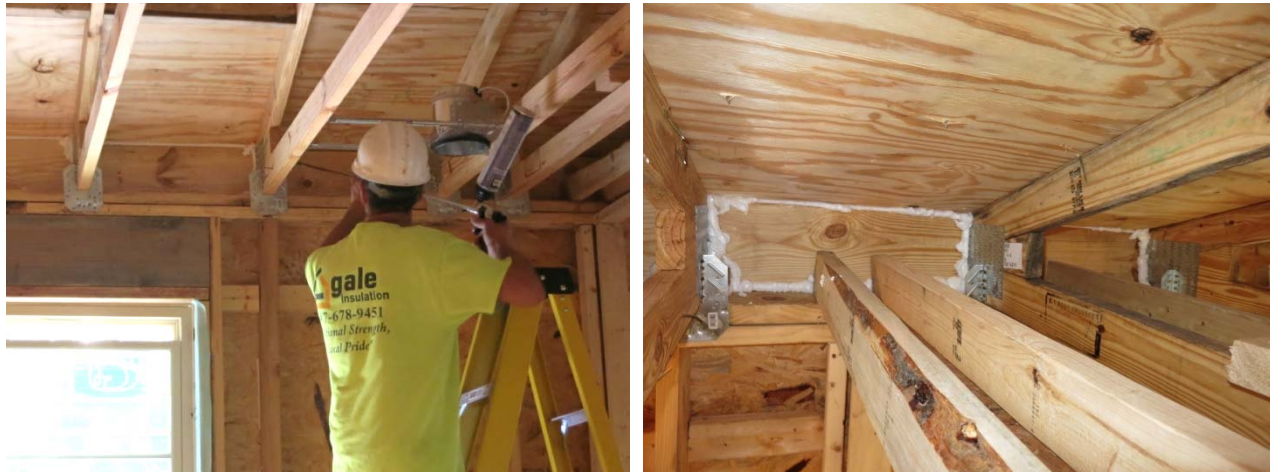
Figure 19. Air sealing roof-to-wall connection; note 2x blocking and single-component foam

At the roof-wall (eave/overhang) interface, the air barrier connection was made using 2x wood blocking between the wall top plate and roof sheathing; gaps were filled with single-component urethane foam (Figure 19). Two-component SPF was used at this connection in other projects, which would have provided more effective coverage and air sealing and possibly more resistance to long-term movement.

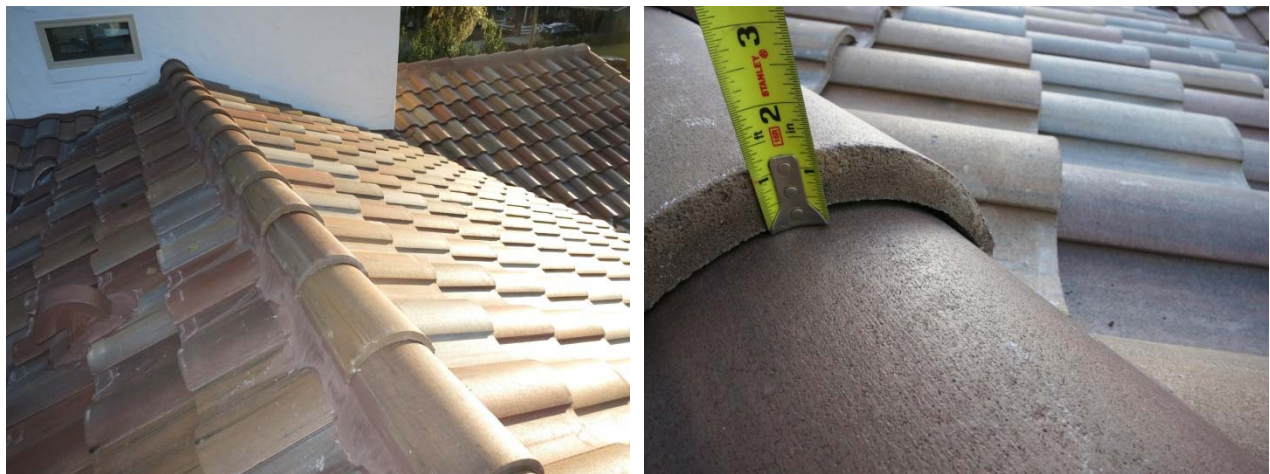
Figure 26. Completed roof ridge tile geometry (left); gaps in ridge tile (right)

At the ridge metal channel (Figure 25 right), some type of open-weave mortar mesh was placed between the metal and the roof tile to ensure an open air channel for lateral airflow. Air flows under the roof tiles and exits through the gaps between the ridge tiles.

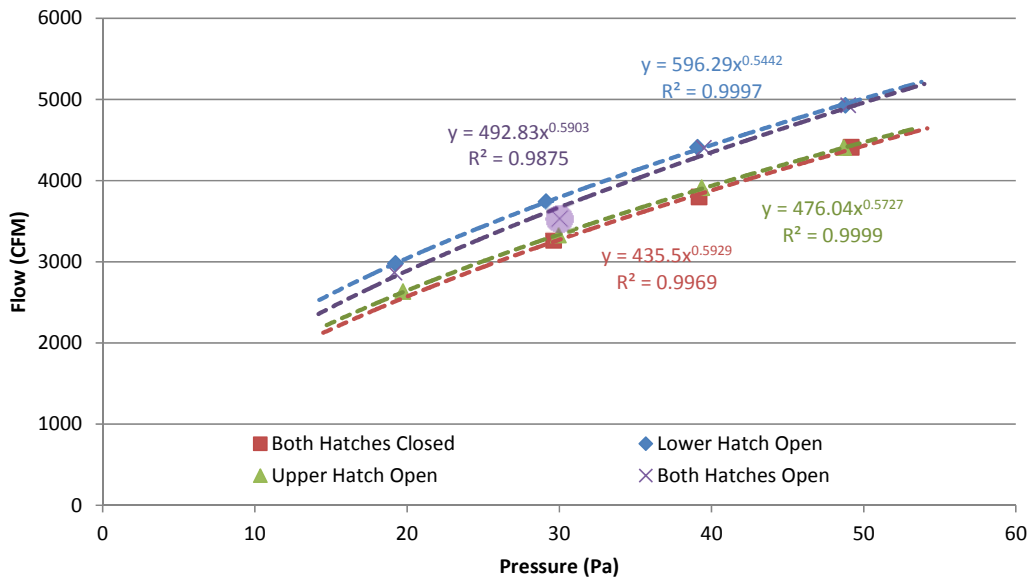
Figure 35. Hatch open/hatch closed multipoint testing with curve fits

The final test (both hatches open) was first calculated to be more airtight than the one hatch open test (an unreasonable result). However, after removing an outlier data point (highlighted in Figure 35, “select data” in Table 3), the results of the two tests were almost identical.

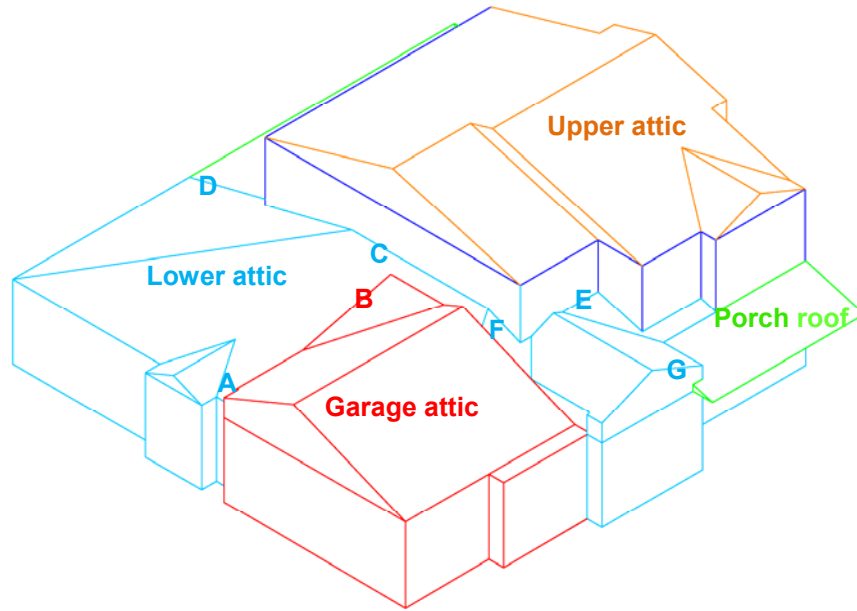
Given the high leakage area associated with the lower attic, the lower attic was examined with infrared thermography with the house and attics depressurized to localize air leakage. Outdoor conditions were cool (~50°F/10°C) during this testing. The areas in Figure 41 through Figure 46 are keyed to the isometric in Figure 40.

Figure 40. Front-left isometric of unvented roof geometry, keyed to Figure 41 through Figure 46

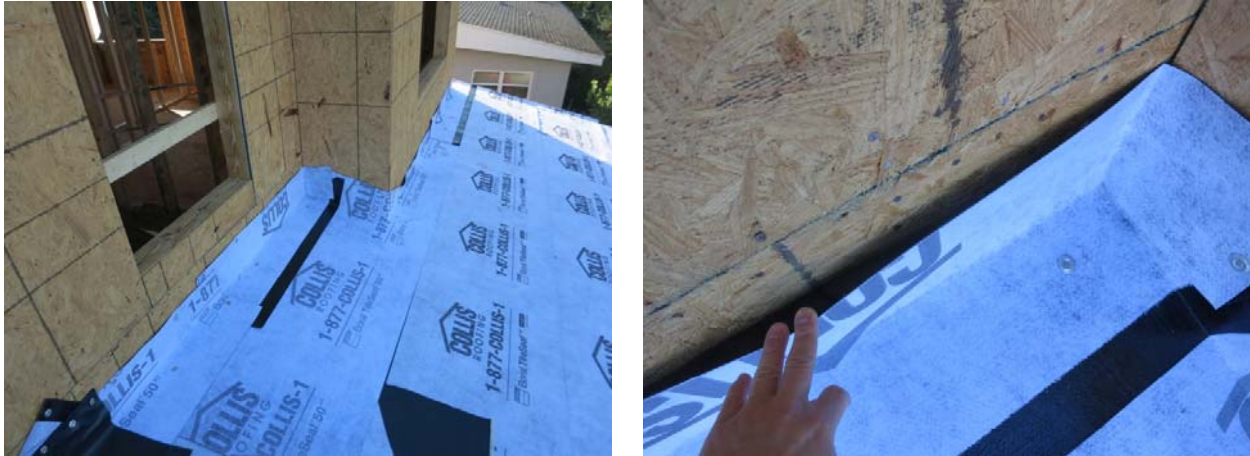
The presence of roof-wall leakage was originally puzzling, given the use of a self-adhered roof membrane that laps onto the wall sheathing. However, examination of construction photos (taken at Location E; Figure 46) showed that membrane adhesion to the vertical wall surface was not consistent; gaps and openings sometimes occurred. Although this detail would provide excellent service for rain control (assuming shingle lapping of the house wrap onto the roof membrane), it was apparently not sufficient for air barrier detailing.

Figure 46. Construction image of roof-wall interface self-adhered membrane (Location E)

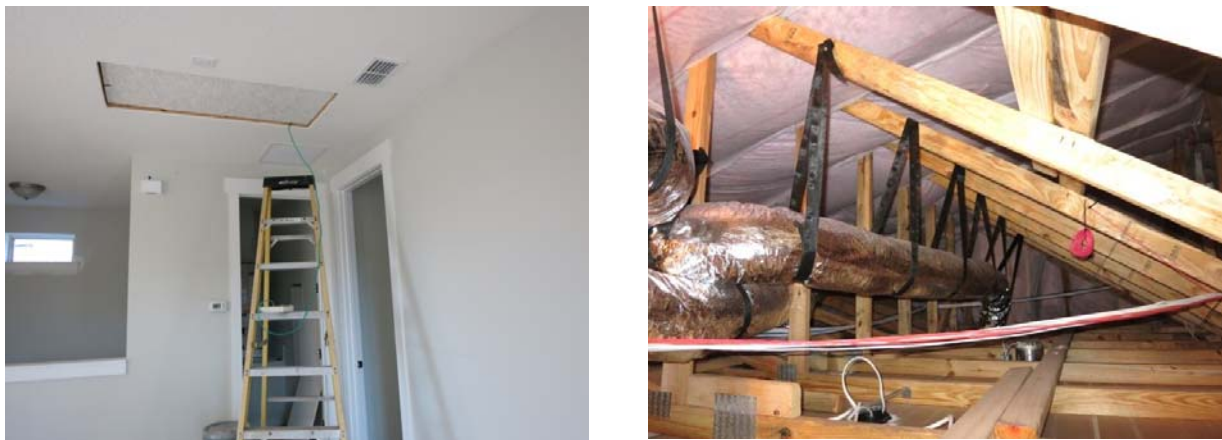
Figure 47. Upper attic ΔP measurement (left); ductwork located in upper attic (right)

The baseline (fan off) measurements of attic pressure (with respect to the main space) varied from 0 Pa to -0.1 Pa. The measurements after turning on the air handling unit were essentially unchanged (0 Pa typical), indicating that any pressurization or depressurization caused by air handling unit operation in this house is minor.

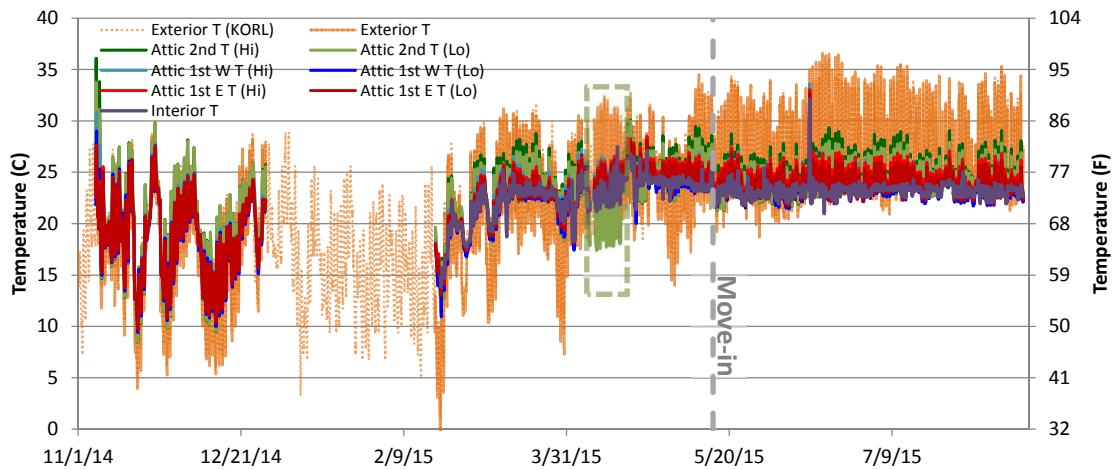
Figure 48. Exterior, attic, and main conditioned space temperatures

There was a temperature anomaly in April 2015, when the second-floor attic (“Attic 2nd T”) temperatures dropped to near-ambient conditions (highlighted in green in Figure 48). This was ascribed to painting work with open windows and an open attic hatch (per the site supervisor).

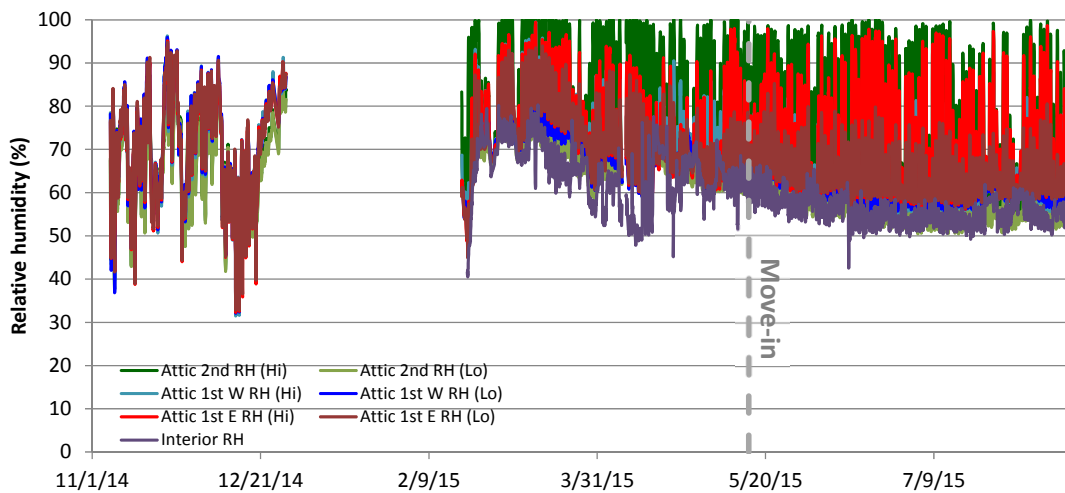
Interior RH is plotted in Figure 51; after the data gap (post mid-February 2015). Attic RHs oscillate between very high (90%–100%) and lower (75%–80%) levels on a diurnal cycle. This period includes conditioned and unconditioned periods; the thermostat was apparently set for cooling only, and the system was operated intermittently (see interior temperatures in Figure 48). After the cooling system was put in operation, interior space RH dropped slowly over time (from roughly 70% to 50%–60%). However, attic peak RHs still cycled up to the 90%–100% range.

Figure 51. Attic and main conditioned space RH

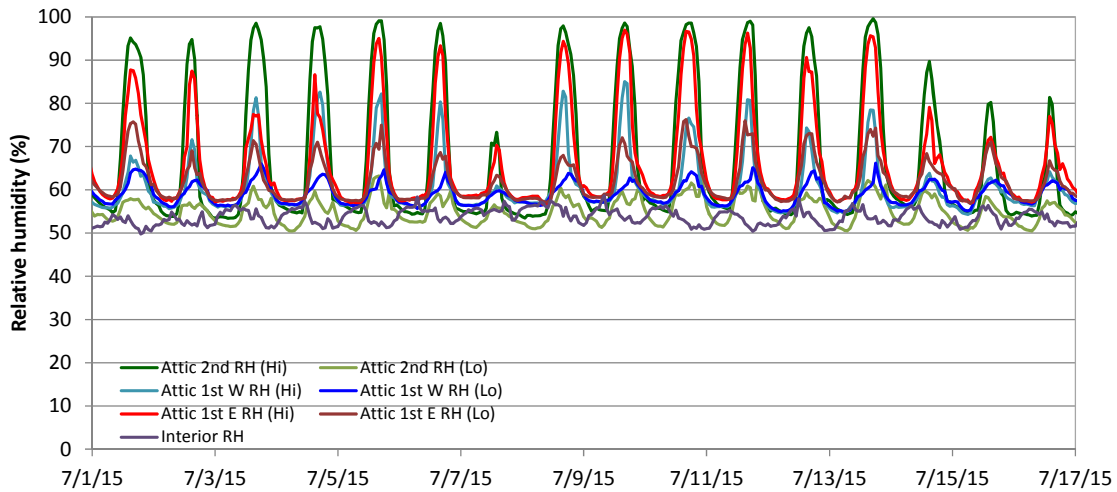
A detail of July RH data (Figure 52) shows that interior RHs are well controlled (50%–60%), but several attic sensors have daily peaks up to 90%–100% RH. The highest RH readings are associated with sensors capturing the upper one-third of attic air conditions (Hi sensors). In contrast, lower one-third (Lo) sensors have less pronounced peaks. These patterns are discussed further below.

Figure 52. Attic and main conditioned space RH, July 2015 detail

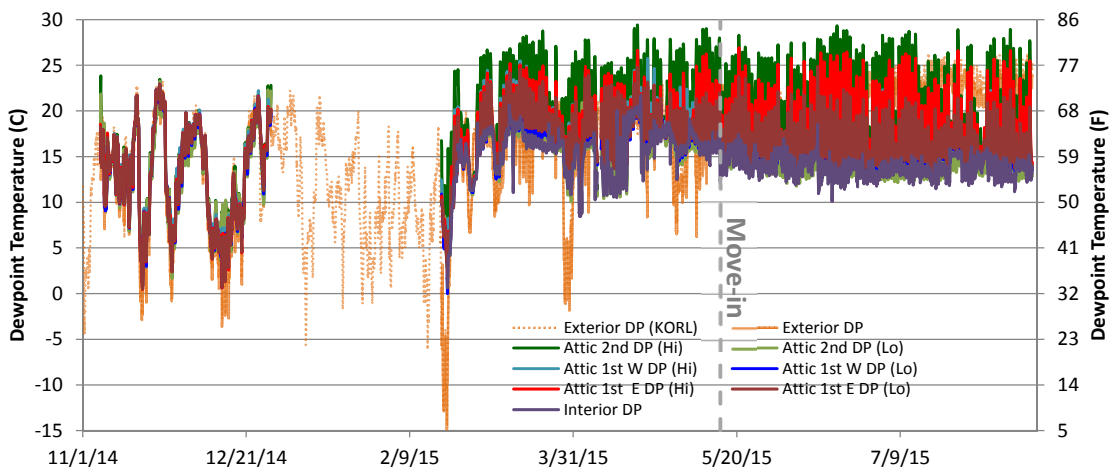
Further insight can be gleaned by plotting moisture conditions in terms of absolute air moisture content (dew point), which removes temperature-RH effects, and allows comparisons with outdoor conditions (Figure 53). The initial data (pre-January 2015) show identical conditions between interior and exterior dew points; after resumption of data collection (February 2015), interior dew points are higher than exterior. The site supervisor confirmed that drywall mudding and interior painting occurred during the missing data period (i.e., construction moisture created interior moisture loads). Similar to RH plots, interior conditions are drier than attic conditions and show a gradual decline over the cooling season.

Figure 53. Exterior, attic, and main conditioned space dew point temperatures

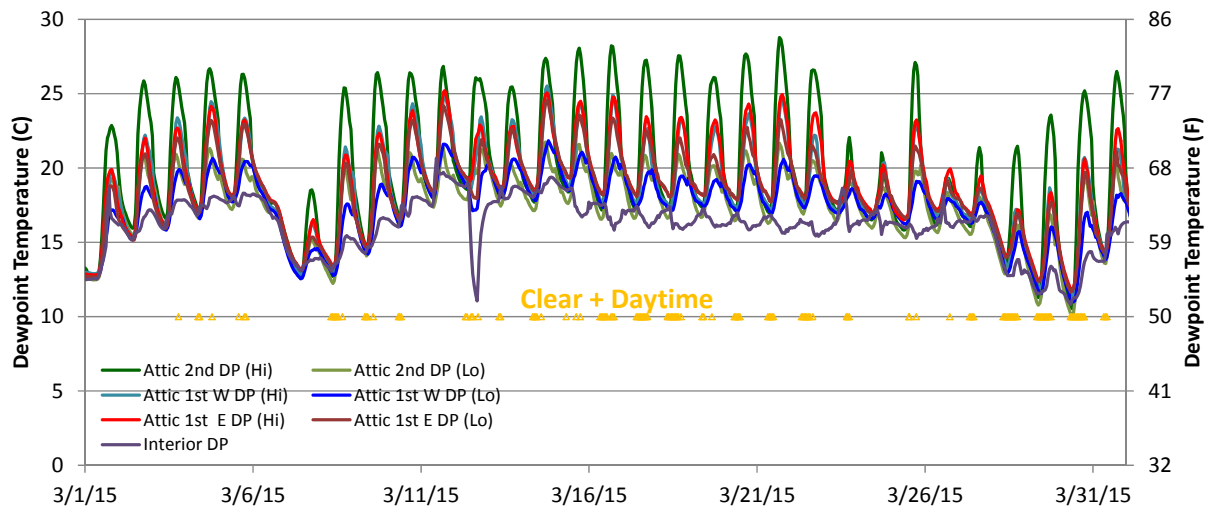
A close-up of March 2015 dew point data is shown in Figure 54: interior dew points exhibit a diurnal cycle; the peaks in these data are typically at 5–6 p.m., which is a rough match to sunset.

Figure 54. Attic and main space dew point temperatures (March 2015) with sky conditions

The diurnal cycles are not consistent day to day; some days have much more pronounced dew point spikes. Weather data (from KORL) were plotted with marker points on hours with “Clear” sky conditions during daylight hours (“Clear + Daytime”; gold dots) in Figure 54. This figure shows days with minimal dew point spikes were typically overcast conditions (e.g., March 24 and March 25). This is consistent with dew point rise being caused by moisture driven out of the roof sheathing by solar gain and temperature rise.

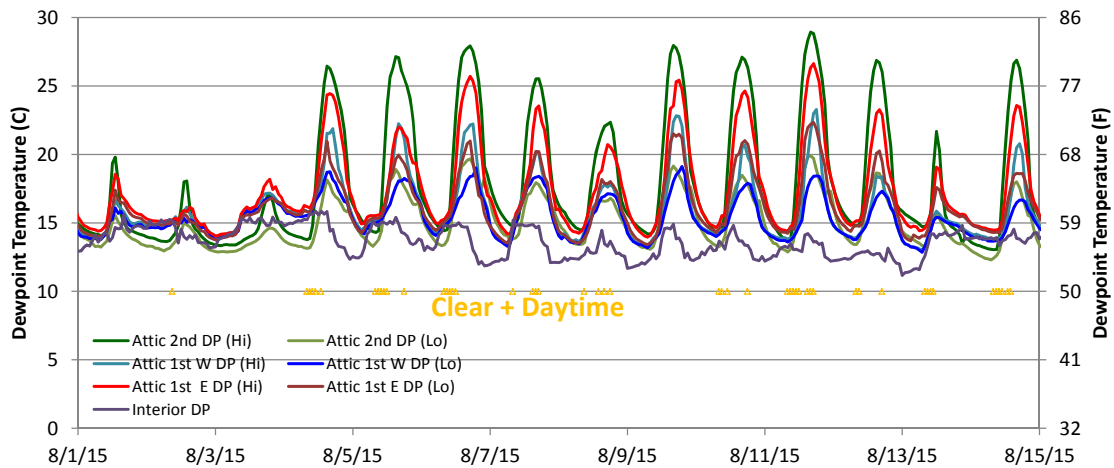
This pattern is also seen in summertime data, such as an August excerpt (Figure 55). Large dew point spikes typically coincided with clear daytime conditions. The same relative attic dew point patterns are seen. The effect of solar gain could also be gauged by plotting roof sheathing temperature.

Figure 55. Attic and main space dew point temperatures (August 2015) with sky conditions

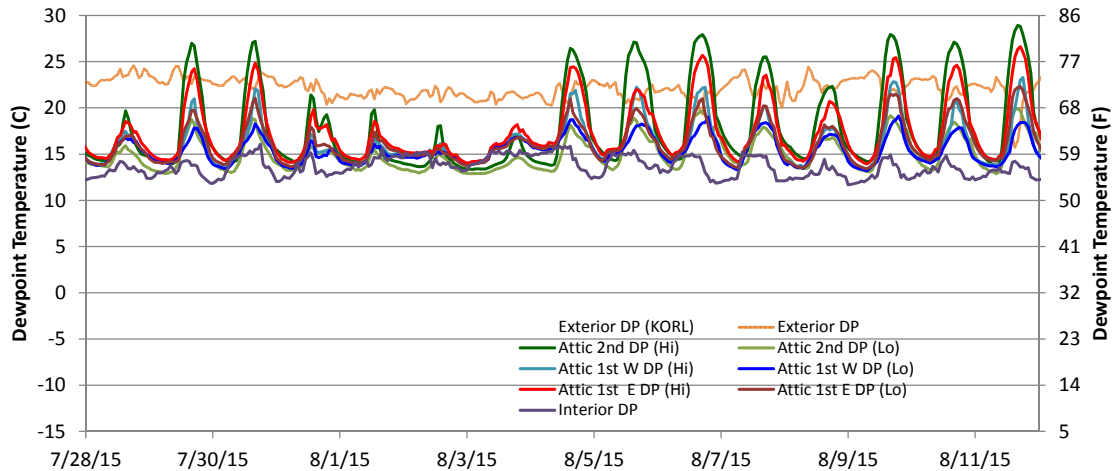
Figure 57. Interior and exterior dew point temperatures, August 2015 detail

Typical August dew point conditions are shown in Figure 57; exterior dew point is consistently higher (wetter) than interior main space conditions and typical attic conditions. However, the

daily dew point spikes are higher than exterior conditions. This indicates that high moisture in unvented attics is not solely due to air leakage; interior-sourced moisture and adsorbing and desorbing moisture play an important role.

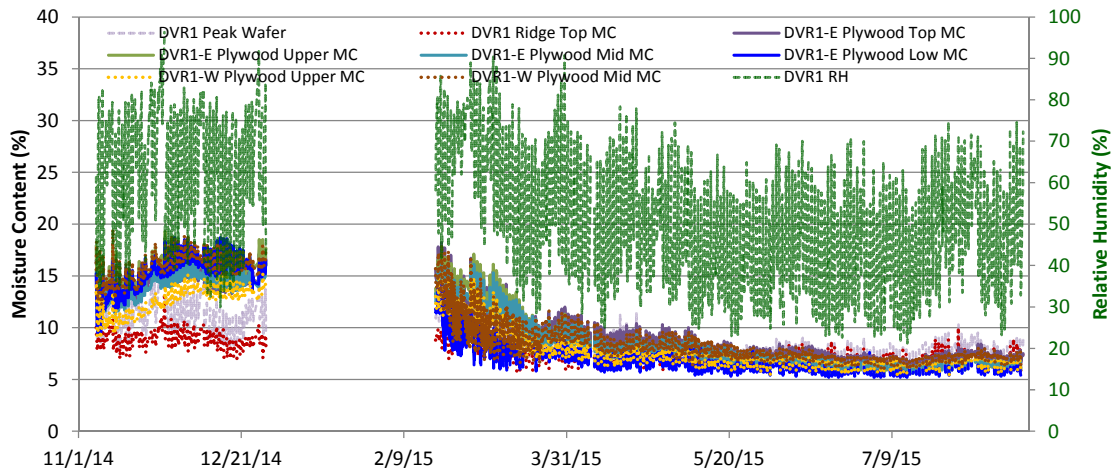
Figure 60. Diffusion vent ridge (DVR1) MC and RH measurements (upper/second-floor attic)

Although the MCs increased after the data gap (i.e., cold weather; addition of interior construction moisture), accumulation was nowhere near levels seen in UVR1 (almost all were lower than 20%). Peak RHs were also drier: they did not hit the 95%–100% levels seen in UVR1. The MCs dropped in the spring, correlating with warmer weather; all were much lower than 10% during the summer. The RH levels did not show such a steep drop into the spring as UVR1. RH levels oscillated noticeably at the ridge compared to UVR1.

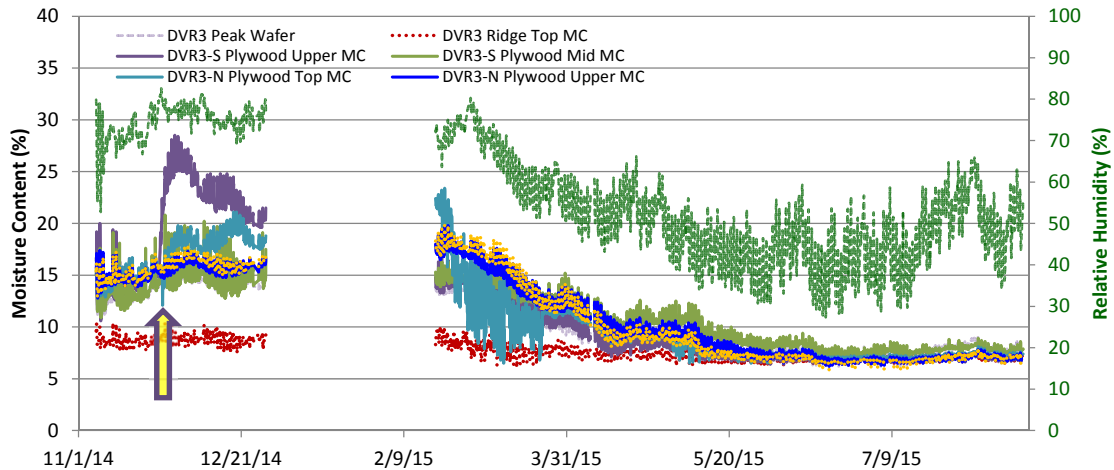
Figure 62. Diffusion vent ridge (DVR3) MC and RH measurements (lower/first-floor attic)

One anomaly was seen at the south plywood upper MC of DVR3 (yellow/purple arrow in Figure 62): MC jumped suddenly in late November 2014; the moisture then dried to safe levels in the spring. This is suspected to be rain leakage; a thunderstorm in the weather data coincided with the jump. However, MC jumps (i.e., further water leakage) did not recur.

One possible roof leak was seen at the south plywood upper MC of DVR3 in November 2014; a sudden jump in MC occurred that later dried. This jump coincided with thunderstorm activity. However, no further wetting was seen in the data. Results from this sensor will be tracked over time.

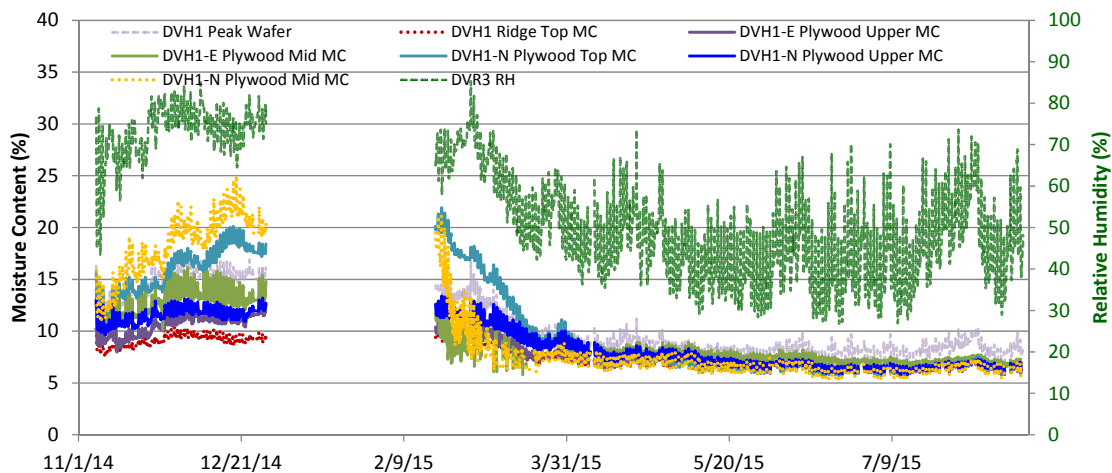
Figure 63. Diffusion vent roof hip (DVH1; lower) MC and RH measurements

A similar pattern to the diffusion vent ridges was seen with high MCs after the data gap, but they were not as wet as the unvented roof. Peak MCs were in the 18%–23% range; MCs then dried as outdoor temperatures increased. RH measurements followed a similar pattern; peak RHs were about 85%.

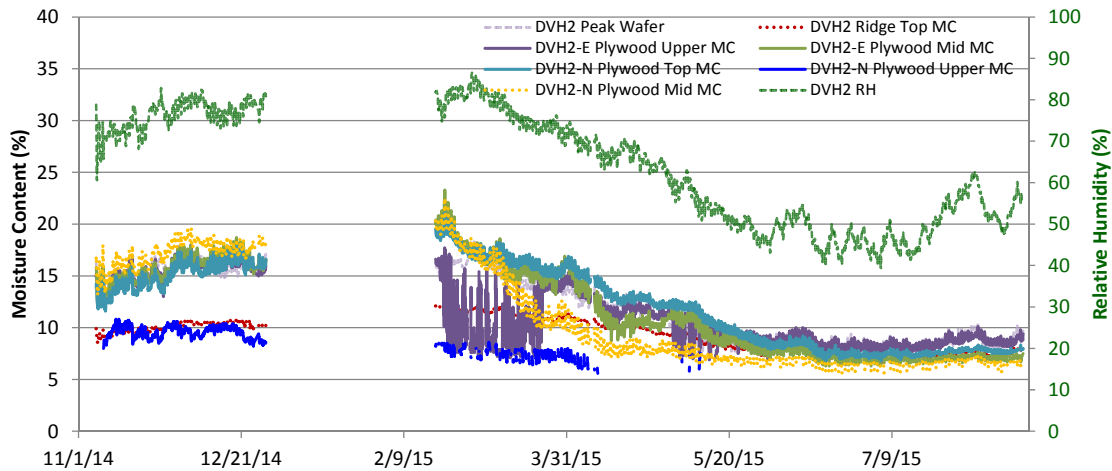
Figure 64. Diffusion vent roof hip (DVH2; upper) MC and RH measurements

The lower diffusion vent hip measurement (DVH1) is fully exposed to the sun, while the upper measurement (DVH2) is shaded by the adjacent second story and roof. The roof-wall interfaces (RW1 and RW2) lie directly north of the wall in shadow. DVR3 (diffusion vent at the front of the house) is shaded for part of the day (morning), depending on the season and sun position. All these observations are consistent with higher RHs and MCs seen at RW1, RW2, and DVH2.

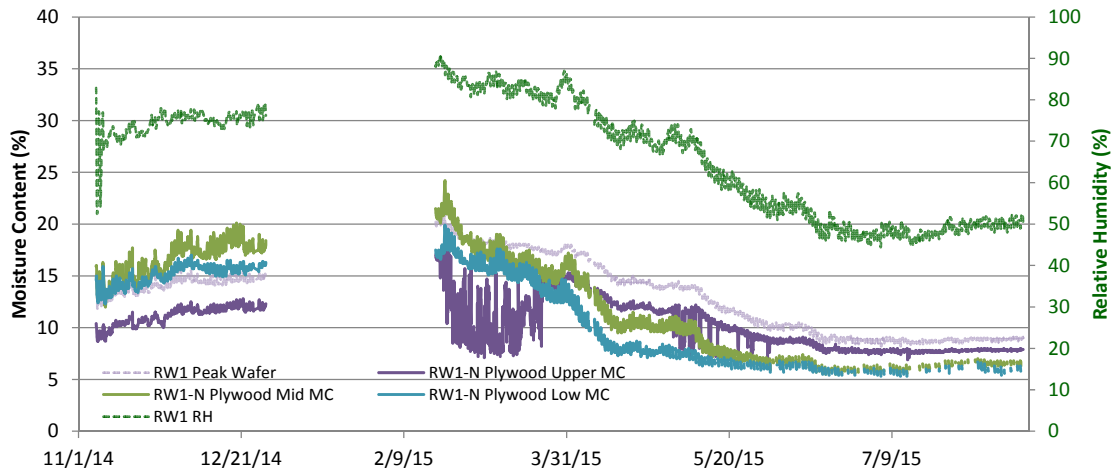
Figure 65. Roof-wall (RW1) MC and RH measurements (downhill area)

Similar patterns were seen of higher wood MCs after the data gap, which then dried in the spring. However, absolute values of MCs were higher more than 20% higher than the previous diffusion vent measurements. This might be ascribed to either the geometry (no diffusion vent) or possibly shading issues (discussed in Section 4.8.3). Similarly, RH levels were slightly higher than previous diffusion vent measurements.

No clear differentiation was seen between the two measurements, which would indicate the effect of downhill contributory roof area. RW1 shows a clear pattern of vertical moisture stratification in the springtime MC measurements.

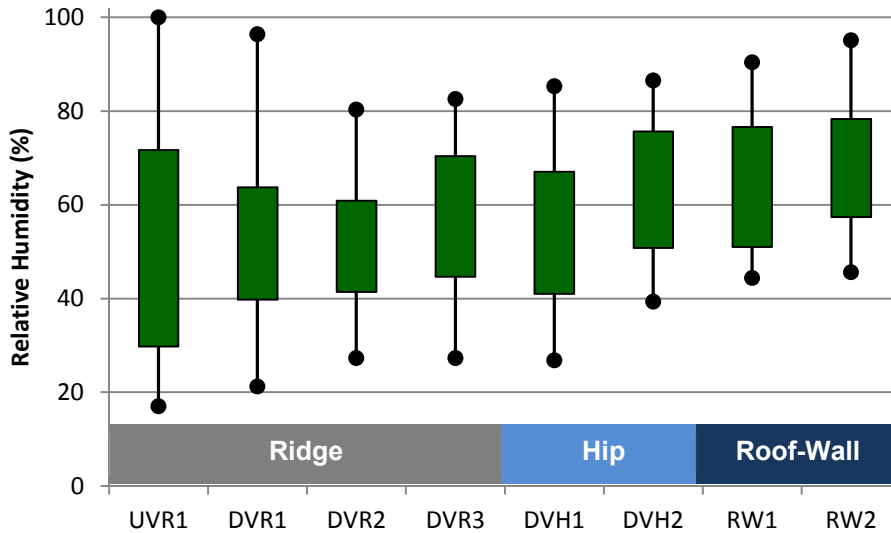
Figure 68. Box/whisker plot of roof peak RH measurements

Figure 68 shows the distribution of ridge RH measurements; the unvented roof (UVR1) is the only one that reaches 100% RH. The diffusion vent roofs are demonstrably drier than the unvented roof. Most of the roofs have hours that exceed 80% RH; however, given the discontinuity (gap) in the data, an ASHRAE 160 analysis (ASHRAE 2009, 2011) does not provide useful information based on a 30-day rolling average.

Table 8: it includes the number of hours and the percentage of the total recording period higher than 80% RH. It shows that most diffusion vent ridges had minimal (0%–3%) time higher than 80% RH, while the unvented roof had significant (13%) time higher than that level. However, several roofs (DVH2, RW1, and RW2) had extended periods higher than 80% RH; they also had distributions on the high end of the scale (Figure 68). The reason for this behavior is covered in more detail below.

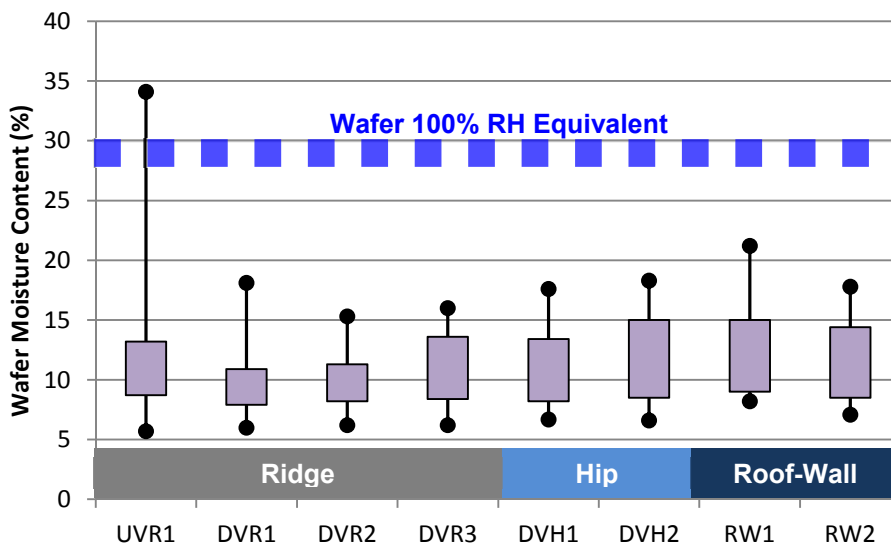
Figure 69. Box/whisker plot of roof peak wafer MC measurements

However, the unvented roof is clearly differentiated; periods of wafer measurements exceed the 100% RH-equivalent (28%–30% MC) level. All other roofs have MCs well in the safe range

(almost all lower than 20%). But again, roofs DVH2, RW1, and RW2 are noticeable outliers with higher moisture levels.

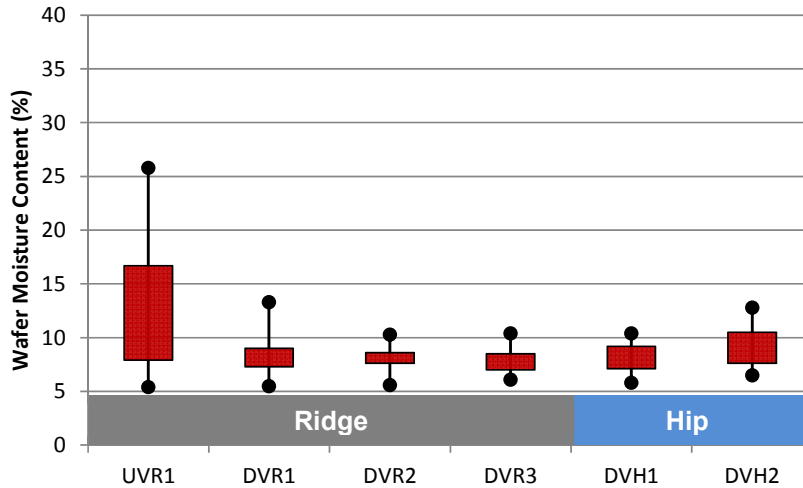
Figure 70. Box/whisker plot of ridge top wood MC measurements

Earlier plots demonstrated that the wood ridge at the ridge and hips was the driest location of the diffusion vent roofs, but the dampest in the unvented roof. This is shown in the box and whisker plot in Figure 70. It demonstrates the localized drying available at the ridge of the diffusion vent roof compared to the moisture accumulation (lack of drying) at the unvented roof. The unvented roof had peak MCs higher than 25%.

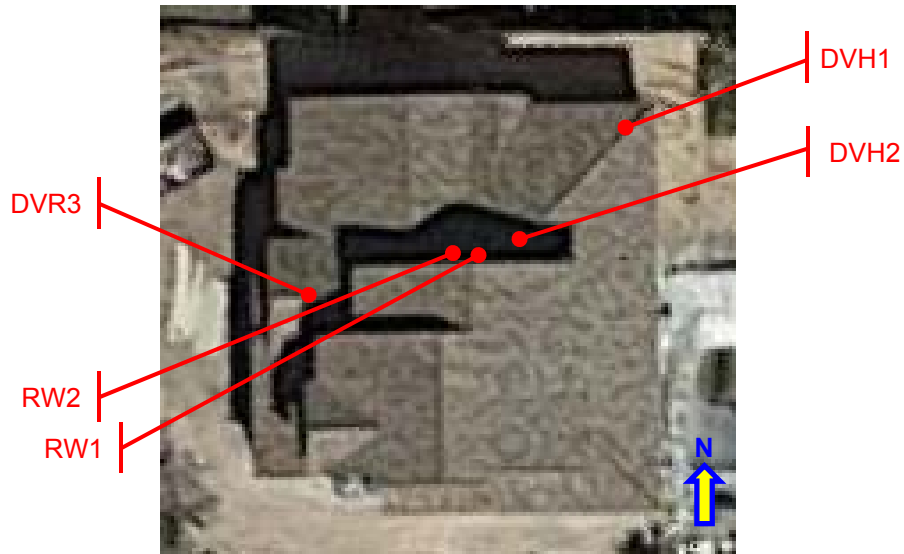
Figure 71. Overhead view of roof shading with key sensor locations

One possible explanation for moisture conditions at DVH2, RW1, and RW2 is the shading patterns created by the building (Figure 71).

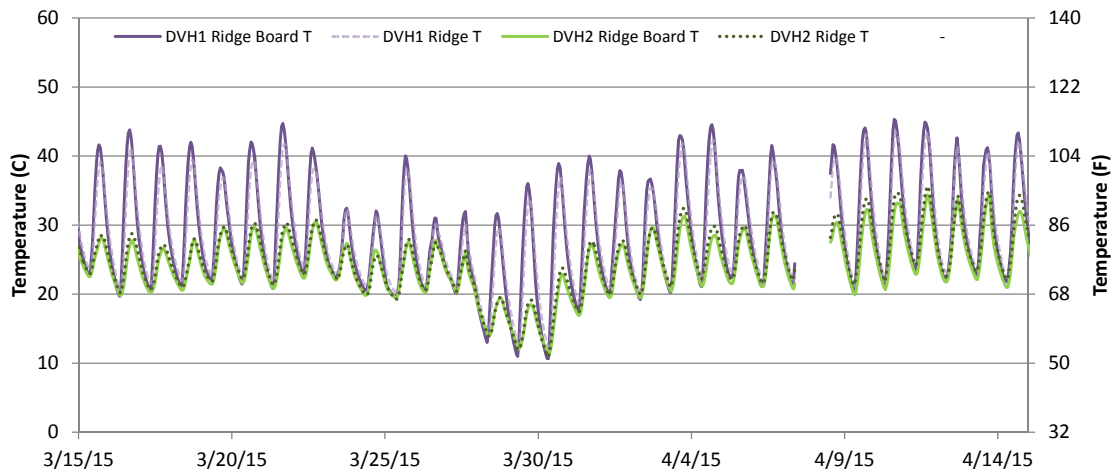
Figure 72. DVH1 versus DVH2 ridge and ridge board temperatures, March–April 2015

To confirm this theory, the temperature at the ridge is plotted for DVH1 and DVH2 in Figure 72 (March–April). It shows that the upper diffusion vent hip measurement had much cooler peak temperatures than the lower measurement (e.g., 95°F versus 115°F peak ranges), because the upper measurement was shaded.

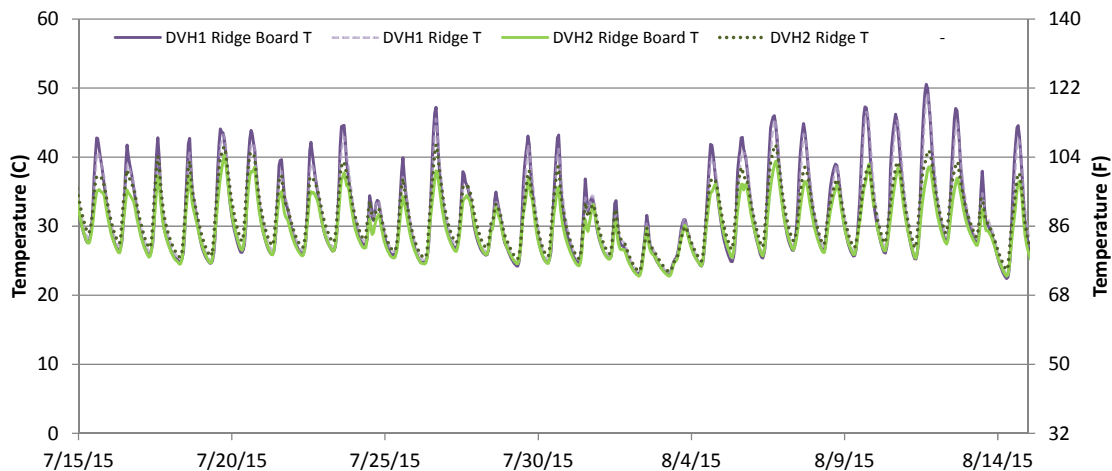
Figure 73. DVH1 versus DVH2 ridge and ridge board temperatures, July–August 2015

However, the temperature difference becomes much smaller during the summer, as shown by July–August data (Figure 73); this is due to the higher summertime sun angle, which reduces the shading provided by the second floor.
