# Residential Exterior Wall Superinsulation Retrofit Details and Analysis

Conference Paper - 1012

15 December 2010 (rev. May 2011)

Kohta Ueno

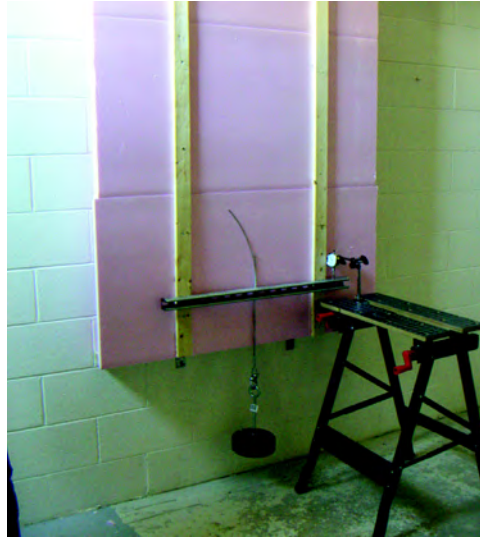
**Figure 4** Laboratory mock up testing of deflection with load; 2 in. (51 mm) XPS foam and 1 × 3 strapping, 24 in. (610 mm) o.c.

compression strut forms through the strapping and the foam. This calculation is not performed here; however, laboratory mock up tests were conducted (Figure 4), demonstrating a very high safety factor.
