Analysis of Joist Masonry Moisture Content Monitoring

Building America Report - 1508

October 2015

Kohta Ueno

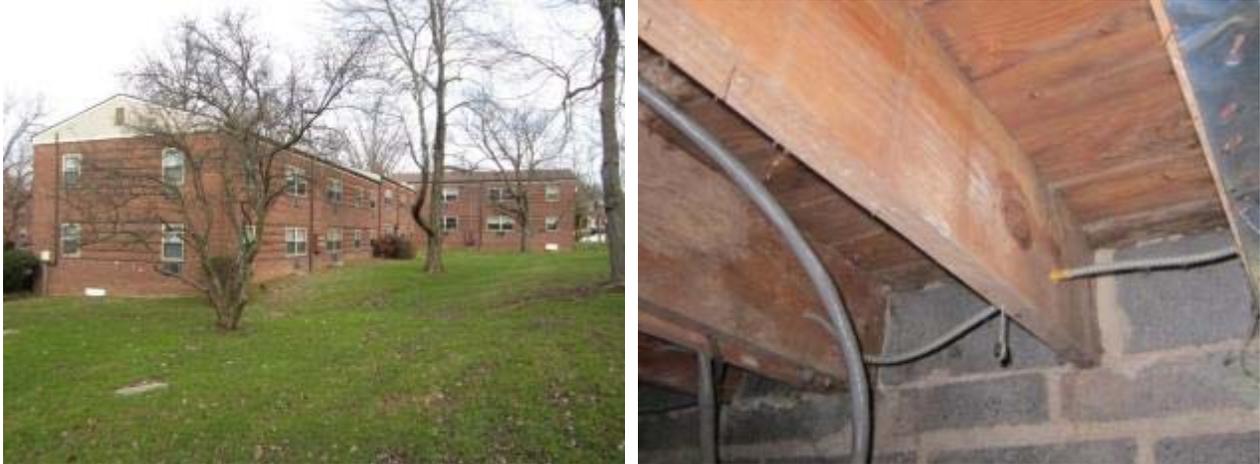
Figure 2. Overview of apartment complex (left); preretrofit joist ends in concrete masonry unit walls (right)

Rudd (2014) described the retrofit of a crawl space in a circa 1940 multifamily building in the Philadelphia area (zone 4A). The crawl space foundations were ungrouted (hollow) concrete block with a brick veneer (Figure 2, left); above-grade walls were wood frame with a brick veneer. The first-floor framing (sawn lumber) was grouted in place and embedded in the concrete masonry unit wall (Figure 2, right).

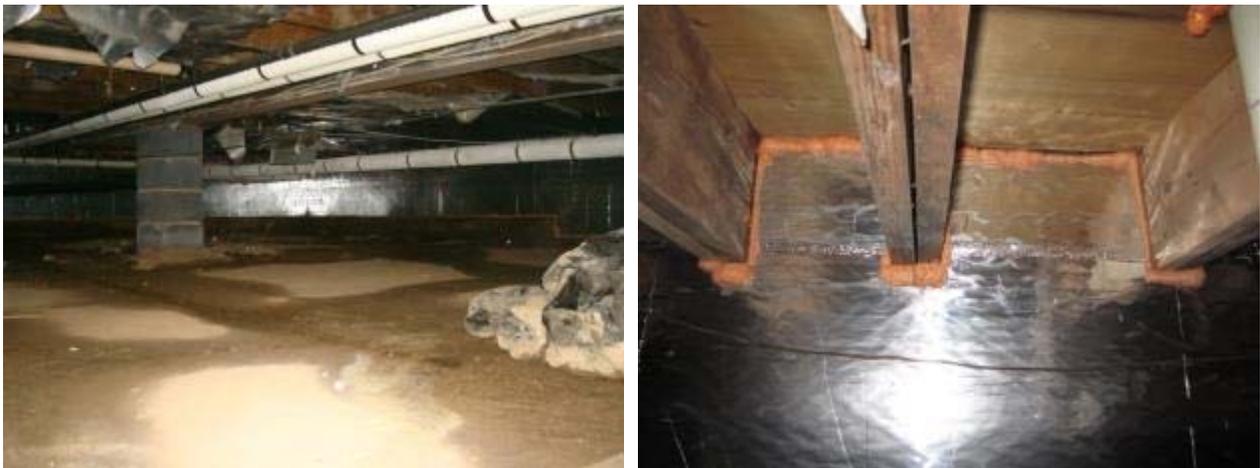
Figure 3. Postretrofit crawl space conditions (left); insulation board sealed at joist ends (right)

As an energy upgrade, the crawl space was converted from conventional vented/unconditioned to sealed and conditioned crawl space, per §R408.3 of the International Residential Code (ICC 2009a). Rigid foil-faced polyisocyanurate was installed on the crawl space walls and sealed around the joist ends (Figure 3). A continuously running exhaust fan was added to draw air from the crawl space; it pulls makeup air from the units above and provides a continuous supply of dry, semiconditioned air to the crawl space.

Joist MCs were measured: initially, they were 6%–10% in the main space and only 1–2 percentage points higher near the joist ends. However, the site later flooded (immersing the floor framing), and some joist ends remained at 40%+ MC. The author recommended cutting back insulation ½ in. around the joist ends to facilitate drying. Other joist ends had lower (10%–12%) MCs.

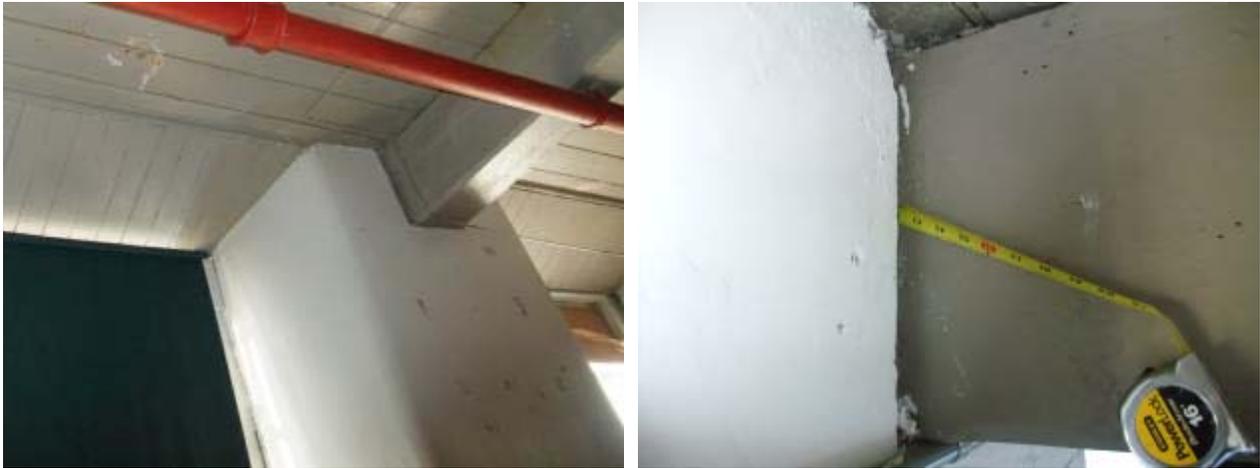
Figure 7. Beam pocket gap on sides; conditions vary by building

The sides of the beam sometimes have an air gap between the wood beam and the masonry; Figure 7 shows a relatively large ($\sim\frac{3}{4}$ -in.) gap. However, these conditions vary widely from building to building; some buildings have masonry tight against the beam.

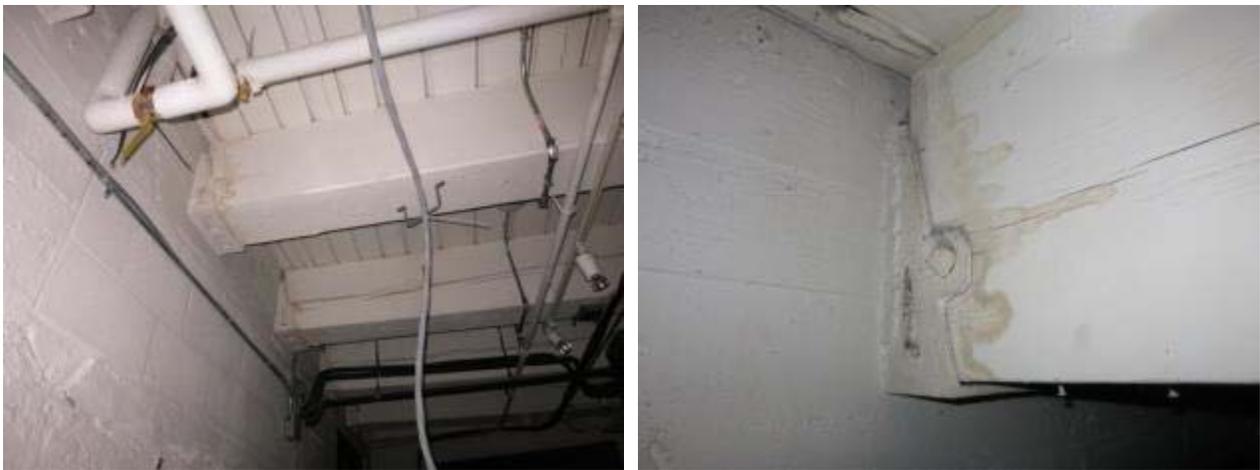
Figure 8. Steel saddle hanger detail, with beam clear of masonry wall at grade

One historic design in a Boston-area building clearly acknowledges the risks that are associated with wood beams near grade. Beam pockets were used for most of the building; however, at the basement level (with beam ends near grade), cast-in steel plate saddle hangers were used to support the beam (Figure 8). This detail completely removes the vulnerable wood from contact with the masonry (Figure 9, left). Several areas were stained (Figure 8, right) with paint blow-off; however, measurement of the wood MC showed dry conditions, even at extensively water-stained areas (Figure 9, right). Keeping the wood beam end clear of the wall (with this saddle detail) allows significant drying of any incidental wetting in service.

This wetting might have been caused by interior-sourced flooding, based on the water stain patterns (e.g., visible staining between subfloor gaps). Whatever the wetting source, however, this detail allows for greater drying than an embedded beam.

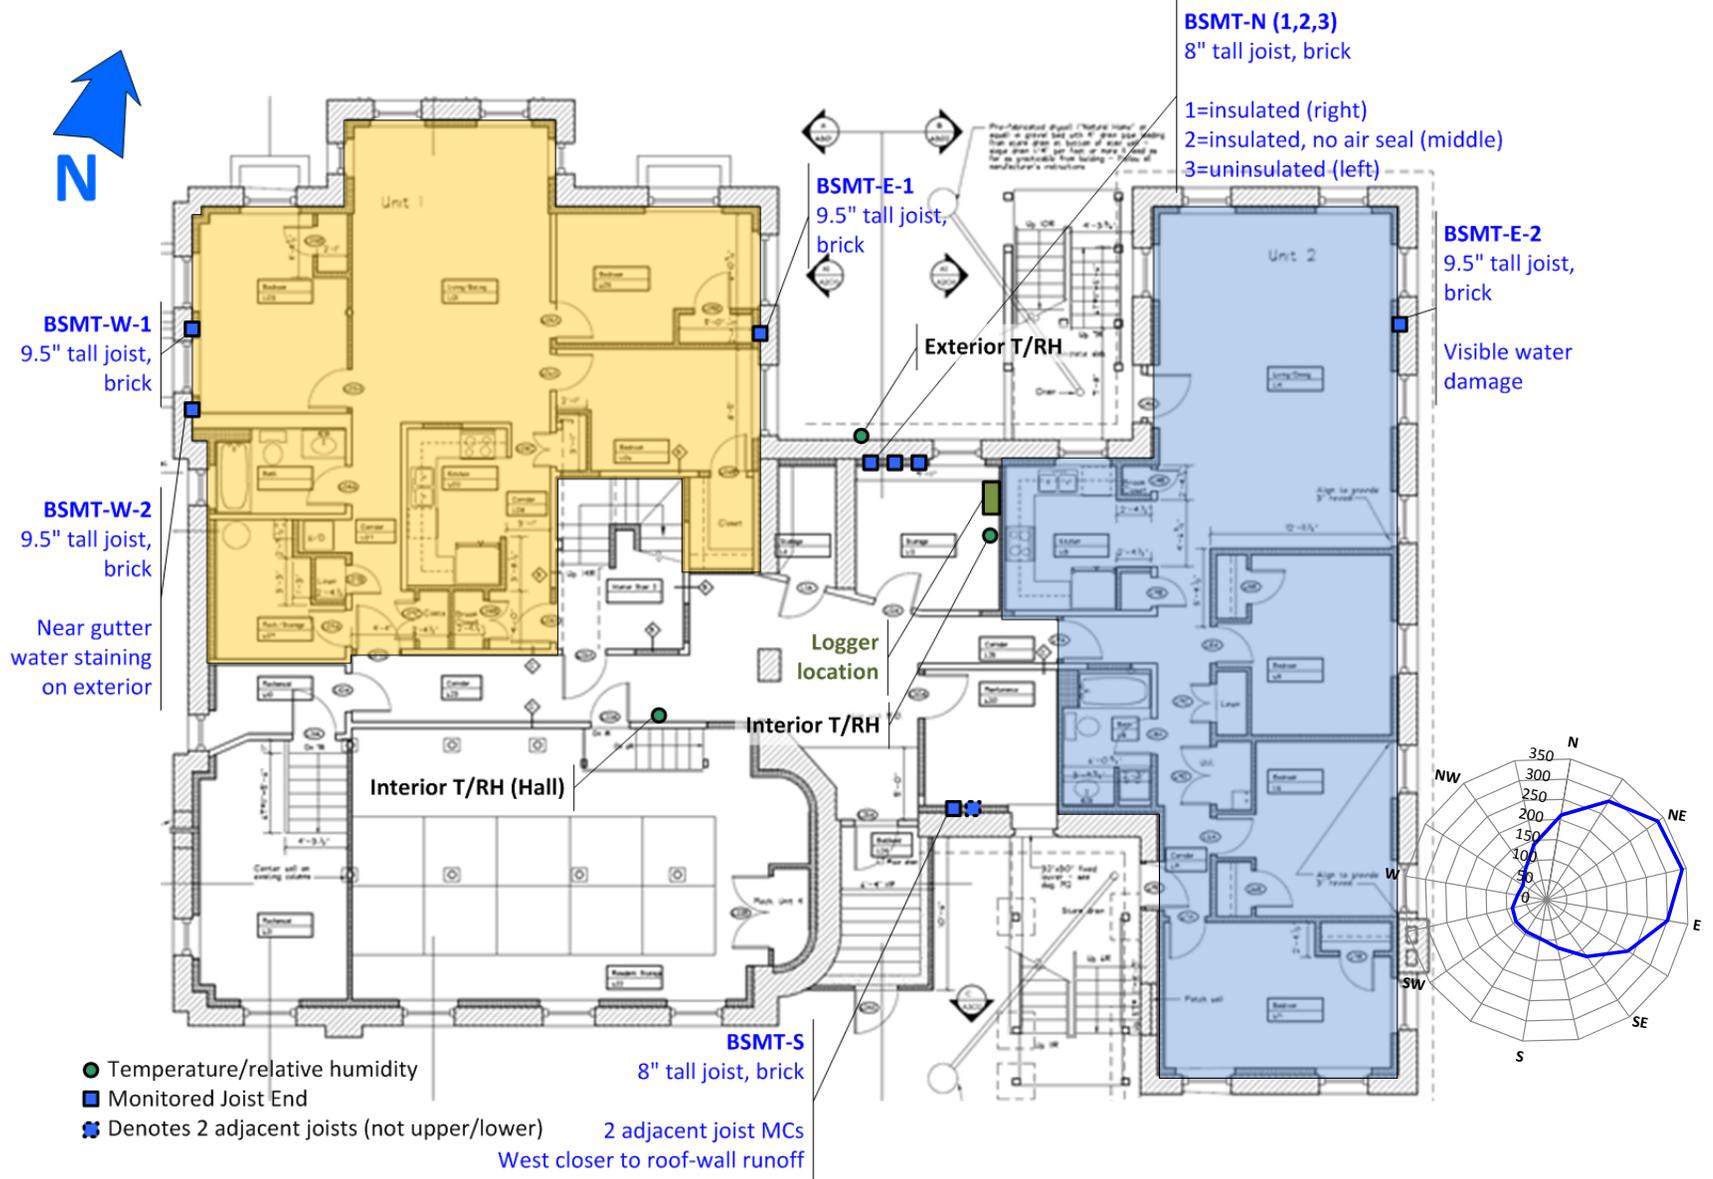
Figure 21. Location of monitored joist ends at basement level (basement ceiling) with driving rain; residential units highlighted

BSMT-E2 is of particular interest because it shows evidence of previous water penetration (staining of the beam end). The east orientation at the rear of the building also has the highest exposure for driving rain, based on airport weather data. Whether these bulk water issues were resolved during previous renovations, or whether the building has some unknown hidden leakage path, is unknown.

BSMT-W1 and BSMT-W2 are of interest because the site inspection revealed that rainwater was being deposited on the wall at the jog (see Figure 21). BSMT-W1 was set up to capture the mostly dry field of the wall; BSMT-W2 was located close to the jog to determine whether this bulk water was sufficient to cause issues with the embedded joist end moisture behavior. This cardinal orientation has low driving rain exposure (see Figure 15).

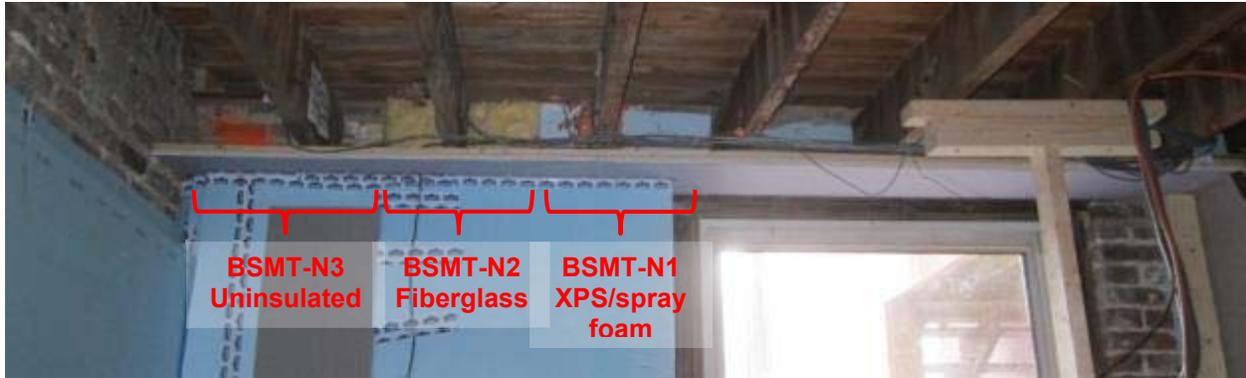
Figure 23. Comparison of insulation strategies for joist ends BSMT-N-1/2/3, predrywall

Basement ceiling joists are monitored on all four orientations, including multiple measurements on some orientations; all are embedded in solid brick masonry. BSMT-N1/N2/N3 are joists with identical exposure; however, each uses a different retrofit strategy (Figure 23 through Figure 26):

- BSMT-N1 is insulated per the remainder of this project, insulated and air sealed with rigid XPS foam and urethane spray foam.
- BSMT-N2 is insulated with air- and vapor-permeable insulation (two R-13 layers of fiberglass batt, or R-26), which captures the effect of insulating, while still allowing airflow.
- BSMT-N3 is left uninsulated, similar to assemblies described in Morelli et al. (2010).

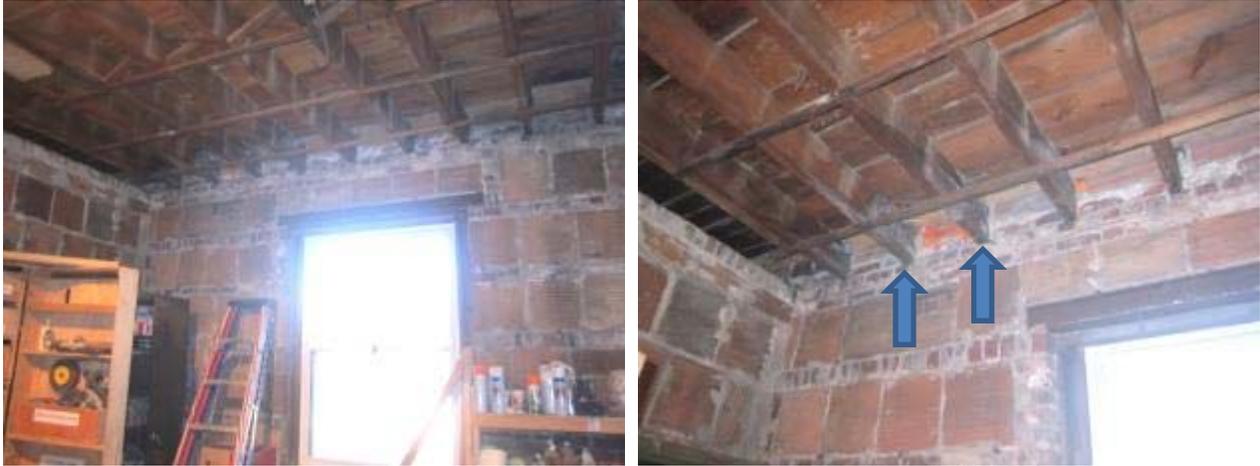
Figure 27. FIRST-N joists showing brick and clay block wall construction

On the first floor, joists were monitored in the addition (hollow clay block) walls only, because the joists in the original first-floor wing were inaccessible. Figure 27 shows the FIRST-N monitoring locations, and that the hollow clay block backup walls were actually constructed with alternating layers of block and brick.

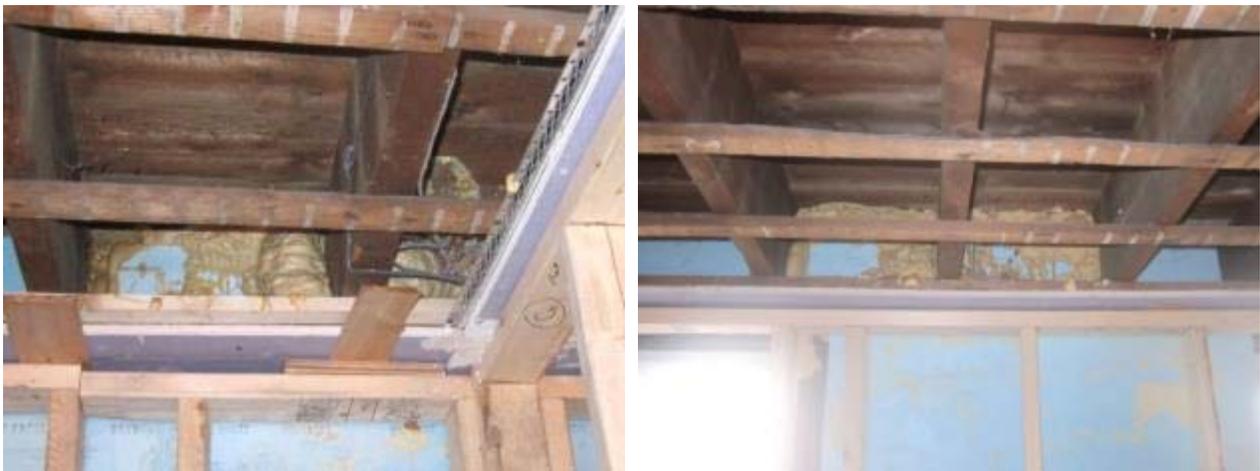
Figure 29. Two-component spray foam air seal at joists BSMT-W1 and BSMT-E1

The insulation was installed first at the floor joists at the front (west) wing, which contains BSMT-W1, BSMT-W2, and BSMT-E1. Those joists were insulated and air sealed to the

perimeter of the foam blocks with a two-component spray foam pack (Figure 29). The remaining joists were insulated on an ongoing basis during construction.

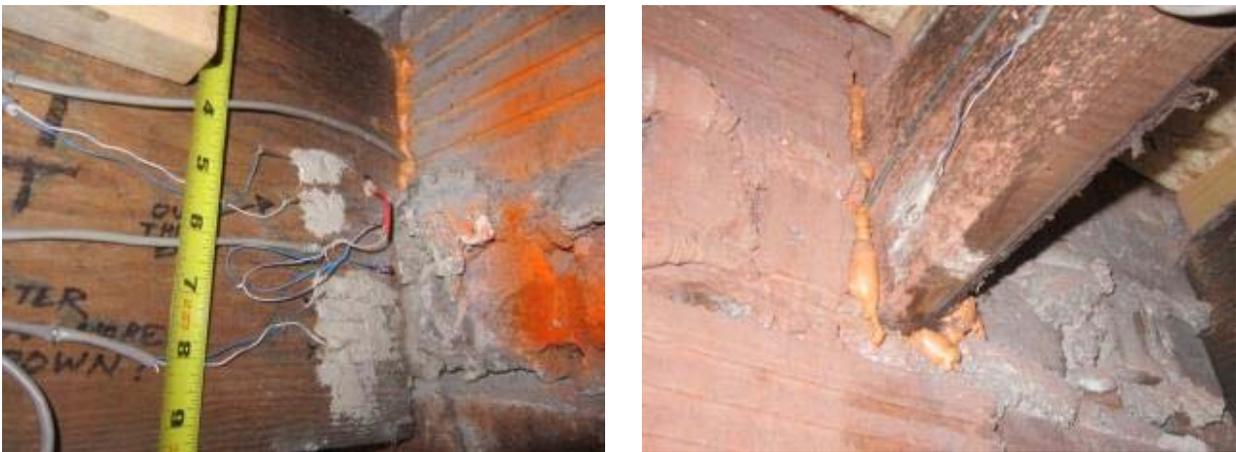
Figure 32. Pocket hole jig (left); installed MC pins (right)

Then a pocket hole jig was used to drill a pilot hole at a shallow angle in the beam (Figure 32, left). A $\frac{1}{8}$ -in.-diameter hole was drilled for clearance for the pin, but the joist end was left undisturbed so the pin would be driven directly into the wood fibers with frictional contact. Figure 32 (right) shows the upper and lower joist end MC measurements and the cheek MC/temperature measurement.

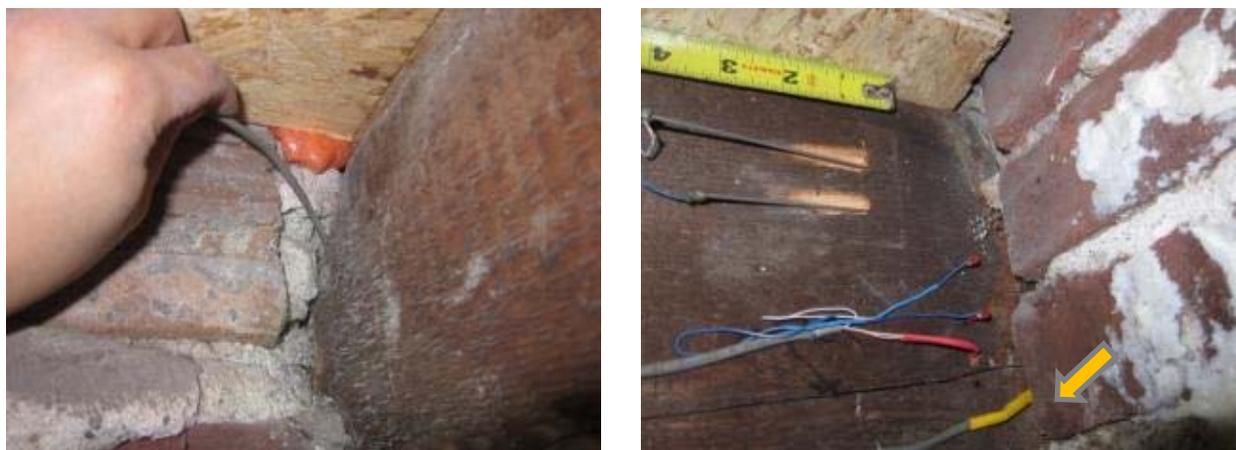
Figure 33. Caulked pocket holes (left); air seal at joist pocket (right)

The pocket holes for the joist end MCs were sealed from interior air and water vapor with a vapor-impermeable synthetic rubber caulk (Figure 33, left). The joist pockets were air sealed from the interior with a combination of can-based expanding foam (Figure 33, right), and the spray foam kit used around the rigid blocks of foam mentioned earlier (Figure 29).

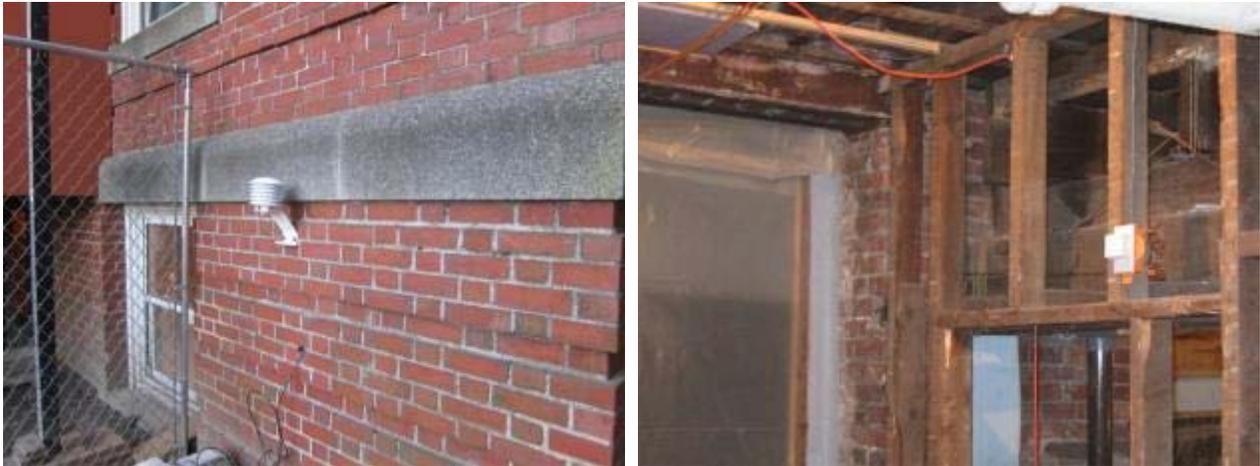
The condition of the masonry joist pocket could be observed directly at several north-facing openings in the addition section where a beam had been removed (Figure 35). Mortar or grout was packed between the brick and the wood joist during installation; mortar was also packed in the angled space behind the fire cut. However, an airspace adjacent to the joist at the hollow clay block would likely increase drying.

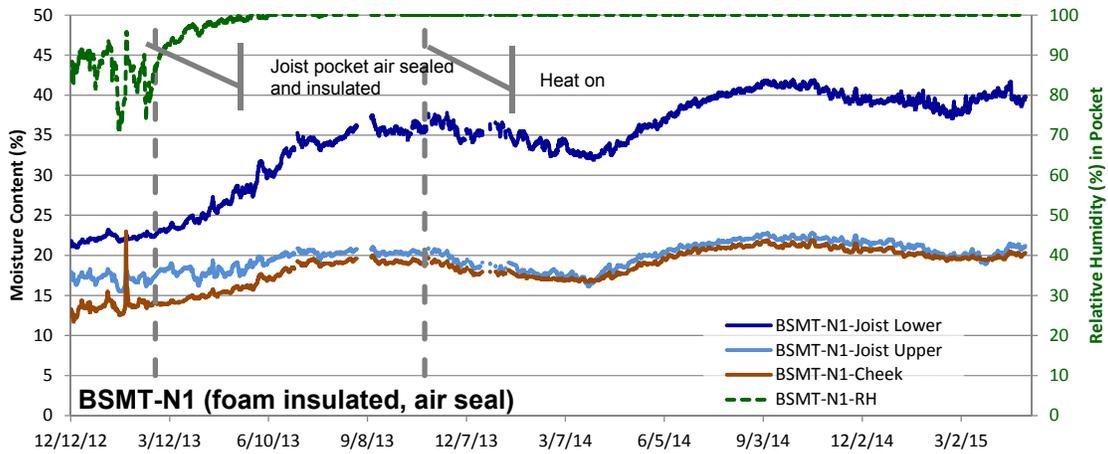
Figure 42. BSMT-N1 (insulated) joist end MCs and RHs

The joist pocket RH measurements showed high levels of either constant 100% (BSMT-N2 and BSMT-N3), or a quick rise from 80% to constant 100% (BSMT-N1). The reason for the RH difference between BSMT-N1 and BSMT-N2/N3 was not evident from visual or infrared observations (Figure 24). Temperature measurements showed that the largest differences between joist ends were 1°F (0.5°C), and visual inspection of the temperature and RH sensor installation showed no significant installation differences between the three joists.

The joist end MC levels were higher than recommended for durability: lower joist ends were 20%–40%+ (BSMT-N1 joist lower was wettest by far), and upper joist ends were typically 15%–36%. Joist cheek MCs were safer (10%–22%). The high moisture levels might reflect unheated or “mothballed” building conditions (previous 2 years of operation). However, no damage to the beam ends was evident during sensor installation.

MCs demonstrated a distinct seasonal cycle: peaks occurred during late summer and early fall (September). More importantly, MCs dropped when heat was introduced in October 2013, especially in N3 (uninsulated). An outward temperature gradient would result in outward drying of the beam end; summer conditions have an inward temperature and water vapor gradient.

Moisture levels did not differ markedly between the three joist ends: although N1 (insulated) had very high “lower” MCs, measurements at other parts of the joist were drier than N2 and N3. High MCs were found at all three joist ends.

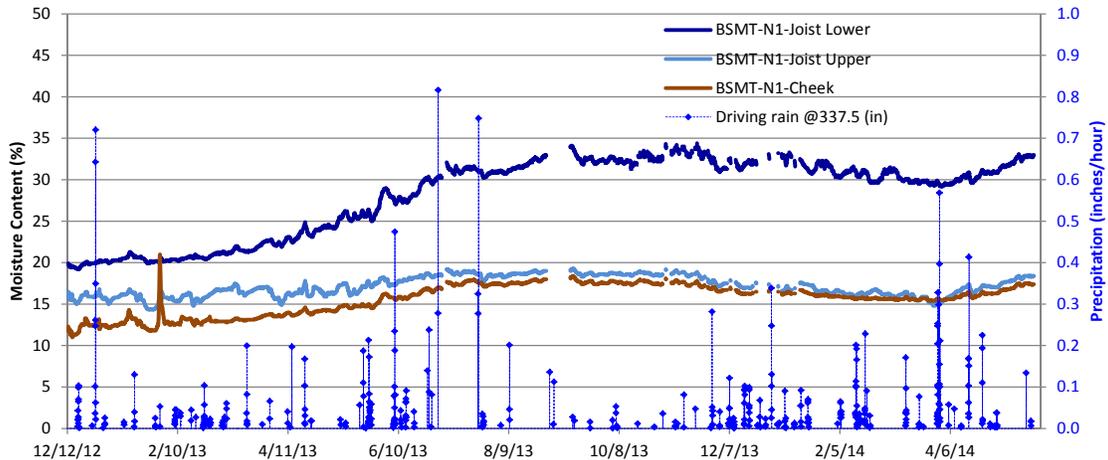
Figure 45. BSMT-N1 joist end MCs with calculated driving rain

The MCs were plotted with driving rain deposition on the north wall, which was calculated using methods from Straube and Burnett (2005) (Figure 45) from late 2012 to mid-2014. Distinct rain events showed no discernable responses in the measured data.

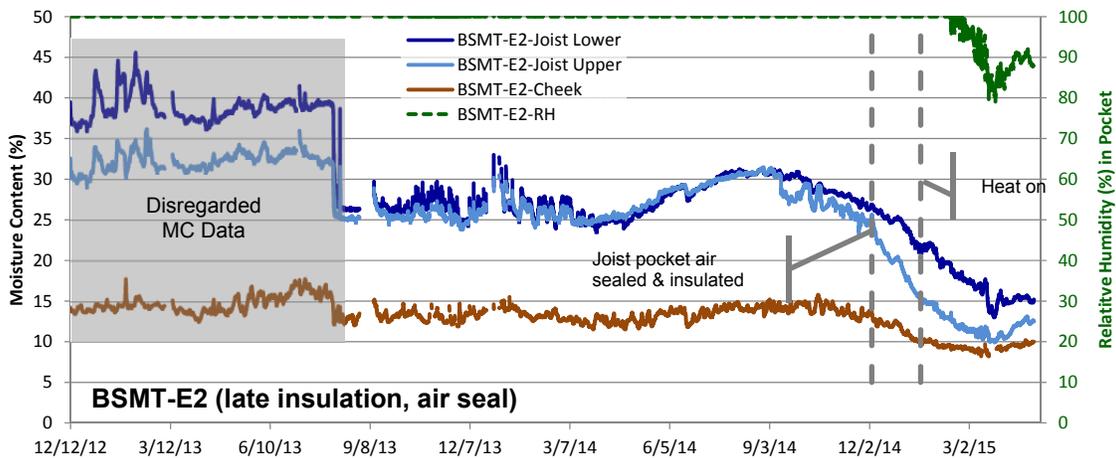
Figure 46. BSMT-E2 joist end MCs and RHs

Measurements from the east-facing joist from the rear of the building (BSMT-E2) are shown in Figure 46: the sensor measurements underwent a step change downward in August 2013 (highlighted in gray). Given the parallel and sudden shift of all three MC levels, it was clearly a sensor (electrical) issue as opposed to a true MC change. Previous work has shown that MC pins can be short-circuited by wet masonry. Construction activity repeatedly damaged sensors (given the monitoring of an active jobsite), which required return trips for repair. This was often manifested as failures or electrical anomalies in the data. Based on these facts, data before August 2013 were disregarded.

BSMT-E2 was in a part of the building that had minimal wintertime heating (similar to BSMT-N1/N2/N3) and was insulated and air sealed late in the construction process (December 2014). It had similar patterns to the previous graphs, including high peak MCs (25%–31%), cheek measurements that were drier than the embedded joist ends, a seasonal swing (with peak in summer), and drying into the winter (especially with the addition of heating). RH also dropped from its continuous 100% in the final winter, which was consistent with a drop in the joist end MCs.

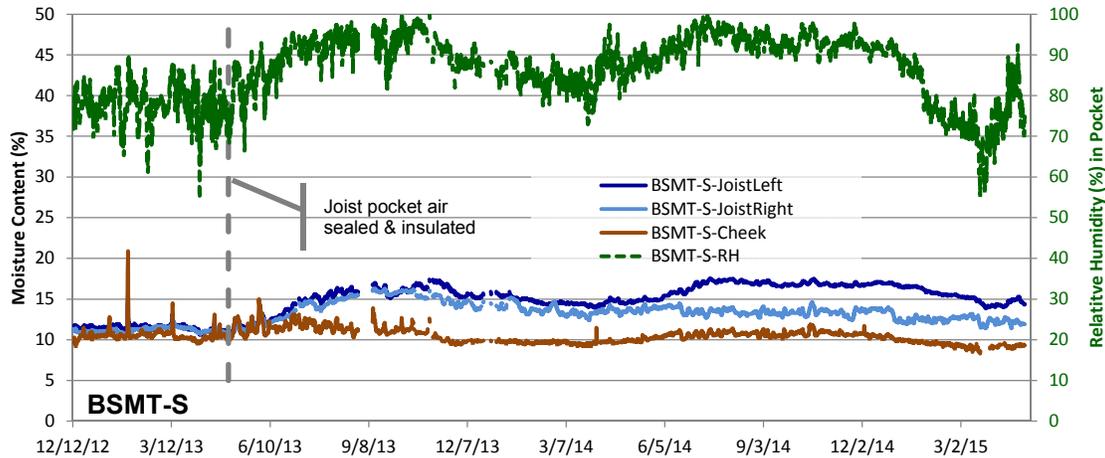
Figure 47. BSMT-S joist end MCs and RHs

The south-facing basement joist is plotted in Figure 47; it also had minimal wintertime heating (the same interior conditions as BSMT-N1/N2/N3). MCs were substantially lower (~10%–16%) than the north- and east-facing basement joists, and the RH in the joist pocket was markedly lower (seasonal rise and fall of ~70%–100%). This is attributed to the warmer temperatures due to solar gain on this orientation. These drier conditions are a function of solar heating, which is evident if north and south temperatures are compared (Figure 48 for part of winter 2012–2013). The south side was slightly but consistently warmer in winter, and joist end temperatures converged as outdoor temperatures rose.

The BSMT-S joist end measurements are a left/right pairing, not an upper/lower pairing; both are in the lower joist position.

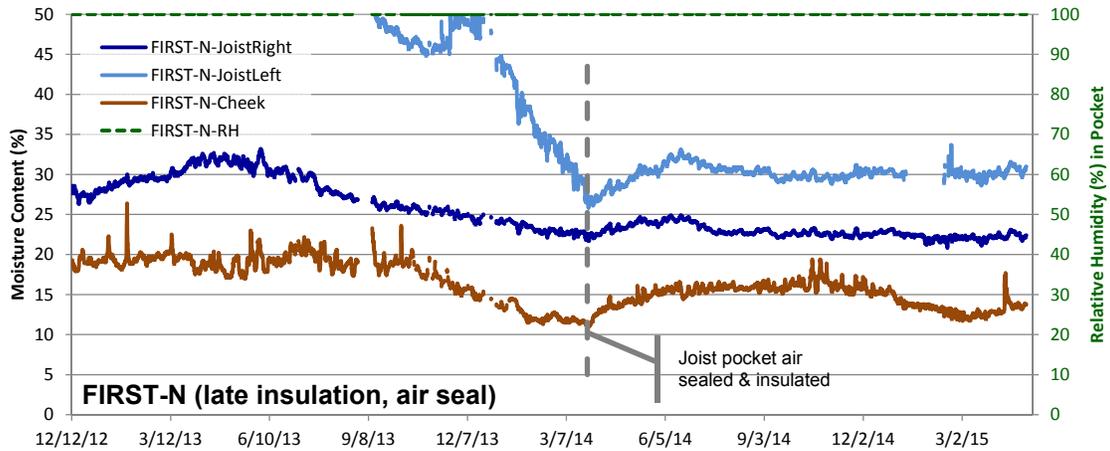
Figure 51. First-N joist end MCs and RH

The north-facing joists (left/right pair) measurements are shown in Figure 51; the left-facing joist (FIRST-N-JoistLeft) had initial measurements in the 60%+ range (off the graph). The MCs gradually fell over time and reached a range that was consistent with the other joists by winter 2013–2014. This was far higher than any other measurements in the building; the reason for this

anomaly has not been positively determined, but electrical issues are suspected (as opposed to massive moisture loading of a single joist).

Figure 51 shows that the beam pocket RH remained at 100% throughout these measurements. Similar to previous measurements, the cheek MC was lower (drier) than the joist end MC. The right joist pocket MC (FIRST-N-JoistRight) showed a seasonal rise and fall throughout the monitoring period (it was wetter in spring and summer and showed a general drying trend).

The joist pocket was insulated and air sealed in late March 2014; all MCs began to rise (consistent with cutting off drying to the interior seen in other joist pockets) and then exhibited a slight seasonal rise and fall pattern.

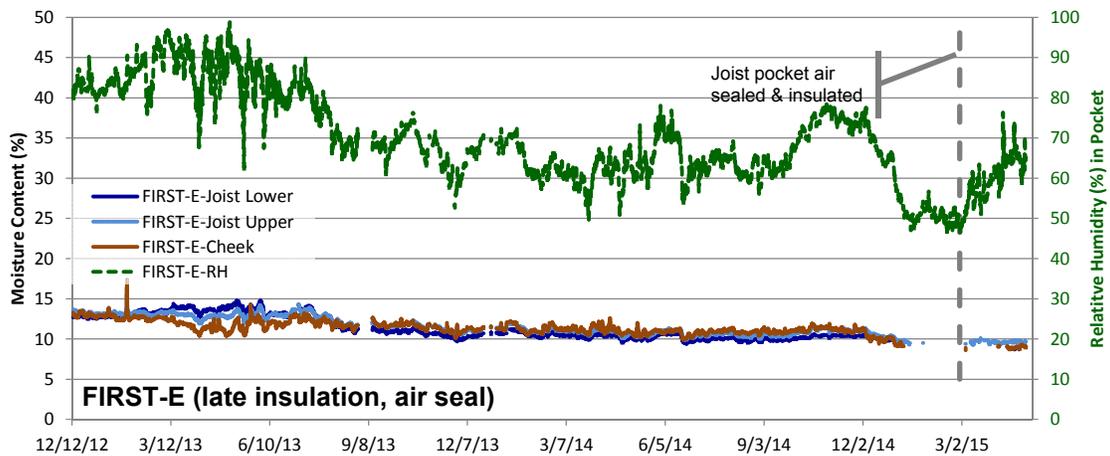
Figure 52. First-E joist end moisture contents and RH

The first-floor east (FIRST-E) sensors had low MCs of about 9%–15% (Figure 52); this joist was the softer brown wood (possibly a different species) noted earlier. However, the measured pocket RHs (45%–95%) were consistent with lower MC measurements. These low MCs occurred despite a high driving rain exposure on this orientation. This location had noticeably higher summertime temperatures (due to solar gain) than the east-facing joists on the basement level.

This joist pocket was insulated and air sealed late in construction (February 2015); an associated rise in pocket RH occurred, although the change could be associated with seasonal variations.

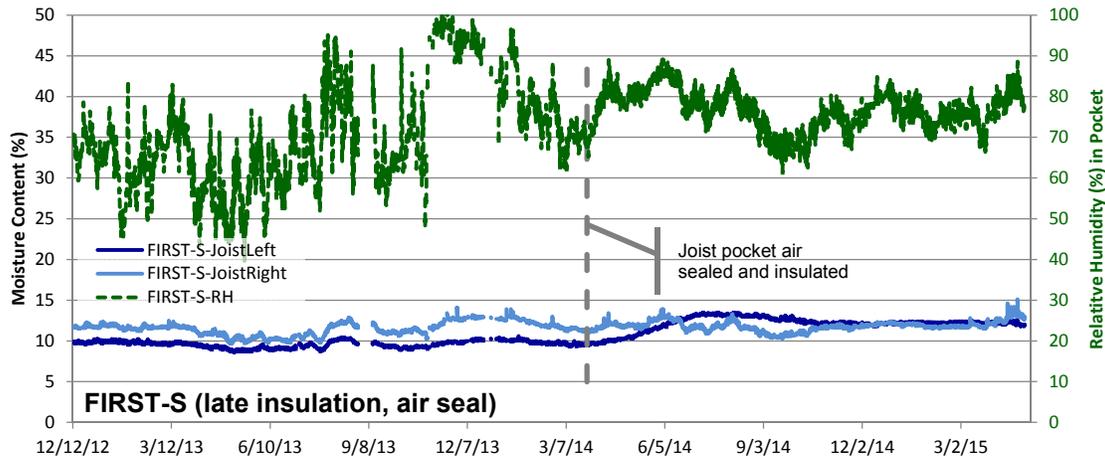
Figure 53. First-S joist end MCs and RHs

The south-facing joist MCs (Figure 53) were also low (9%–15%); RH measurements were consistent with MCs (50%–80% RH, brief spike to 100% in November 2013). This RH spike was checked against rain events, but no correlation was found. This joist had no cheek measurement.

MCs rose slightly after the joist end was insulated and air sealed (March 2014); RH measurements became noticeably more stable after this work was completed.

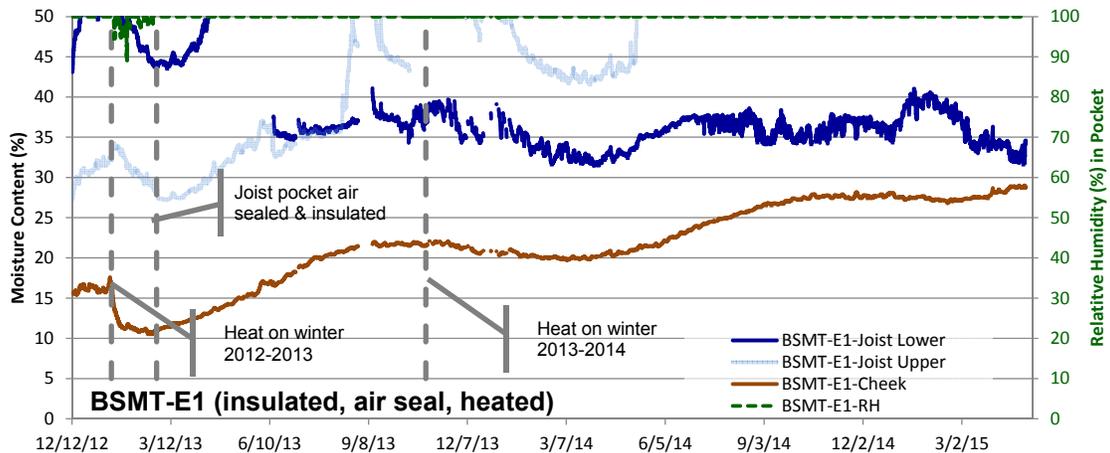
Figure 55. BSMT-E1 joist end MCs and RHs

The east-facing joist (BSMT-E1; Figure 55) showed some sudden changes in the joist end MC, which likely indicated a sensor electrical anomaly rather than a valid MC shift. These shifts were correlated against interior and exterior conditions, including calculated driving rain; no causes were obvious. Overall, BSMT-E1 Joist Upper had data that will be disregarded, but BSMT-E1 Joist Upper had data that looked reasonable after June 2013. The cheek measurement, however, looks reasonable; unfortunately, it shows a pattern of seasonally rising MCs (peaks in summer), of 10% to 29%.

Despite a low confidence in some of these MC measurements, the RH measurements (almost constant 100%) were consistent with high MCs. In terms of exposure, even though this joist faces east, this location is blocked from solar gain by the adjacent wing (see Figure 54).

Although the MC measurements exhibit uncertainty, some shifts can be correlated with various events. In January 2013, interior construction heating was started, and all MCs fell, especially at the joist cheek (which has the greatest exposure and the most drying available). The RH in the joist pocket also shifted slightly off 100%. However, after the joist pockets were air sealed and insulated with spray foam in February 2013, the RH increased back to a constant 100%, and the MCs began to rise again. The cheek MC also increased: it was buried within the spray foam insulation, so it was isolated from interior conditions.

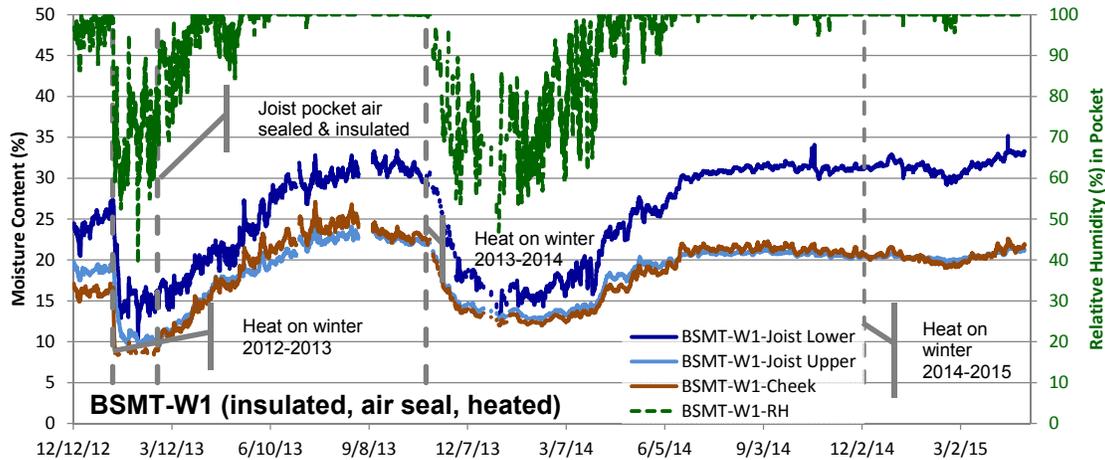
Figure 56. BSMT W1 joist end MCs and RHs

The west-facing joists (BSMT-W1 and W2) have similar—or even more pronounced—seasonal patterns (Figure 56 and Figure 57).

Similar to BSMT-E1, MCs showed a sharp decrease (drying) when construction heating was introduced in January 2013; RHs dropped simultaneously. Sealing the joist pocket (February 2013) correlated with a rise in MCs and RHs, but the rise was also consistent with the seasonal (summertime) pattern. Again, in winter 2013–2014, construction heating caused the joist ends to dry. In spring 2014, MCs and RHs rose again. However, in winter 2014–2015, the drying associated with wintertime heating was barely perceptible, if it was occurring. Part of this may have been due to the installation of interior gypsum board (ceiling and wall), which would have decoupled the insulated joist end further from the interior space.

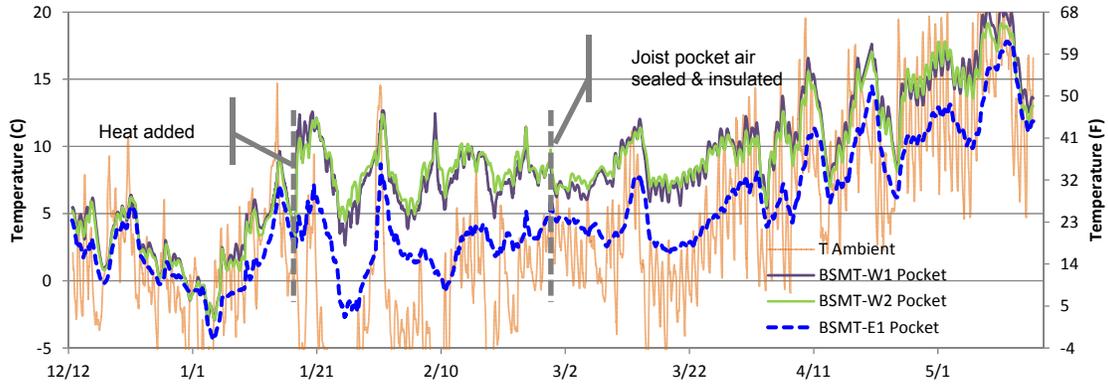
Figure 58. Basement West and East joist end winter/spring temperature comparison

The difference in RHs and MCs between east- and west-facing joists might be ascribed to the temperatures in the pocket (Figure 58).

The west-facing joist pockets were consistently warmer than the east-facing joist. The east-facing joist was shaded from solar gain by the adjacent parts of the building (see Figure 54); the west-facing joists were well exposed to the afternoon sun. This temperature difference increased as heat was added: the space heater for the front of the building was closer to the west-facing joists (front) than the east-facing joist. The temperature difference continued after the wintertime heating was shut off.

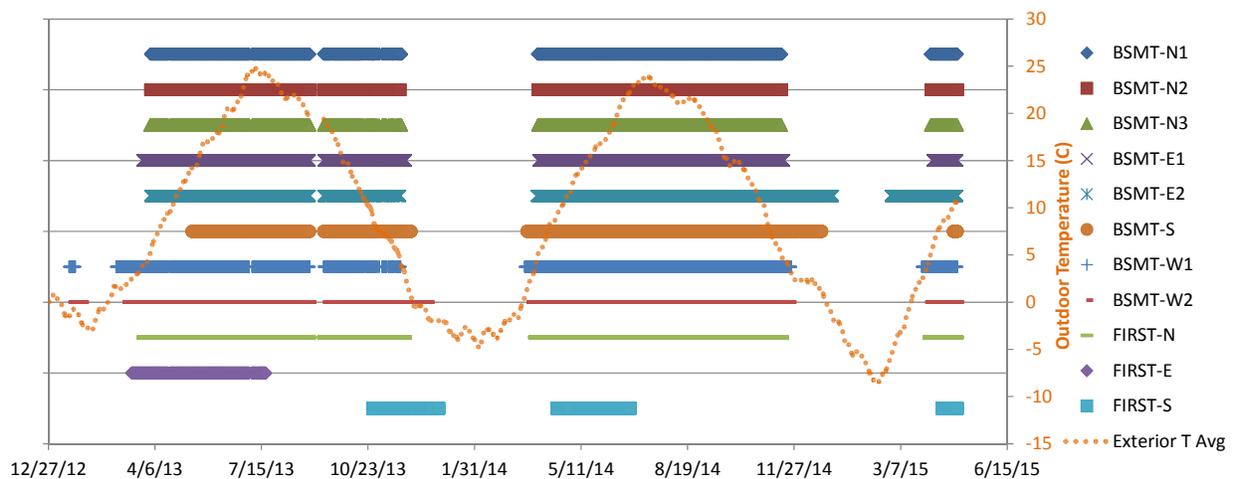
Figure 59. ASHRAE 160 failing hours for joist ends, with exterior temperature 30-day average

The results are not surprising, given that many of the joist end pockets remain at a constant 100% RH throughout the monitoring period. Therefore, they fail ASHRAE 160 criteria whenever

temperatures are sufficiently warm to sustain mold growth. As shown in Figure 59, most joist ends have failure conditions at all times except during winter conditions when temperatures remain below 41°F (5°C). The discontinuity seen in August–September 2013 was a section of missing data, not a period of dry conditions.

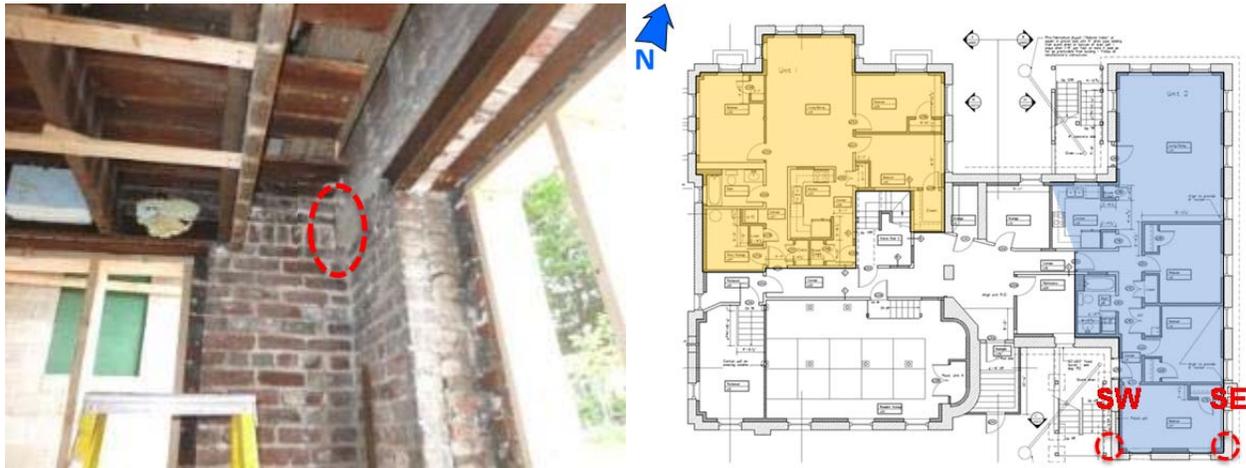
Figure 60. Joist end stub in southeast corner (left), plan showing stub locations (right)

Wood joist samples were collected in September 2014 to allow for species identification (and thus greater accuracy for resistance-based MCs). The samples came from two joist ends that remained embedded in the masonry wall in the rear addition section (Figure 60); sometime after May 2012 the construction crew removed the joist for structural and access reasons.

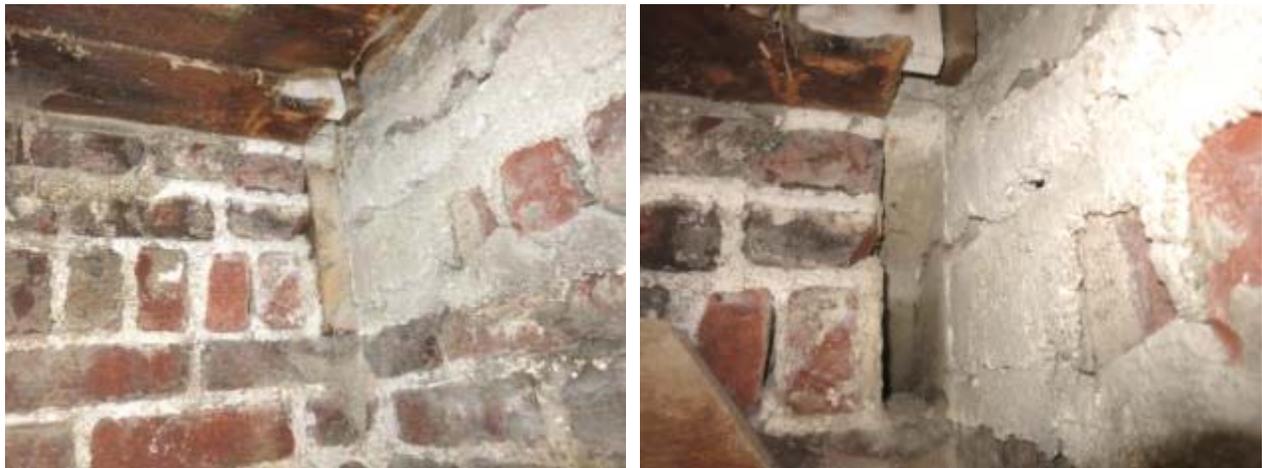
Figure 61. Joist end stub embedded in wall (left); joist pocket showing mortar (right)

The joist end stub that remained in the wall is shown in Figure 61, left; the wood was cut off flush with the masonry surface, and the removed joist was originally tight against the exterior south wall. The pockets are in the southwest and southeast corners. The joist pocket (Figure 61, right) shows that at least in this case, mortar was infilled around the fire cut (sloped) joist end, which left a minimal airspace around the joist pocket.

One of the two joist ends was damp to the touch and had a distinctly moldy odor when it was removed from the wall. However, when the wet joist end was probed with a screwdriver, it was structurally intact; it showed no evidence of rot, decay, or punkiness. Both joist ends had evidence of earlier water staining.

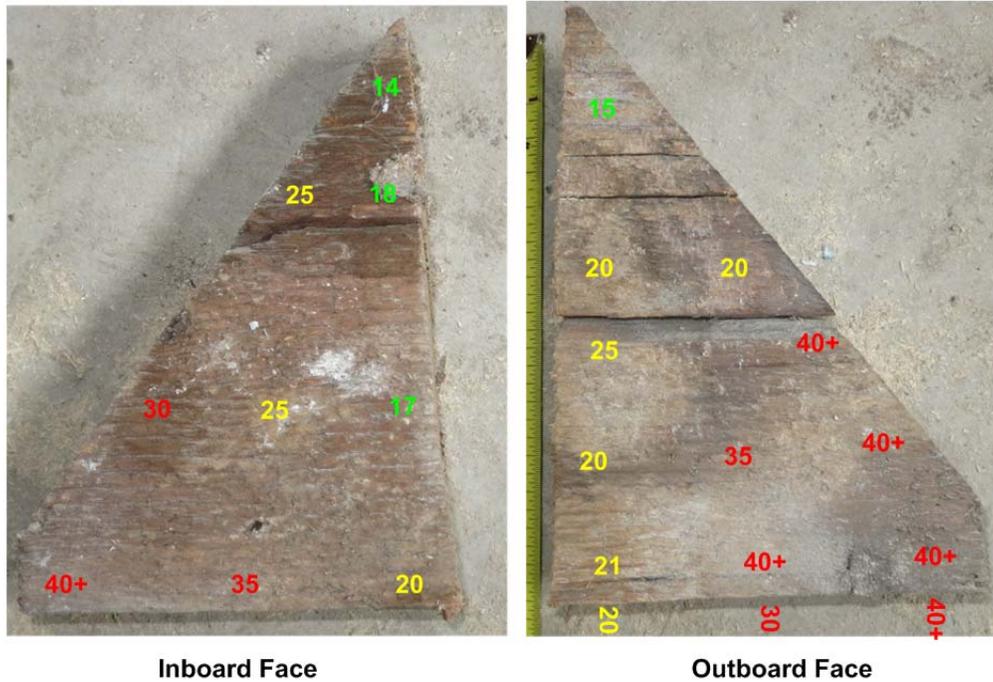
Figure 62. Joist end stub MCs: southeast corner/east-facing (wetter)

The MCs of these joist ends were measured with a resistance (pin-based) MC meter (Delmhorst BD-10) to examine the spatial MC pattern (Figure 62 and Figure 63). The MCs are color coded (red high risk, yellow some risk, green safe) in the photos. The MCs of the underside (horizontal bearing surface) of the joist ends are indicated by rotated text. Some MCs are notated 40%+; this is the upper measurement limit of the meter.

- The embedded joist ends—at least the species/samples taken at this building—can withstand sustained high MCs (40%) without suffering structural damage or rot. This is not meant to imply that 40% MC is a safe condition for this wood; rather, it indicates that the high MCs measured in this building do not necessarily indicate incipient failure.

- Orientation had a significant impact on joist end MCs: the west-facing joists had dry MCs that were well within the safe range; the east-facing joists had MCs that would be considered at risk of failure. This is consistent with the patterns seen during the monitoring period, when orientation had a strong effect: the west-facing joists were generally much drier than the east-facing joists.

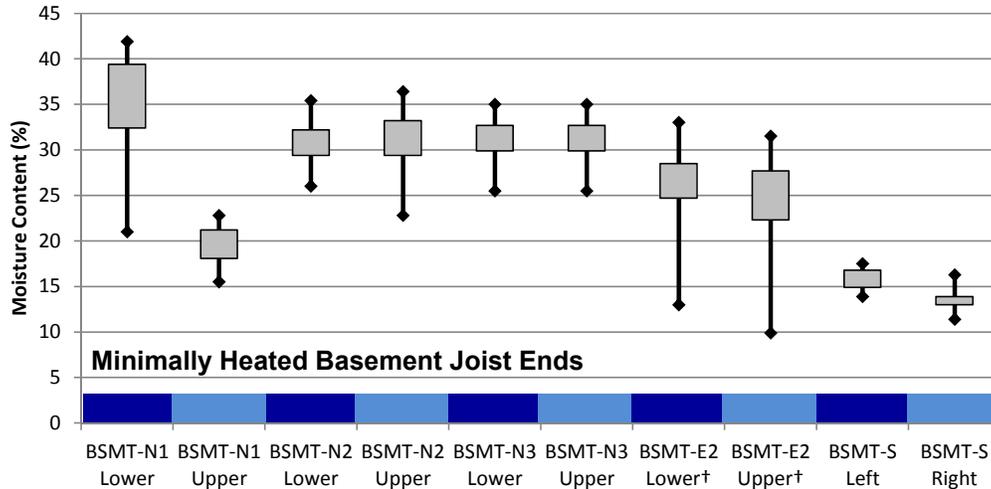
Figure 64. Box/whisker plot for joist end MCs; minimally heated basement joists

Many of the minimally heated basement joist ends (Figure 64) remain at high MCs (25%–35%) for much of the monitoring period; the joist pocket RH measurements were a constant 100% for north- and east-facing joist ends. The south joist end, however, had much lower MCs (with corresponding RH data), and remained well within the safe range. The east joist end was between the north and south behaviors.

The three north-facing joist ends (N1/foam insulation, N2/fiberglass insulation, N3/uninsulated) were set up to compare insulation strategies. However, the MCs overlapped significantly; drawing clear conclusions is difficult. Although the BSMT-N1 lower joist MC was wetter than others, the corresponding upper joist MC was the driest of the BSMT-N joists.

†: BSMT-E2: Data before October 12, 2013 are not plotted due to electrical anomalies.

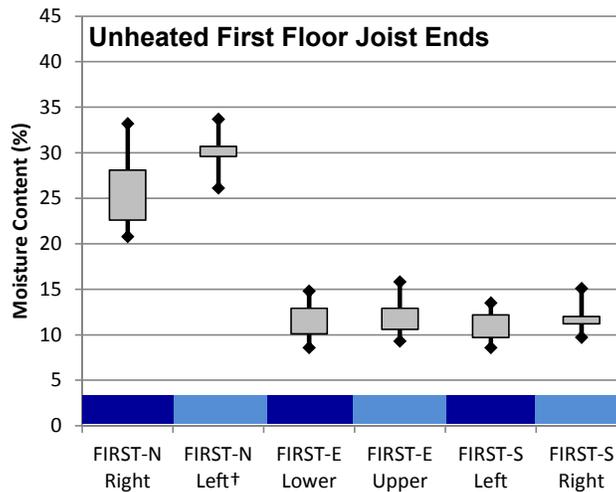
Figure 65. Box/whisker plot for joist end MCs; unheated first-floor joists

Figure 65 shows MC results for the first-floor unheated-area joists. This area was typically warmer than the basement due to solar gain through windows and the stack effect. The joist ends were embedded in hollow clay tile walls with some filler brick in contact with the wood.

†: FIRST-N Left: Data before March 30, 2014 are not plotted due to electrical anomalies.

safe range (10%–15%). The east- and south-facing joists also showed minimal seasonal variation.

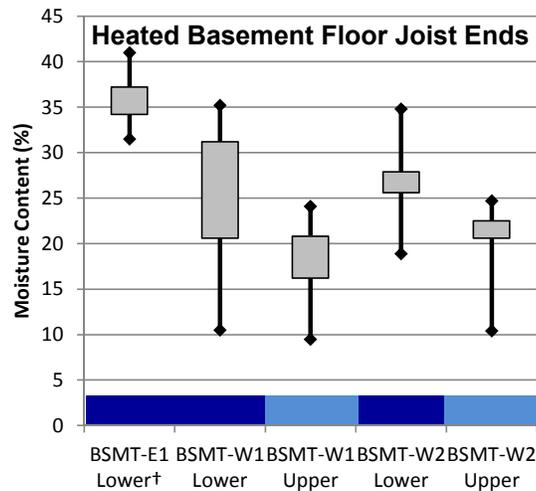
Figure 66. Box/whisker plot for joist end MCs; heated basement joists

Figure 66 shows the basement heated-area joists; however, the wintertime set point was 50°–75°F (10°–24°C) with wide temperature fluctuations (the jobsite was open 3 days per week).

†: BSMT-E1 Lower: Data before October 14, 2013 are not plotted due to electrical anomalies.

These joist ends showed a quick wintertime MC drop when interior heating was added. These joist ends showed wide seasonal swings; summer conditions were wetter and winter conditions were drier. However, the west-facing joists did not dry in winter 2014–2015, unlike previous winters. The east-facing joist end was wetter than the west-facing joists; BSMT-E2 was shaded by the building geometry. Figure 65 also clearly shows the difference between the upper and lower joist end measurements.
