Monitoring of Double-Stud Wall Moisture Conditions in the Northeast

Building America Report - 1501

January 2015

Building Science Corporation

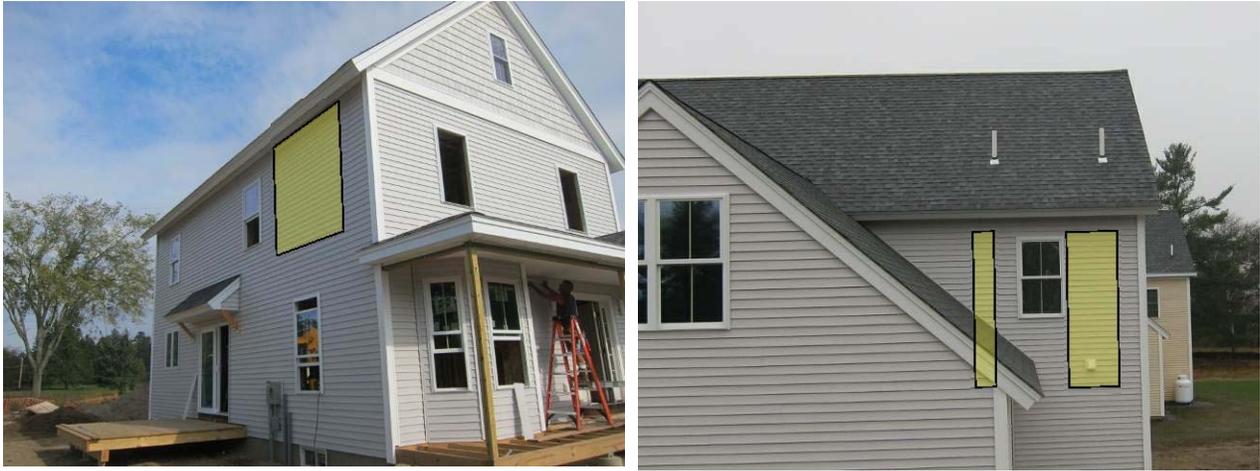
Figure 8. Test wall locations shown on exterior of house; south (L) and north (R) orientations

As shown in Figure 8 (right), the third bay (“control”) on the north side is partially sheltered at the bottom by the sloping garage roof. No better location was available, because of the positioning of windows, bathrooms, and garage.

The base of wall N3 was shielded by the garage roof (Figure 8); the sensors at the “lower” sheathing location were shifted upward, to the lowest exterior exposure in the stud bay.

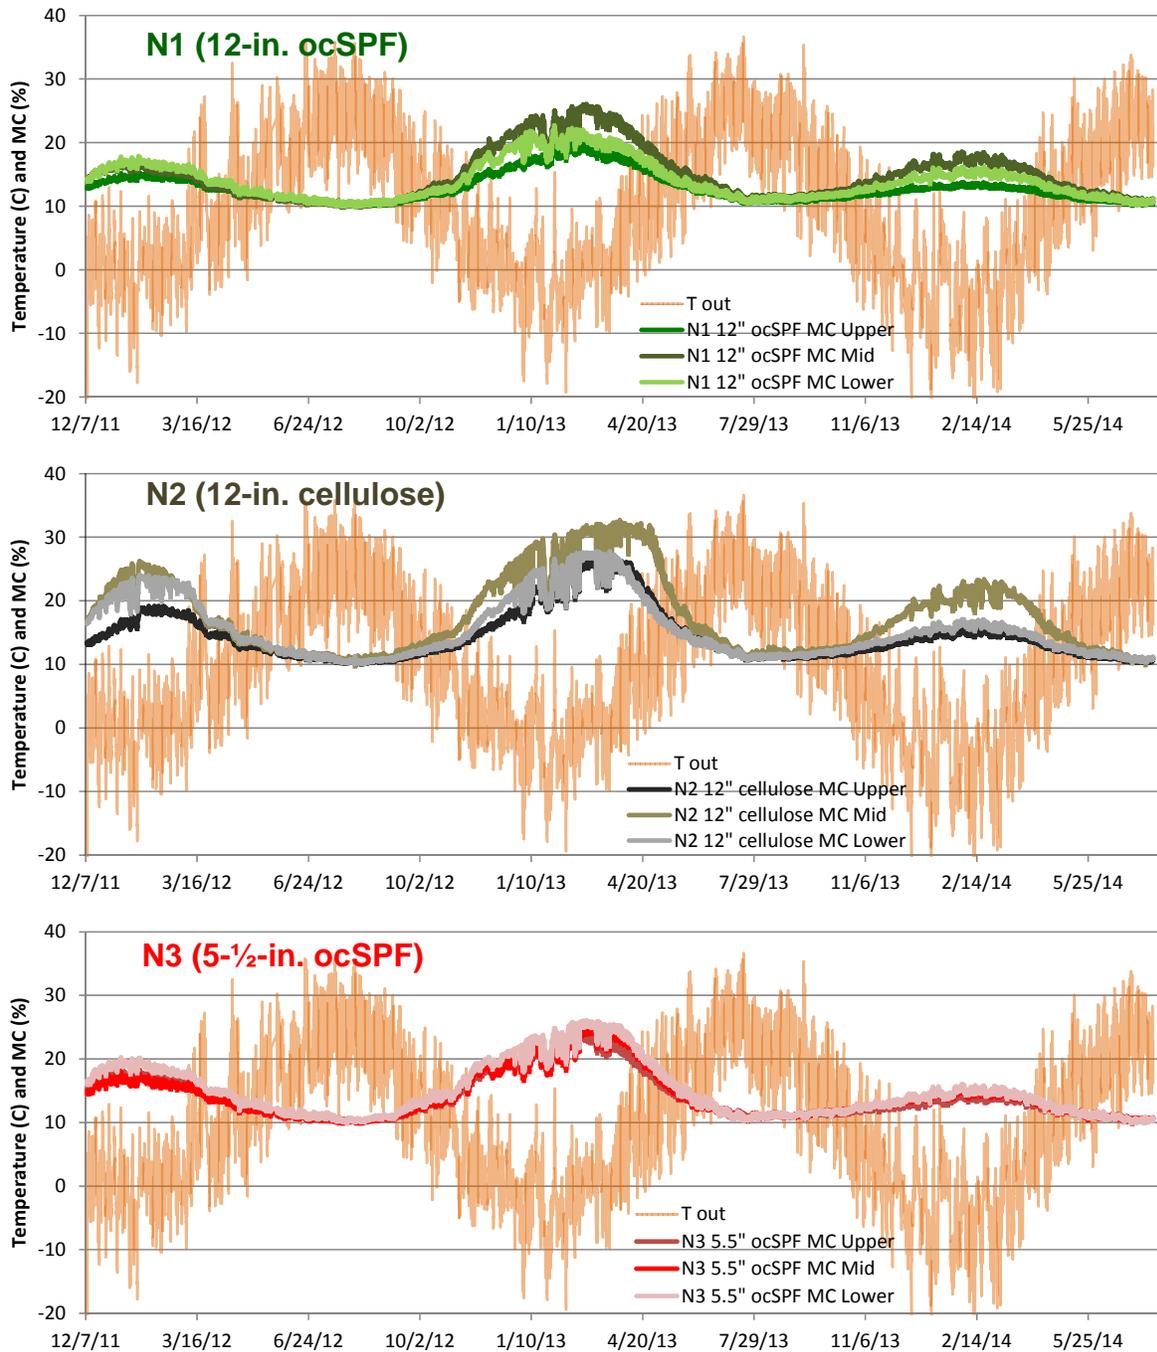
Figure 20. North side sheathing MCs, with exterior temperature for reference

Sheathing MC measurements exceeded the fiber saturation point in some cases: 30% MC typical for solid wood (Glass and Zelinka 2010), but were lower in adhered wood products such as OSB (Glass 2013), in the 25%–26% range. From the fiber saturation point up the capillary saturation, the relationship between MC and electrical resistance is not well defined (James 1988), so the plotted values should not be taken as absolute measurements. However, the high values are useful to show greater wetness levels than lower values.

The MC anomalies seen in the second winter at high MC levels (sudden jumps in MC) coincided with freezing temperatures; freezing of water in the sheathing likely resulted in different electrical resistance response (and thus measured MC). The MC trends during nonfreezing temperatures were more representative of actual conditions.

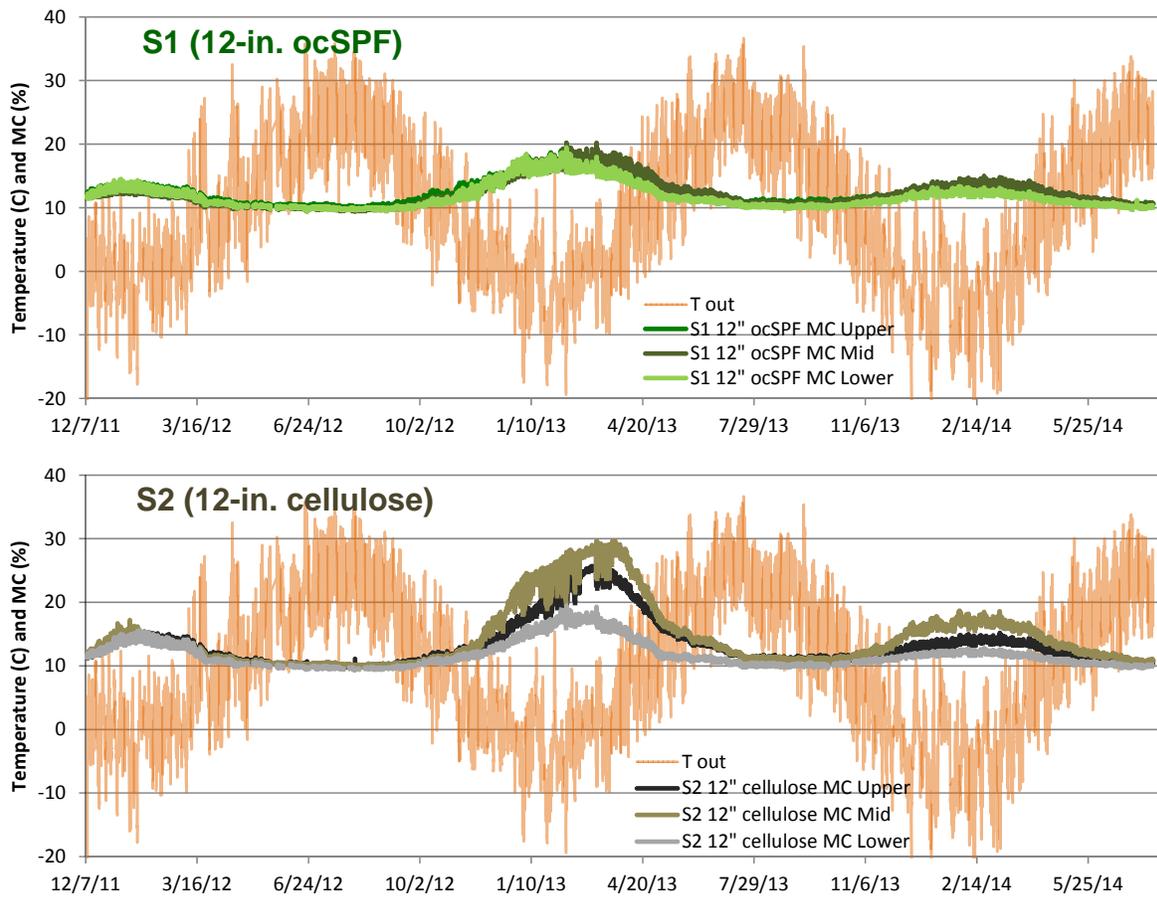
Figure 21. South side sheathing MCs, with exterior temperature for reference

The south-facing walls were all considerably drier than the north-facing walls, but with a similar pattern, where the 12-in. cellulose wall (S2) had higher wintertime peak MCs (Figure 21). In the second winter, the cellulose MCs rose to the 17%–30% range: this was much higher than the ocSPF walls. All walls dried to the 8% range in the summer; the intermittent data seen during summertime indicated periods drier than the measurement range of the data logger (wood electrical resistance was too high for measurement).

Given the low, middle, and high sheathing MC measurements, the data were examined for evidence of spatial MC relationships. The midheight MC was noticeably higher in some cases; the upper MC was lowest in two of three cases: this would be an argument against convective airflow depositing moisture at the top of the stud bay. The upper sheathing might have been slightly shielded from night sky radiation by the roof overhang, resulting in warmer sheathing temperatures (and lower MCs); this is consistent with temperature measurements.

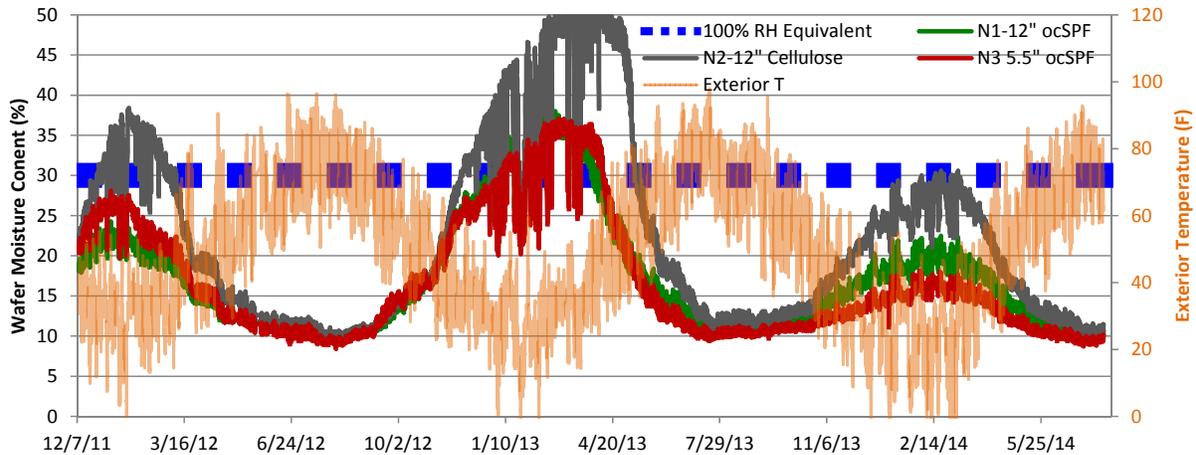
Figure 23. North side wafer sensor MCs, with exterior temperature for reference

The wafer response is consistent with the sheathing MC measurements, as shown in the north-side measurements (Figure 23):

- In the first winter, 12 in. of ocSPF remained the driest through the winter, followed by 5-½-in. ocSPF. The cellulose wall showed much higher wintertime peak moisture levels, consistent with condensation occurring at the sheathing (higher than the 100%-equivalence line). In contrast, the open foam walls remained below the 100% RH-equivalence level. During the following summer, all wafer sensors dried to the 9%–12% MC range (50%–65% RH equivalent).
- In the second winter, all wafer sensors showed MC peaks well into the condensation range, with significant condensation at the 12-in. cellulose wall. Again, the wafers dried in the following summer, because thermal gradients drove moisture inward.
- In the third winter, similar patterns to the first winter are seen, except that 12 in. of ocSPF (N1) and 5-½-in. ocSPF (N3) changed order (although both were well below 100% RH).

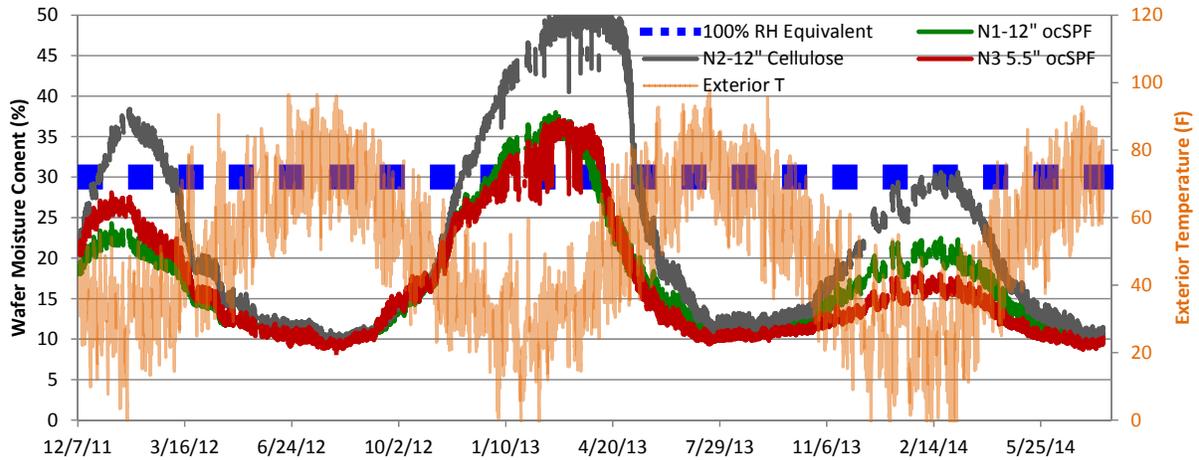
Figure 24. North side wafer sensor MCs, filtered values above 36°F

The wafer MC measurements also showed anomalies during freezing conditions; the peak values should be considered to be most representative. Figure 24 shows the same data, but filtered for values when sheathing temperatures were above the freezing point (35.6°F [2°C] used here); there was a significant reduction in wintertime anomalies.

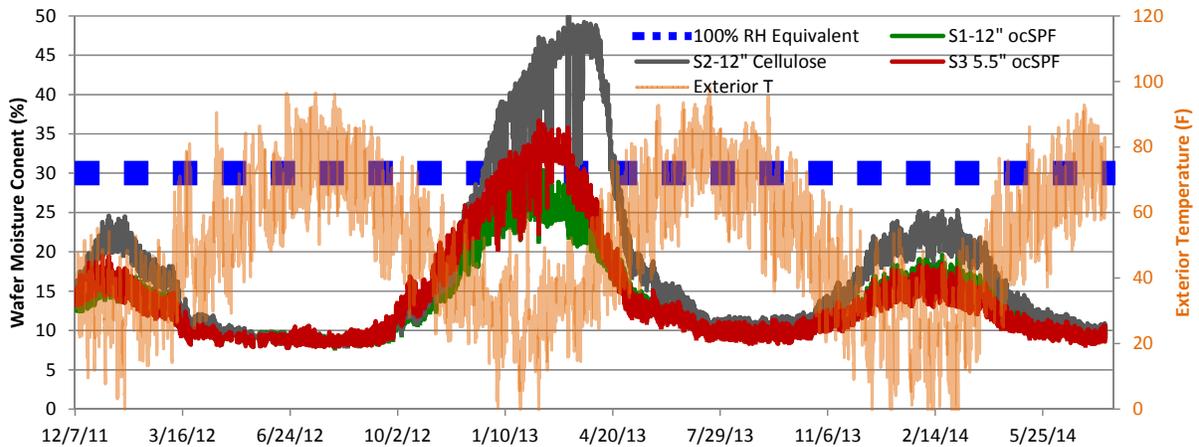
Figure 25. South side wafer sensor MCs, with exterior temperature for reference

The south-facing wall wafer results are shown in Figure 25; again, patterns are analogous to the previous sheathing MC measurements. The cellulose wall showed the highest moisture levels, but were drier than the north walls. In the second winter, significant condensation was indicated in the cellulose wall; again in the following summer, the wafers returned to the dry range. In the third winter, all measurements were below 100% RH equivalent. Also, during each summer, the wafers dried to roughly 10% MC, which is well into the safe range.

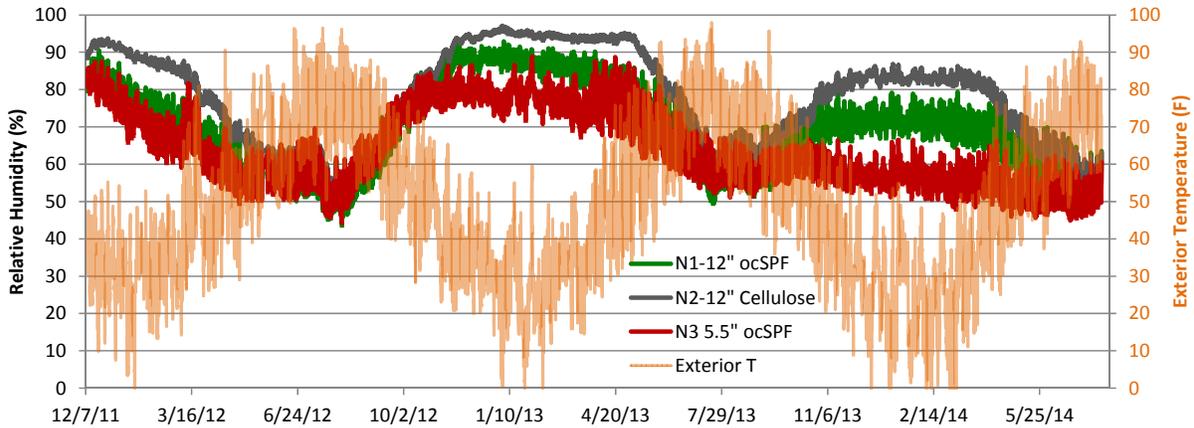
Figure 28. North-facing wall exterior side RH, with exterior temperature for reference

The temperatures at the RH sensors followed the expected wintertime pattern: N1 and N2 were close to identical (tracking outdoor conditions), and N3 was slightly warmer (because of reduced insulation inboard of the sensor).

The relative order of RHs was similar to what was seen in the wafer data, with the cellulose (N2) consistently the wettest, and the 5-1/2-in. osSPF (N3) typically driest. During the second winter (high interior RH), the RH at the cellulose wall was roughly 95% for most of the winter. During the summers, all RH sensors at the sheathing fell to the 50%–70% range, because the temperature gradient and moisture drive were inward, away from the sheathing.

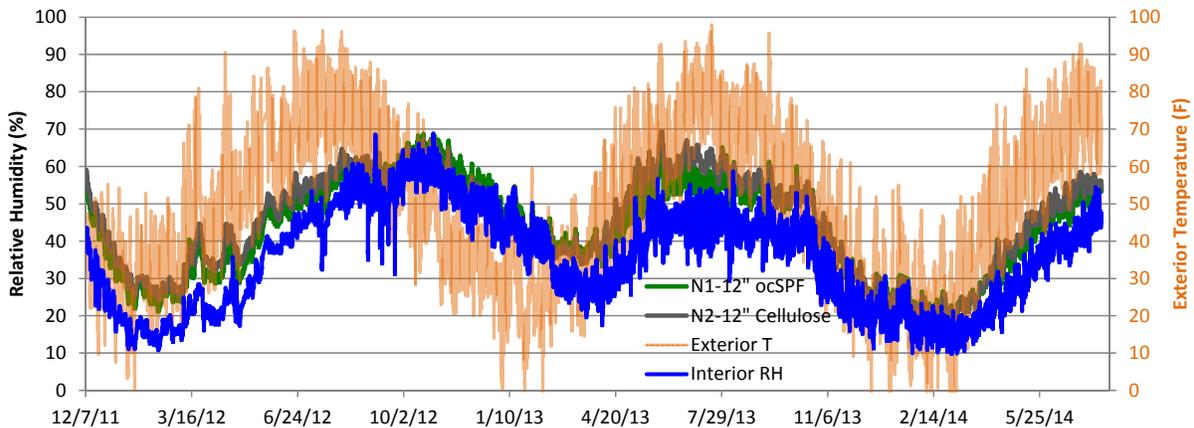
Figure 29. North-facing wall interior side RH, with interior RH and exterior temperature for reference

The inboard RH sensors for the north-facing walls are plotted in Figure 29, with exterior temperature and interior RH for reference. The RH levels essentially tracked interior conditions. The void space inboard of N3/S3 (5-1/2-in. ocSPF) showed similar behavior.

In the summers, when the walls dried inward, there was no sign of moisture accumulation at the inboard side of the wall. This was due to the vapor-open nature of the interior finishes (latex paint on gypsum board, Class III vapor retarder).

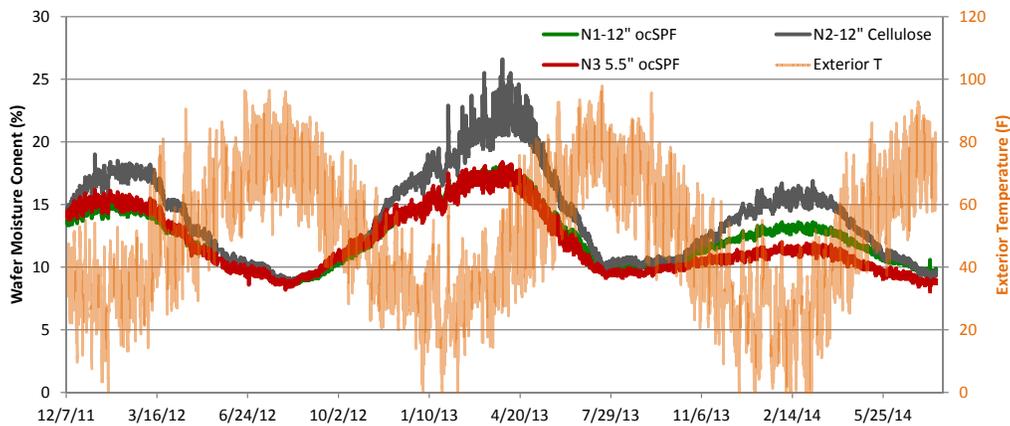
Figure 31. North-facing wall exterior framing MC, with exterior temperature for reference

The relationships between the test walls were again similar, with north walls wetter than the south, cellulose wetter than ocSPF walls, and outboard MCs higher than inboard MCs. Peak MCs were generally lower in the framing than the sheathing measurements. In the second winter (worst wetting), the north cellulose outboard framing peaked at 20%–25%, while the two ocSPF walls peaked near 16%–18%.

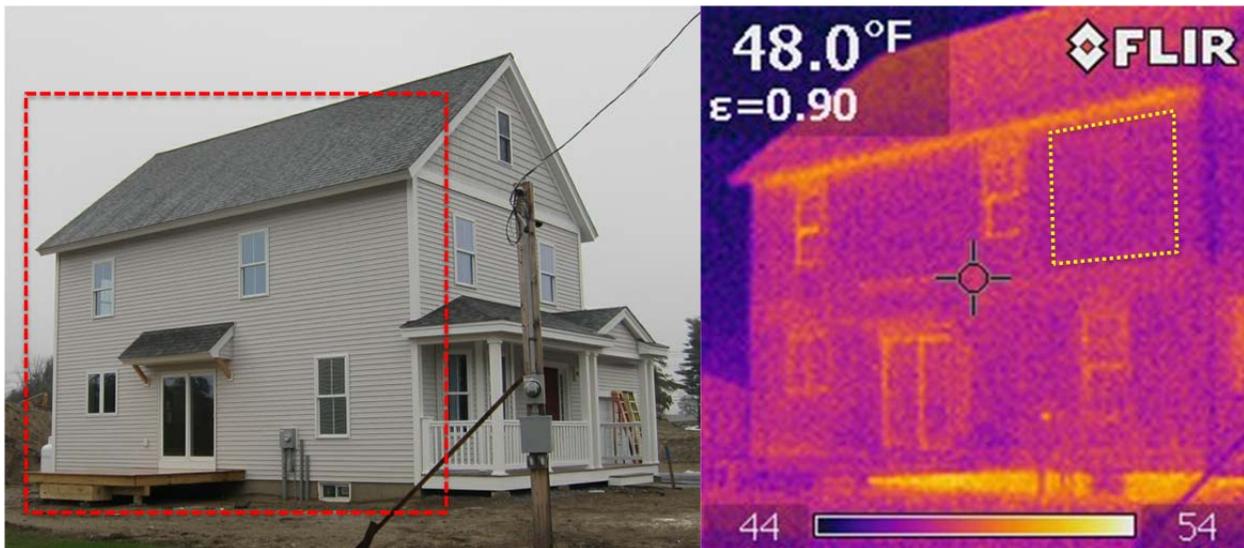
Figure 35. South-facing wall infrared image; 50°F (10°C) outdoor conditions

An infrared image at mild outdoor temperatures (50°F [10°C], overcast conditions/little direct solar gain) shows no clear difference between the three test walls (Figure 35). Of course, greater surface temperature differences would be expected in colder conditions. In addition, vinyl siding is a ventilated cladding, and would tend to “mask” sheathing temperature differences.

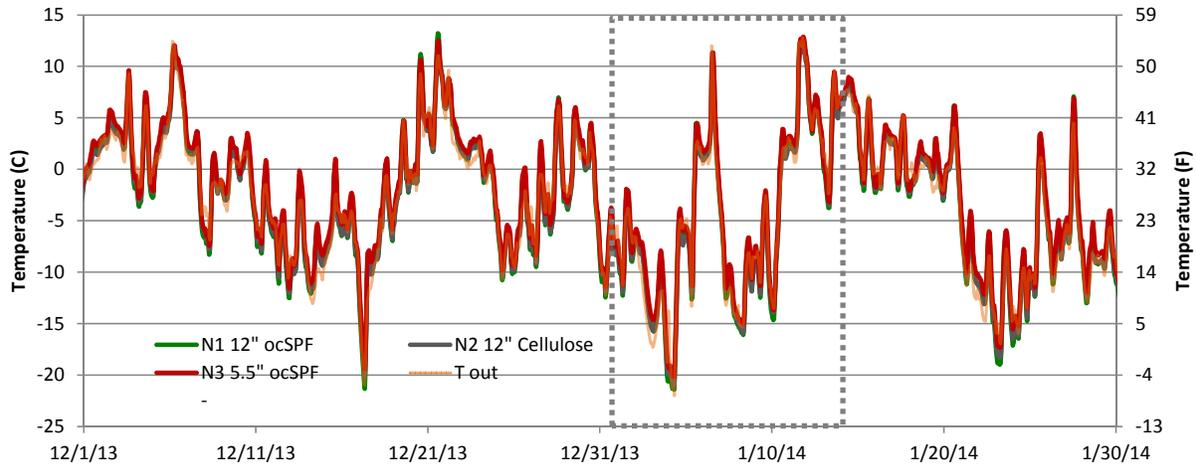
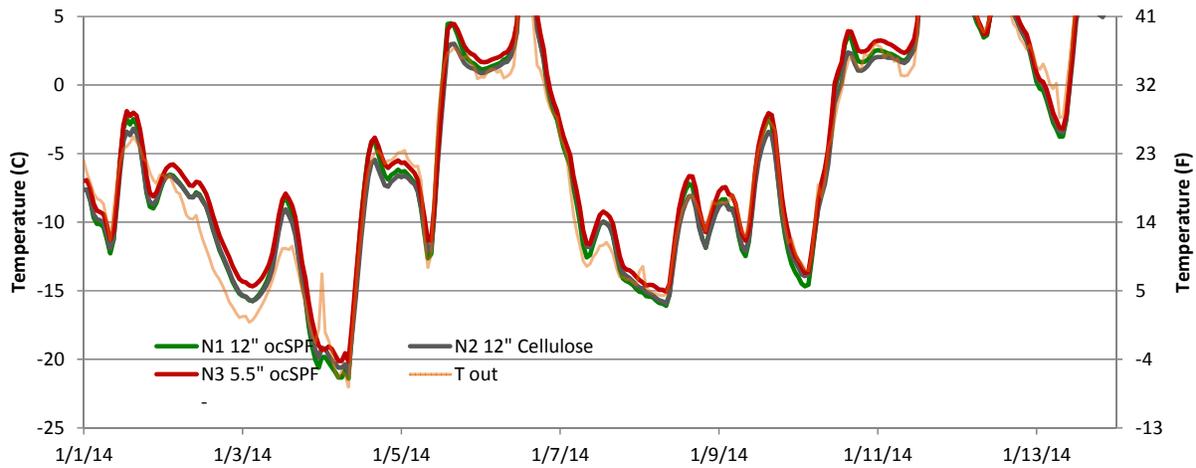
The mid-height sheathing temperature for the north side wall for 2 winter months (December 2013–January 2014) is shown in Figure 36, with exterior temperature for reference. It is very difficult to differentiate between the walls, so a 2-week period in January was plotted at higher resolution (Figure 37).

The plot appears to show that the 5-1/2-in. ocSPF wall (N3) has slightly higher sheathing temperatures, but the difference is very small—the largest discernable differences are generally about 1°F (0.5°C) or less..

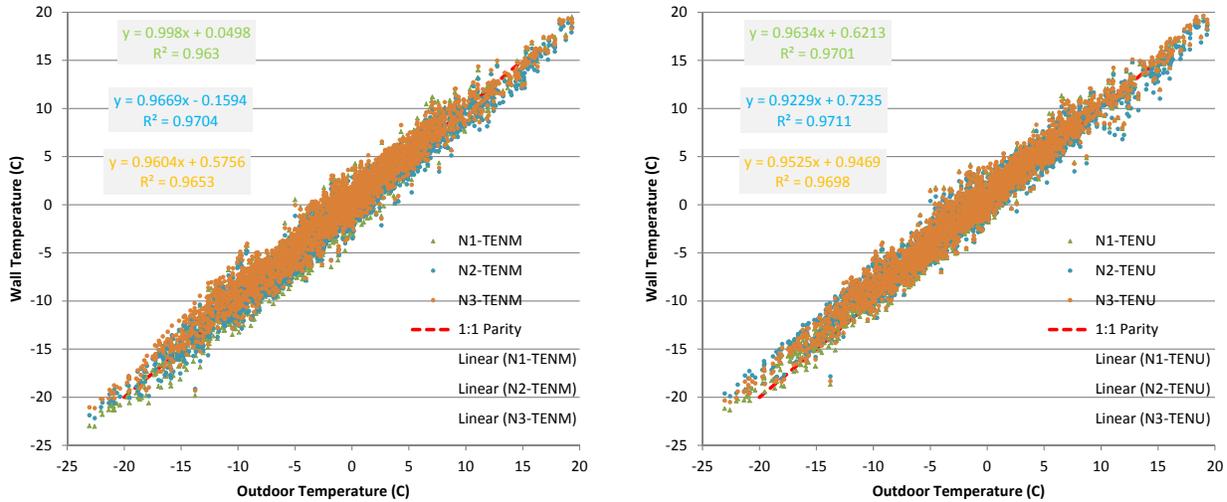
Figure 38. Sheathing temperature versus outdoor temperature, middle and upper north sheathing

A larger data set can be examined by plotting the sheathing temperature against outdoor temperature, as shown in Figure 38 for the north-facing middle and upper sheathing sensors. Sheathing that is warmer or colder, on average, should show a pattern of being above or below the 1:1 diagonal parity line.

However, it is difficult to visualize any clear patterns in the data. A further step was taken of plotting the trendlines for the data (assuming a linear relationship) and calculating sheathing temperature as a function of outdoor temperature. The calculations show inconsistent results, with N2/5-1/2-in. ocSPF not always coldest.

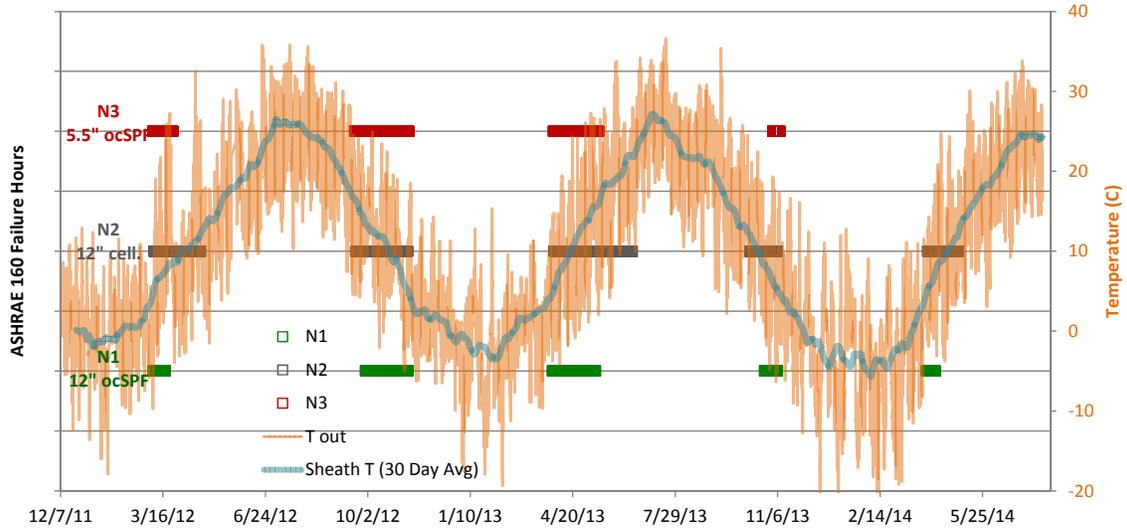
Figure 46. ASHRAE Standard 160 evaluation of north-facing walls, insulation-sheathing interface

The results for the north-facing walls are plotted in Figure 46: hours that fail ASHRAE 160 are denoted by points; outdoor temperature and the sheathing temperature (30-day rolling average) are plotted for reference.

The results show that all three walls fail ASHRAE 160 requirements during all three winters, and that the cellulose wall (N2) has the worst performance according to these criteria. In addition, winter 2012–2013 (high humidity winter) has more failing hours: the cellulose wall (N2) fails ASHRAE 160 from mid-September through mid-November, and then April through late June. It is interesting to note that failures occur in the walls in fall and spring. During the winters, sheathing temperatures drop below the 41°F (5°C) lower limit, even though the RH criterion is exceeded. Overall, based on an ASHRAE 160 analysis, the walls do not dry rapidly enough to avoid problems.

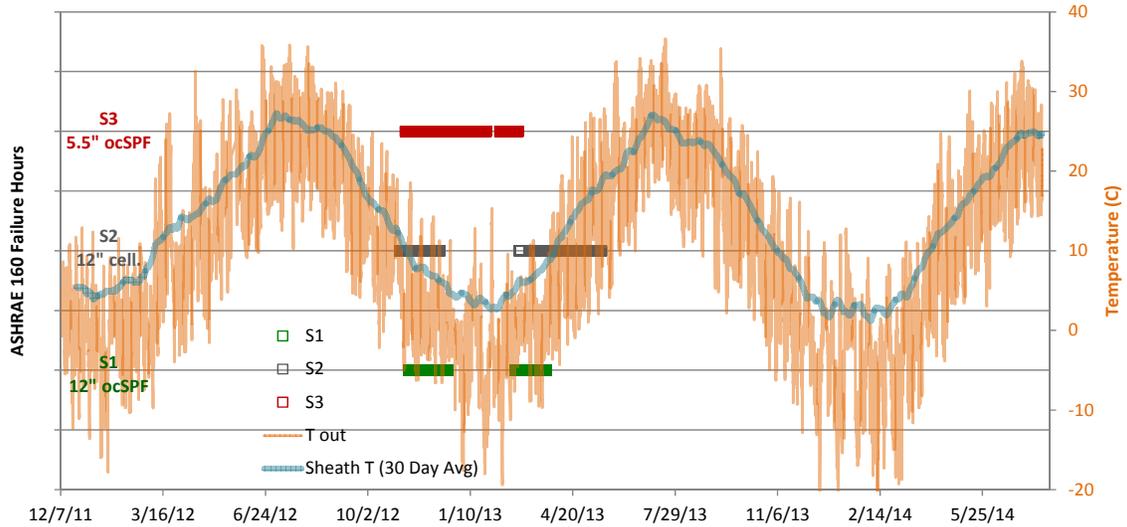
Figure 47. ASHRAE Standard 160 evaluation of south-facing walls, insulation-sheathing interface

A similar plot was generated for the south-facing walls (Figure 47): on this orientation, failures occurred only during the high-humidity winter (2012–2013). Again, the cellulose wall (N2) had the worst performance, with extended periods exceeding ASHRAE conditions.

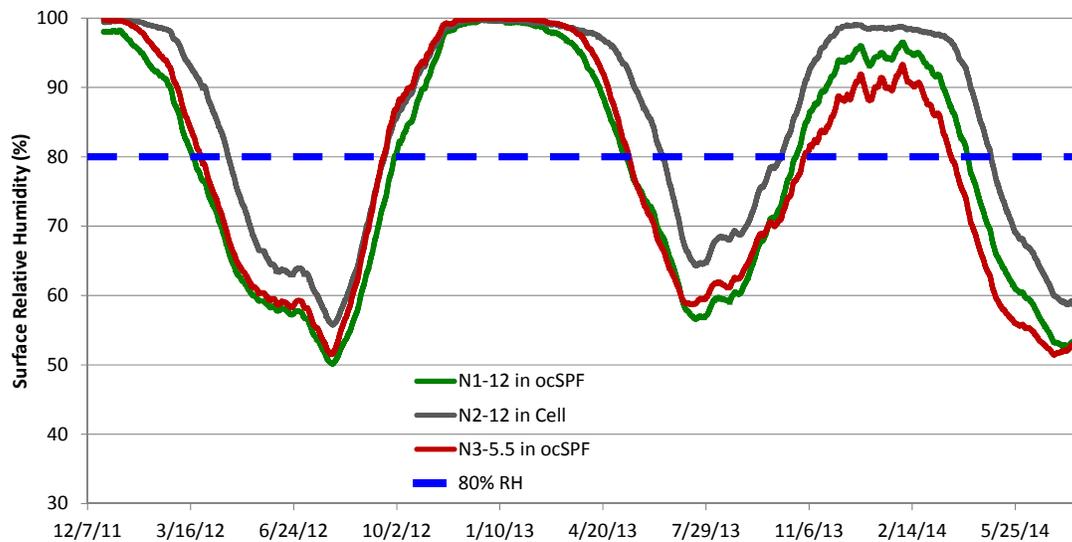
Figure 48. 30-day running average surface RH, north walls

For reference, the 30-day average calculated surface RH for the north walls is shown in Figure 48. It demonstrates the fact that average surface humidities exceeded 80% for the entire winter, and for much of the fall and spring. However, the temperature criterion in ASHRAE 160 (temperature too low for mold growth) results in failure hours occurring in fall and spring only. It also shows the greater number of failing hours in the cellulose wall (N2), compared to the ocSPF walls (N1 and N3).

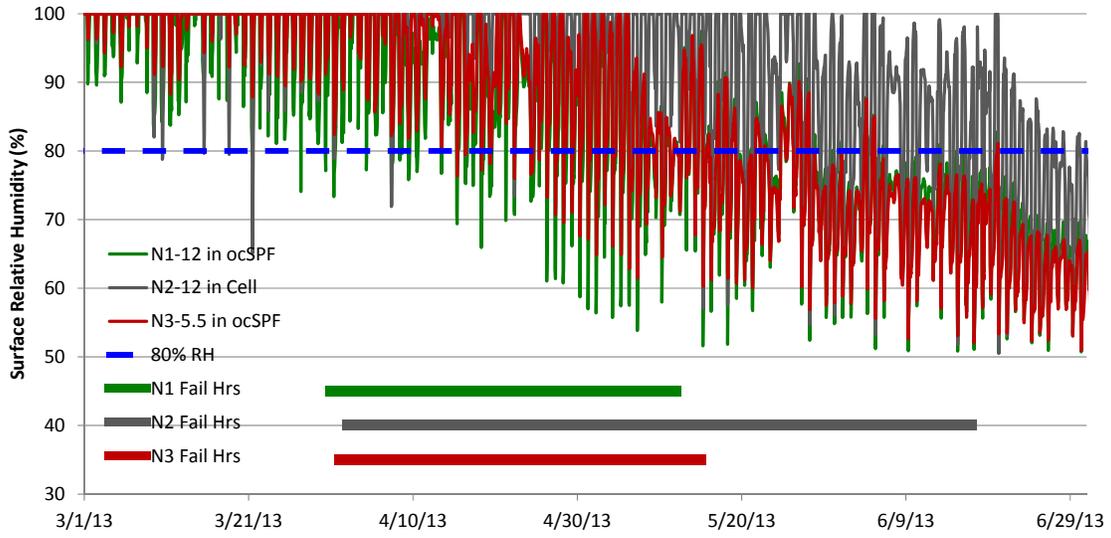
Figure 49. Hourly surface RH, north walls, with ASHRAE 160 failure hours

The diurnal cycling of surface RH levels is demonstrated in Figure 49, which plots hourly (not averaged) RH levels at the insulation-sheathing interface, for spring 2013 (March through June). The hours that fail ASHRAE 160 criteria are highlighted as well. Warmer temperatures during the daytime result in lower surface RH because of warmer sheathing temperatures.

It shows that there are hours when surface RH drops below 80% that still fail ASHRAE 160 criteria. However, given that the ASHRAE 160 criteria are a 30-day running average, this fact is largely irrelevant.

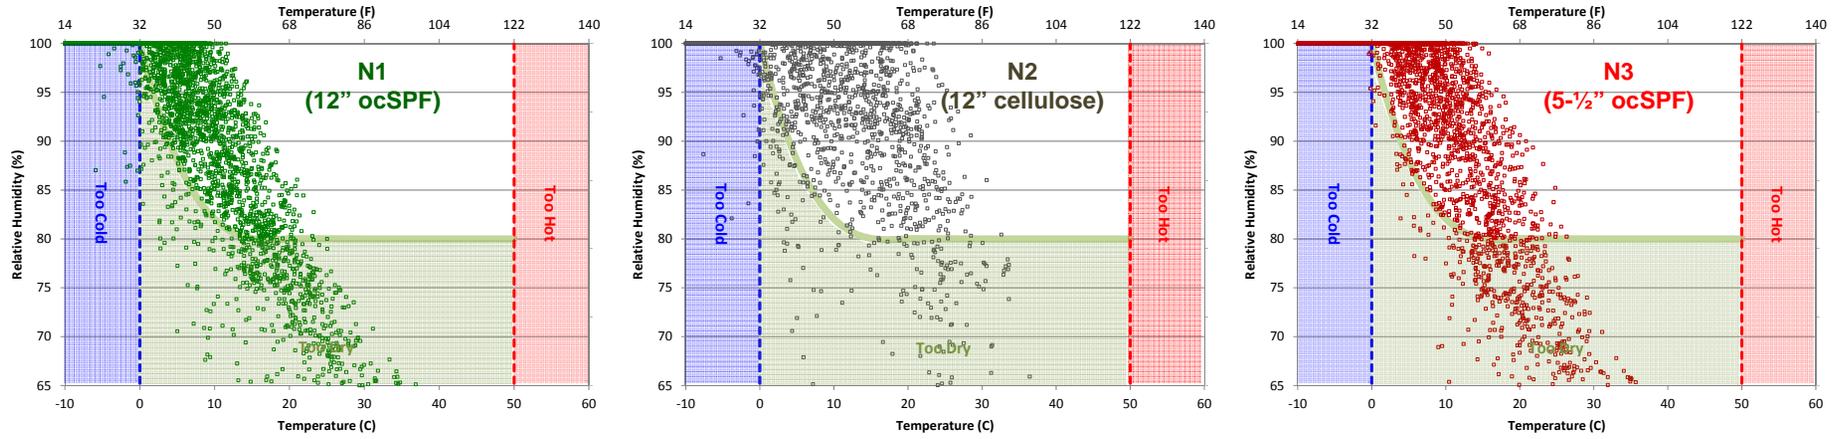
The north-facing walls (Figure 52) show many hours with sufficient humidity and temperature to allow mold growth. The ocSPF walls (N1 and N3) have data that are clustered toward the lower risk side of the growth range (immediately to the right of the green curve). However, the cellulose wall (N2) shows a larger number of hours with warmer temperatures and high humidity levels (further to the right of the green curve). This is consistent with the other analysis and measurements described earlier.

Figure 52. North-facing walls, winter 2012–2013 (November–May) T/RH plots, insulation-sheathing interface

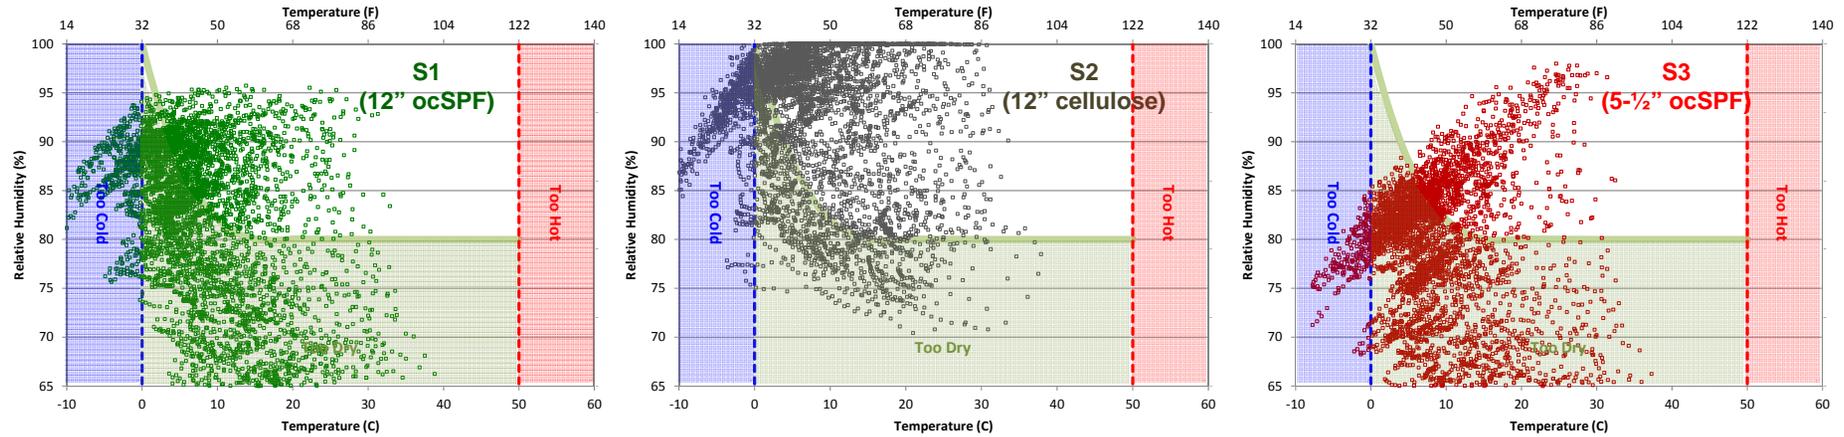
The south-facing walls (Figure 53) show a different temperature-RH plot shape caused by solar heating on that orientation. However, as a result, there appear to be more hours spent at higher risk (warmer/high RH) conditions. The cellulose wall (S2) shows many hours at moderate temperatures and very high RHs (95%–100%). The ocSPF walls (S1 and S3) have many fewer hours in this high risk range.

Figure 53. South-facing walls, winter 2012–2013 (November–May) T/RH plots, insulation-sheathing interface
