# Measuring the Impact of Interior Insulation on Solid Masonry Walls in a Cold Climate

By J. Wilkinson, D. De Rose, B. Sullivan and J.F. Straube

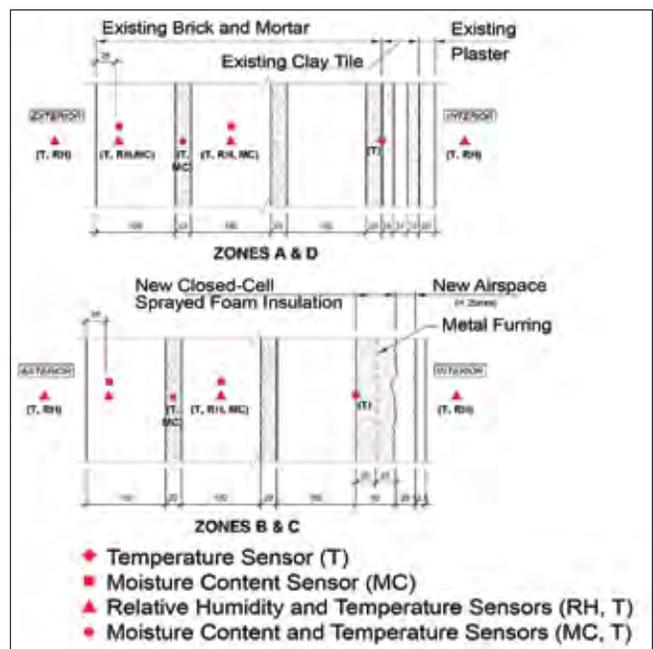
Nine sensors were installed in each wall to measure temperature, relative humidity and moisture content at various locations across the wall (see **FIGURE 1**). Exterior temperature and relative humidity were measured directly outside the test walls. Driving rain was measured on the exterior of the walls, at the bottom of Zones B and C (south and east). Interior temperature and relative humidity were also measured at two locations within the test room.

Figure 1. Mock-up wall sections. Zones A&D: existing un-insulated wall assembly. Zones B&C: modified insulated wall.

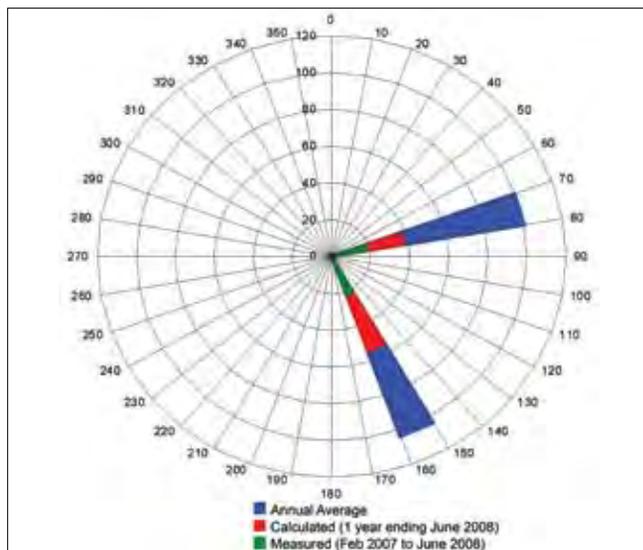
using publicly available vertical rainfall, wind direction and wind speed data from nearby Queens Park (calculated per procedures described in Straube and Burnett (2005)). A rain deposition factor of 0.5 was used, as determined by comparing calculated wind driven rain from the data noted above against measured wind driven rain on site. Based on this evaluation, the monitored walls were only exposed to about half the driving rain that occurs in an average year, as shown in **FIGURE 2**.

Figure 2. Wind-driven rainfall on test walls. Wind-driven rain shown is for various periods using Toronto Pearson Airport and Queen's Park Weather Stations. A rain deposition factor of 0.5 is used, as determined by on site wind-driven rain measurement.

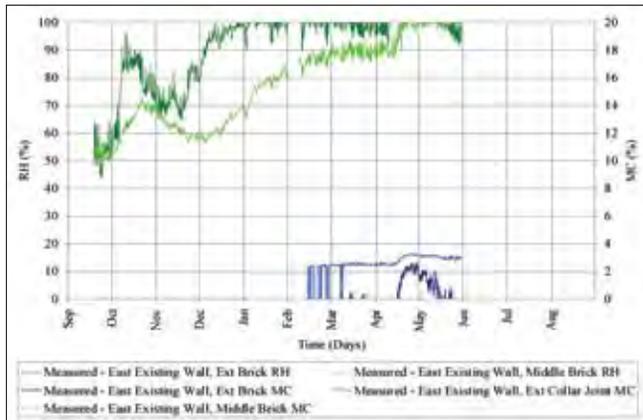
The moisture content in the measured walls was low throughout the monitoring period and, as a result, there were no hours where freeze-thaw damage was likely to occur (see **FIGURES 5**

and **FIGURE 6**). The maximum monitored moisture content was 4 percent in the brick and mortar, which is below the estimated 12 percent threshold where freeze-thaw damage is expected to occur (this 12 percent threshold corresponds to 85 percent of the free water saturation). This threshold is expected to be conservative since there should be sufficient room remaining in the pores to alleviate pressures from freezing water.

Figure 5. Measured RH and MC in east existing wall. Actual relative humidity and moisture content (wood wafer) measured in the existing east wall. The moisture content is well below thresholds for freeze-thaw. MC values shown are for the wood resistance sensors embedded in the brick, instead of the corresponding brick moisture content in order to increase measurement resolution.

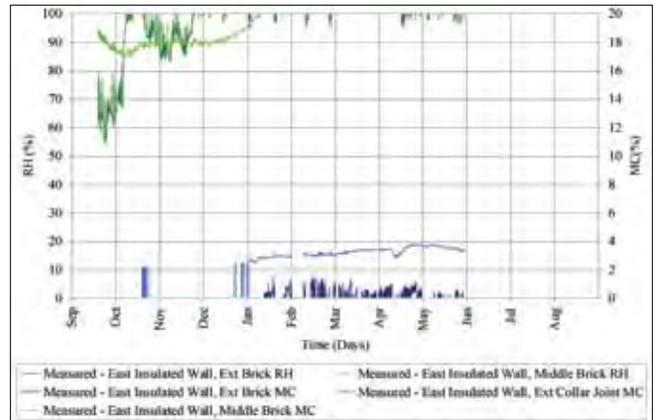
Figure 6. Measured RH and MC in east insulated wall. Actual relative humidity and moisture content (wood wafer) measured in the insulated east wall. The moisture content is well below thresholds for freeze-thaw. MC values shown are for the wood resistance sensors embedded in the brick, instead of the corresponding brick moisture content in order to increase measurement resolution.

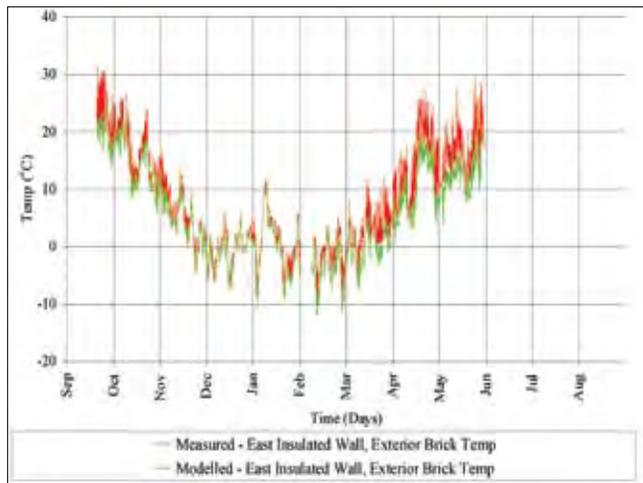
The hygrothermal performance of the modeled and measured walls generally compared well (see **FIGURE 7**), particularly at locations sensitive to freeze-thaw (exterior brick and exterior collar joint). The thermal properties of the components are well understood. The relative humidity trends are also consistent between the measured and modeled results, but the modeled values are typically within 10 percent of the measured values.

Figure 7. Temperatures shown are similar between modeled and measured walls. Other locations also compare well.
