BUILDINGENERGY BOSTON

Unvented Roofs Without Spray Foam: The Rest of the Story

Kohta Ueno (Building Science Corporation)

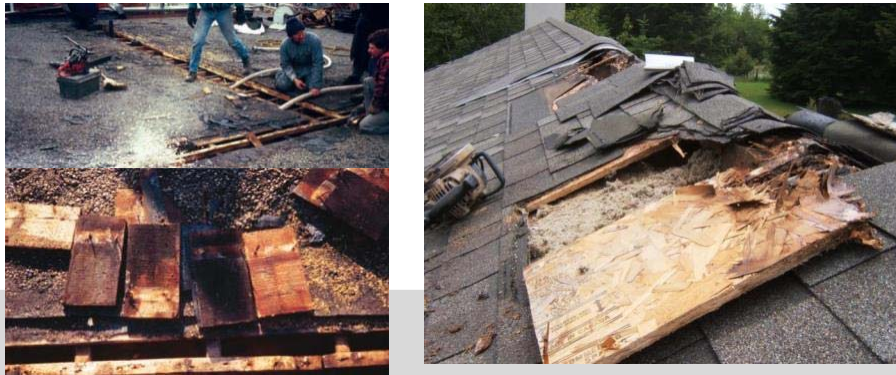
Fibrous Insulation Unvented Roofs

- Dense pack insulation of unvented roofs common in cold-climate retrofits
 - Moisture risks (see BSI-043 “Don't Be Dense—Cellulose and Dense-Pack Insulation”)—2 in 10 failure?
 - Violates I-codes (see IRC § R806.4/R806.5)
 - “Ridge rot”—localized problems (SIPS same problem)

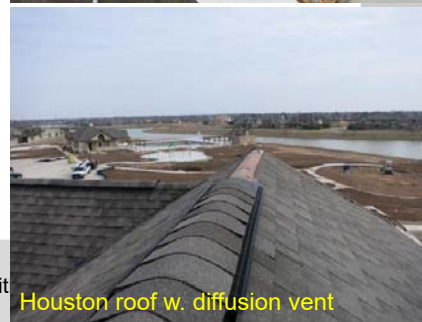
Previous Building America Research

- Chicago (CZ 5A):
 - One winter, 50% RH
 - Unvented roofs-high risk
 - Cellulose lower risk than FG batt
 - Vented compact roof (chute) safe-but poor air leakage
- Houston/Orlando (CZ 2A):
 - 2 attics, multiple seasons
 - Diffusion vents allow greater drying, avoid moisture problems

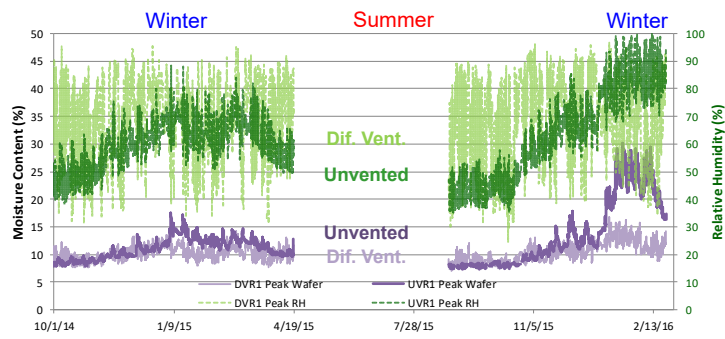
Houston/Orlando Results

- Diffusion vent avoids wintertime ridge accumulation problems (ridge peak RHs/MCs)
- No failures at low interior RH, bigger difference at higher RH (interior humidification)
- Airtightness disappointing in some cases-no SPF

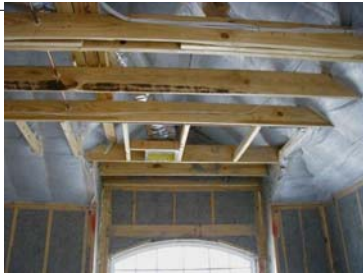
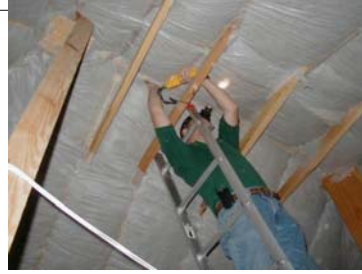
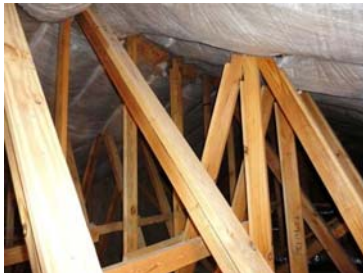
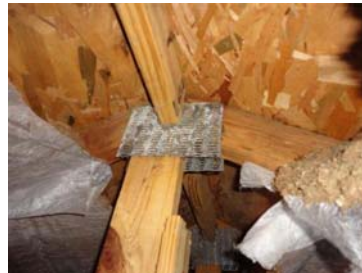
Houston and Jacksonville (CZ 2A) 2001

- Moisture concentrated at highest point in conditioned attic (ridge)
- Not a simple one-dimensional problem
- Not a straight-up air leakage problem
- Problem with open-cell spray foam (ocSPF) unvented roofs (high RHs in attic)-many climates
 - But not ccSPF—lower vapor permeance
- Concentration of interior-sourced moisture
- Moist air is lower density (“lighter”) than dry air
- Others: “system in equilibrium has same dewpoint in connected air space”

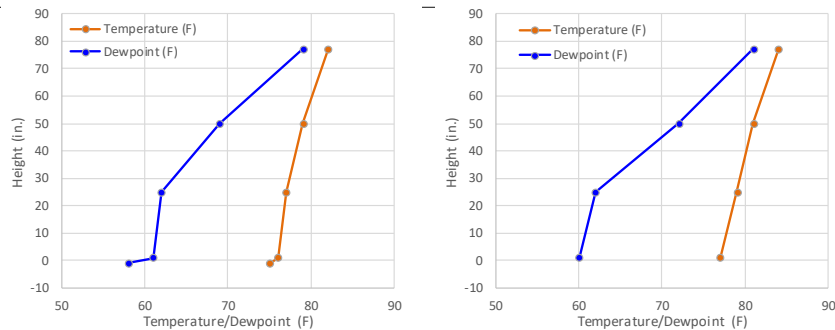
Orlando Decommissioning

- Temperature and dewpoint stratification directly measured
- 90%+ RH near ridge
- System is not in equilibrium

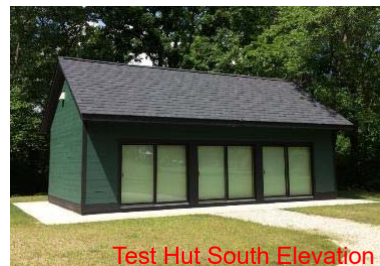
Test Hut Experimental Approach

- Climate Zone 5A test hut
- Eight north-south roof bays; guard bays
- $\pm R-50$ (14- $\frac{3}{4}$ " framing, 2012 IECC)
- Test variables (changed year-to-year):
 - Vapor retarder: variable perm vs. fixed perm, various permeance curves
 - Diffusion vent at ridge: full size, none, "small," or "tight"
 - Fiberglass vs. cellulose
 - "Control" comparison § R806.4 spray foam + fibrous
- Varying interior boundary conditions
 - Winter 1: "Normal" interior conditions
 - Winter 2: Elevated RH (50% constant)
 - Winter 3: Air leakage into rafter bays

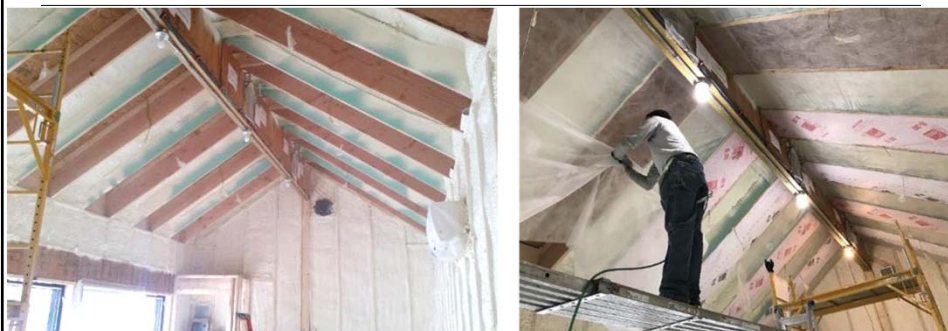
Test Hut Construction

- Flash and blow bays (ccSPF shown)
 - ccSPF completes air barrier between bays, wiring holes
- Insulation netted & blown

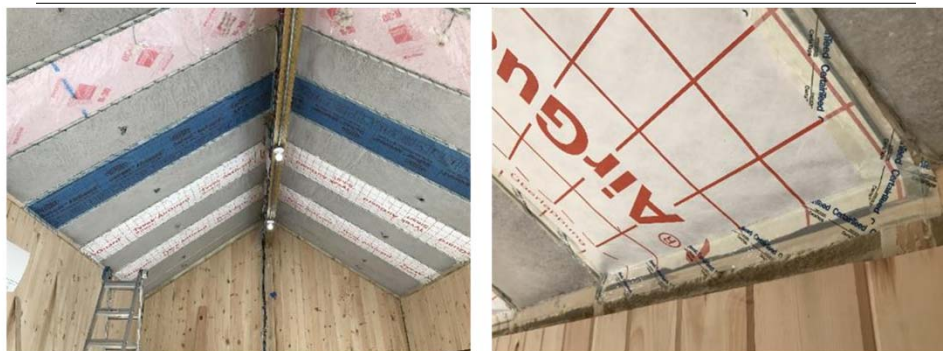
Test Hut Construction

- Interior air barrier & vapor retarder membrane
- Adhesive spray + double tape seal (double-sided tape + housewrap tape) plus mechanical fasteners

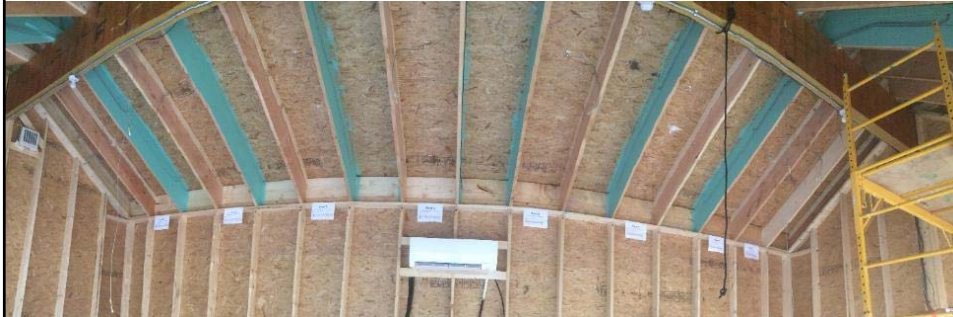
Test Hut Construction

- Instrumentation completion

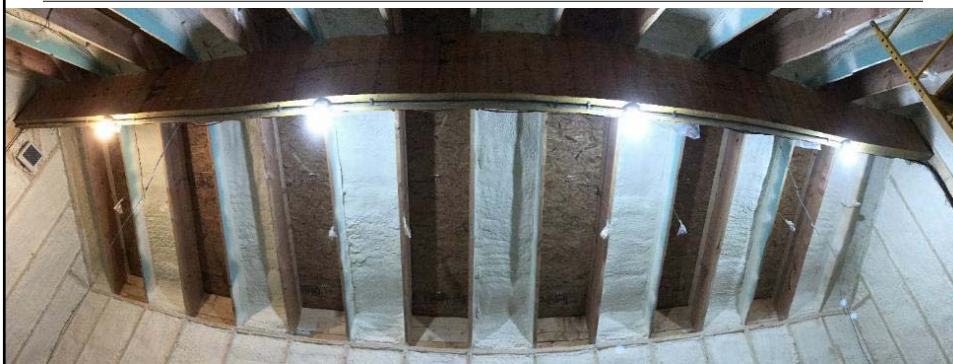
Test Hut Construction

- ccSPF in guard bays and walls

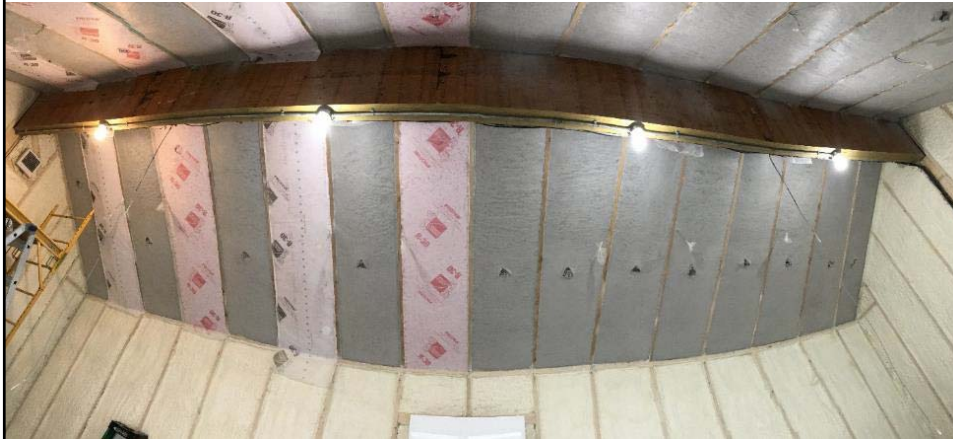
Test Hut Construction

- Fibrous insulation installed

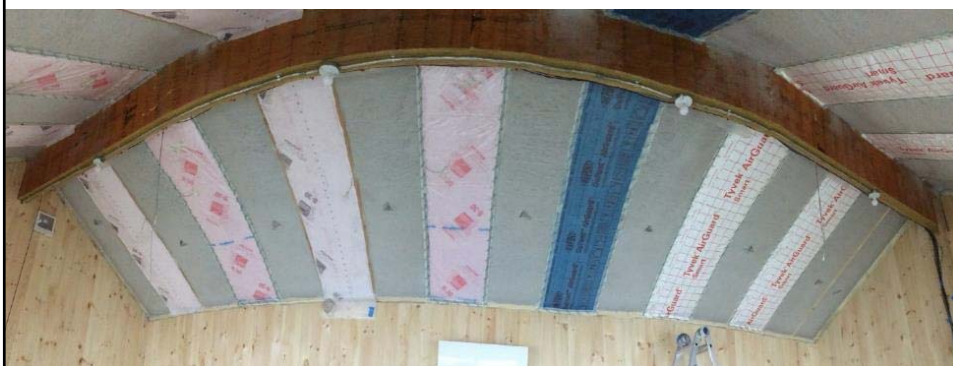
Test Hut Construction

- Interior air/vapor control installed

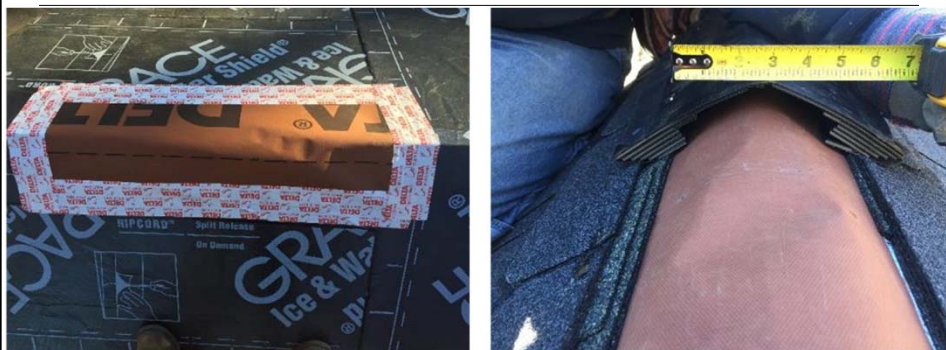
Experimental Approach: Diffusion Vent

- ~6 in. opening (fits under typical ridge cap)
- Dörken Delta-Foxx membrane
 - 214 perms dry cup, 550 perms wet cup

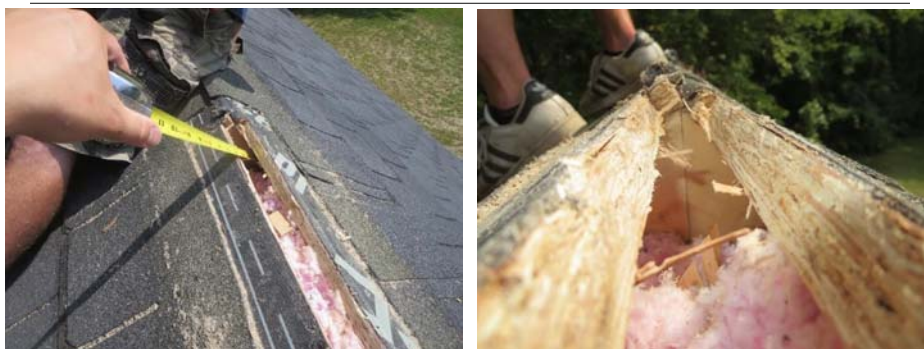
Roof Insulation Settling (Fiberglass)

- Insulation settling noted during diffusion vent retrofit
- Fiberglass roof shown above

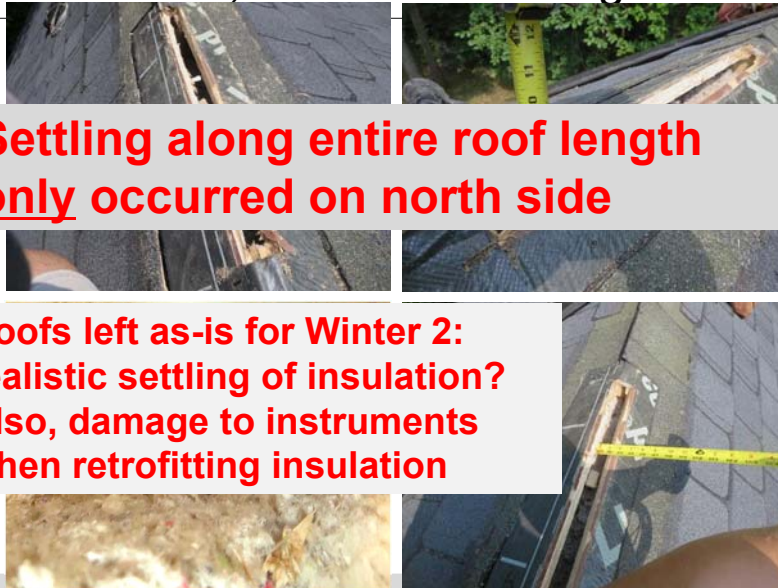
Retrofit Work, Cellulose Settling

**Settling along entire roof length
only occurred on north side**

**Roofs left as-is for Winter 2:
realistic settling of insulation?
Also, damage to instruments
when retrofitting insulation**

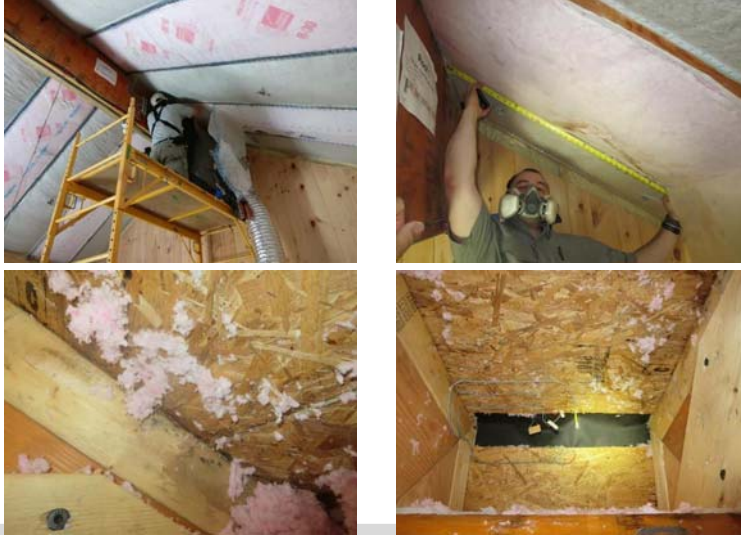
Summer 2 Ridge Disassembly Work

- Fiberglass: staining, rundown, some mold spotting

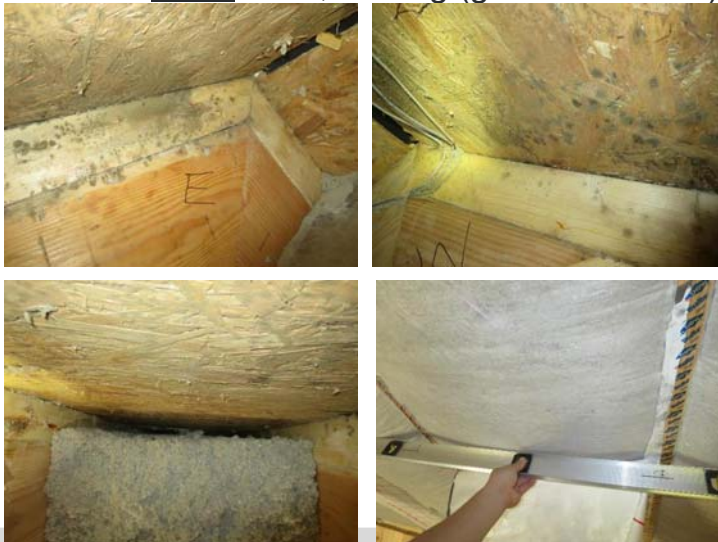
Summer 2 Ridge Disassembly Work

- Cellulose: worst mold, settling (greater at north)

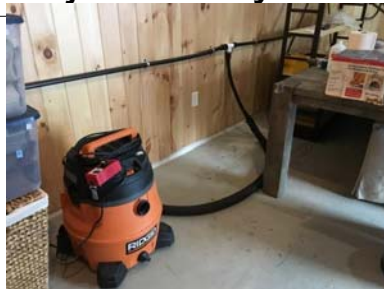
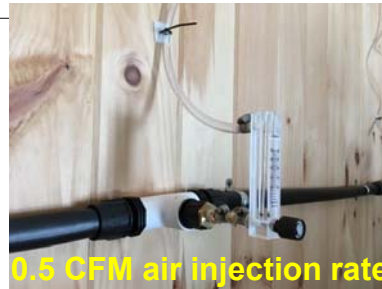
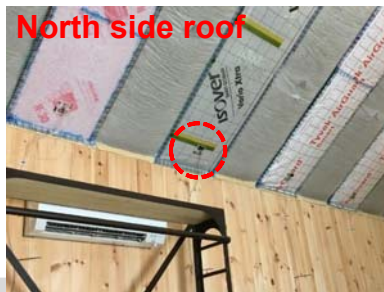
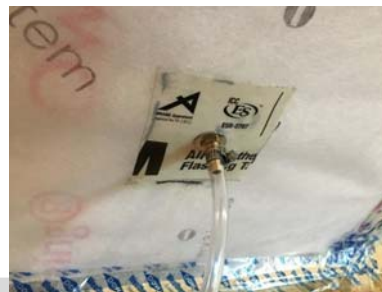
Air Injection System

- Early winter 50% RH, no air leak
- February onward-add air leak
- Air injection system
 - Interior-to-interior leak
 - Very small air leak, 0.5 CFM per bay
 - Comparable to very airtight construction
- Before air injection: much drier than Year 2
 - Repacking insulation suppresses convection?
- Air injection: severe spike in sheathing MC
 - Localized to injection site
 - Disassembly in summer: no visible damage

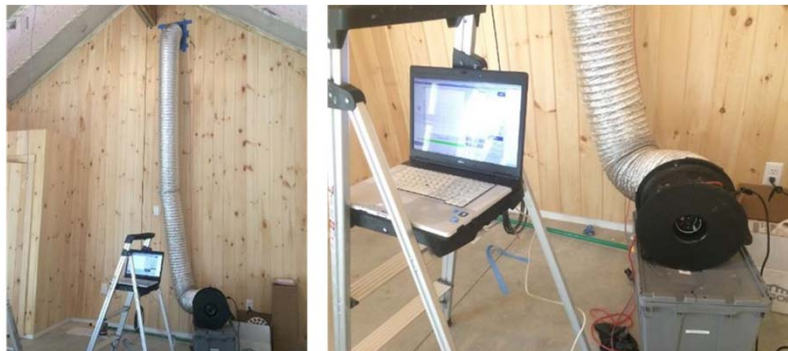
Air Leakage Testing

- Duct Blaster™ attached to exhaust opening
- Pressurization & depressurization
- ~50 CFM 50 (0.02 CFM 50/sf enclosure)
- Sliding door seal effect on airtightness

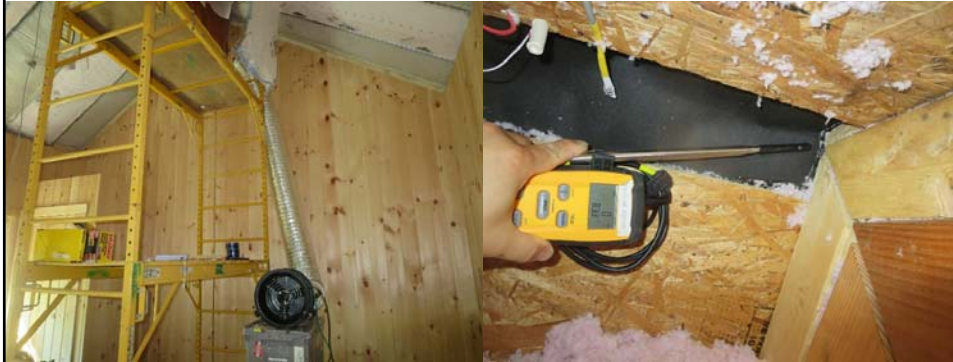
Air Leakage Testing During Disassembly

- Depressurized to -75 Pascals
- No detectable air leakage
- No indication of tape seam failure

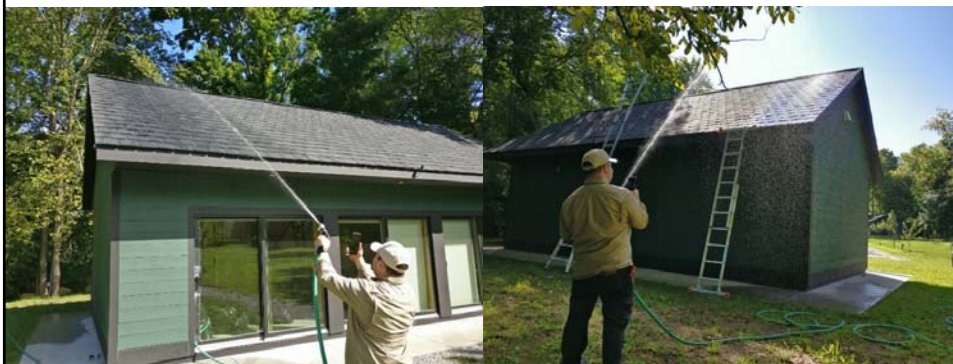
Water Leakage Testing

- Insulation removed from interior
- -75 Pascal depressurization, 10 minutes water spraying each side
- No sign of water leakage
