Residential Exterior Wall Superinsulation Retrofit Details and Analysis

Research Report - 1012

15 December 2010 (rev. May 2011)

Kohta Ueno

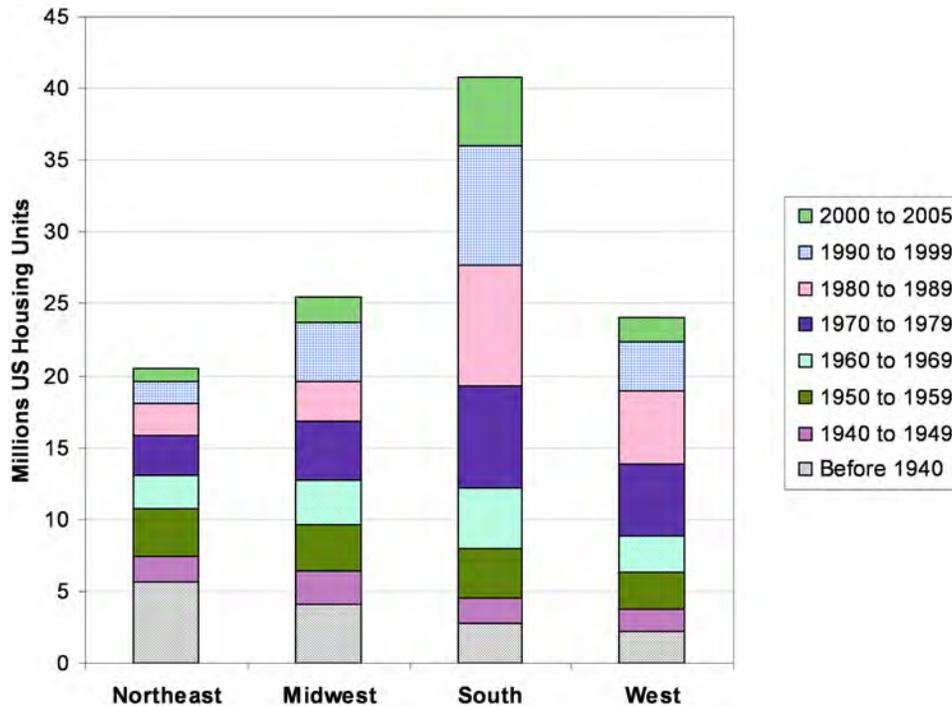
Figure 1 Vintage of US housing units, subdivided by US census region (EIA 2005).

The nationwide distribution of housing stock by geographic census region and age is shown in Figure 1, based on US Energy Information Administration (EIA 2005) data. It demonstrates trends noted by others (Lutz 2004): for instance, much of the oldest housing stock is concentrated in the Northeast, and since the 1970s, the majority of new construction was concentrated in the South and West regions.

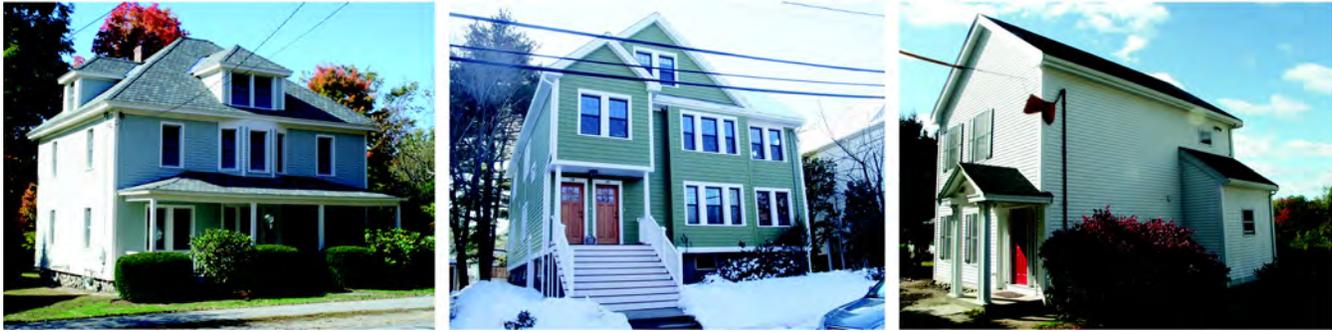
Figure 2 Front views of case study houses (left to right): Concord Four Square, Arlington Duplex, and Bedford Farmhouse.

All three of the case study houses are located in the Boston area of Massachusetts (DOE Climate Zone 5A, 5600–6400 HDD 65°F or 3110–3560 HDD 18°C in locations listed below). They are all wood frame houses that are older than 1940s vintage. All are built on basement foundations, with rubble stone walls below grade, and concrete block or stone above grade. All of the houses are two to three stories, and include the area enclosed by the sloped roof area within the conditioned space, using an unvented (“compact”) roof design. Figure 2 shows each house’s facade, and Table 1 summarizes each case’s characteristics.

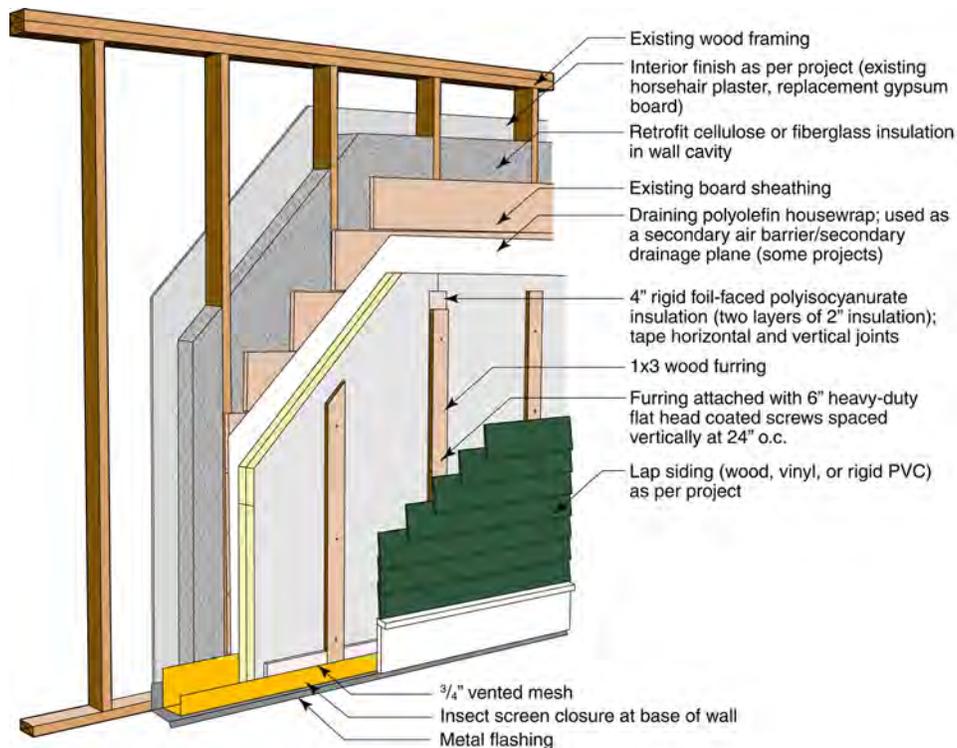
Figure 3 Isometric view of wall retrofit assembly, showing assembly components.

The retrofit wall assembly used in these case studies was largely the same, albeit with slight variations. The wall was composed of the following layers (Figure 3):

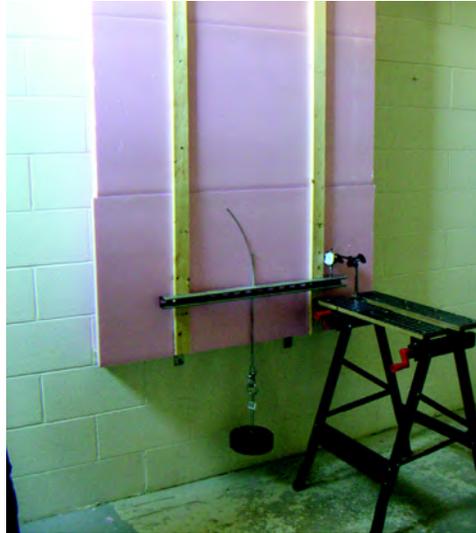
Figure 4 Laboratory mock up testing of deflection with load; 2 in. (51 mm) XPS foam and 1 × 3 strapping, 24 in. (610 mm) o.c.

compression strut forms through the strapping and the foam. This calculation is not performed here; however, laboratory mock up tests were conducted (Figure 4), demonstrating a very high safety factor.

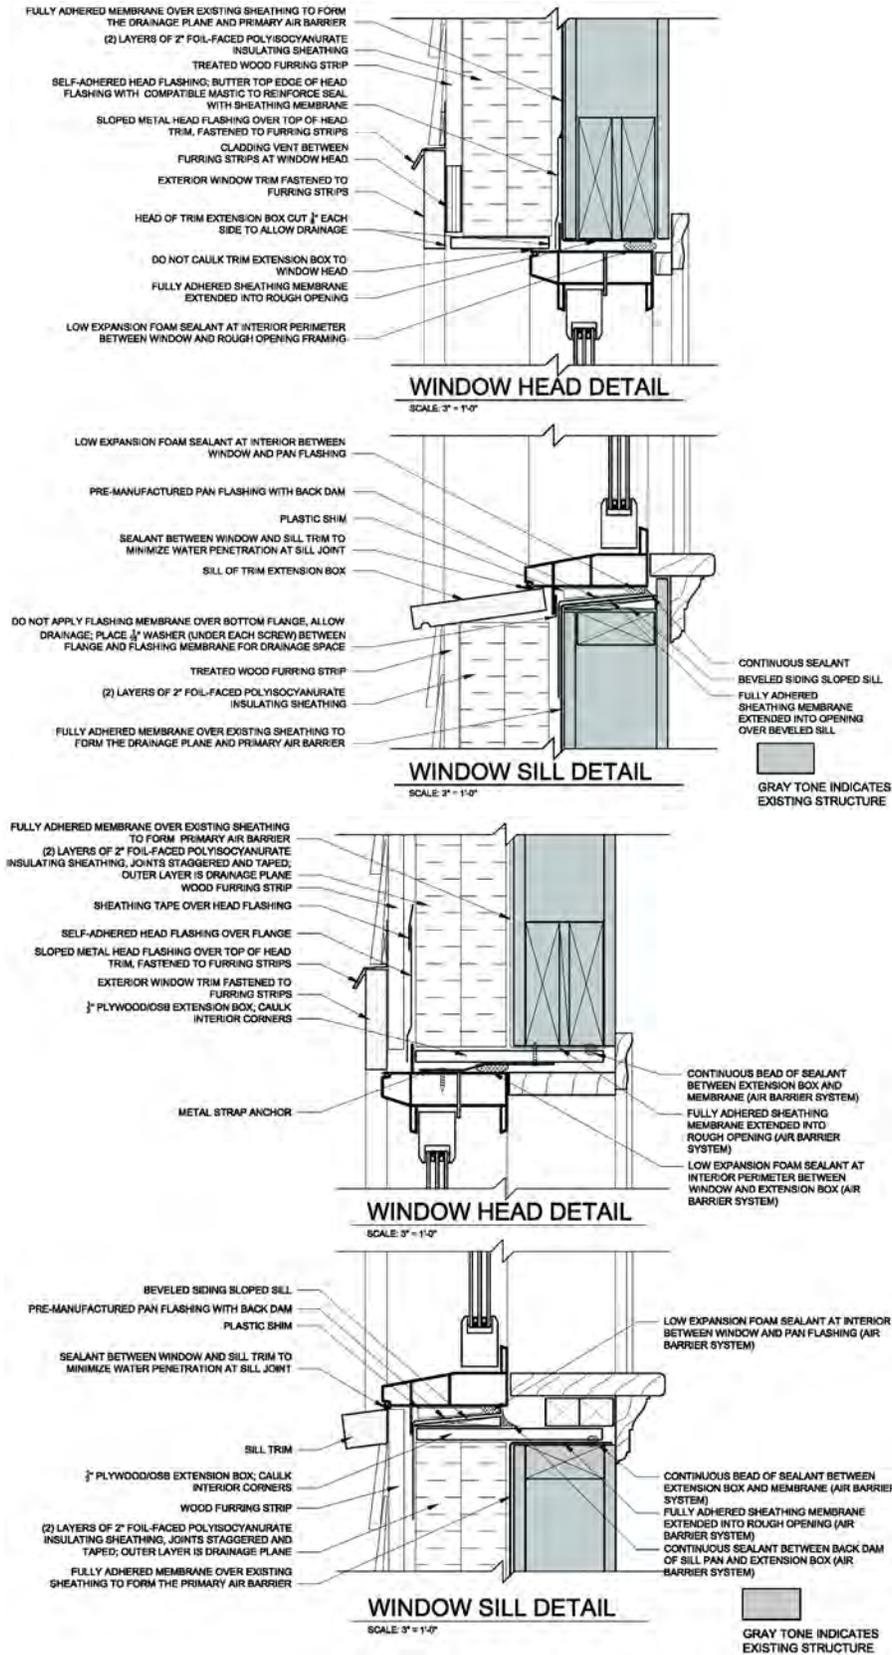
Figure 5 Details of interior (“innie”) window installation (top) and exterior (“outie”) window installation (bottom), showing head and sill details (jamb detail omitted for clarity)

doors and windows require details to account for the resulting deep wells. A window requires some type of sill extension to account for the wall thickness: the window plane location in the wall can be towards the exterior (colloquially known as an “outie” window), or towards the interior (“innie” window). An exterior window is detailed with an extension “box,” to provide solid attachment for the window in the plane of the nonstructural foam. An interior window requires exterior jamb, sill, and head extensions, which need to be exterior-grade materials. Basic details of both of these options are shown in Figure 5; complete details with construction sequencing will be published in the future. Benesh (2009) and Holladay (2009) discuss of the pros and cons of the two options. It should be noted that the choice is also influenced by the location of the primary water control layer/drainage plane, as the connection between the window drainage system and the wall’s drainage plane is critical.

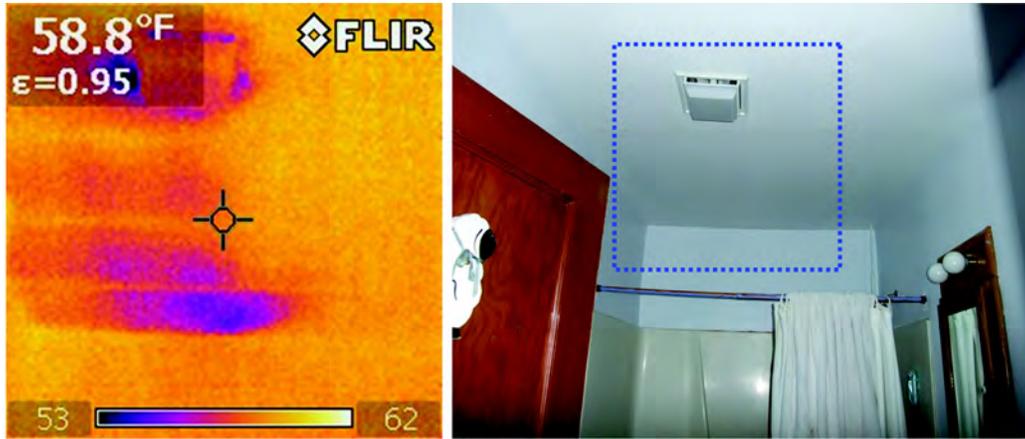
Figure 6 Air infiltration visible at bathroom exhaust fan; exterior wall beyond shower. Infrared image shows strapping/furring at ceiling, perpendicular to joists, supporting lath and plaster.

- **Mechanical:** Several mechanical exhaust fans proved to be significant leakage locations, including the kitchen range hood at the Concord Four Square and the bathroom exhausts at the Arlington Duplex, as shown in Figure 6. In addition, leakage bypassing the backdraft damper is visible. It is not clear whether the leakage occurs at the exterior penetration, or via leakage of the exhaust duct within the joist cavity.

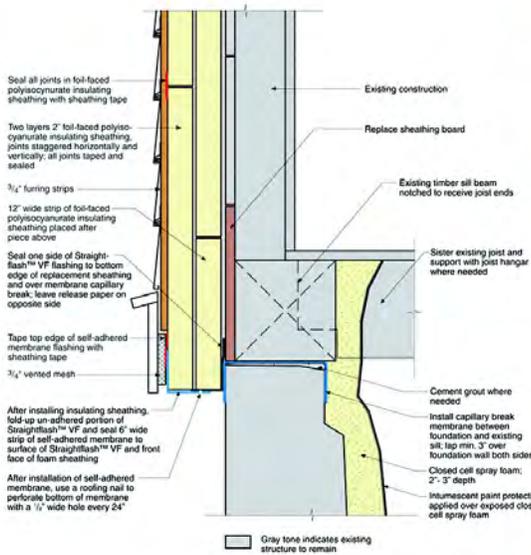
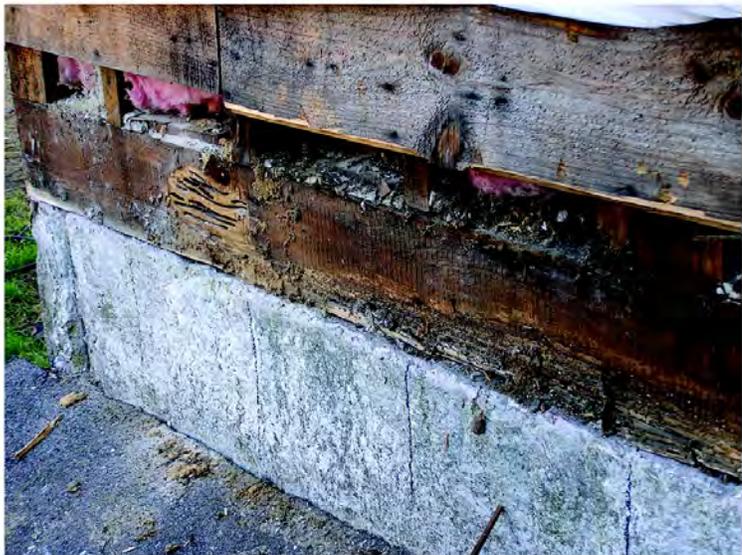
Figure 7 Sill detail, including air barrier transition wrapped to front of foam, and capillary break over foundation (left); existing sill beam, showing long-term moisture damage (right).

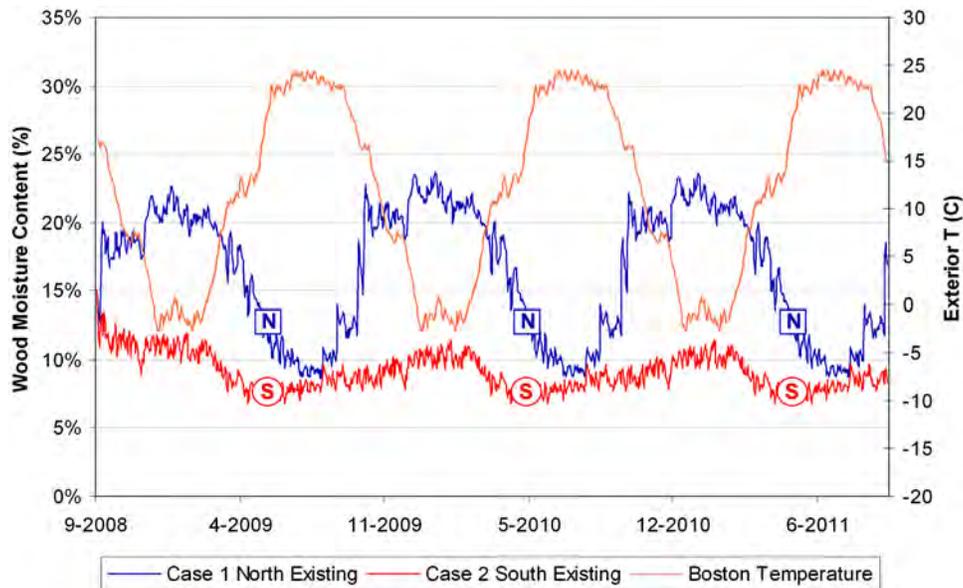
Figure 8 Existing wall with 0.5% of incident rain penetration, north and south exposures, with exterior temperature for reference (seasonal patterns).

When the rain penetration was reduced to 0.5% of rainfall, the results are shown in Figure 8 (with the exterior temperature to show seasonal patterns): moisture contents peak in wintertime to 23%, and dry to below 10% in summertime, with a seasonally stable pattern.

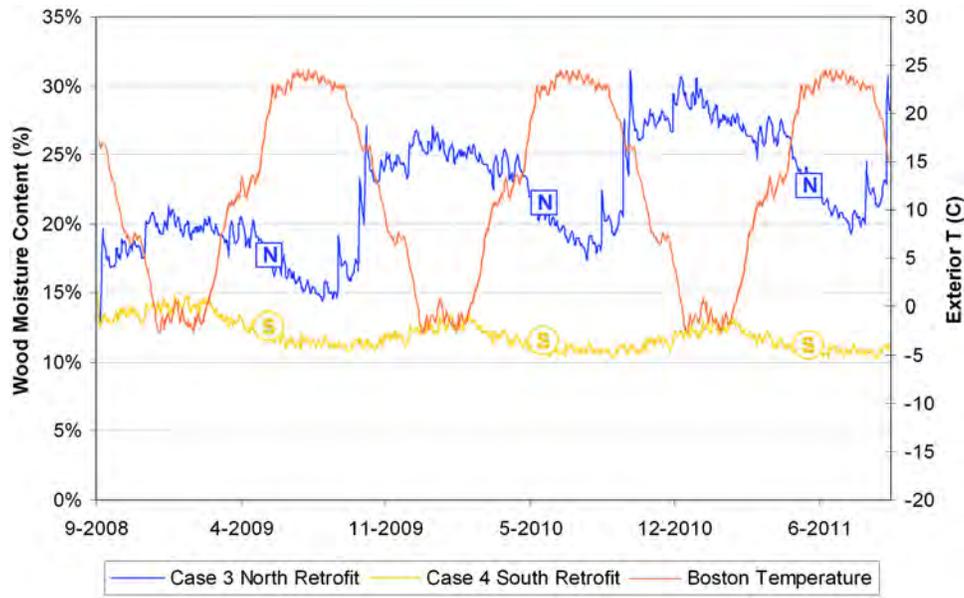
Figure 9 Retrofitted wall with 0.5% of incident rain penetration, north and south exposures, with exterior temperature for reference (seasonal patterns).

However, when these same rain penetration levels are applied to the retrofitted wall (Figure 9), the north side shows a seasonally increasing moisture content, exceeding 30% by the third winter. This indicates a greater sensitivity to rain penetration. If the rain penetration is reduced by half (to 0.25%), the moisture content of the north-side sheathing stays at safe levels, with lower peak moisture contents relative to the original wall (peaks at roughly 17%).
