Residential Exterior Wall Superinsulation Retrofit Details and Analysis

Research Report - 1012

15 December 2010 (rev. May 2011)

Kohta Ueno

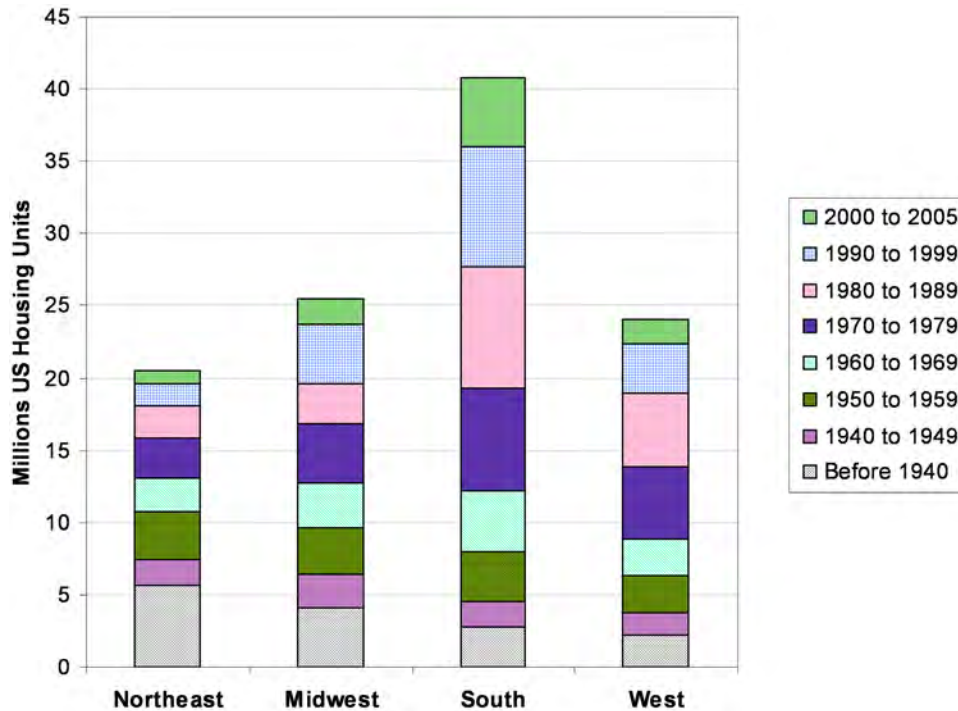
Figure 1 Vintage of US housing units, subdivided by US census region (EIA 2005).

The nationwide distribution of housing stock by geographic census region and age is shown in Figure 1, based on US Energy Information Administration (EIA 2005) data. It demonstrates trends noted by others (Lutz 2004): for instance, much of the oldest housing stock is concentrated in the Northeast, and since the 1970s, the majority of new construction was concentrated in the South and West regions.

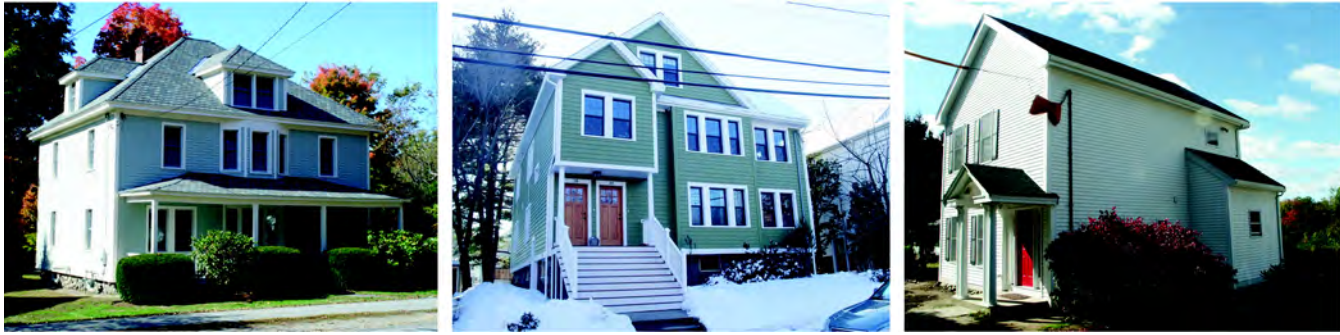
Figure 2 Front views of case study houses (left to right): Concord Four Square, Arlington Duplex, and Bedford Farmhouse.

All three of the case study houses are located in the Boston area of Massachusetts (DOE Climate Zone 5A, 5600–6400 HDD 65°F or 3110–3560 HDD 18°C in locations listed below). They are all wood frame houses that are older than 1940s vintage. All are built on basement foundations, with rubble stone walls below grade, and concrete block or stone above grade. All of the houses are two to three stories, and include the area enclosed by the sloped roof area within the conditioned space, using an unvented (“compact”) roof design. Figure 2 shows each house’s facade, and Table 1 summarizes each case’s characteristics.

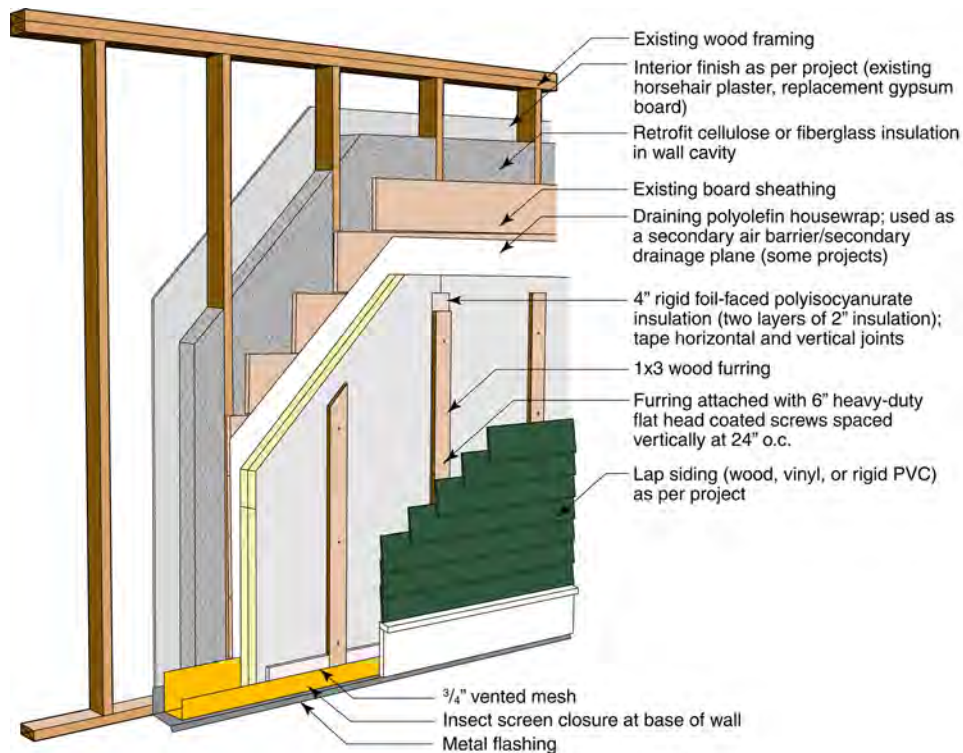
Figure 3 Isometric view of wall retrofit assembly, showing assembly components.

The retrofit wall assembly used in these case studies was largely the same, albeit with slight variations. The wall was composed of the following layers (Figure 3):

- Existing structure: the existing cladding and water control layer (building paper, rosin paper) were stripped from the building, revealing the board sheathing; all projects here had horizontal board sheathing. The sheathing was examined for any signs of long-term moisture damage; any problems could be repaired, and noted for closer attention when assembling new drainage plane details.

- If the wall cavities were uninsulated, they were retrofitted with insulation; dense-pack cellulose was used at the Concord Four Square, and fiberglass batt at the Bedford Farmhouse. The Arlington Duplex already had been retrofitted with blown-in insulation.

- A layer of spun-bonded polyolefin housewrap was then applied as an exterior air barrier and a secondary drainage plane. In addition, it serves as a temporary weather barrier during construction. Alternatively, it can be detailed to function only as an exterior air barrier, which simplifies window detailing in some cases. This layer is located between the board sheathing and the polyisocyanurate foam, and there is some risk of retaining moisture in this space, due to “sandwiching” of flat surfaces and the resulting capillarity. Therefore, a housewrap

with corrugations to provide drainage was chosen. In order for this layer to be effective as an air barrier, connection details were required: for instance, at the foundation to above-grade wall connection, the housewrap was caulked to the lowest piece of board sheathing.

- Vertical wood 1 × 3 strapping (0.75 in. × 2.5 in. or 19 mm × 64 mm) was applied outboard of the foam at the stud locations, using self-drilling heavy-duty flat-head screw fasteners with sufficient length to provide attachment to the stud. This strapping serves several purposes. First, it acts as an oversized washer, holding the foam to the surface of the house. Second, it acts as a substrate for cladding attachment. Third, and most importantly, the 3/4 in. (19 mm) space created by the strapping results in a drainage and ventilation cavity. Drained wall systems are widely recommended as the best strategy for controlling rain penetration. (Ritchie 1961; CMHC 1999; Lstiburek 2006); wall ventilation has been demonstrated to add significant drying capacity to cladding assemblies (Straube et al. 2004; Straube and Burnett 2005). Both of these increase the durability of the assembly, and greatly limit the amount of rain penetration to the secondary drainage plane (housewrap).

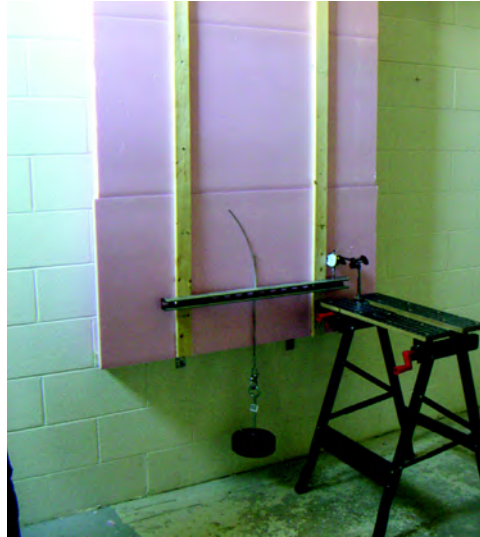
Figure 4 Laboratory mock up testing of deflection with load; 2 in. (51 mm) XPS foam and 1 × 3 strapping, 24 in. (610 mm) o.c.

Strapping Attachment. A question commonly asked in the field concerns the strength and durability of strapping attached through rigid plastic foam insulation, and the possibility of sagging of the cladding or crushing of the foam. These concerns, while understandable, have little validity; this is borne out by a long history (20+ years) of large numbers of similar assemblies in the field with no evidence of systematic problems.

compression strut forms through the strapping and the foam. This calculation is not performed here; however, laboratory mock up tests were conducted (Figure 4), demonstrating a very high safety factor.

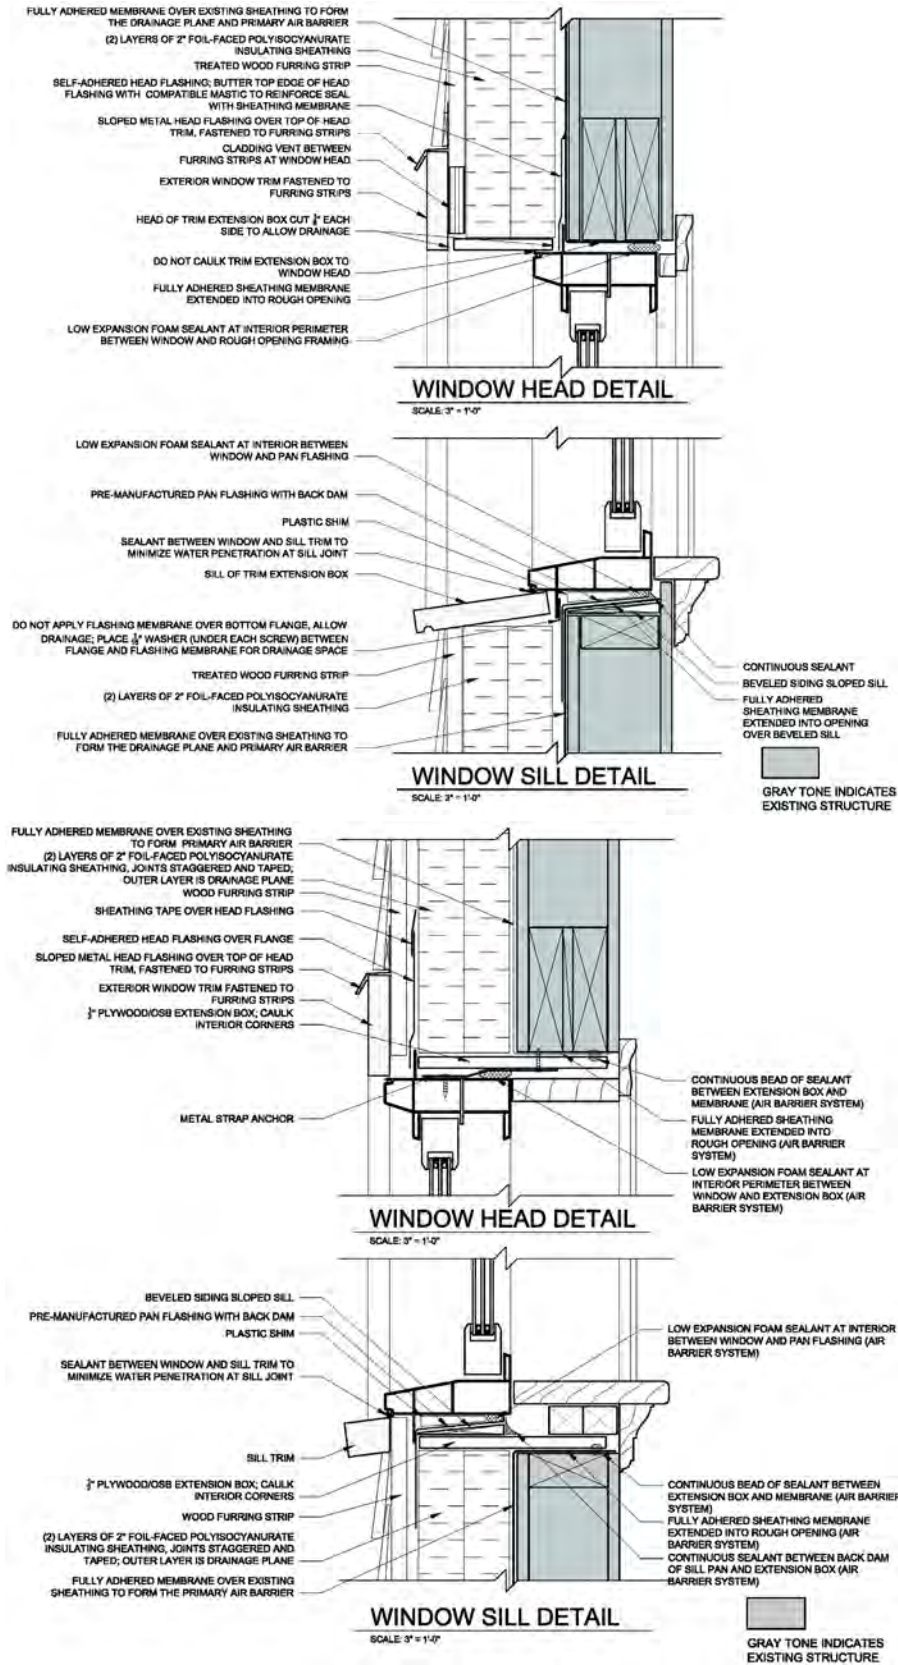
Figure 5 Details of interior (“innie”) window installation (top) and exterior (“outie”) window installation (bottom), showing head and sill details (jamb detail omitted for clarity)

doors and windows require details to account for the resulting deep wells. A window requires some type of sill extension to account for the wall thickness: the window plane location in the wall can be towards the exterior (colloquially known as an “outie” window), or towards the interior (“innie” window). An exterior window is detailed with an extension “box,” to provide solid attachment for the window in the plane of the nonstructural foam. An interior window requires exterior jamb, sill, and head extensions, which need to be exterior-grade materials. Basic details of both of these options are shown in Figure 5; complete details with construction sequencing will be published in the future. Benesh (2009) and Holladay (2009) discuss of the pros and cons of the two options. It should be noted that the choice is also influenced by the location of the primary water control layer/drainage plane, as the connection between the window drainage system and the wall’s drainage plane is critical.

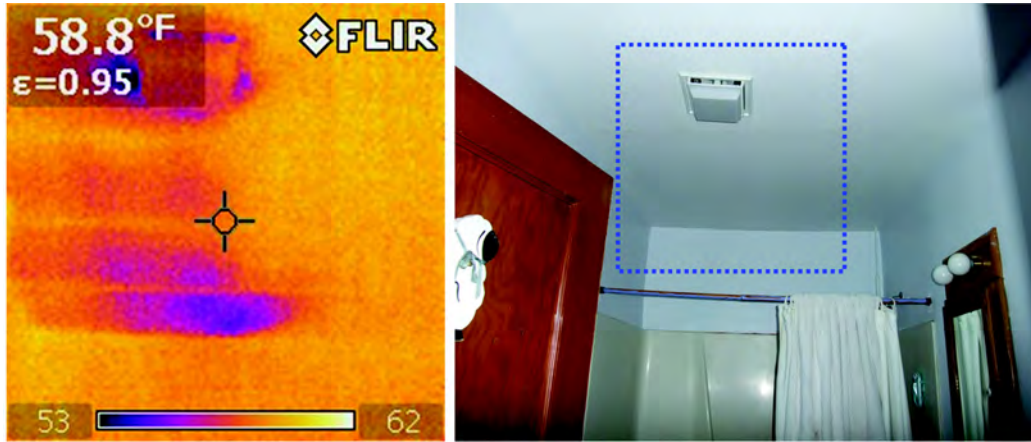
Figure 6 Air infiltration visible at bathroom exhaust fan; exterior wall beyond shower. Infrared image shows strapping/furring at ceiling, perpendicular to joists, supporting lath and plaster.

- Mechanical:** Several mechanical exhaust fans proved to be significant leakage locations, including the kitchen range hood at the Concord Four Square and the bathroom exhausts at the Arlington Duplex, as shown in Figure 6. In addition, leakage bypassing the backdraft damper is visible. It is not clear whether the leakage occurs at the exterior penetration, or via leakage of the exhaust duct within the joist cavity.

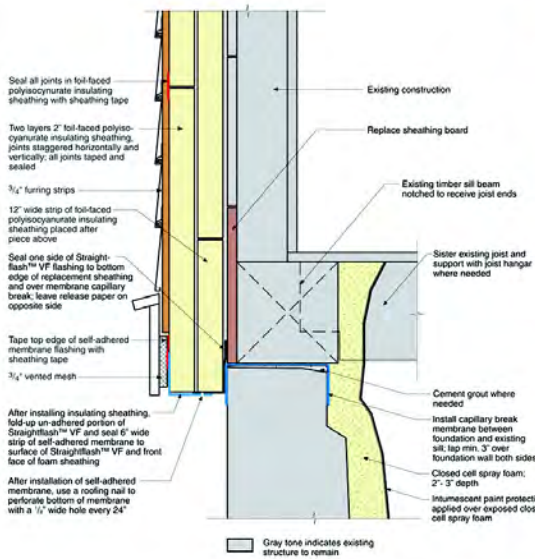
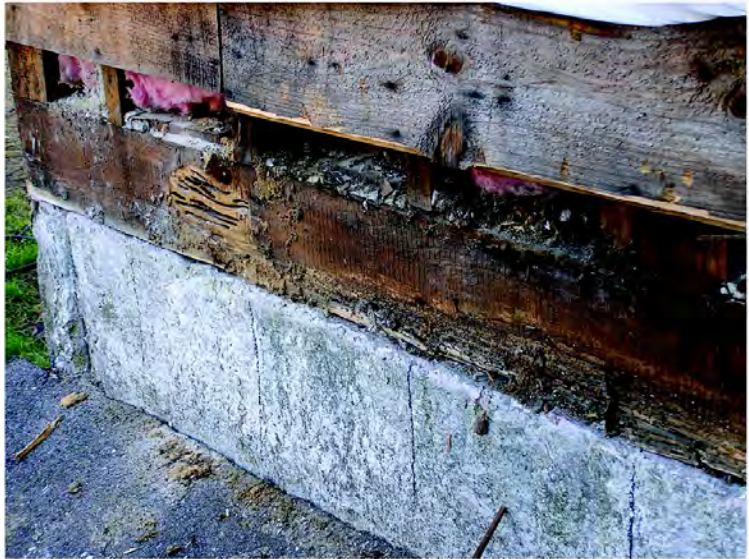
Figure 7 Sill detail, including air barrier transition wrapped to front of foam, and capillary break over foundation (left); existing sill beam, showing long-term moisture damage (right).

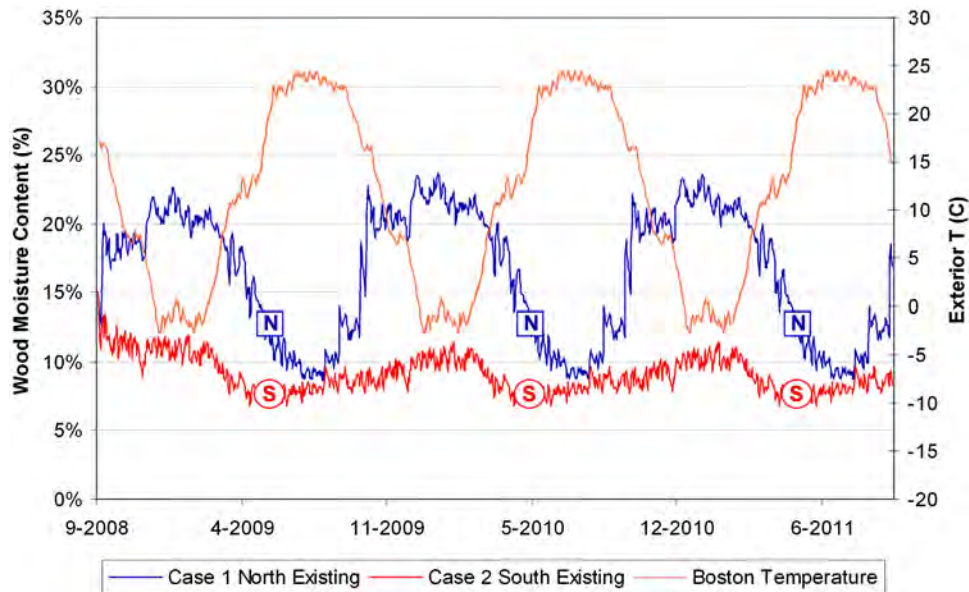
Figure 8 Existing wall with 0.5% of incident rain penetration, north and south exposures, with exterior temperature for reference (seasonal patterns).

When the rain penetration was reduced to 0.5% of rainfall, the results are shown in Figure 8 (with the exterior temperature to show seasonal patterns): moisture contents peak in wintertime to 23%, and dry to below 10% in summertime, with a seasonally stable pattern.

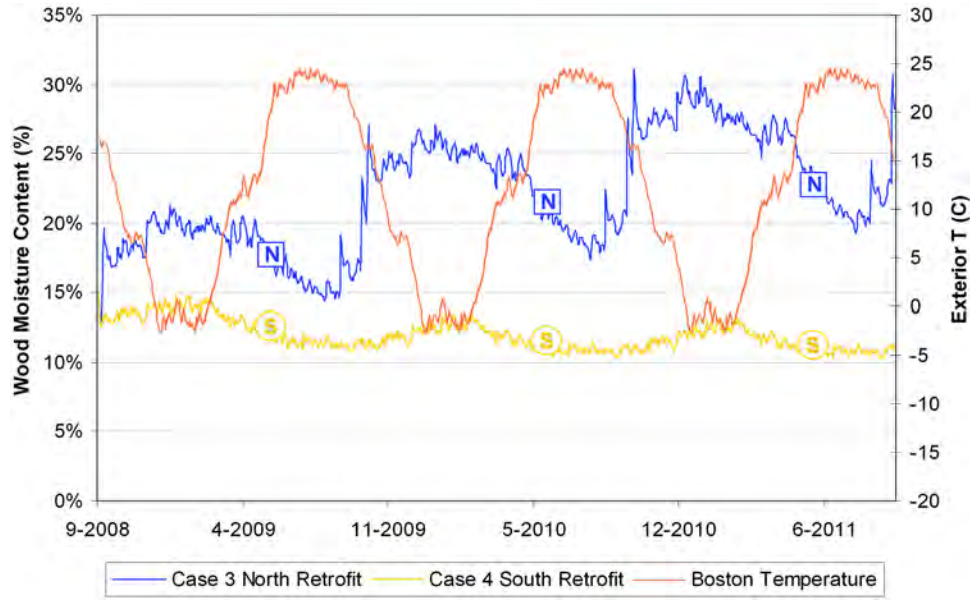
Figure 9 Retrofitted wall with 0.5% of incident rain penetration, north and south exposures, with exterior temperature for reference (seasonal patterns).

However, when these same rain penetration levels are applied to the retrofitted wall (Figure 9), the north side shows a seasonally increasing moisture content, exceeding 30% by the third winter. This indicates a greater sensitivity to rain penetration. If the rain penetration is reduced by half (to 0.25%), the moisture content of the north-side sheathing stays at safe levels, with lower peak moisture contents relative to the original wall (peaks at roughly 17%).
