## Using Unsealed Wall Cavities Between Garage and Living Space as Return Plenum

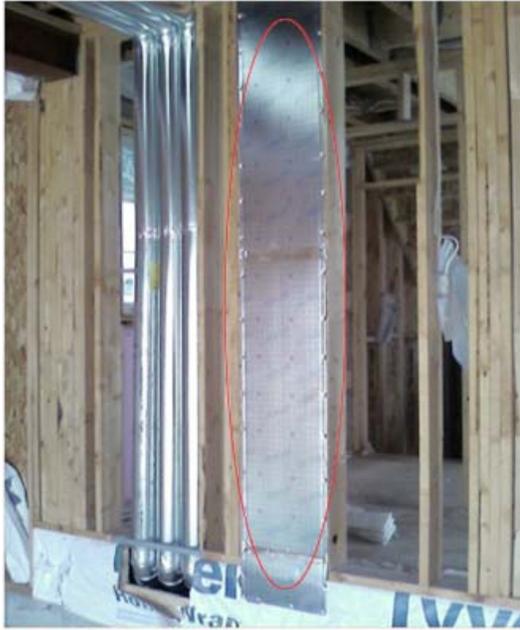
- View of unsealed wall cavity between garage and living space seen from the garage

Unsealed wall stud cavities as a return air plenum located in a wall between a garage and living space.

Building cavities are not practical to seal, and therefore remain unsealed, but they are used instead of conventional ductwork to return air from the conditioned space to the conditioning equipment whether it is from a furnace or air conditioner.

The practice of using unsealed building cavities as ductwork may result in indoor air quality issues. The negatively pressurized cavities will draw air through any cracks to try to alleviate the pressure difference. This means that the return system will suck on the walls—and any contaminants that might be in the walls *or in the garage*—and redistribute them to the living space. By negatively pressuring the walls in a hot-humid climate, warm humid air could be drawn into the walls from the exterior, and condensation is likely to occur on the cooler air-conditioned surfaces.

Only fully ducted and sealed returns should be used but it is also important that the air conditioning equipment should also be sealed, especially when located in a vented crawlspace or attic. Air sealing should ideally be done with mastic, or (second choice) tape meeting UL 181A or 181B.<sup>1</sup> Pressure testing of the entire ducting system and conditioning equipment will determine the amount and location of air leakage with a fan and manometer.

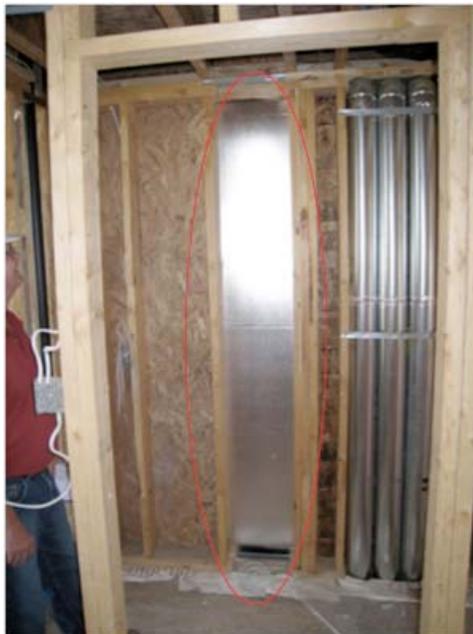
- View of unsealed wall cavity between garage and living space seen from the living space
