# Insight Mold in Alligator Alley

An edited version of this Insight first appeared in the ASHRAE Journal.

By Joseph W. Lstiburek, Ph.D., P.Eng., Fellow ASHRAE

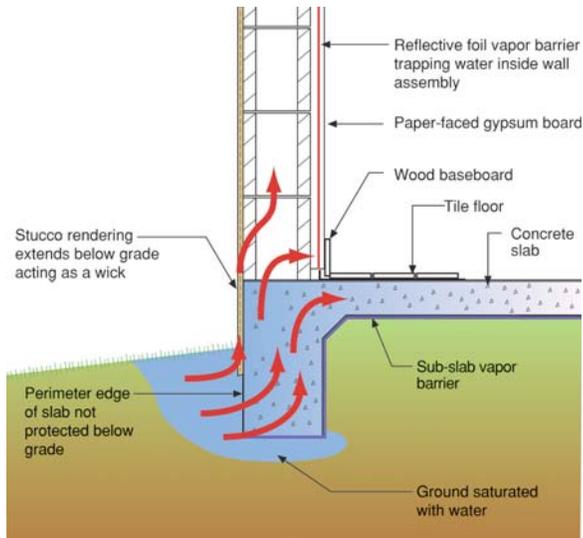
**Figure 1a: Maximizing Damage**—Wicking water inward at perimeter while trapping water in the assembly with an interior reflective insulation foil faced vapor barrier.

It's not like we don't understand the physics of building on wet ground. You build on top of it and you prevent water from wicking into the building by capillarity. But in Florida we seem to go out of our way to do it wrong. We use capillary active materials like concrete and block and stucco and configure them in such a manner as to maximize damage (**Figure 1a**). We don't wrap a sub-slab vapor barrier capillary break around the perimeter of the foundation and we extend a stucco cladding into the ground in order to suck every last available drop of water in the ground into the structure. But we're not done yet, we line the interior with a reflective insulation foil-faced vapor barrier reinforced with mold food (a.k.a. "kraft paper").<sup>3</sup> There's more. We rain on the sides of the structure (**Figure 1b**). We apply the stucco directly to concrete block and assume that the stucco (oh, I forgot, also the paint on the stucco) keeps the rain out. We call this "faith-based rain control." The stucco leaks, the paint leaks, the block leaks, and the wall can't dry to the interior because of the reflective insulation foil-faced vapor barrier.

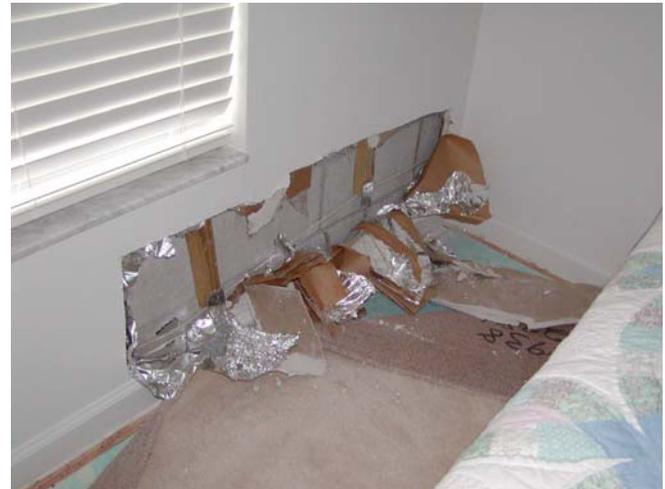
**Photograph 1: Unique Florida Experience**—Baseboard gets moldy, gypsum board at baseboard gets moldy, kraft paper facing of reflective foil gets moldy...

Couple the capillary active materials, wet ground, rain, the mold sensitive materials, air-conditioning and wrong-side-of-the-assembly vapor barriers and we get a unique Florida experience (**Photograph 1**).

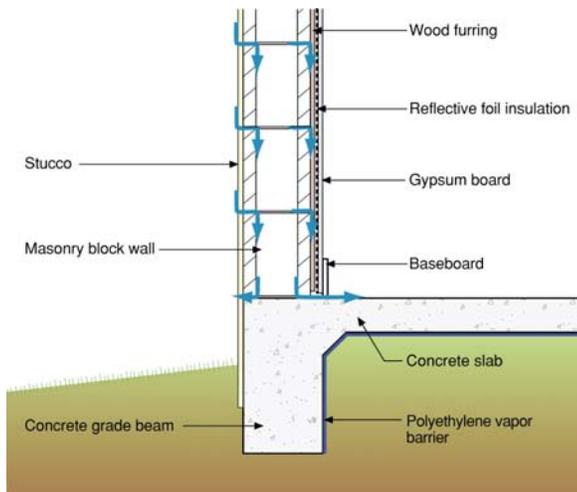
**Figure 1b: Rain Penetration**—There are only two kinds of stucco – stucco that leaks and stucco that will leak... Notice that the reflective insulation foil faced vapor barrier traps water in the wall.

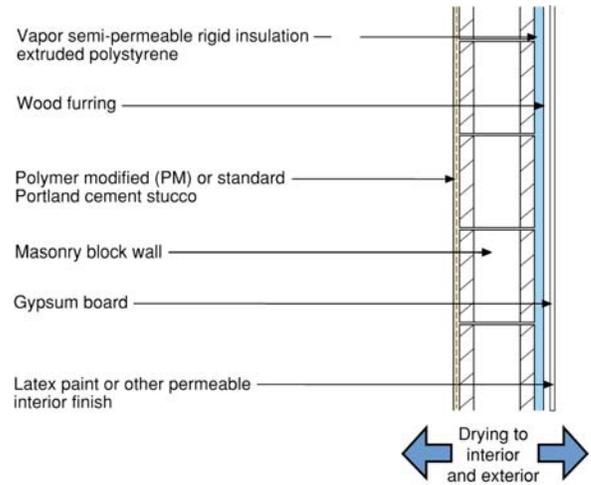
**Figure 2a: Vapor Flow-Through Assembly**—Wall dries in both directions. Interior vapor semi-permeable rigid insulation is not moisture sensitive and also protects the water sensitive interior paper faced gypsum lining.

It does not take much to make these problems go away. Construct a flow-through assembly from non-water sensitive materials, and also use the same non-water sensitive materials to protect the water sensitive materials inboard of them (**Figure 2a**). Install a plastic vapor barrier and capillary break completely under the perimeter foundation grade beam (**Photograph 2**). Use a vapor semi-permeable rigid foam insulation that water does not hurt to replace the foil reflective insulation vapor barrier (**Photograph 3**). This same rigid foam insulation protects the interior water-sensitive paper faced gypsum lining. Then don't extend the stucco into the ground and construct the slab with a perimeter "seat" that acts as a concrete flashing that drains rainwater penetrating the painted stucco rendering out of the block wall at its base and protect the exposed concrete slab edge with a hydrophobic vapor permeable coating – a.k.a. "latex paint" (**Figure 2b**).

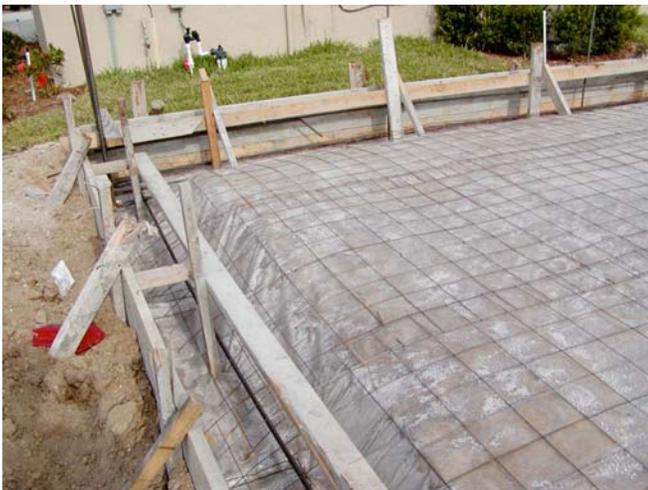
**Photograph 2: Perimeter Capillary Break**—Plastic sheet extends out under perimeter of slab edge foundation. Plastic skirt is attached to perimeter form boards protecting below grade portion of exterior slab edge.

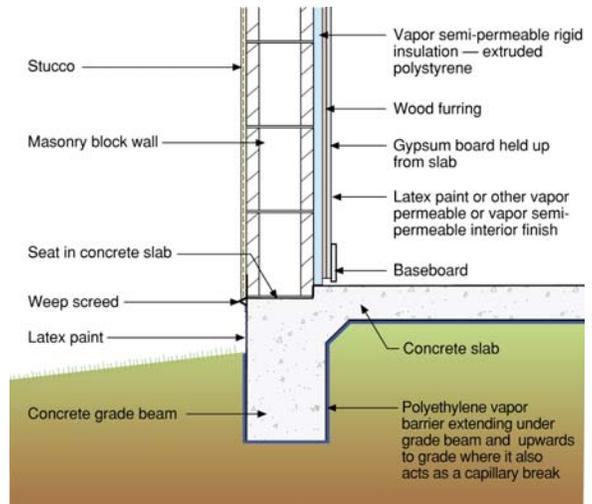
**Figure 2b: Exterior Wall Done Right**—Seat in the slab, vapor semi-permeable non-water sensitive interior rigid insulation, stucco not extending into the ground, latex paint on the exposed slab – it does not get much better than this.

Not extending the stucco into the ground also improves termite resistance. The little buggers can pass through tiny gaps or flaws that arise from incomplete adhesion of the stucco to the concrete slab edge of the foundation perimeter.

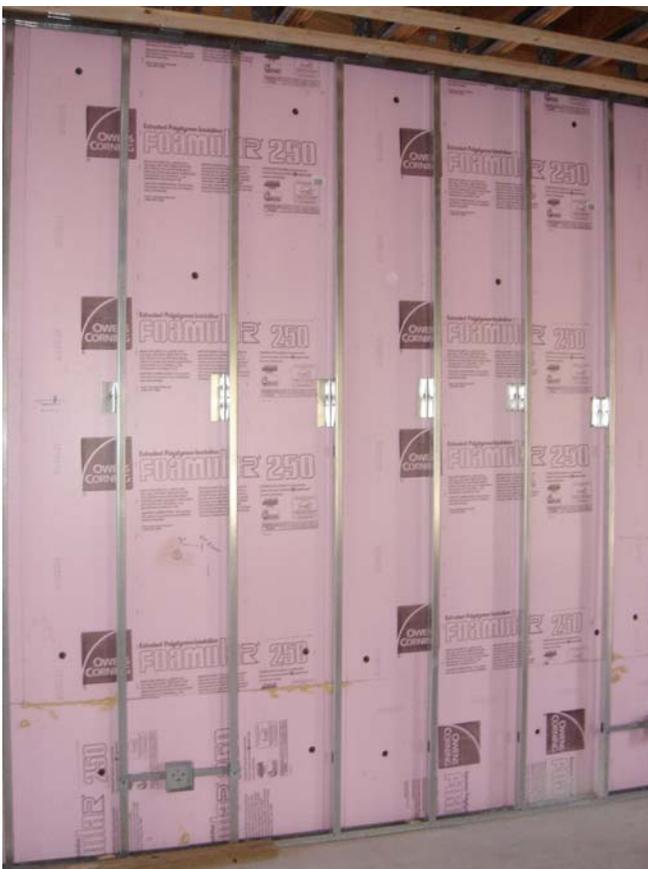
**Photograph 3: Vapor Semi-Permeable Rigid Insulation**—Note the steel stud interior wall framing is supported by brackets that do not penetrate the foam insulation but are installed over the top of the foam insulation.

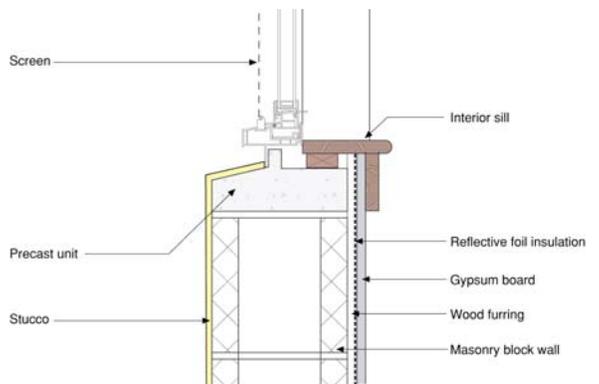
**Figure 3a: Rainwater Injection System**—Ridge on precast designed to structurally resist wind pressures during hurricane events. Unfortunately this ridge results in water draining inward into the building rather than outward. Notice that the reflective insulation foil faced vapor barrier traps water in the wall.

mmmm....but there I was<sup>4</sup>.... For good structural engineering reasons, but for bad water management reasons the bottom of masonry window openings in Florida are typically lined with precast elements that are manufactured with a vertical ridge (**Figure 3a**) that serves to inadvertently direct rainwater that leaks through a window unit or that penetrates the window-to-wall interface inward (**Photograph 4**). And the reflective

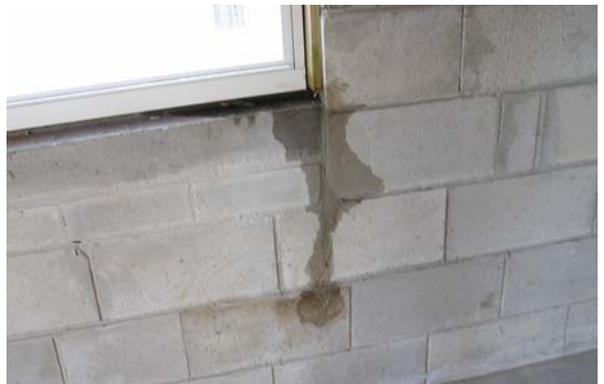
**Photograph 4: Leakage Path**—Yes, they all really do leak; at the window-to-wall interface and through the window itself.

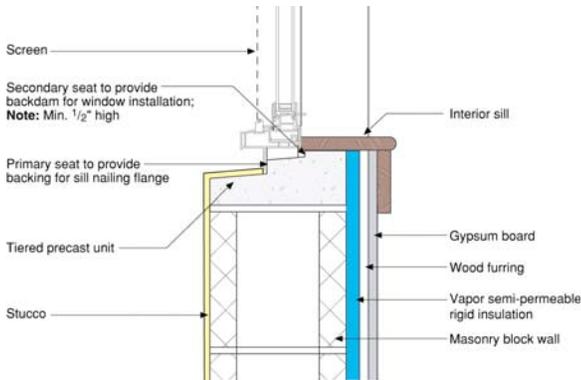
**Figure 3b: Drain the Rain**—Tiered precast element draining water to exterior while providing structural load resistance.

Again it does not take much to make this type of problem go away. Just “tier” the precast unit at the bottom of the window opening by adding a secondary seat thereby draining penetrating rainwater back to the exterior (Figure 3b).

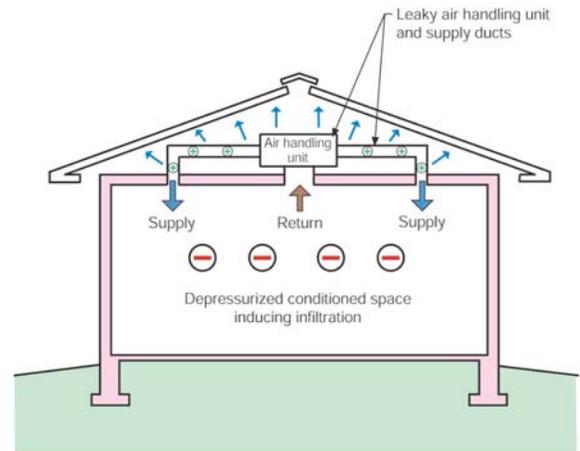
**Figure 4a: Going Negative**—Leaky duct distribution system in a vented attic is a recipe for problems.

Finally, and most importantly, make this air distribution system leaky (**Figure 4a**). The resulting negative pressure in the conditioned space draws humid air from the attic into the belly of the beast (**Figure 4b**). We can enhance this negative pressure by not providing return paths to the air handlers and closing doors (**Figure 4c**).

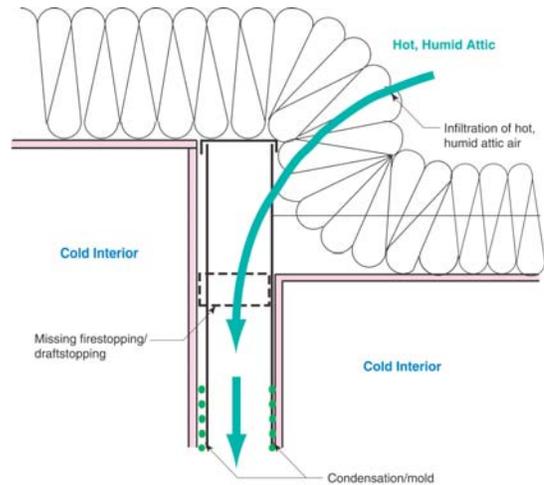
**Figure 4b: Leakage Path**—Unfortunately a common experience.

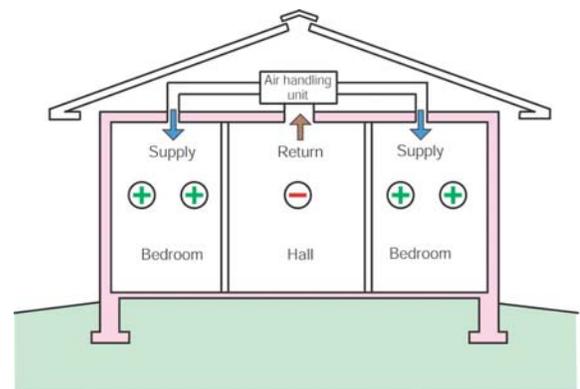
**Figure 4c: Door Closure**—Closing doors magnifies the effect of pressures. All we need is a dependable return path and this particular problem goes away.

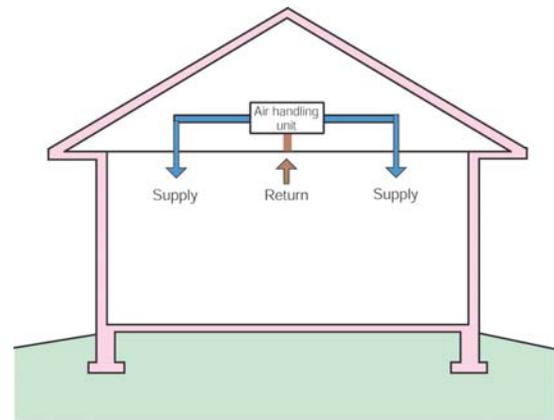
**Figure 4d: Moving the Boundary**—Locate the ducts inside by moving the air barrier and thermal barrier to the underside of the roof deck. Ducts are now inside. Duct leakage does not lead to major problems. Save some energy, be nice to the planet.

Wow, how to fix this mess? Once again pretty simple approaches work well. Construct the attic as a conditioned space thereby locating the air distribution system within the conditioned space and reducing the major adverse effects of system leakage (**Figure 4d**). The technology of choice is spray foam applied directly to the underside of the roof deck (**Photograph 5**). This approach also handles the rain penetration through attic vent problem. It also addresses the durability problem of the ductwork. It is also energy efficient. There are clearly a lot of things not to like about this approach. The next step is to install “jump ducts” (**Figure 4e**) to provide adequate return paths when doors are closed without sacrificing noise transmission performance.

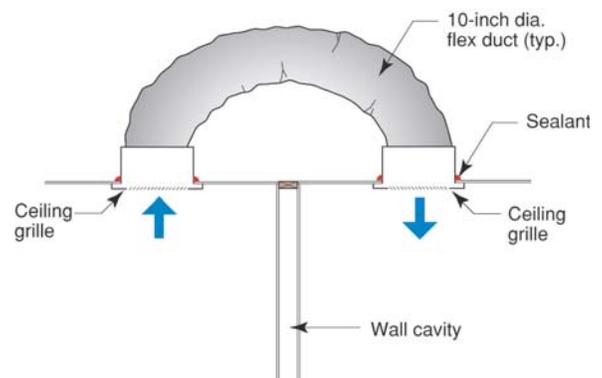
**Figure 4e: Jump Ducts**—Provide dependable return path without noise transfer.

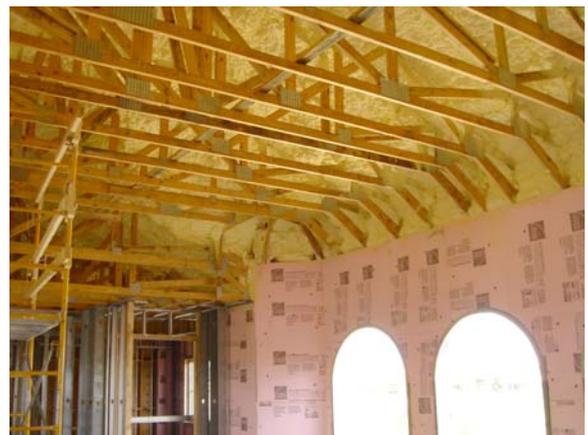
**Photograph 5: Unvented Roof**—Spray foam insulation applied to the underside of the roof deck bringing the attic and the ductwork inside the conditioned space.

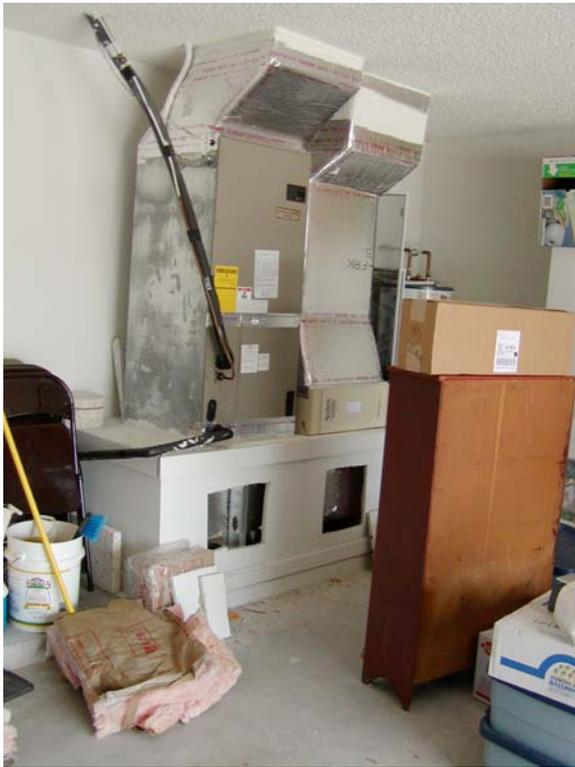
**Photograph 6: Garage Return Platform**—After a vented attic what is the worst possible place to locate an air-handler? Yes, you guessed it, the garage. Florida HVAC at its best.

What other innovative technology is available to hurt us in Florida? My absolute favorite because it is so subtle and nefarious is the return platform in the garage (**Photograph 6**). The return platform encloses the return duct. The return duct within the return platform leaks leading to a negative pressure within the return platform (**Photograph 7** and **Figure 5**). You get to suck air out of the garage and you get to suck air from under the slab - the return platform creates an elegant

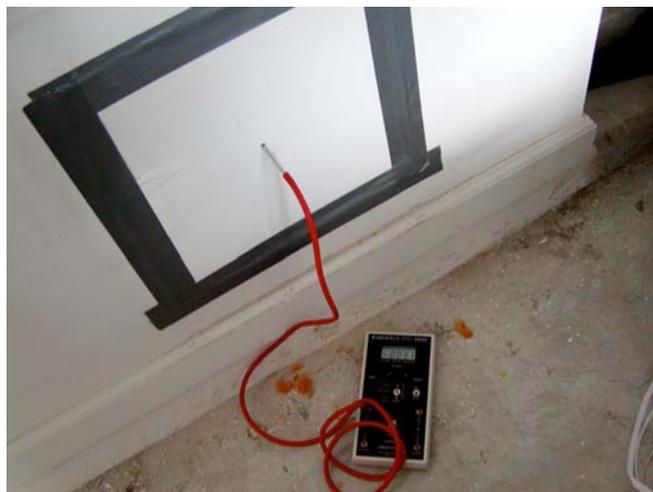
**Photograph 7: Pressure Measurement**—Return platform goes negative due to return leakage.

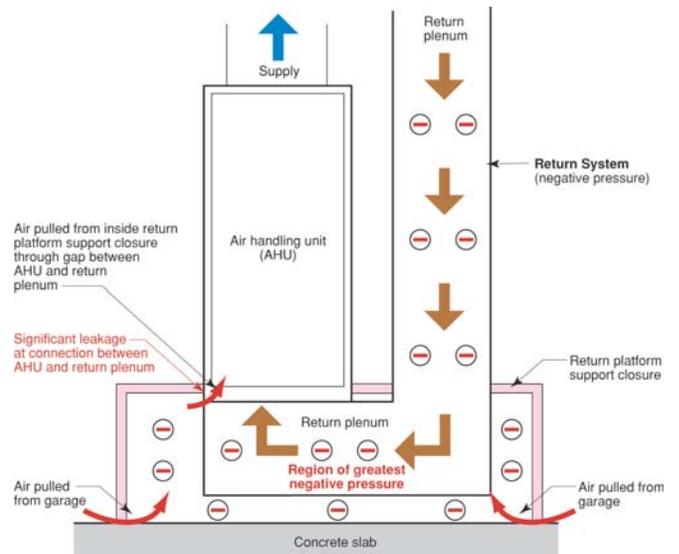
**Figure 5: Nefarious Return Platform**—The fix for this is to make the return side tight and “bleed” the pressure in the return platform enclosure by installing a “grille” through the enclosure connecting the platform enclosure to the space it is in.
