Historical Development of the Building Enclosure

By John Straube, Ph.D., P.Eng.

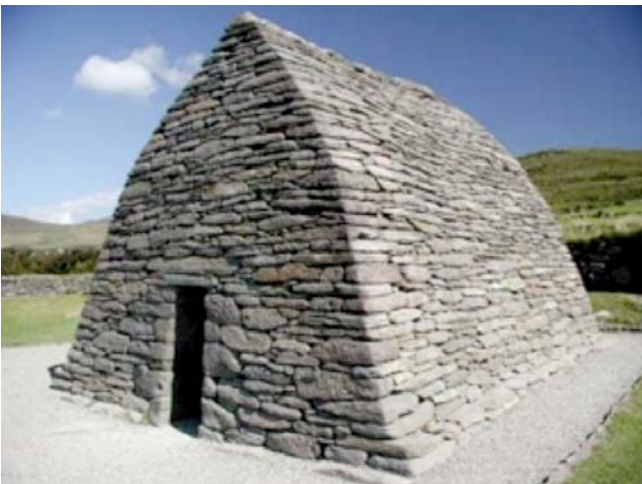
In traditional mass walls, e.g. a wall of solid masonry or earth, the resistance to rain penetration was only one aspect of enclosure performance (**Photograph 1**). Heat flow was also controlled by the thermal storage capacity of the massive walls, not just by virtue of the materials' thermal conductivity like the specialized insulation layers commonly used in modern building assemblies. The sun's heat was absorbed, stored, and slowly released to the interior and exterior, effectively damping typical daily fluctuations and thus increasing comfort. Vapor and airflow were also controlled by the mass of the wall. It is little wonder that such walls were used for thousands of years. Built of only brick and

Photograph 1: Traditional mass walls

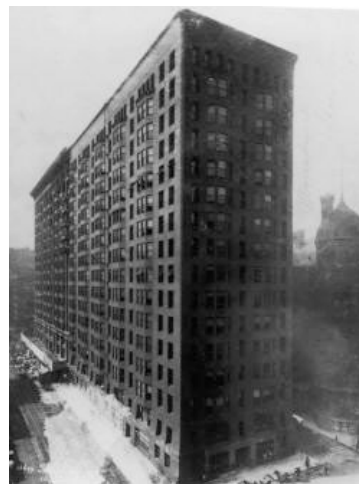
With the change from low-rise buildings with solid load-bearing walls to taller framed buildings, the dead weight and cost of traditional mass wall systems became prohibitive. Chicago's 16-storey Monadnock Building, constructed with 6-foot thick base walls between 1889 and 1891, pushed to the limit the load-bearing mass masonry wall (**Photograph 2**). Taller buildings with mass walls were practically impossible with the combination of high dead weight and low compressive strength. A large percentage of valuable ground floor area was lost to load-bearing walls and the resistance to seismic loads was poor. Today, poor control of rain penetration, heat, air, and vapor flow can be added to the list of drawbacks.

Photograph 2: Monadnock Building
(www.monadnockbuilding.com)

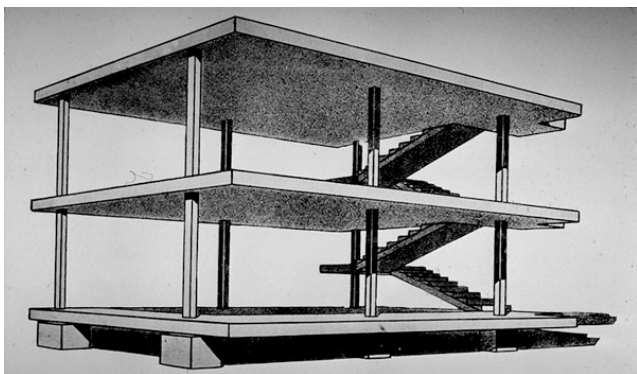
Corbusier is largely credited with popularizing the idea of separating the primary structural system from the enclosure system. Although the concept itself was well-developed by his time, the Domino house project made this approach desirable (**Photograph 3**). However, it is only in recent decades that the separation of the enclosure into layers and sub-systems for specific functions (support and control) has become more widely accepted and actually applied to building enclosures.

Photograph 3: Le Corbusier's Domino House
(www.usc.edu)

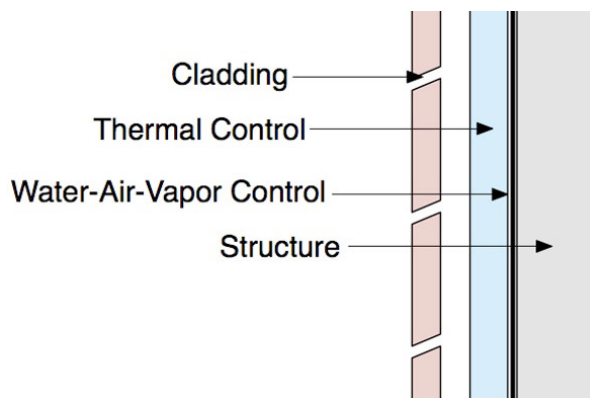
What is needed is a re-evaluation of how we assemble enclosures, and improvements in ensuring continuity of the control functions. As we change the insulation levels, airtightness, and materials, we need to consider changes in how materials are assembled in enclosures. The steel-stud framed walls of the 80's and 90's cannot continue to be built in the same manner in the 2010's and 2020's. It is now clear that such walls did not provide continuous thermal control. Better rain control is a critical part of the needed change, as are increases in tightness, better control of thermal bridging, and a protection of moisture-sensitive materials from extreme temperatures and prolonged wetting. The "perfect wall" approach (**Figure 1**) described above provides all of these improvements. Once thought of as an ideal enclosure assembly that would rarely be built, it is becoming the new standard for durable, energy-efficient, high-performance enclosures.

Figure 1: The Perfect Wall — see also *BSI-001: The Perfect Wall* (www.buildingscience.com/documents/insights/bsi-001-the-perfect-wall/view)
