# BSC Information

*What's Wrong With This Project?*

## Interior Framed Beam

## Sheet 705

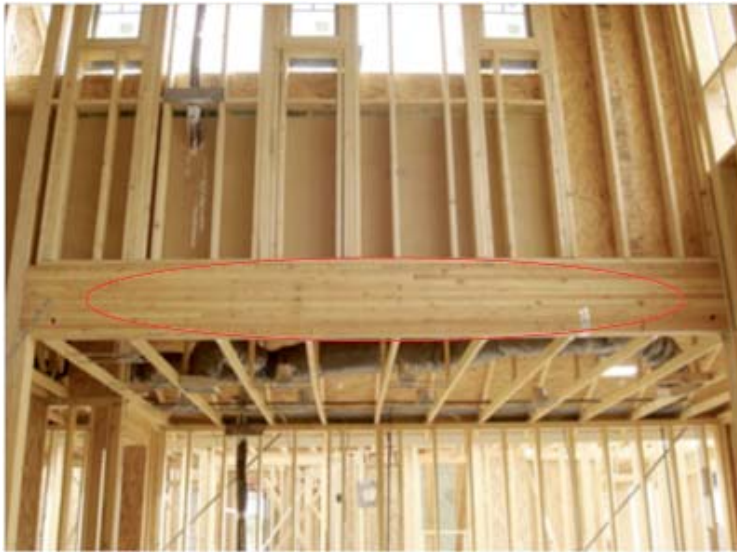
- Interior framed beam; note the cripple studs are not required above the beam/below the windows

Horizontally layered site-made beam.

Typical construction throughout the house.

Had Advanced Framing techniques been used an overall savings of approximately \$2,000 per building would have been realized. The money could have been available to improve other building components to make them more energy efficient in addition to increasing the builder's profit margin and improving the marketability of the product.

Use an engineered LVL instead and Advanced Framing techniques.
