# BSC Information Sheet 703

*What's Wrong With This Project?*

## Interior Door Framing

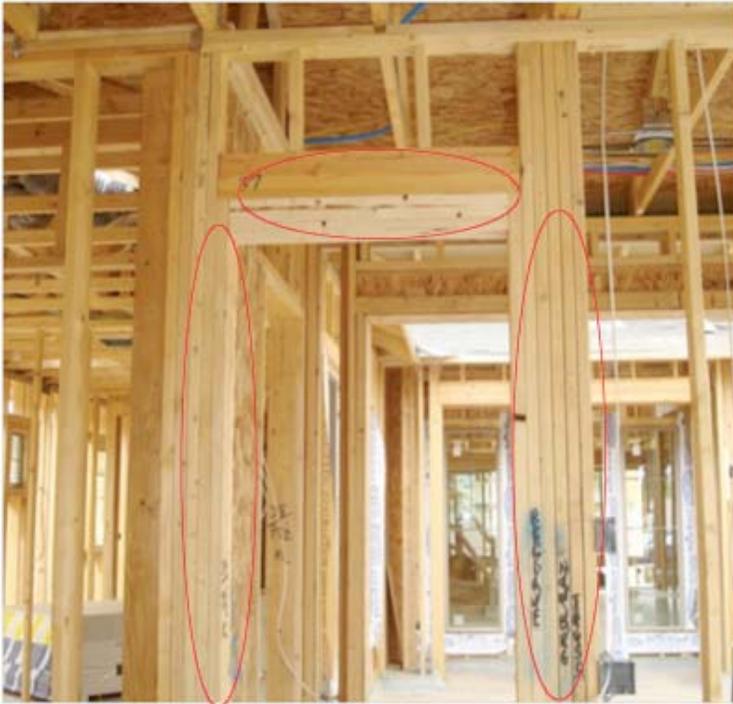
- The framing above the door can be minimized by using a header of two vertical framing pieces.
- The vertical framing against the door can be reduced to half of the framing used.

Interior door framed with an excessive amount of wood.

All interior doors in the building framed with unnecessary extra wood.

Had Advanced Framing techniques been used an overall savings of approximately \$2,000 per building would have been realized. The money could have been available to improve other building components to make them more energy efficient in addition to increasing the builder's profit margin and improving the marketability of the product.

The framing above the door can be minimized by using a header of two vertical framing pieces and the vertical wood framing against the door can be reduced to half of the framing used and incorporating Advanced Framing techniques.
