# Innovative Passive Ventilation Water-Resistive Barriers—How Do They Work?

Conference Paper - 1010

M. Jablonka, A. Karagiozjs, and John Straube

This paper is from the proceedings of the Thermal Performance of the Exterior Envelopes of Whole Buildings XI International Conference, December 5-9, 2010 in Clearwater, Florida.

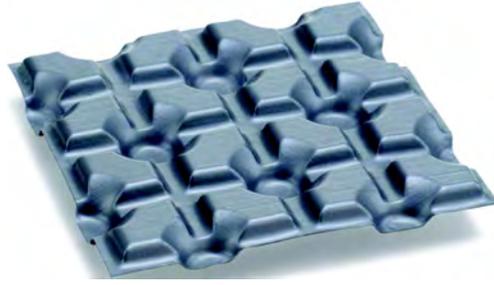
**Figure 1** Impermeable three-dimensional polyethylene membrane with ventilated air-gap.

A proposed solution to minimize the risk of these moisture problems is the use of a vapor-impermeable ventilated air-gap membrane behind absorptive claddings. A three-dimensional polyethylene membrane will preclude inward solar moisture drive, and at the same time it allows water vapor within the wall cavity to diffuse into the ventilated air-space behind or inside the three-dimensional membrane and escape to the exterior. Hence the three-dimensional membrane allows a method of mass transfer to occur that is more effective than vapor diffusion: Air transport dries out both, the cladding and the sheathing board at the same time. An example of a three-

dimensional vapor impermeable membrane with ventilated air-gap is shown in Figure 1.

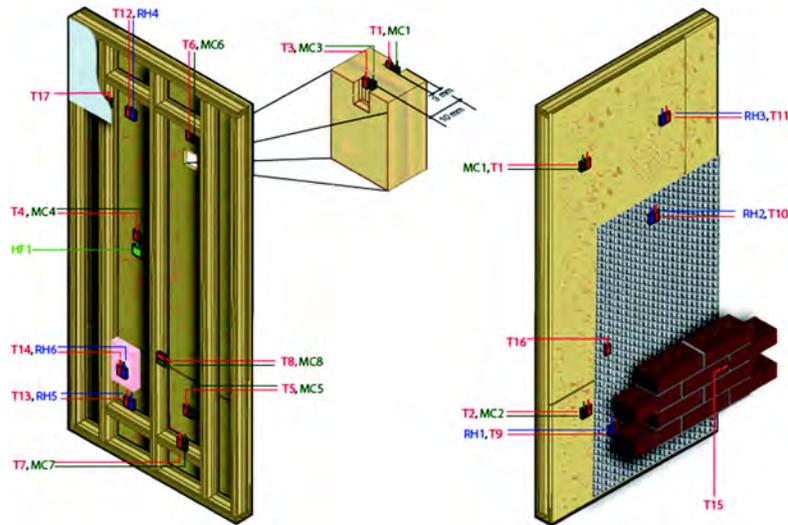
**Figure 2** Typical wall setup and sensor layout for full-scale wall testing in Charleston, SC.

The field monitoring was conducted with a combination of temperature and relative humidity sensors in the drain space and the stud space, wood moisture content sensors in sheathing and framing, temperature sensors in the cladding and the drywall, and heat flux sensors located behind the interior drywall. The sensor locations in the brick walls tested in Charleston, SC is shown in Figure 2.

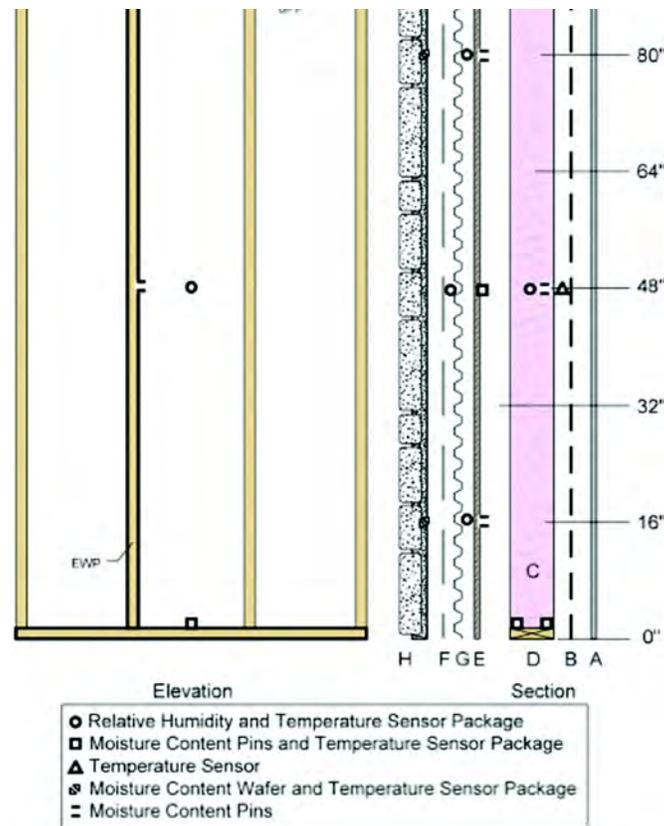
**Figure 3** Typical wall setup and sensor layout for full-scale wall testing in Waterloo, ON.

The sensor locations in the adhered manufactured masonry veneer walls tested in Waterloo, ON are shown in Figure 3.

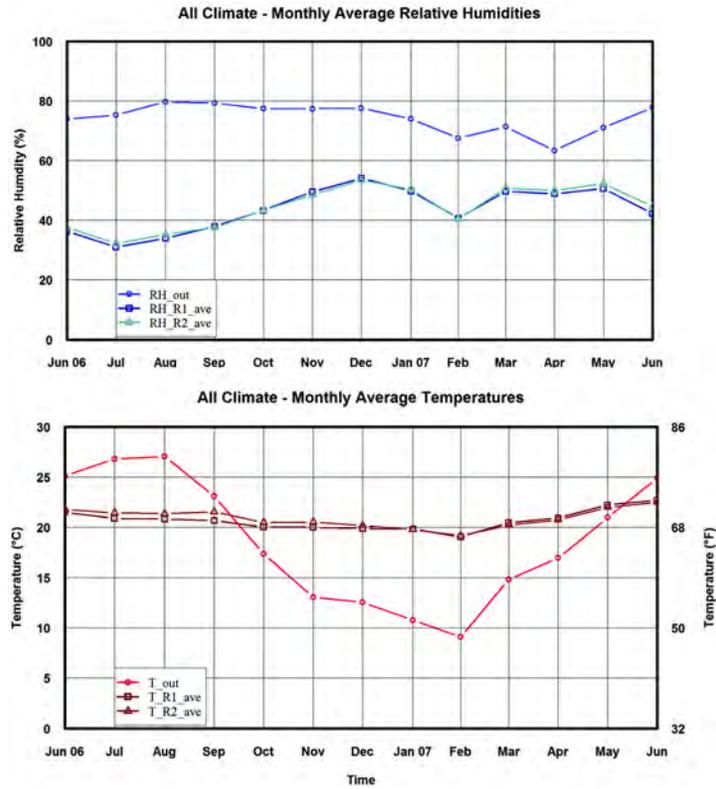
Figure 4 Interior and exterior relative humidity and temperatures during testing in Charleston, SC.

The interior and exterior boundary conditions simulated normal conditioned spaces and were measured and recorded over the entire test period. The interior (R1 = room 1; R2 = room 2) and exterior temperatures and relative humidity for Charleston, SC are shown in Figure 4.

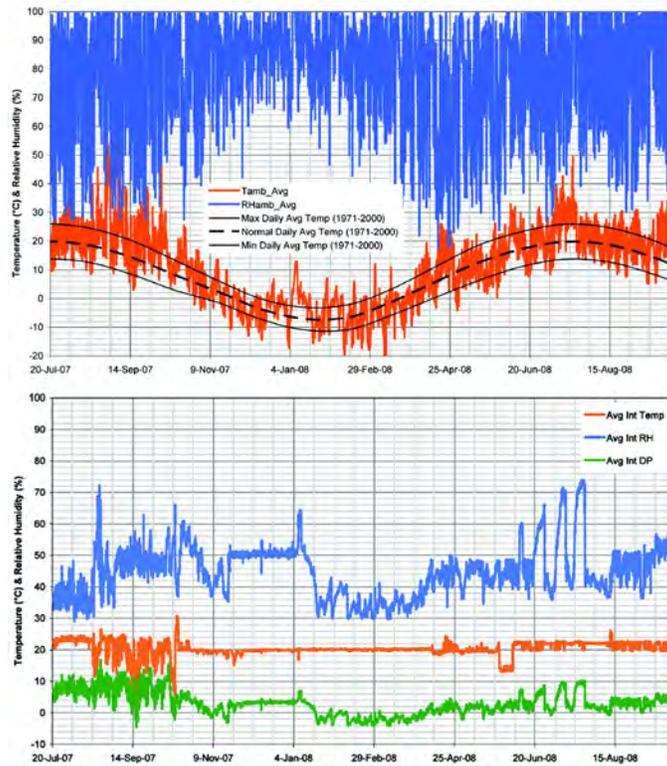
Figure 5 Interior and exterior relative humidity and temperatures during testing in Waterloo, ON.

The interior and exterior temperatures and relative humidity for Waterloo, ON are shown in Figure 5.

The periodic increase of relative humidity in the Waterloo testing period did not affect the hygrothermal conditions in the test walls, since these walls had continuous polyethylene vapor barriers.

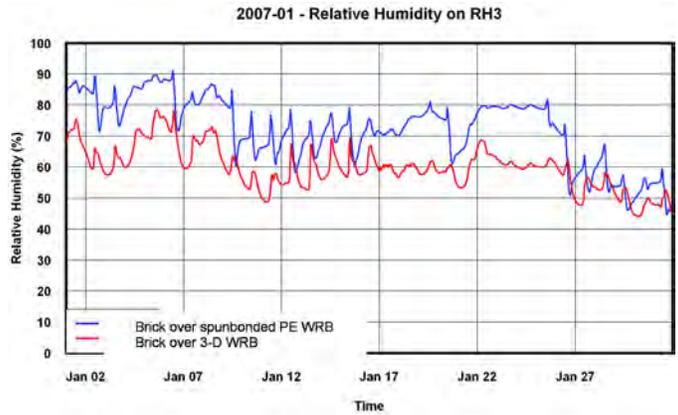
**Figure 6** Relative humidity comparison near sheathing of brick walls in Charleston, SC shown for the month of January 2007.

surface of the wood sheathing was up to 20% higher for the walls without the ventilated air-gap membrane compared to the walls with the conventional spunbonded WRB. Figure 6 shows the relative humidity at the outer surface of the wood sheathing for the month of January 2007. It is evident from this data that the relative humidity in this location rises well above 80% for several days in January for the wall without the air-gap membrane. Moisture-related problems in wall assemblies may occur at relative humidity levels above 80% and wood moisture contents above 20%. Yet, the elevated RH levels of this wall did not cause the moisture content in the wood framing to rise to critical levels.

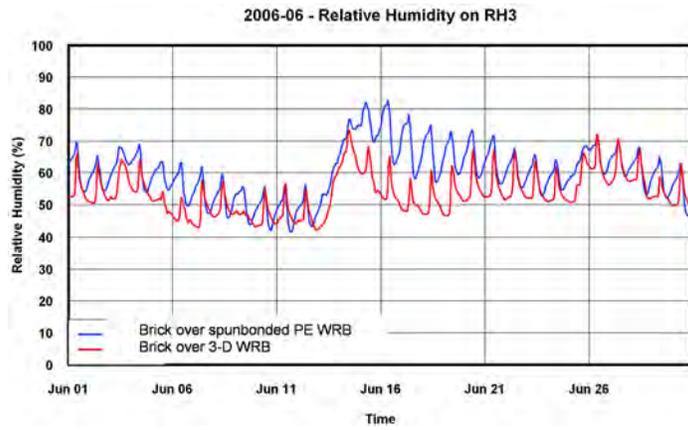
**Figure 7** Relative humidity comparison near sheathing of brick walls in Charleston, SC shown for the month of June 2006.

Figure 7 shows the relative humidity on the outer surface of the wood sheathing of the brick walls for the month of June 2006.

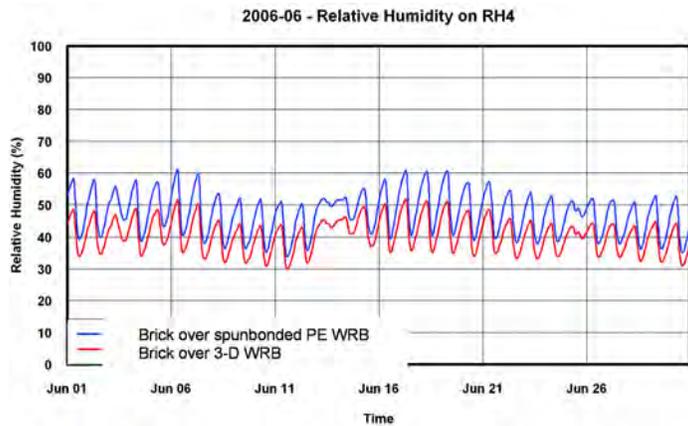
**Figure 8** Relative humidity comparison inside wall cavity of brick walls in Charleston, SC shown for the month of June 2006.

The analysis of the relative humidity inside the wall cavity (RH 4) during the same time periods shows consistently lower RH levels for the walls with the air-gap membrane by around 10% compared to the standard walls. Figure 8 shows the relative humidity inside the wall cavity of the brick walls for the month of June 2006.

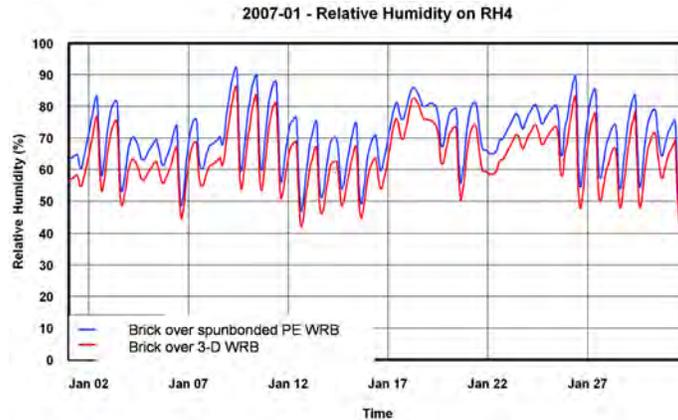
**Figure 9** Relative humidity comparison inside wall cavity of brick walls in Charleston, SC shown for the month of January 2007.

Figure 9 shows the relative humidity in the wall cavity of the brick walls for the month of January 2007. Throughout the

entire month the RH in the wall with the air-gap membrane is around 8% lower than in the standard wall.

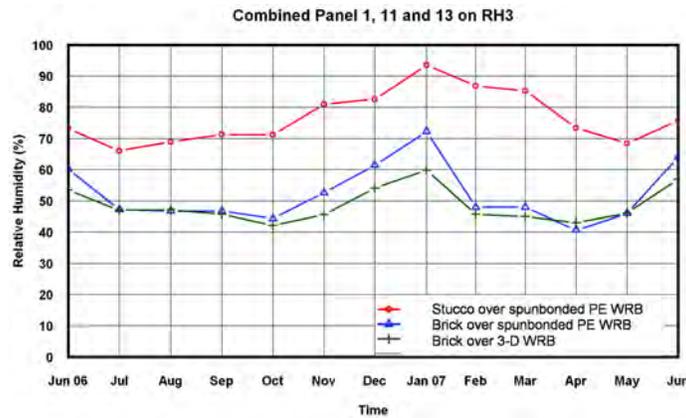
**Figure 10** Average relative humidity comparison near wood sheathing of brick and stucco walls in Charleston, SC shown for the entire test period.

The data in Figure 10 shows the average relative humidity on the outside of the OSB sheathing for the complete year of testing. It is evident that the brick walls with air-gap membrane show lower relative humidity during the summer and winter months. Both walls were averaging well under 80% relative humidity.

The red line in Figure 10 shows the measured data for three-coat stucco that was directly applied over a spunbonded Polyethylene based water-resistive barrier. It is evident that the average relative humidity on the outside of the wood sheathing was in excess of 80% from November 2006 to mid-March 2007, and even in excess of 90% for several weeks during this time period. The relative humidity for the stucco wall in this location is significantly higher than for both brick walls during the entire test period. The difference of the RH between the directly applied stucco wall and the brick wall with air-gap membrane is at times as high as 40%. This shows the significance of the ventilated air-gap between exterior sheathing and backside of absorptive cladding. The highest impact from exterior moisture load is to be expected on walls without such an air-gap.

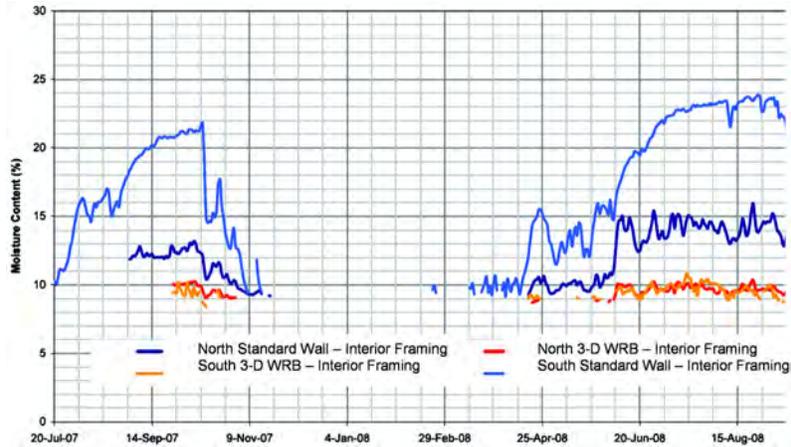
**Figure 11** Moisture content comparison of wood studs in walls with adhered manufactured veneer in Waterloo, ON shown for September 2007 to September 2008.

Figure 11 shows the moisture content of the framing lumber at mid height for the south and north orientation of the test walls with ventilated air-gap membrane in comparison

with the walls with building paper without a ventilated air-gap. The moisture content in the wood studs on these walls was measured near the inside surface of the framing in order to capture potential condensation on the vapor barrier resulting from inward moisture drive. It is evident from the measured data that the moisture content exceeded 20% on the south-facing wall without air-gap from June till September. The moisture content in the wood framing of the north-facing wall without air-gap shows a moisture content of around 15% for the entire summer. The north- and south-facing walls with the air-gap membrane do not show any considerable increase in moisture content during the summer months. This clearly shows the significance of solar driven moisture and how it is influenced by a ventilated air-gap and the impermeability of the three-dimensional membrane behind the absorptive

adhered veneer. No data is plotted during the winter months due to the moisture contents in all walls dropping below the accuracy range of the measuring equipment (below 8%).

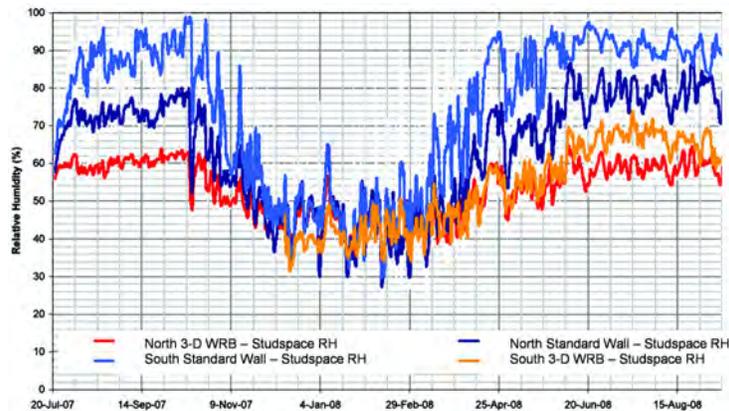
**Figure 12** Relative humidity comparison of stud cavities in walls with adhered manufactured veneer in Waterloo, ON shown for September 2007 to September 2008.

This is verified in Figure 12, which compares the relative humidity of the stud cavities for all four test walls. The south-facing wall without air-gap membrane shows the highest relative of all walls, ranging around 90% for more than 6 months of the test year. While the north-facing wall without air-gap membrane shows elevated relative humidity levels of around 80% during the summer months, the north- and south-facing walls with air-gap membrane remain at 60% to 70% for the

entire summer. The combination of ventilated air-gap with the vapor impermeable three-dimensional membrane does not allow the solar driven moisture to get pushed into the wall cavity.
