Corrosion of Galvanized Fasteners used in Cold-Formed Steel Framing

Ian N. Robertson Ph.D., P.E.

Steel Framing Alliance
and
University of Hawaii

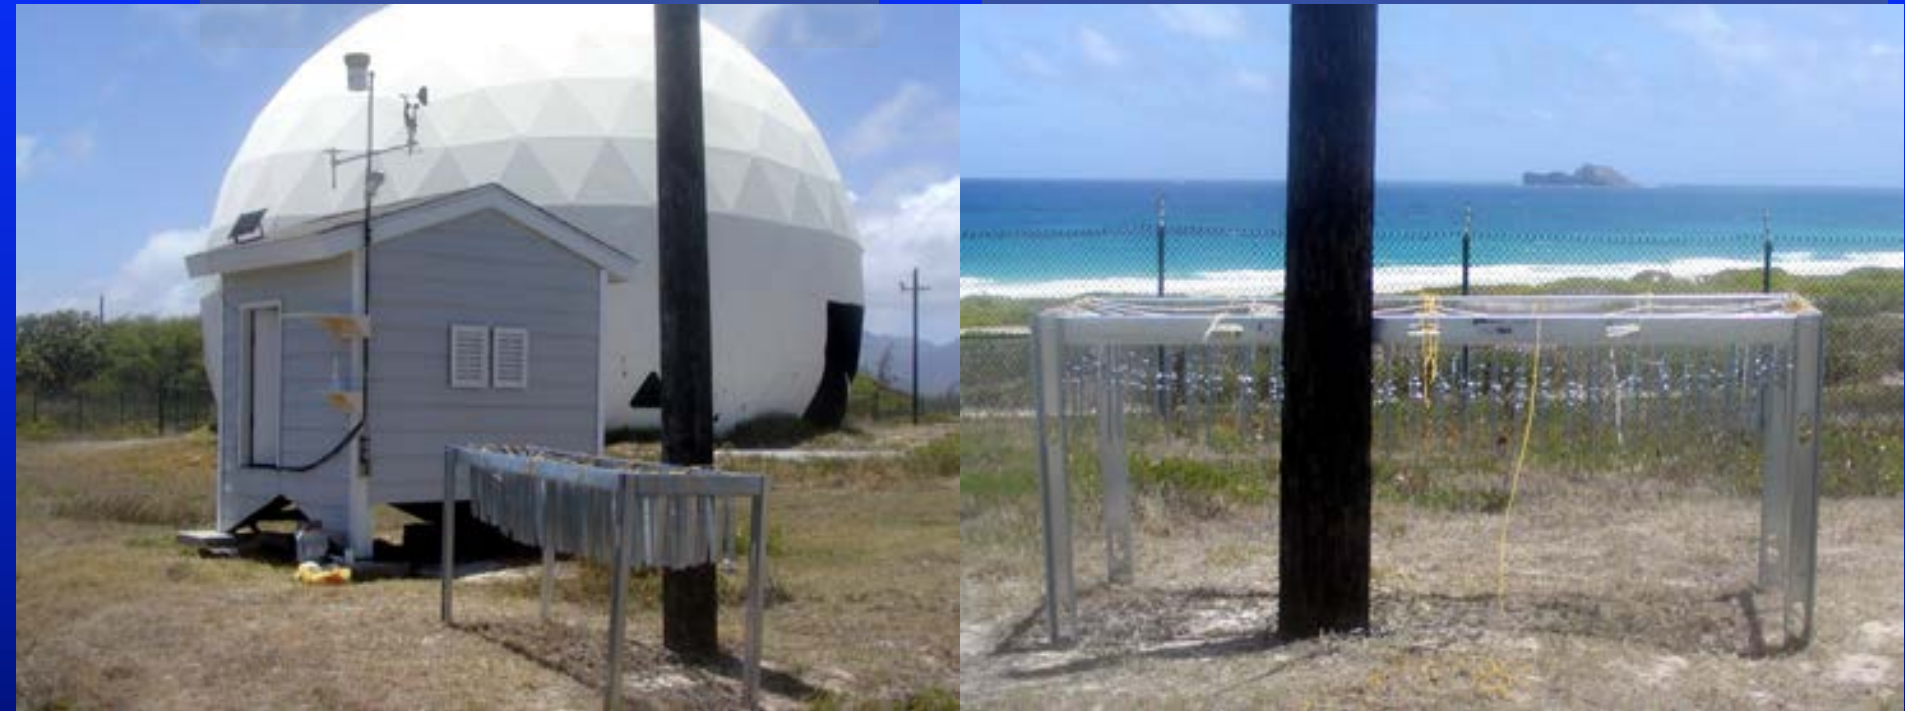
MCBH Coastal – Exterior Connections 7 Months Exposure

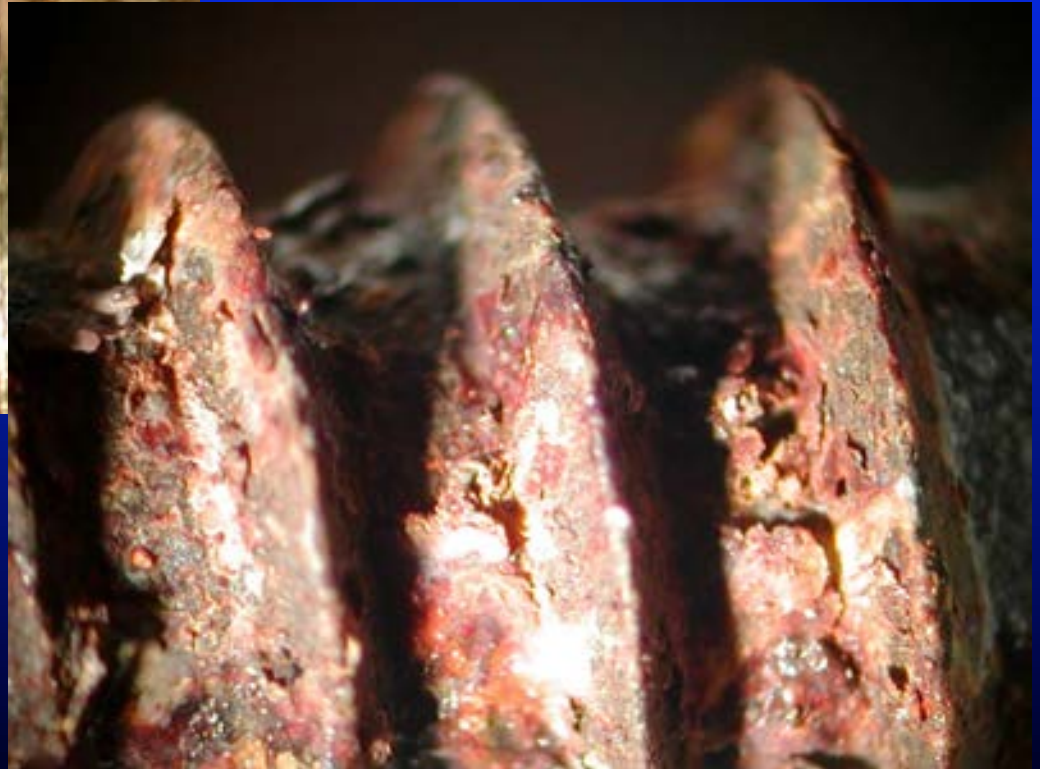
Microscopic Inspection

Screw
Threads -
Original

Screw
Threads -
1537 Cycles

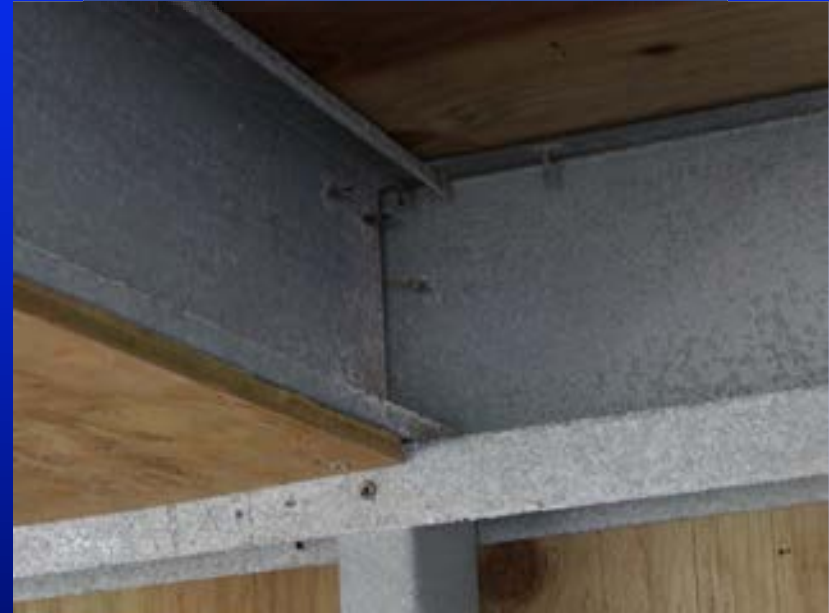
Exposed and Covered Floor Framing

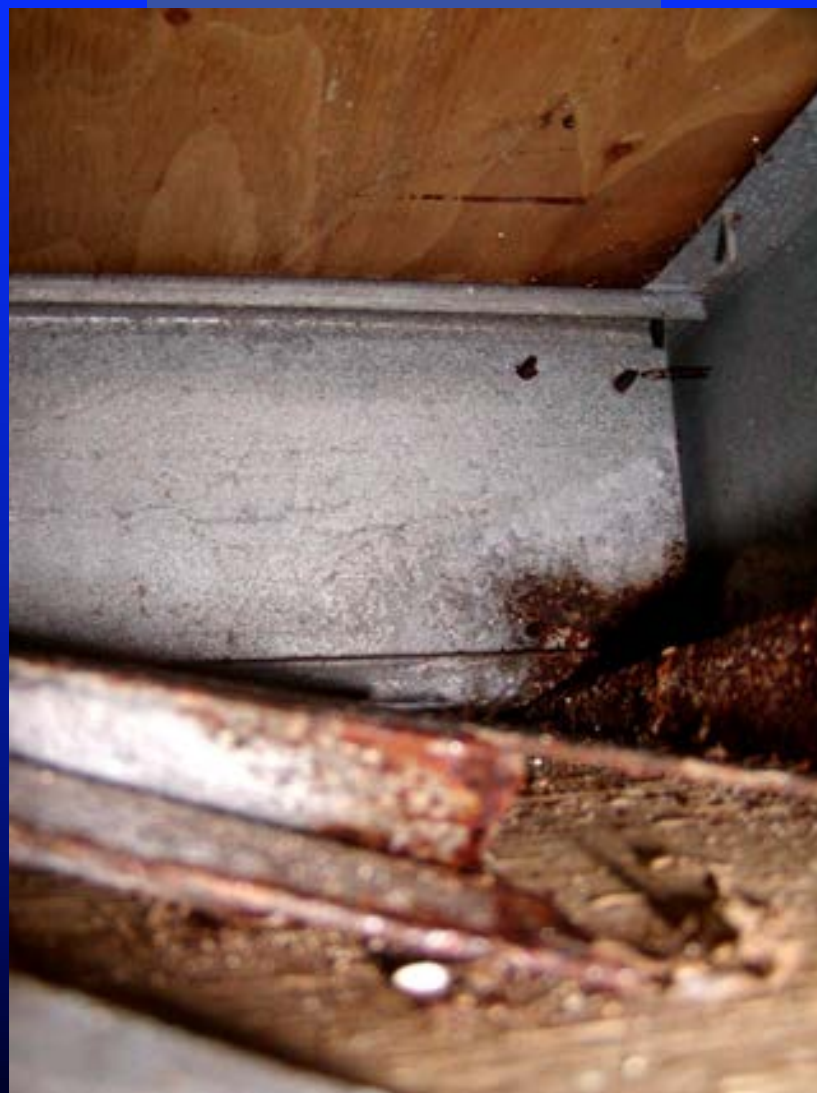
56 Months

Covered Crawl Space

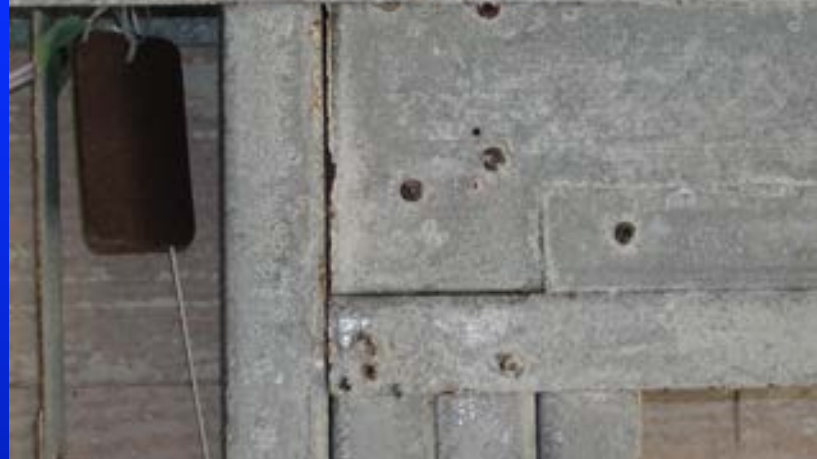
28 Months

Hardie Board without
Vapor Barrier

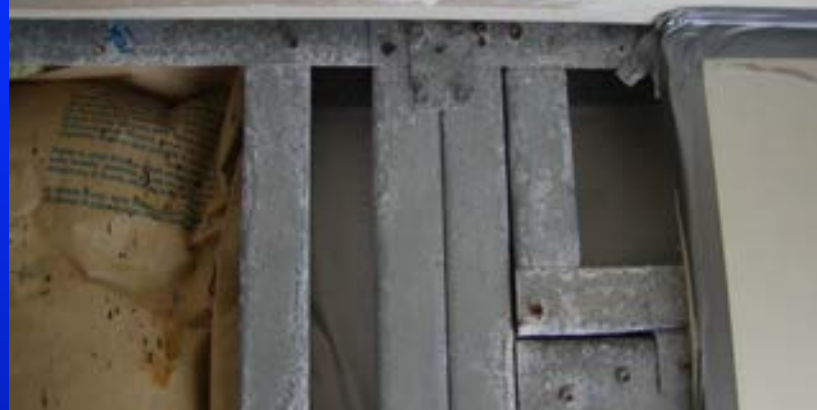
28 Months

Hardie Board with Vapor
Barrier

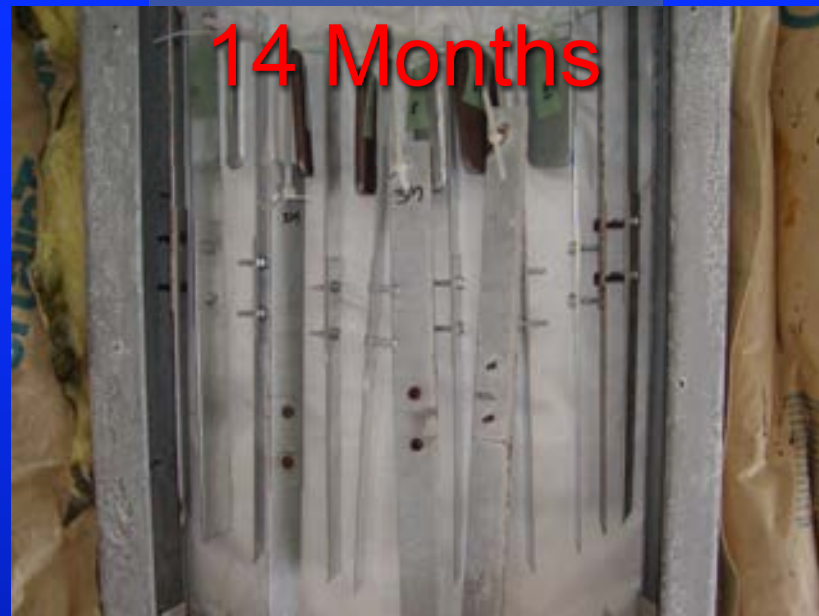
14 Months

Hardie Board with Vapor
Barrier

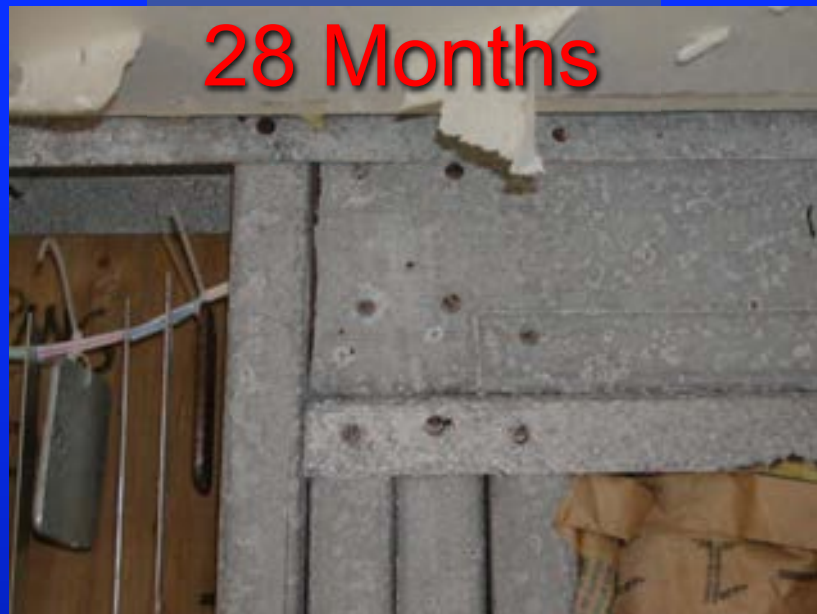
28 Months

Plywood without Vapor
Barrier
